April 8, 2024
Project#01349-0001

Subject: Summary of Instrumentation Monitoring
1st Quarter 2024
Bowie Coal Waste Disposal Area No. 3
Paonia, Colorado

**SUBJECT: Summary Report, 1st Quarter 2024, Vibrating Wire Piezometers
January – March 2024, Bowie Mine #2
Coal Waste Disposal Area (CWDA) #3**

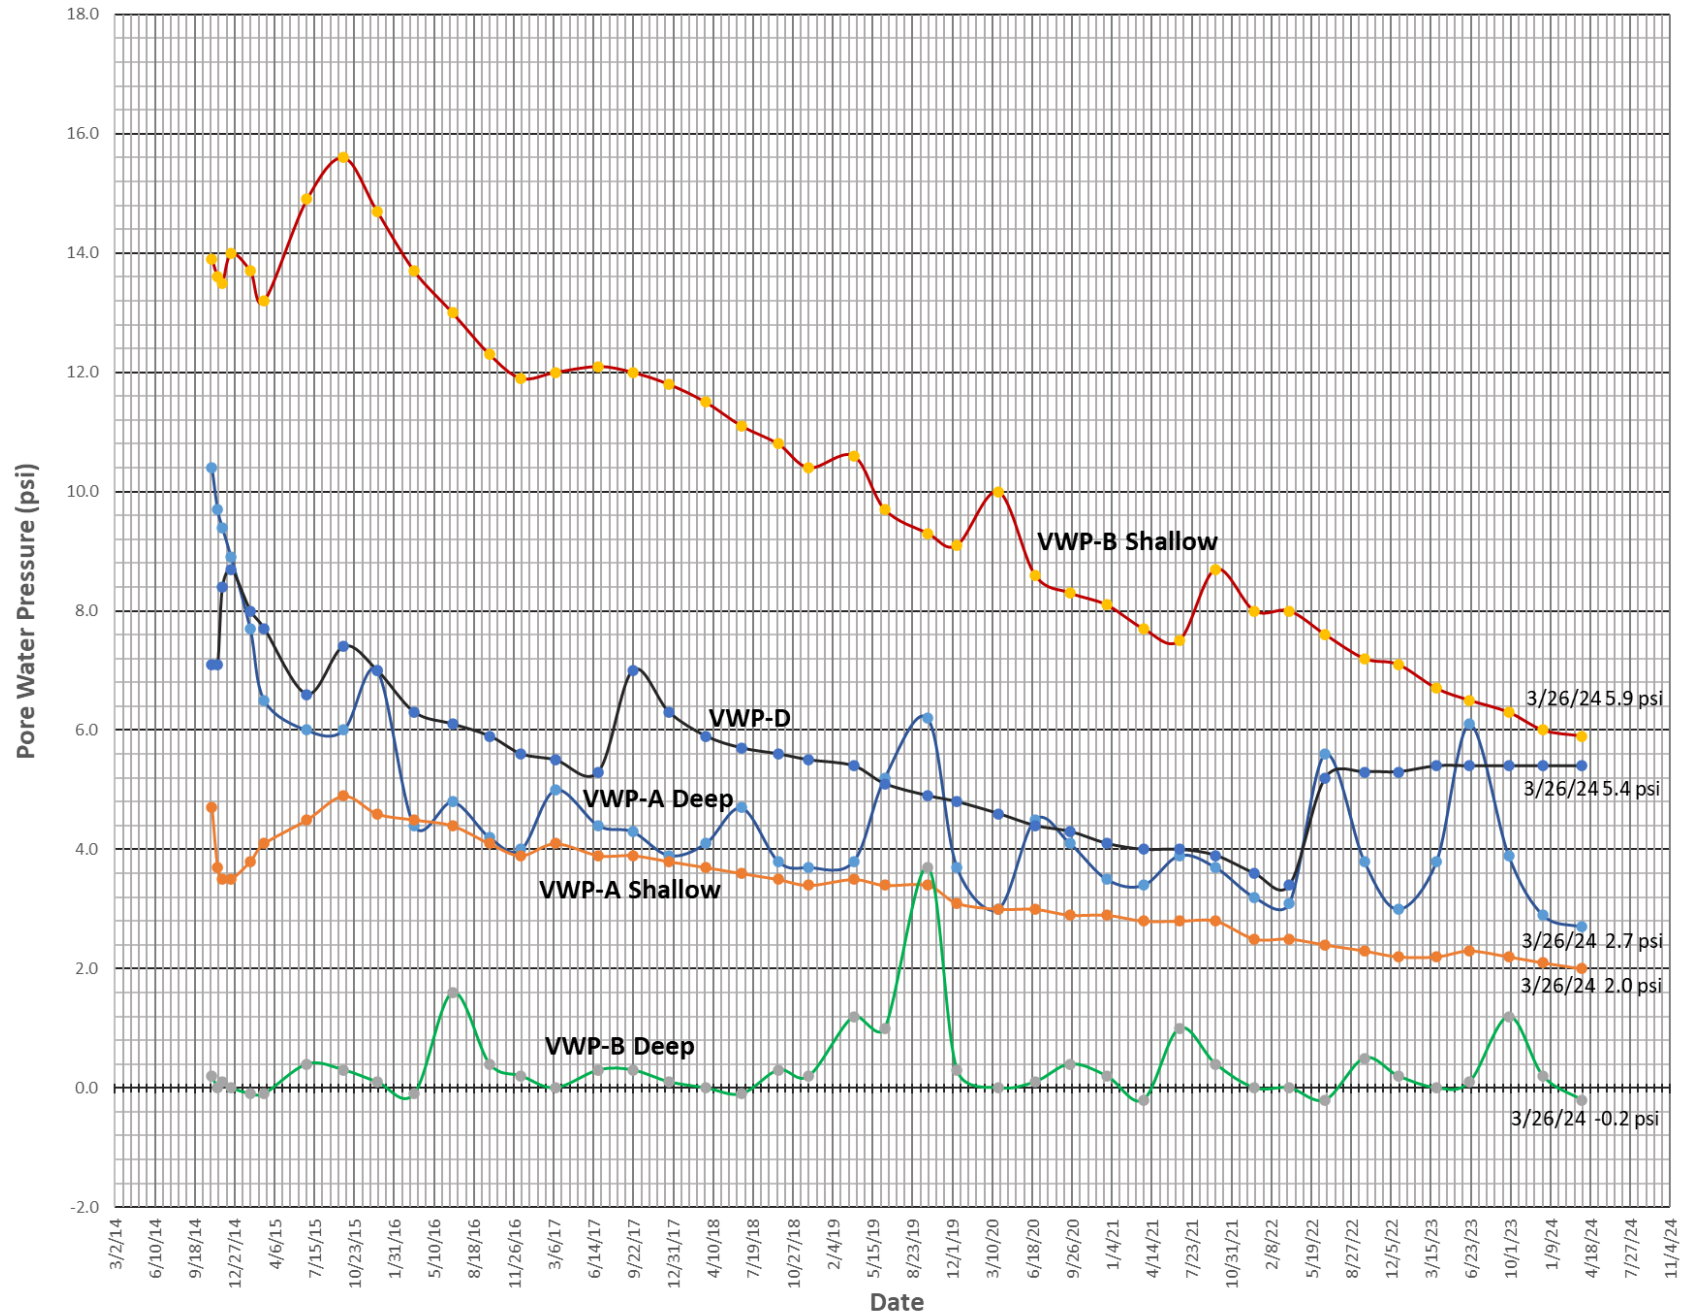
Figure 1 - Bowie Mine #2 - CWDA #3
Vibrating Wire Piezometer Data

As seen on Figure 1 and Table 1, when compared with the previous quarter, four VWP's decreased 0.1 to 0.4 psi and one (VWP-D) had no change in pore pressure. When compared with the 1st quarter of last year, four VWP's decreased 0.2 to 1.1 psi and one (VWP-B Deep) had no change in pore pressure. Since installation in 2014, all VWP's have generally decreased in pore pressure (by 0.4 to 8.0 psi). Although there is a general trend of decreasing pore pressure over time, two of the piezometers (VWP-A Deep and VWP-B-Deep) exhibit seasonal fluctuations in pore pressure since 2019 that roughly mirror each other. VWP-D had a general decline in pore pressures through much of its history until the second quarter of 2022 when pore pressures rose and then have stayed roughly the same elevated level since then.

We present a graph of measured pore pressures on the attached Figure 1 and numerically in Table 1 below. Table 1 is a summary of the initial, last year, last quarter, and current readings. In addition, we present the difference between the current pore pressures and those at the time of installation, the previous year, and the previous quarter.

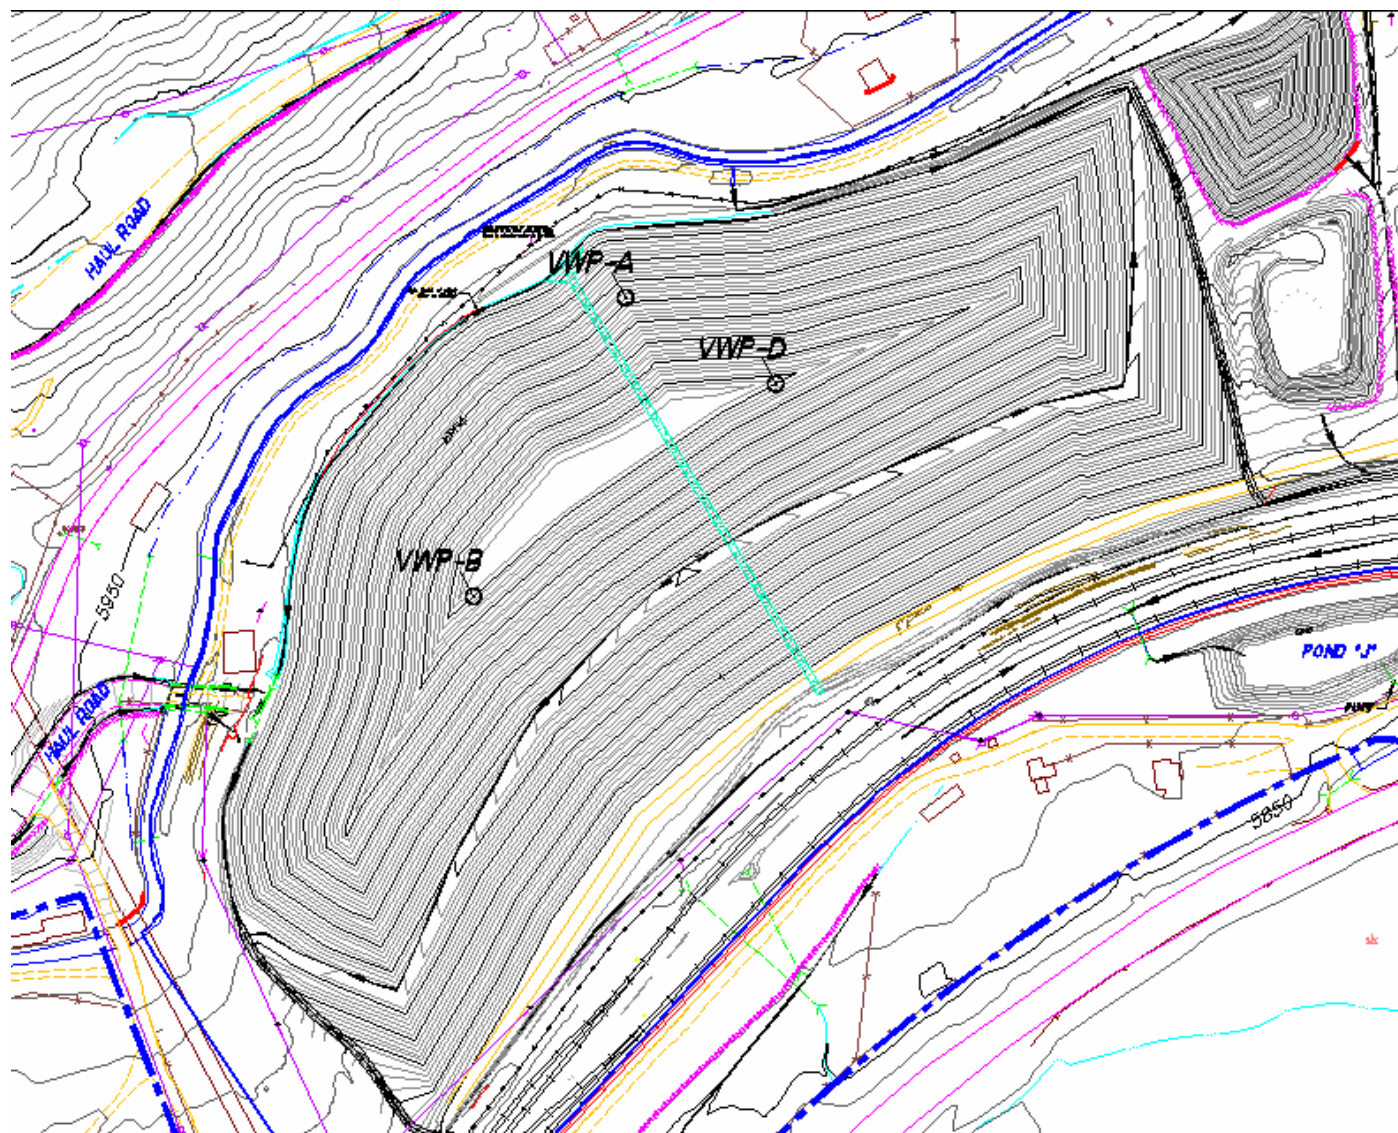
Five vibrating wire piezometers were installed in CWDA No. 3 in October 2014. The piezometers were installed at three locations within the footprint of the gob pile as shown on the attached figure. Monitoring of the functioning piezometers was completed by Buckhorn Engineering (Buckhorn) on March 26, 2024. The attached monitoring report prepared by Buckhorn includes the piezometer monitoring data and the data is summarized in the following table.
