Permit M-1980-244

Cresson Project Amendment 14

Geotechnical Evaluation of Structures

Exhibit T – Permanent Man-Made Structures

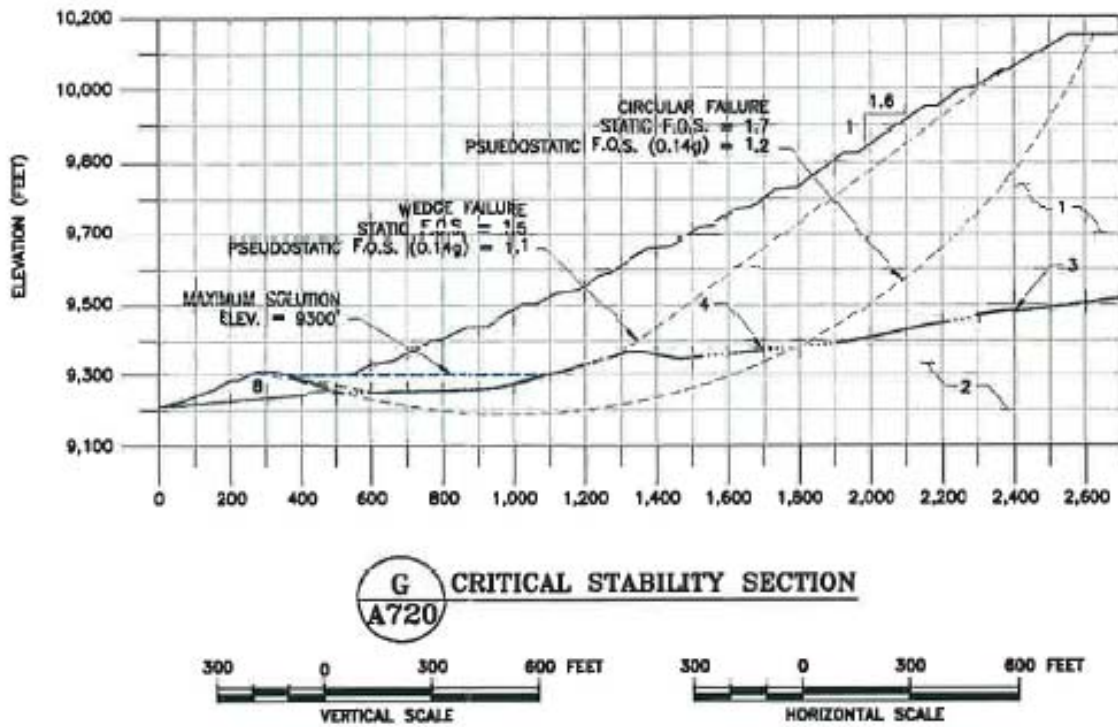
Highway 67 is at the extreme left at horizontal distance 0 feet in Cross Section G.
