PERMIT INFORMATION

Permit Number: C-1981-028 Mine Name: Keenesburg Strip Mine Operator: Coors Energy Company Operator Address: Mr. Ben Moline P.O. Box 4030 Golden, CO 80402	County: Weld Operation Type: Surface Permit Status: Permanent Cessation Ownership: Private
	Operator Representative Present: None
Operator Representative Signature: (Field Issuance Only)

INSPECTION INFORMATION

Inspection Topic Summary

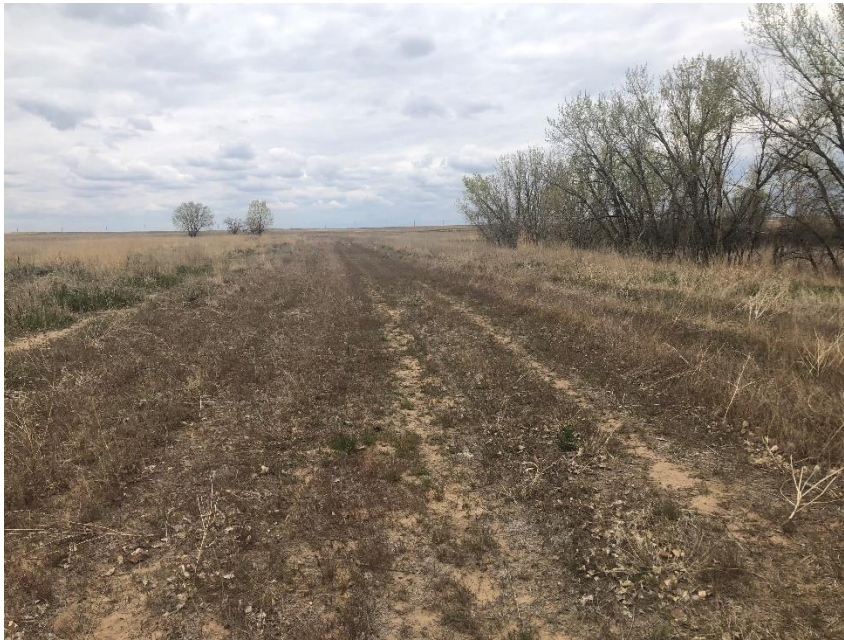
Green grasses were emerging in many locations, including Areas 37 and 42. Cheat grass was seen in several areas, including the reclaimed road by Sediment Pond 2 and the southwest corner of Area 37 (which was reseeded in 2023).

Reclaimed road adjacent to Sediment Pond 2

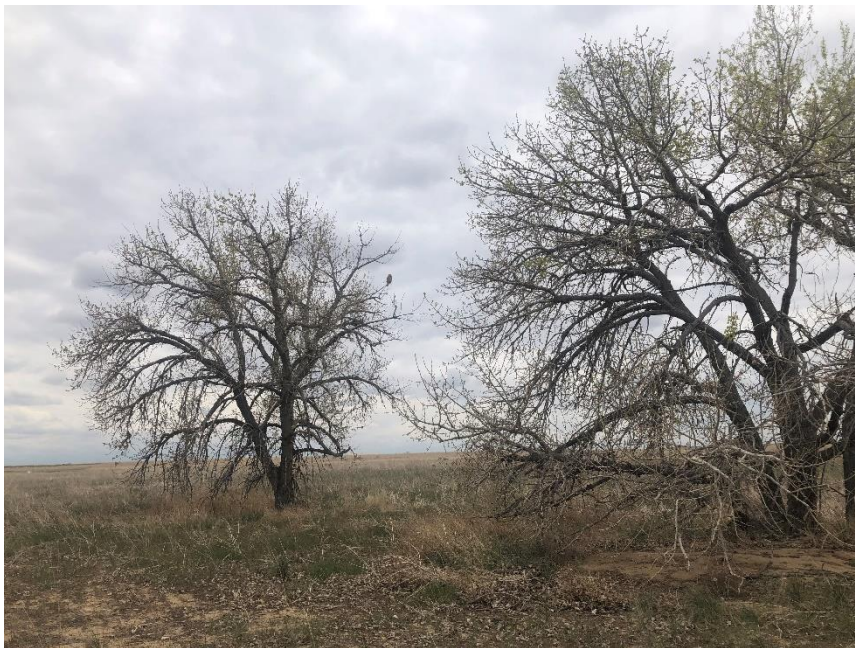
Many birds were seen and heard at Sediment Pond 2. An owl was seen in a tree west of the pond.

Owl in tree west of Sediment Pond 2

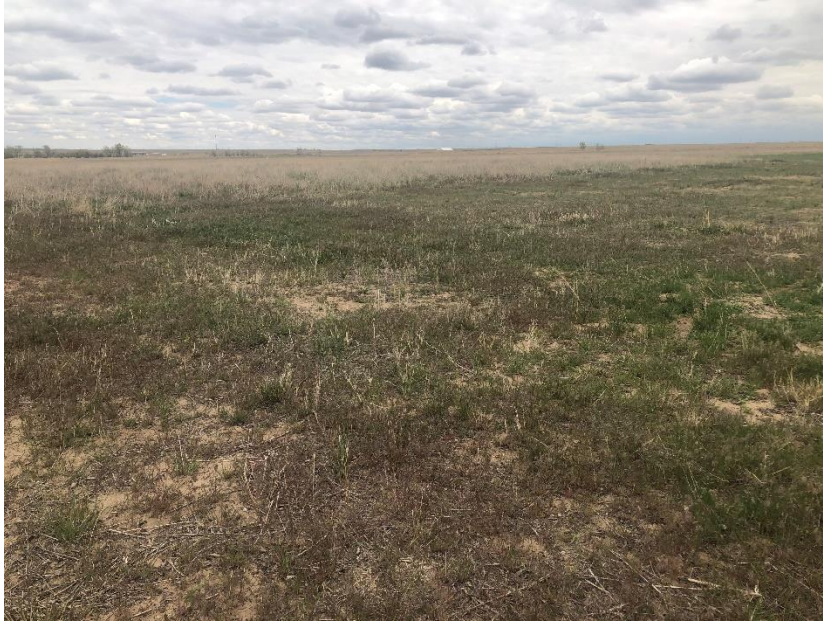
No erosion problems were seen onsite. A large bare area was still visible in the southern portion of Area 37, and minor erosion was seen in this area.

Area 37 – area reseeded in 2023

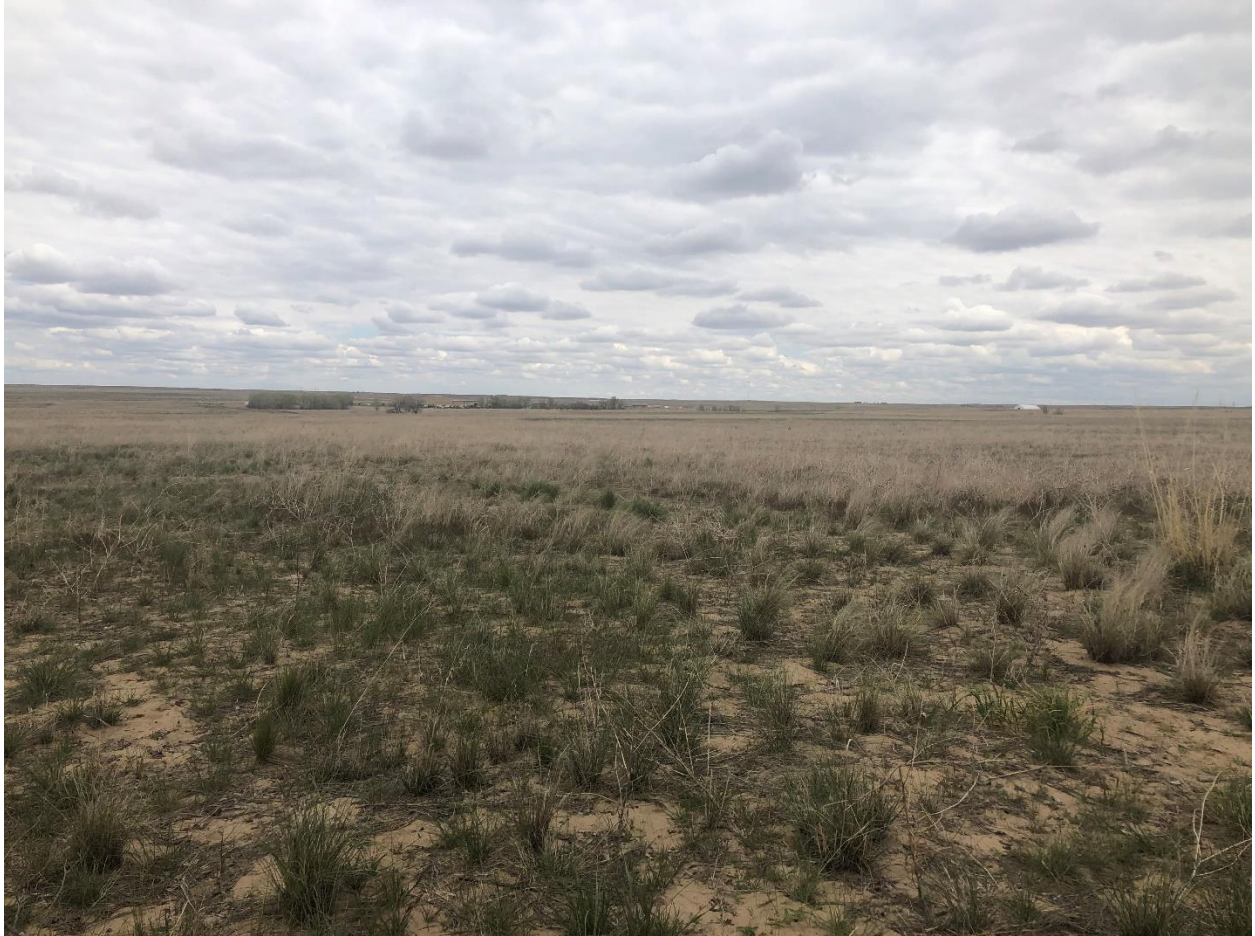
Long Term Spoil area, looking east from Area 44

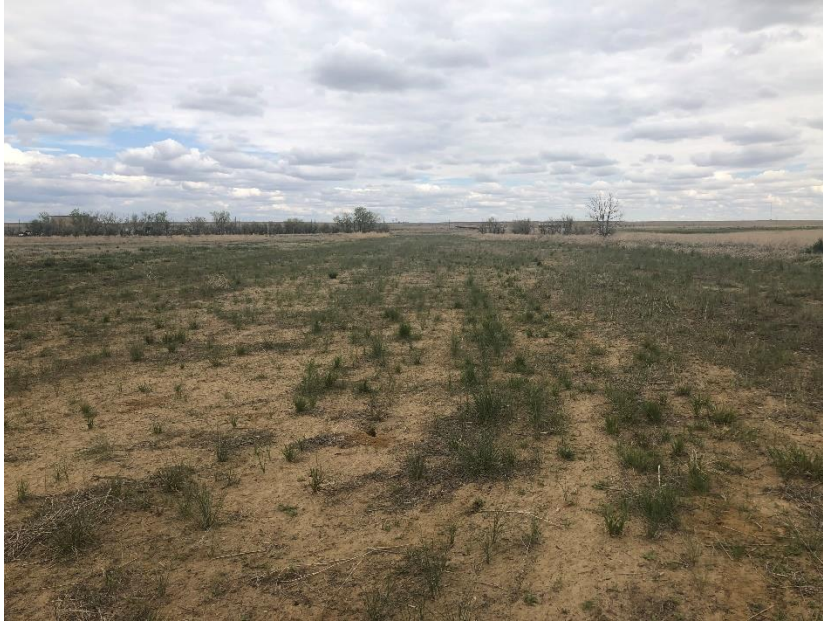
No water was visible in Sediment Pond 2 or the Dugout Pond. Both ponds contain thick vegetation that obscures their bottoms. They were not discharging during the inspection. There were no signs that either pond had discharged recently. No problems were observed with structures for the ponds.

Area 42 near Area 33, looking east toward Dugout Pond

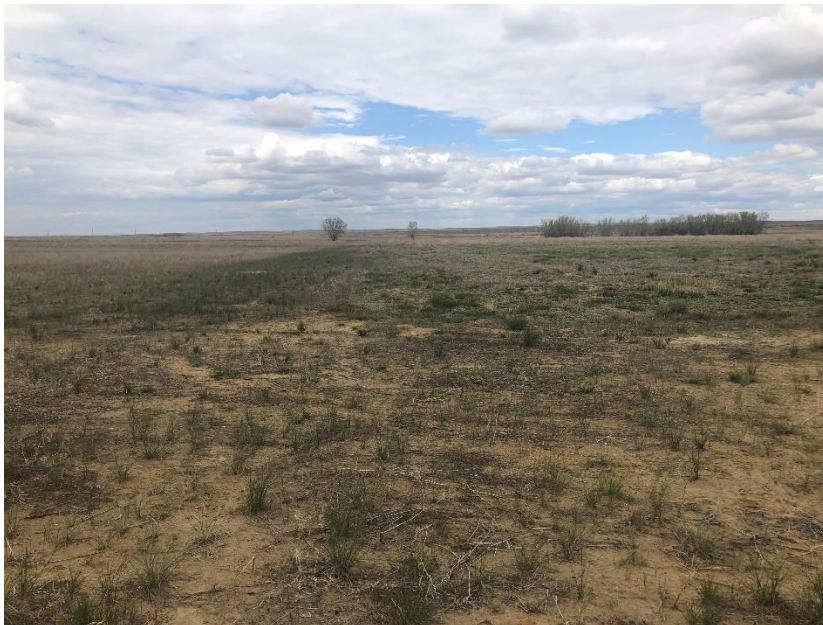
Area 42 near Area 33, looking north toward Sediment Pond 2
