MINERALS PROGRAM INSPECTION REPORT
PHONE: (303) 866-3567

MINE NAME: Ritchey Sand Pit Reclamation	MINE/PROSPECTING ID#: M-2023-027	MINERAL: Sand	COUNTY: Yuma
INSPECTION TYPE: Preoperation Inspection	WEATHER: Clear	INSP. DATE: April 24, 2024	INSP. TIME: 09:00
OPERATOR: Yuma County	OPERATOR REPRESENTATIVE: Tom Andersen	TYPE OF OPERATION: 110c - Construction Limited Impact	
REASON FOR INSPECTION: Preoperation Inspection	BOND CALCULATION TYPE: NA	BOND AMOUNT: NA – County Government	
DATE OF COMPLAINT: NA	POST INSP. CONTACTS: None	JOINT INSP. AGENCY: None	
INSPECTOR(S): Nikie Gagnon	INSPECTOR'S SIGNATURE:

This was a pre-operation inspection for the proposed Ritchey Sand Pit Reclamation Pit. Yuma County submitted a 110c application to comply with Board Order MV2023020. The application proposes to reclaim a 0.549 acre sand excavation on the side of a hill located at the intersection of County Roads HH.5 and 36 in Wray, CO. Nikie Gagnon with the Colorado Division of Reclamation, Mining and Safety (Division) conducted the inspection. Tom Andersen, representing Yuma County (Operator), accompanied the Division during the inspection. The weather was clear and warm and the site was dry.

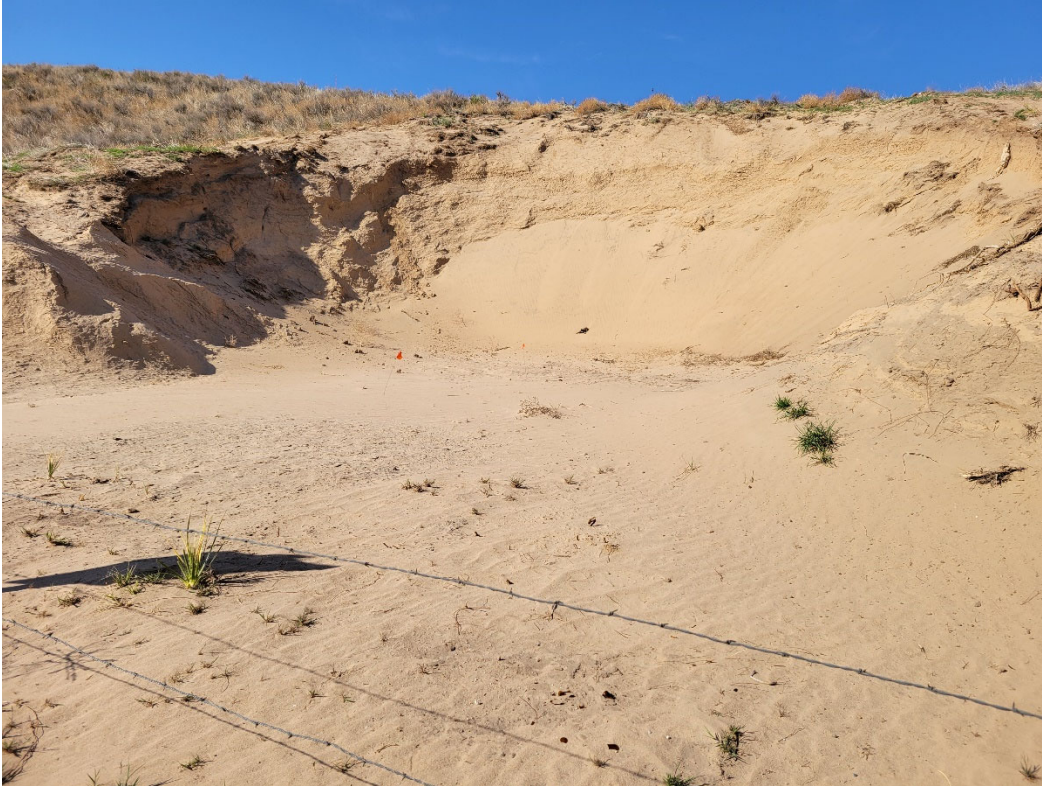
Yuma County submitted a reclamation only permit application and does not propose additional mining at the site. During the inspection the current site conditions were compared to the conditions noted during the complaint inspection conducted on August 31, 2023, and the descriptions provided in the reclamation application. The Division observed a sidehill excavation approximately 1200 square feet and 20 feet high. The Division did not see any evidence of ongoing excavation at the site. A barbed wire fence runs along the front of the pit to keep the public from removing additional material.

Photo 1: View of the excavation from County Road 36. Barbed wire fence installed along the front of the pit in the foreground.

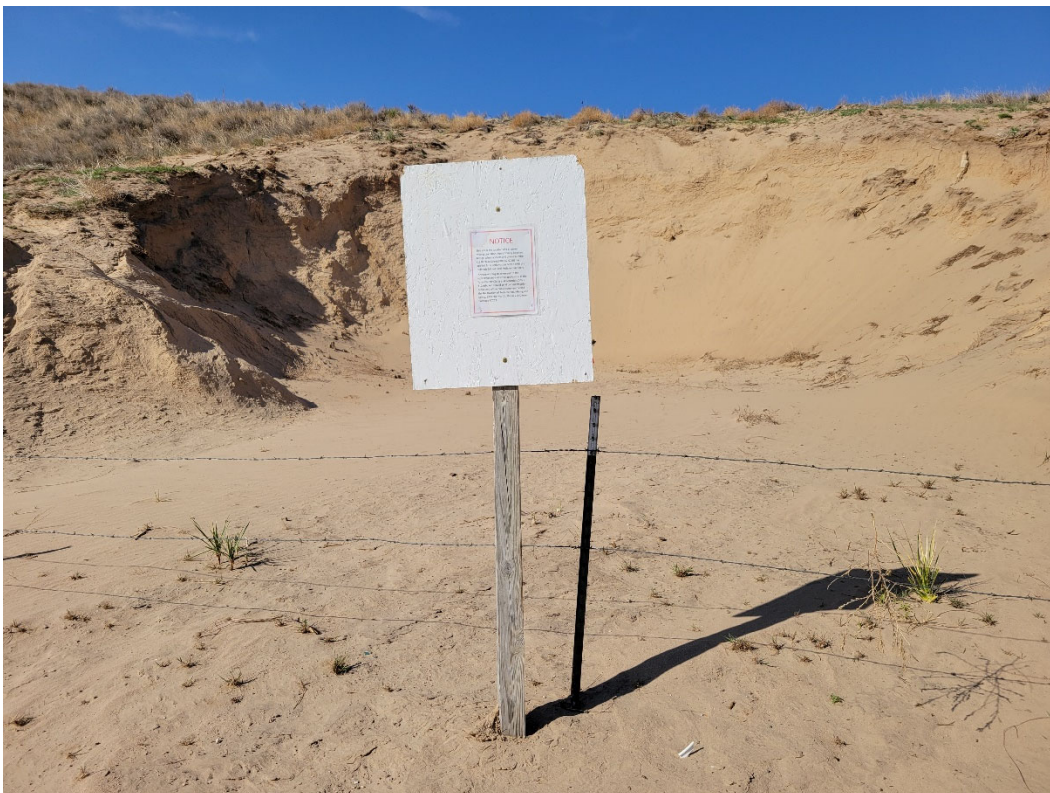
A public notice sign was posted at the front of the excavation in accordance with Rule 1.6.2(1)(b). Permit boundary markers were observed at the four corners of the permit area. The Operator provided GPS points for the marker locations, and these were confirmed in the field and correlate with the affected area shown on the reclamation map submitted with the application.

Photo 2: Public notice sign posted at the front of the excavation.

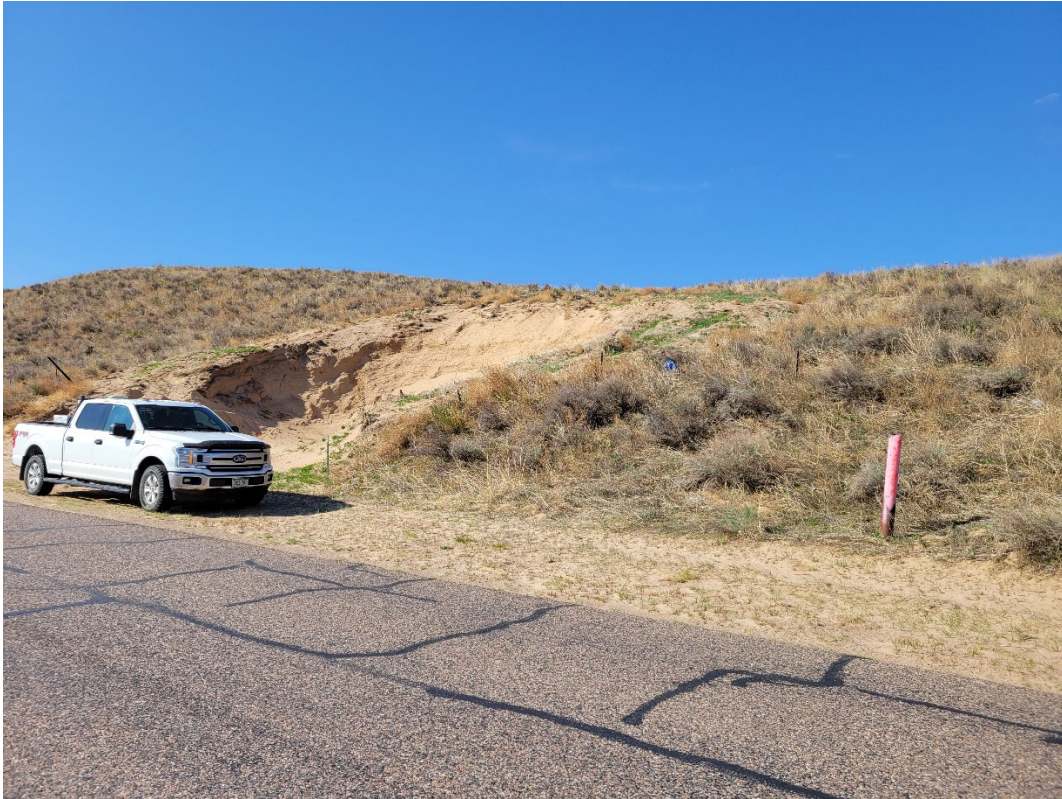
Photo 3: View showing the size of the excavation from across the road.

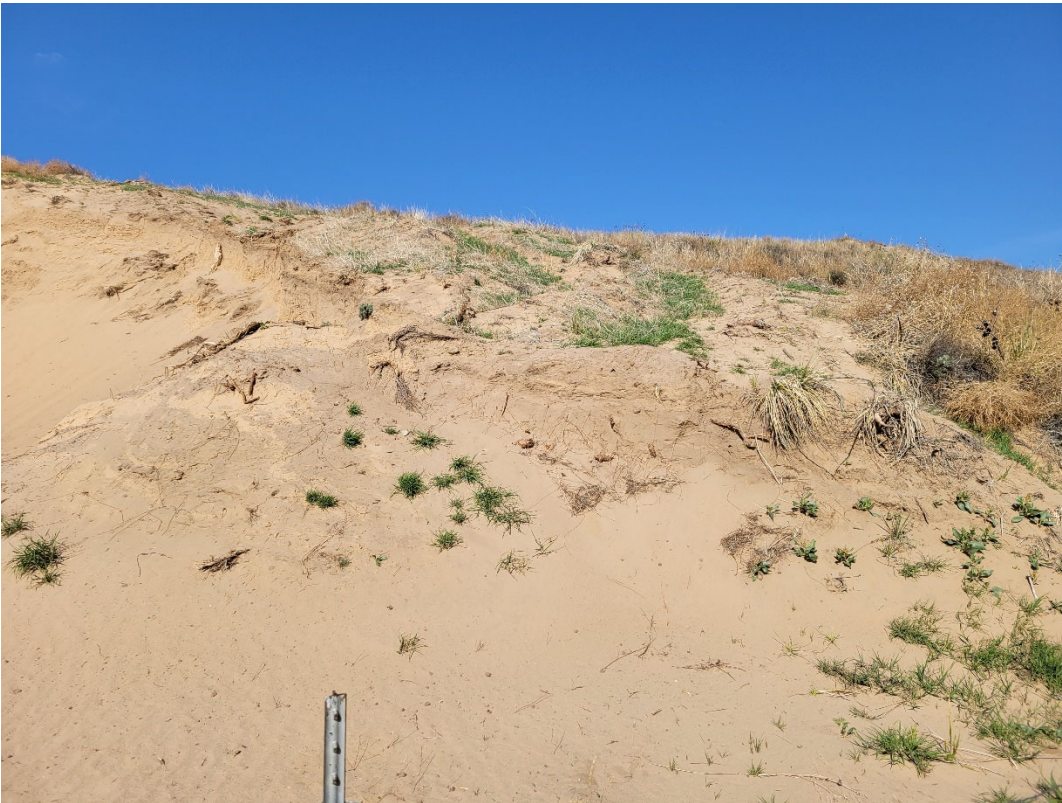
The excavation is on the side of a large sand hill and the current land use is pastureland. The Operator consulted with the local conservation service and submitted their recommended seed mix and general guidelines for successful reclamation of the site. The Division observed vegetation and topsoil that was salvaged around the pit prior to excavation. According to the Reclamation Plan in the application, the Operator plans to place this material on top to help in revegetating the slope after backfilling to a 3:1 slope is complete. The NRCS recommendations include broadcast seeding at a double rate, and applying 2300 lb/ac of straw mulch, crimped or blown on after seeding. According to the Reclamation Plan, the Operator plans to water the site with a water truck to speed up the establishment of vegetation. The Division recommends monitoring for weeds and treating as necessary until the site is released.

Photo 4: View of the north side of the excavation. Soil and vegetation pushed to the sides during excavation that will be pushed back and used for reclamation.

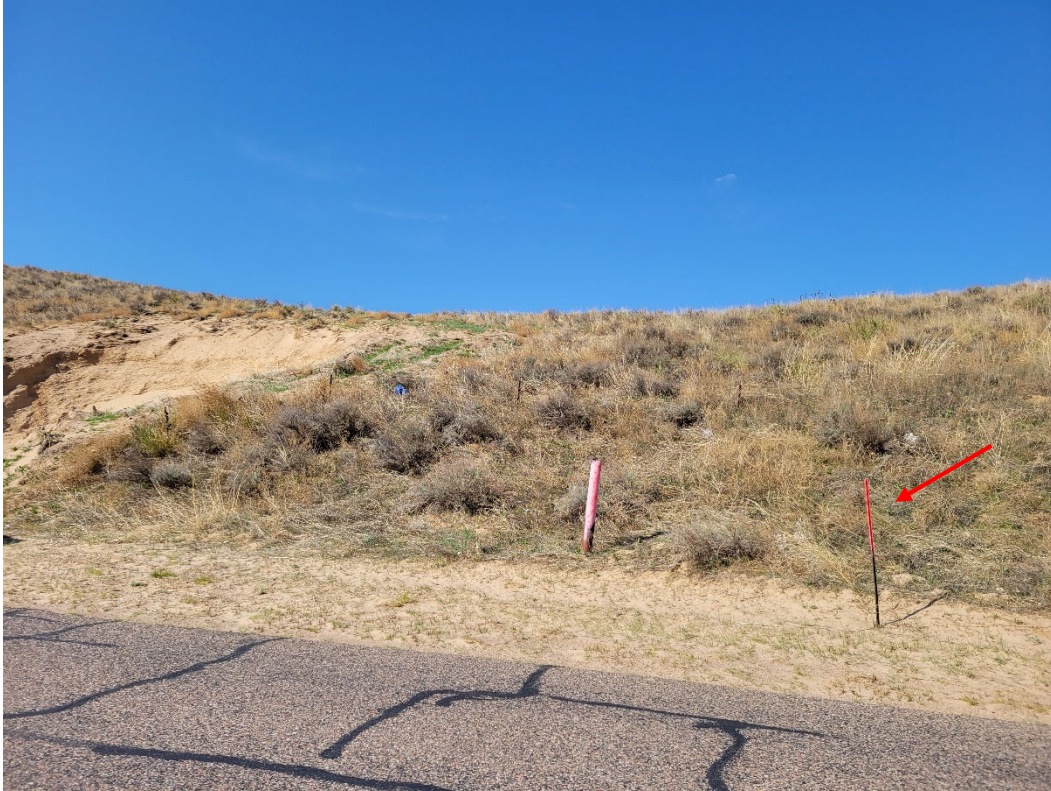
Photo 5: Boundary marker on the north side.

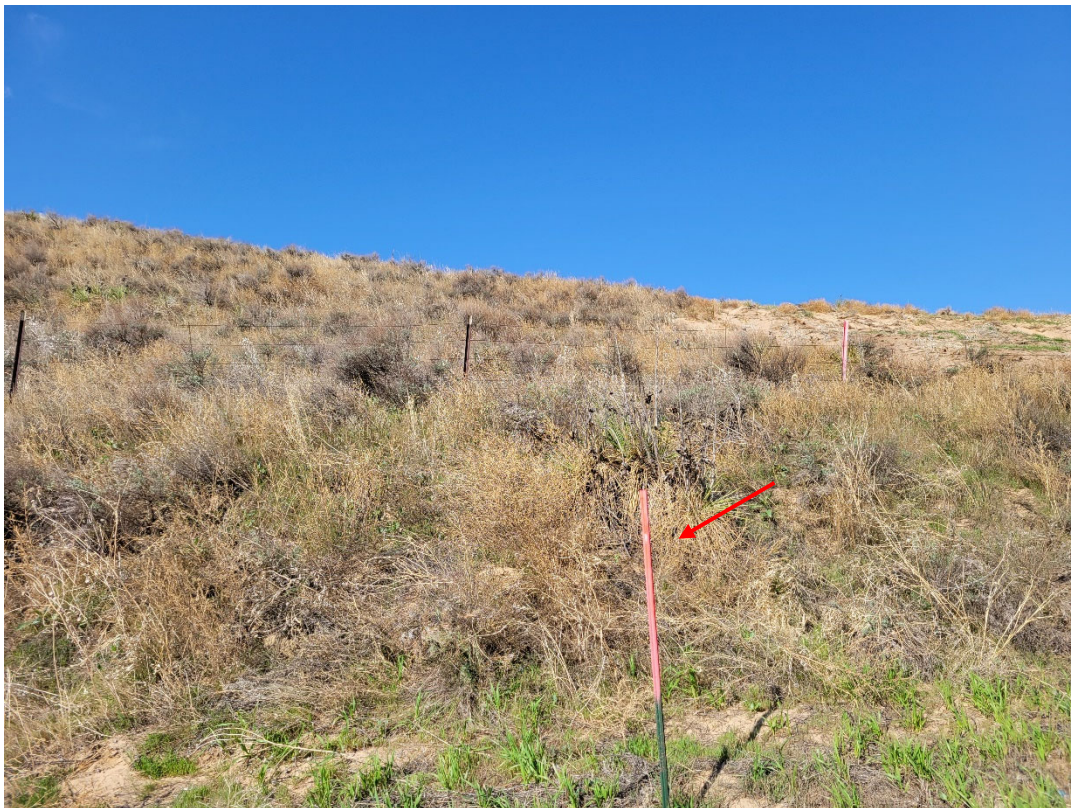
Photo 6: Boundary marker on the south side.
