MINERALS PROGRAM INSPECTION REPORT
PHONE: (303) 866-3567

MINE NAME: Tallahassee Resources Exploration	MINE/PROSPECTING ID#: P-2023-015	MINERAL: Uranium	COUNTY: Fremont
INSPECTION TYPE: Monitoring	WEATHER: Clear	INSP. DATE: May 3, 2024	INSP. TIME: 10:00
OPERATOR: Tallahassee Resources LLC	OPERATOR REPRESENTATIVE: Tim Brown	TYPE OF OPERATION: MP - Mineral Prospecting	
REASON FOR INSPECTION: Normal I&E Program	BOND CALCULATION TYPE: None	BOND AMOUNT: \$115,568.00	
DATE OF COMPLAINT: NA	POST INSP. CONTACTS: None	JOINT INSP. AGENCY: None	
INSPECTOR(S): Hunter Ridley	INSPECTOR'S SIGNATURE:

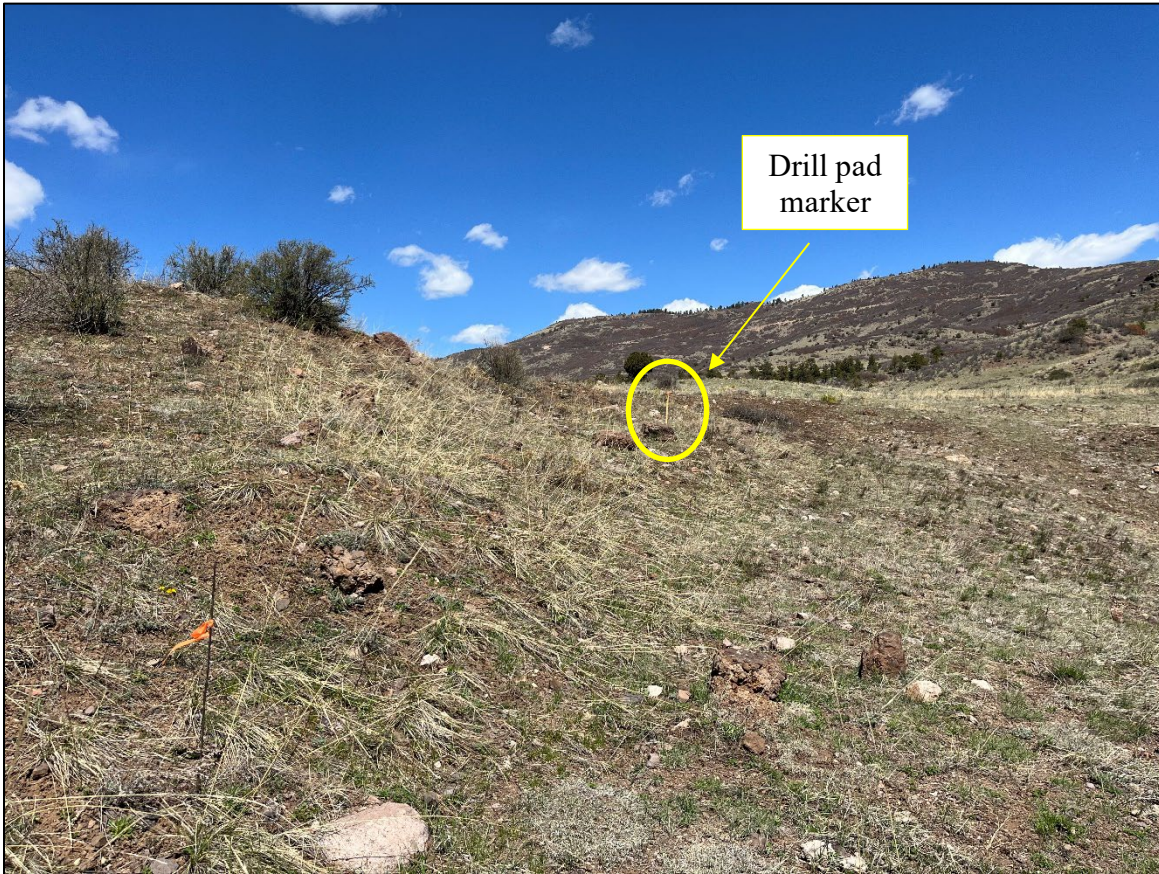
Backfilling and Grading: Twenty boreholes have approved to be drilled for the project. Mr. Brown stated that there would likely be a reduced number of holes drilled than what was originally permitted. The Division visited each of these proposed sites. Only one site will require earthwork to level the area for a drill pad (Photo 1). Total earthwork disturbances will be less than the approved 4.5 acres of max allowed affected acreage.

Photo 1: View north of a proposed drill site near S Tallahassee Trail, this is the only pad site which will require earthwork to level.

Gen. Compliance with Mine Plan: Planned locations for drill holes and pads were marked with wooden posts and orange flags (Photos 1 and 3). Smaller posts also marked out the proposed trails to be utilized between the main road and the drill pad.

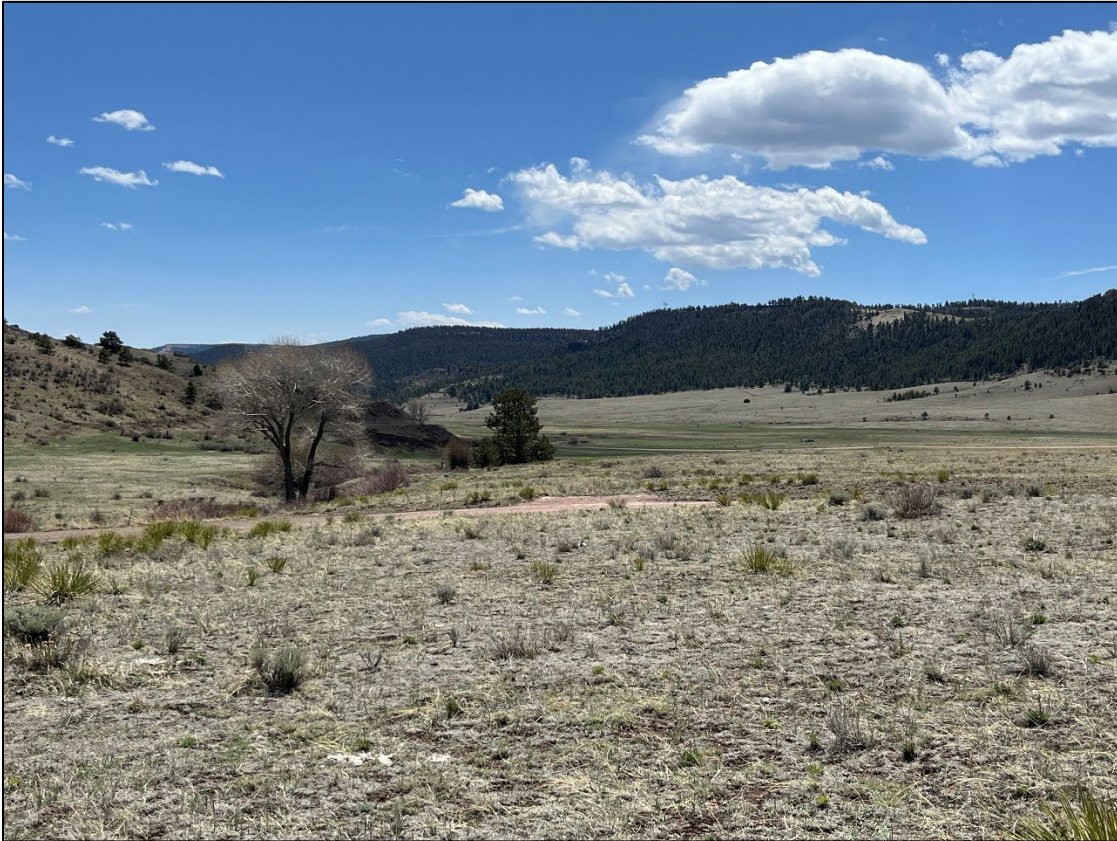
Hydrologic Balance: A Solids Removal Unit (SRU) will be used for this drilling operation. This eliminates the need for sumps to be constructed at the drill sites as drill cuttings and water will be contained within the SRU system. The MLRB has approved Tallahassee Resources LLC's justification that the proposed methods and timeline of this drilling project significantly reduce the risk of any cross contamination with groundwater. A buffer will be maintained between drilling operations and the small stream which flows to Middle Tallahassee Creek (Photo 2).

Photo 2: View southeast of a proposed drill site, activity will maintain a buffer along the small stream which flows through this area to Middle Tallahassee Creek.

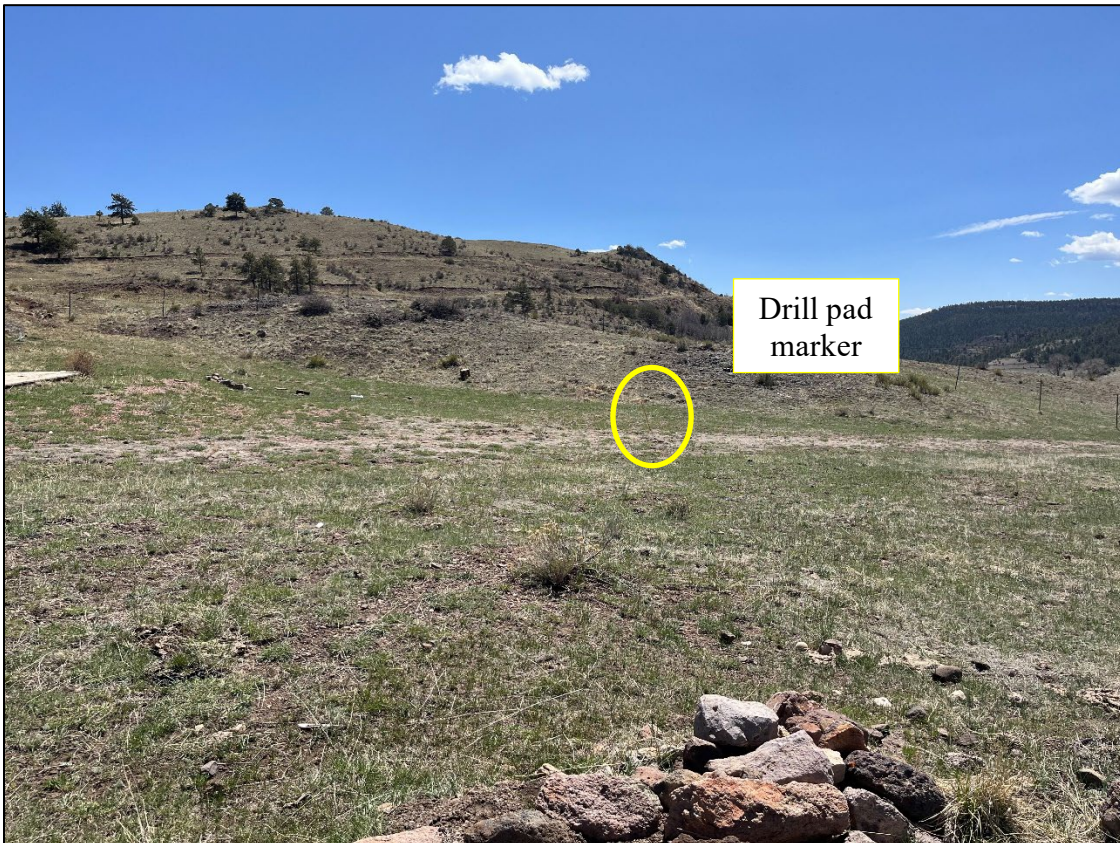
Photo 3: View east of a proposed drill pad.
