Keenesburg Strip Mine inspection report

INSP-REPORTC_C1981028_RDZ_05302024.pdf

Permit Number: C-1981-028 Mine Name: Keenesburg Strip Mine Operator: Coors Energy Company Operator Address: Mr. Ben Moline	County: Weld Operation Type: Surface Permit Status: Permanent Cessation Ownership: Private			
P.O. Box 4030	Operator Representative Present:			
Golden, CO 80402	operator representative resent.			
Golden, CO 80402	None			
Operator Representative Signature: (Field Issuance Only)

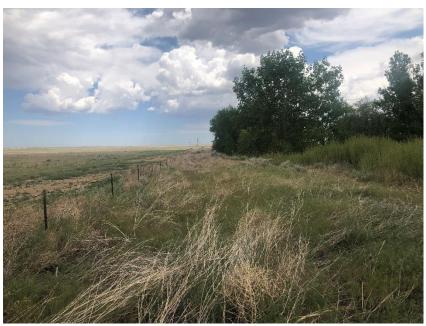
Sediment Pond 2 and the Dugout Pond contained no visible water. In both ponds the bottom is obscured by heavy vegetation. They were not discharging during the inspection. There were no signs that either pond had discharged recently. No problems were observed.

Sediment Pond 2, looking east towards spillway

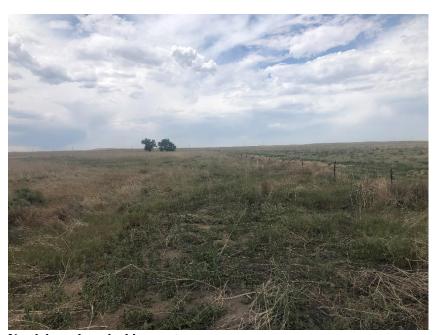
The northern boundary of the site (the down gradient side) was observed, and no signs of pollutant loading from the mine site, or any other problems, were seen. All other sides were also observed, and no problems were seen.

North boundary, looking west

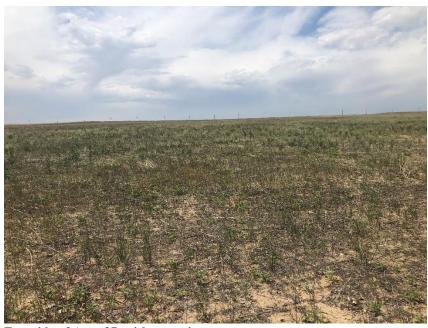
Area 37 – On the east side of this area, green grass, sunflowers, and other desirable species were seen. In the southwest corner of this area (which was harrowed and re-seeded in 2023), a large amount of cheat grass is present.

East side of Area 37, with emerging grasses

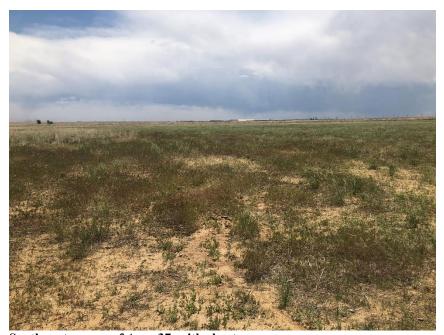
Southwest corner of Area 37, with cheat grass

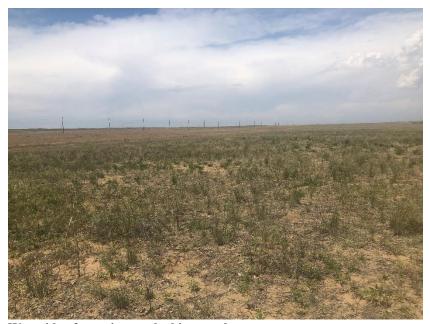
West side of permit area, looking northwest

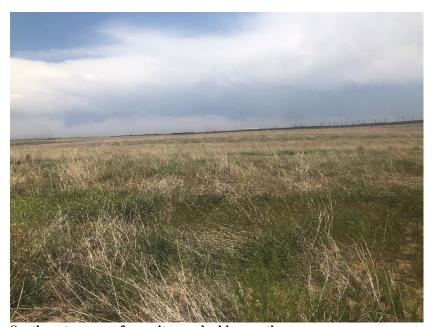
The southwest corner of the site (Areas 29 - 32) were observed from afar, and the cover appears to be excellent.

Southwest corner of permit area, looking south
