**MINERALS PROGRAM INSPECTION REPORT**  
**PHONE: (303) 866-3567**

<b>MINE NAME:</b> Klassen Pit	<b>MINE/PROSPECTING ID#:</b> M-2006-047	<b>MINERAL:</b> Sand and gravel	<b>COUNTY:</b> Kit Carson
<b>INSPECTION TYPE:</b> Monitoring	<b>WEATHER:</b> Foggy	<b>INSP. DATE:</b> February 16, 2024	<b>INSP. TIME:</b> 12:20
<b>OPERATOR:</b> Kit Carson County	<b>OPERATOR REPRESENTATIVE:</b> Dave Hornung	<b>TYPE OF OPERATION:</b> 110c - Construction Limited Impact	
<b>REASON FOR INSPECTION:</b> Normal I&E Program	<b>BOND CALCULATION TYPE:</b> None	<b>BOND AMOUNT:</b> NA- Government Site	
<b>DATE OF COMPLAINT:</b> NA	<b>POST INSP. CONTACTS:</b> None	<b>JOINT INSP. AGENCY:</b> None	
<b>INSPECTOR(S):</b> Elliott Russell	<b>INSPECTOR'S SIGNATURE:</b>

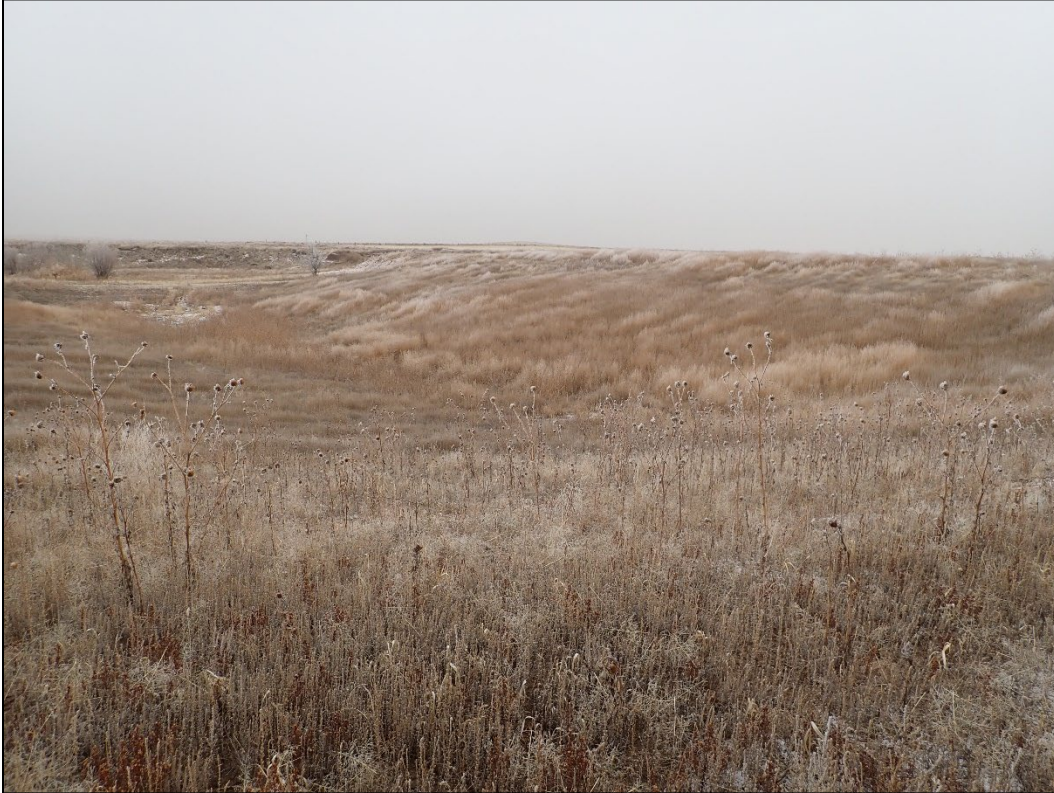
Backfilling and Grading: All slopes appeared to be appropriately backfilled and/or graded.

Sediment Control: The slopes within the permit boundary appeared stable and showed no signs of erosion.

Revegetation: Although dormant, the Division has determined that the affected lands were vegetated with a diverse stand of mature grass species. Vegetative cover appeared to match adjacent off-site areas. Although the site contained annual weedy species, there were no noxious weed infestations were observed.

**Photo 1.** Sample photo of reclamation work (southern slope); looking southeast.

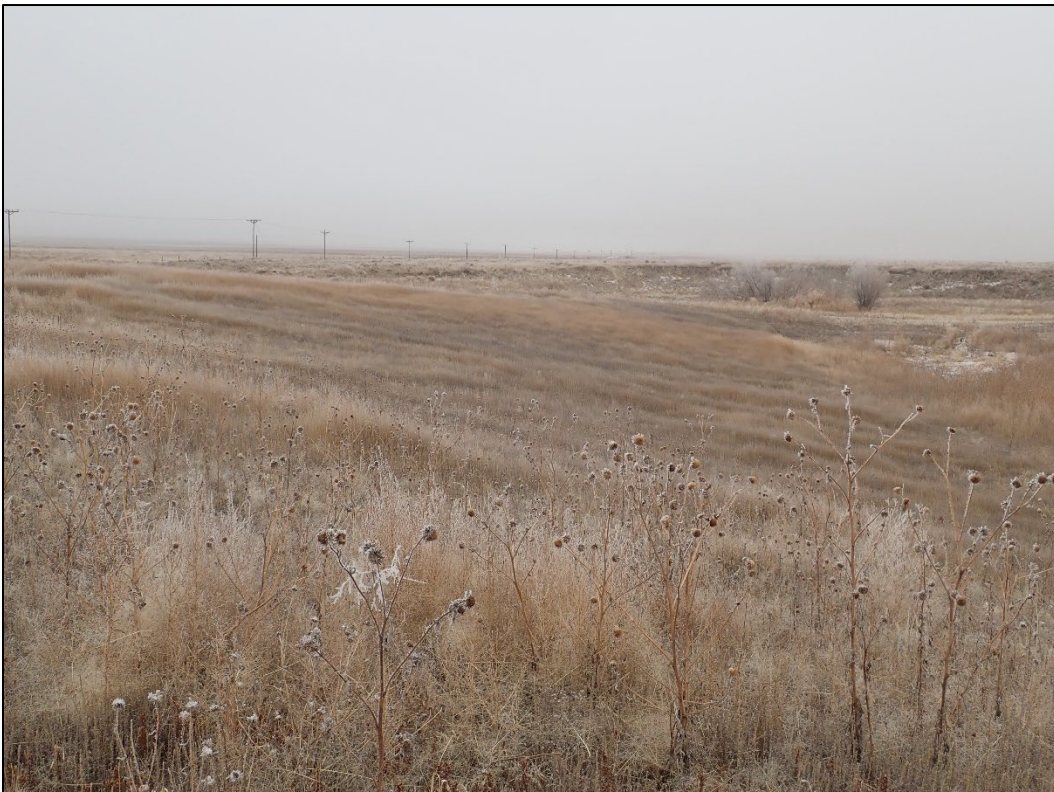
**Photo 2.** Sample photo of reclamation work (northern slope); looking east.

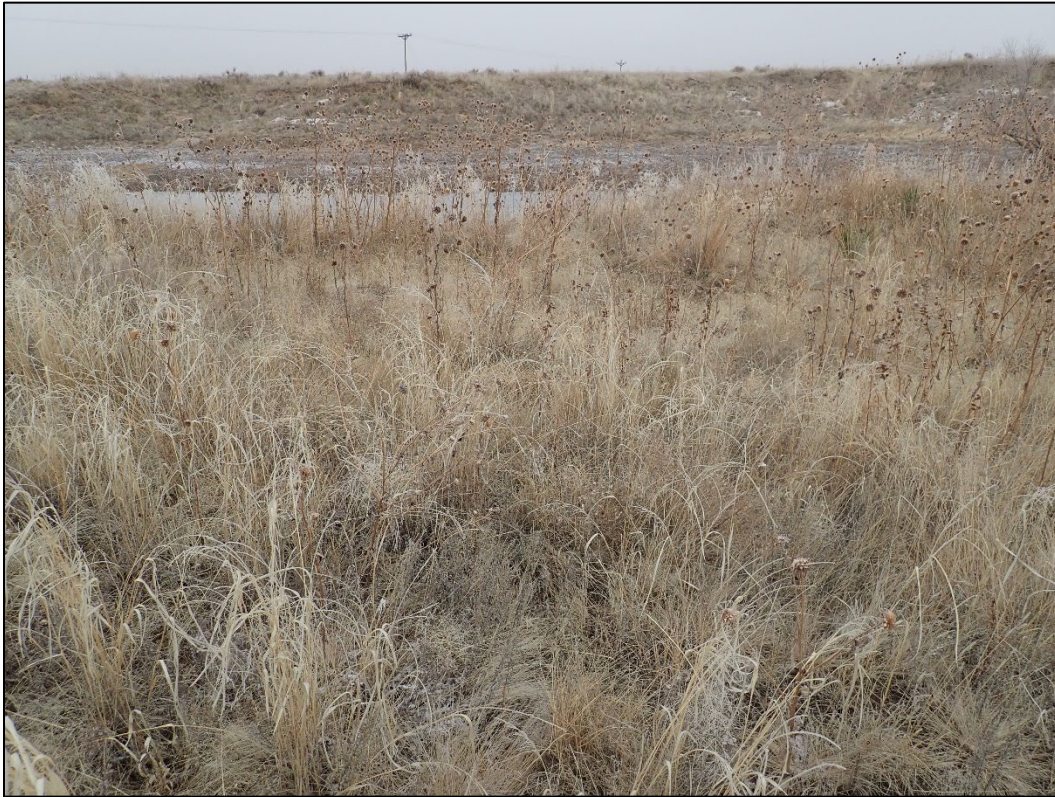
Reclamation Success: Reclamation efforts appeared to have been successful. Nothing observed during the inspection would prevent the Division from approving the release request. **The Division will approve the release request at this time.** The final release of paperwork and performance warranty will be returned to the Operator after the 30-day appeal period has expired if there are no objections to the release decision.

**Photo 3.** Sample photo of reclamation work; looking east.
