# C1981022, Elk Creek Mine, June Inspection Report

Permit Number: C-1981-022 Mine Name: Elk Creek Mine Operator: Oxbow Mining, LLC Operator Address: Mr Doug Smith	County: Delta, Gunnison Operation Type: Underground Permit Status: Active Ownership: Private		
3737 Hwy 133	<b>Operator Representative Present:</b>		
P. O. Box 535	•		
Somerset, CO 81434	N/A		
Operator Representative Signature: (Field Issuance Only)

Inspection Start Date: June 13, 2 Inspection Start Time: 08:30 Inspection End Date: Inspection End Time:	024		Inspection Type: Coal Complete Inspection Inspection Reason: Normal I&E Program Weather: Clear	
Joint Inspection Agency:		Joint Inspection Contacts:		
None				
Post Inspection Agency:		Post Inspection Contacts:		
None				
Inspector(s):	Inspector's Signature: Signature Date:			
Leigh Simmons	Bi		June 13, 2024

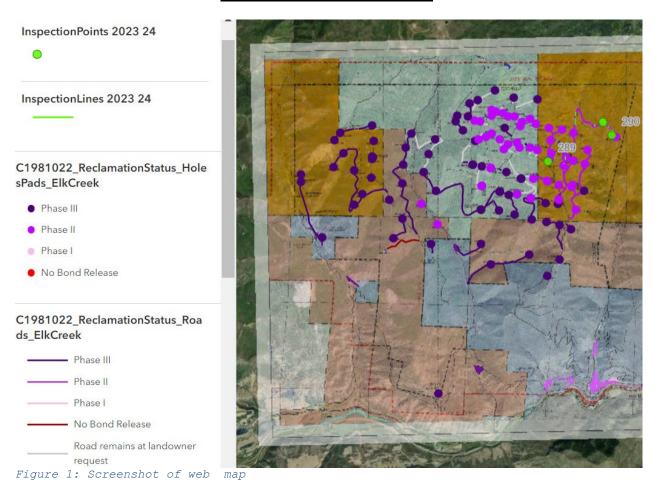
A screenshot of the web map used during the inspection is shown in Figure 1 with a legend, and a more zoomed in screenshot of the same map without the legend is given in Figure 2. Reclaimed pads and roads are shown in purple, and inspection features are shown in green.

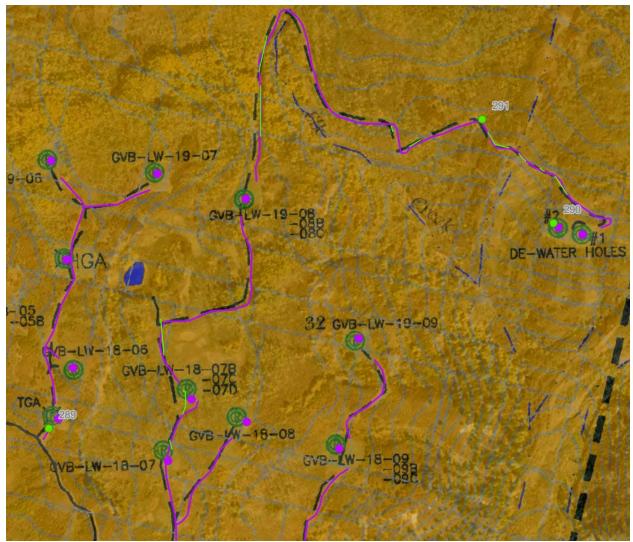
Figure 2: Area inspected, with green lines representing weedy areas

The reclaimed areas inspected were generally very well vegetated, with excellent cover and diversity in comparison to the adjacent undisturbed areas. The long segment out to the DW-1 and DW-2 pad was inspected. Some weeds were observed, with Canada thistle (*Cirsium arvense*) the most prevalent by far. Hound's tongue (*Cynoglossum officinale*), Musk thistle (*Carduus nutans*) and Bull thistle (*Cirsium vulgare*) were also observed. The densest stands of Canada thistle were found farthest from the road. In an attempt to show this, line features were collected along the road in areas where dense stands of weeds were present. On the DW-1/DW-2 pad itself weeds were widespread, but particularly dense on the north-west side of the pad. Despite the difficult access, the Division recommends that Oxbow makes a concerted effort to spray for Canada thistle as soon as possible, before it flowers.

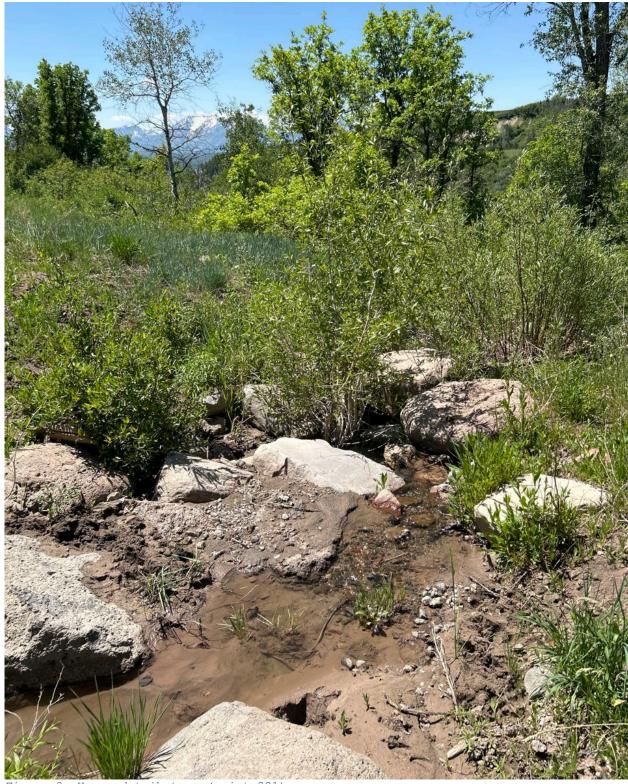
Flow in Elk Creek had slowed to a trickle through the facilities area. Bear Creek was flowing well, but nowhere near the flood levels of last year. A small, unnamed tributary to Elk Creek was flowing across the reclaimed road to the DW-1 and DW-2 pad.

Figure 9: Unnamed tributary (point 291)

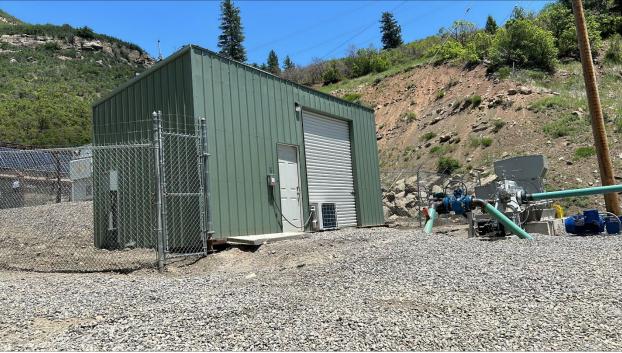
At the Bear Creek Methane Destruction Facility 3 of the 4 burners were operating. The security fence around the facility had been repaired.

Figure 11: Fence repaired at Bear Creek Methane Destruction Facility

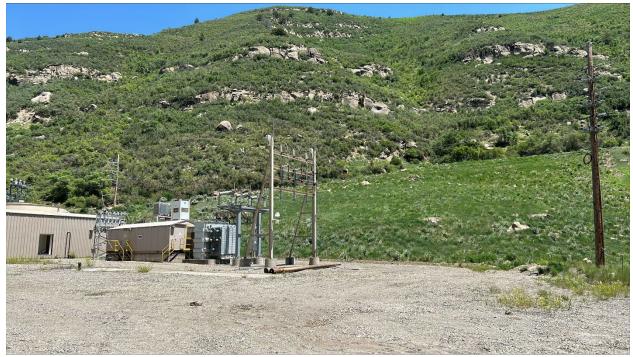
The partially dismantled substation on the upper Elk Creek facilities pad had not yet been removed.

Figure 12: Partially dismantled substation on Upper Elk Creek facilities pad

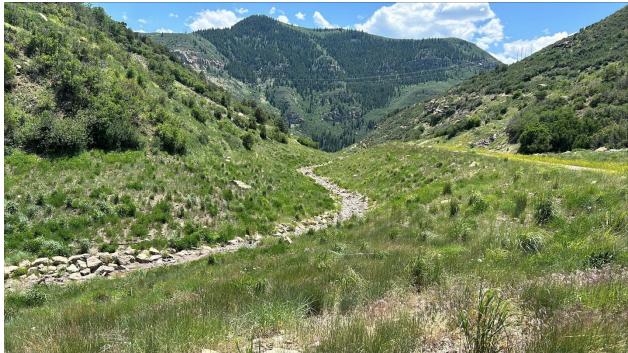
Figure 13: Upper section of reclaimed Elk Creek channel

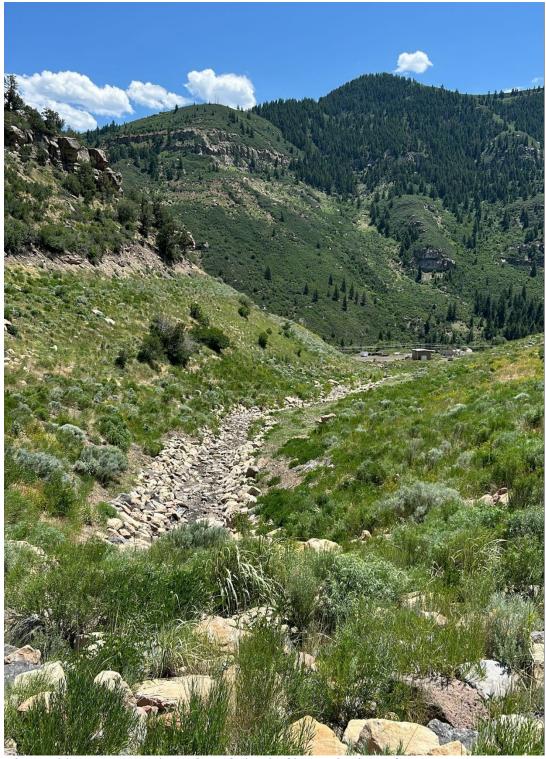
Figure 14: Lower section of reclaimed Elk Creek channel
