MINERALS PROGRAM INSPECTION REPORT
PHONE: (303) 866-3567

| MINE NAME: Brandstadt Rock Pit | MINE/PROSPECTING ID#: M-1986-004 | MINERAL: Sand and gravel | COUNTY: Delta |
| INSPECTION TYPE: Surety Release Inspection | WEATHER: Clear | INSP. DATE: June 5, 2024 | INSP. TIME: 10:00 |

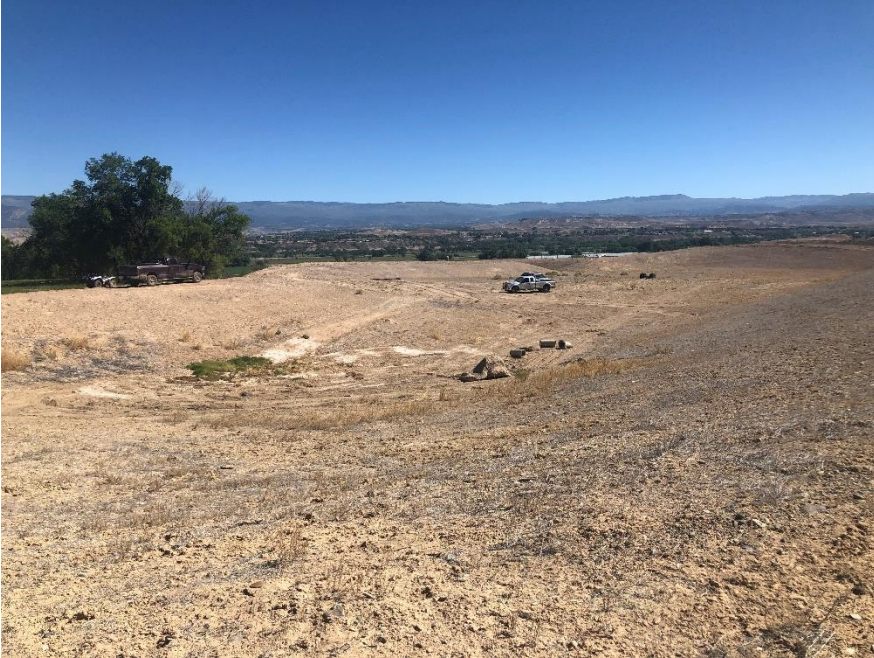
No erosion was seen on the slopes of the pit. The slopes are gentle (flatter than 3H:1V, which is the requirement in the approved Reclamation Plan), and the site drains to the northeast, which agrees with the surrounding area. No signs of sediment loading, or other off-site impacts, were identified.

Looking northeast from the entrance (photo encompasses majority of site)

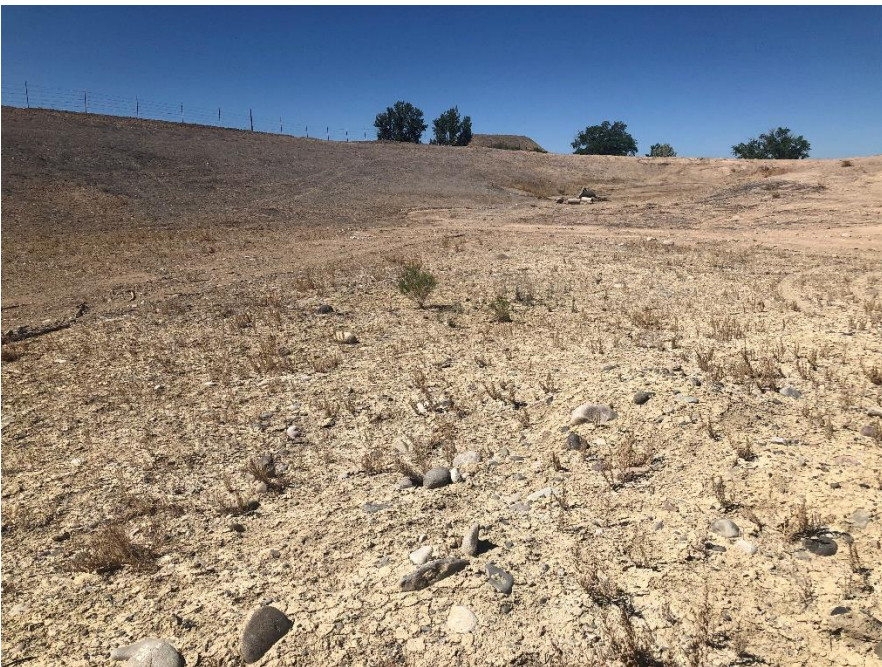
Vegetation around the site is extremely sparse. On most of the site there is none, and in the low area there are a small number of rabbit brush plants and a weedy species that resembles kochia. No state-listed noxious weed species were identified around the site.

The soil on site is white and appears to be devoid of nutrients. Per the information submitted with TR-02, the soils on site and in the surrounding area are very high in soluble salts and strongly alkaline. It was determined by the Division that it is not practical to expect the soil of the reclaimed area to support a diverse, effective, and long-lasting vegetative cover that is capable of self-generating.

Very poor vegetation at bottom of pit

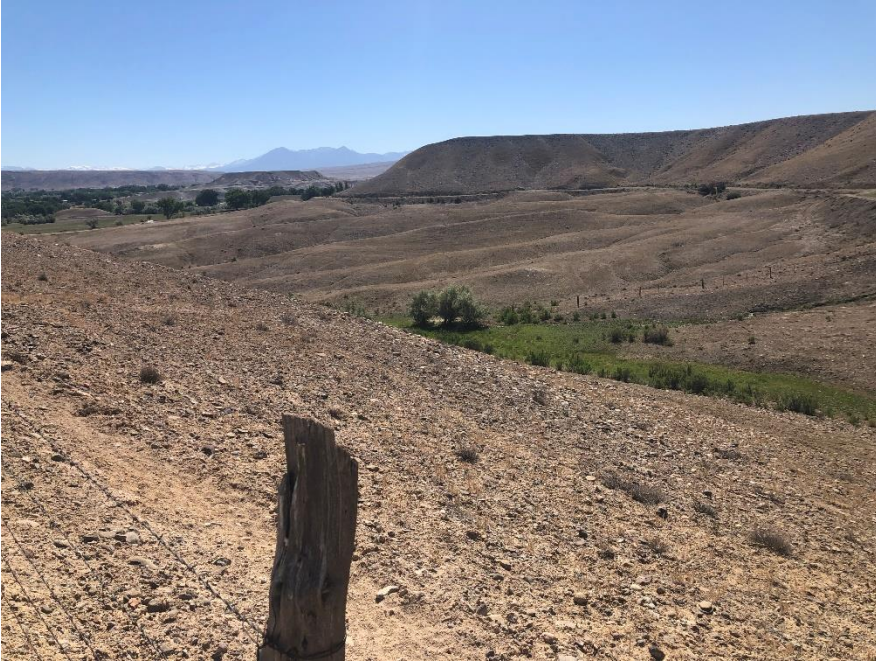
The adjacent lands consist of an irrigated field to the west, undisturbed land to the south and east, and barren land (apparently disturbed by other operations) to the north. The undisturbed land is mostly devoid of vegetation, and the soil appears to have little or no nutrients. There are some plants in the low areas where water collects, and these include Russian olive trees. The surrounding area, seen driving to the site, is barren land with very little vegetation and poor species diversity.

Undisturbed area to the east of site

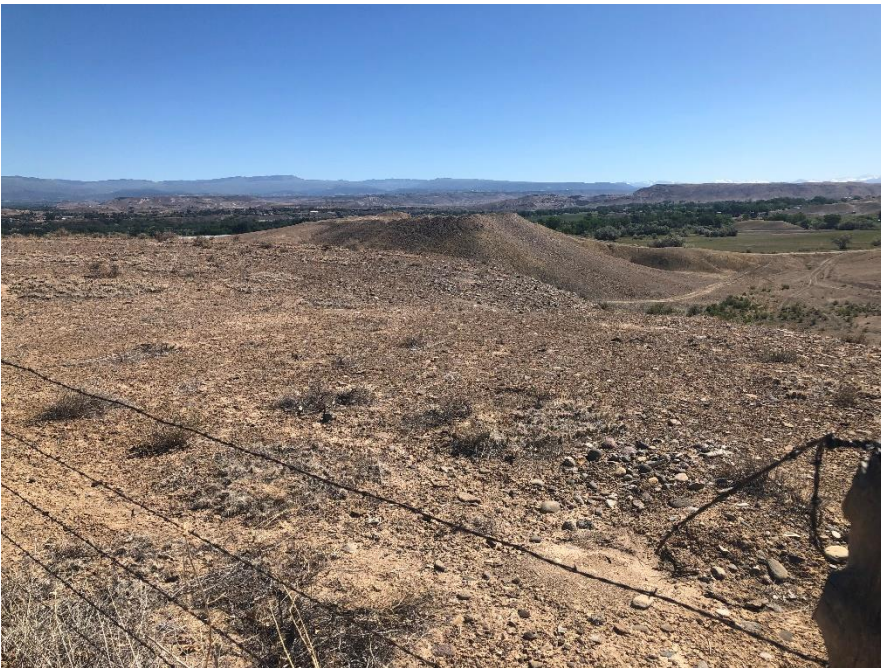
Adjacent property to the northeast of the site
