Job Number: 99-3983

Subject: Quarterly Observation Report,  
Refuse Pile, Foidel Creek Mine, Routt  
County, Colorado.

<b>Project:</b>	Refuse Pile	<b>Project No.:</b>	99-3983	<b>Date:</b>	3/29/24
<b>Location:</b>	Foidel Creek Mine	<b>Report No.:</b>	111	<b>Time:</b>	2.0
<b>Client:</b>	Twentymile Coal Co.			<b>Mileage:</b>	45
				<b>Engr. /Tech:</b>	TT

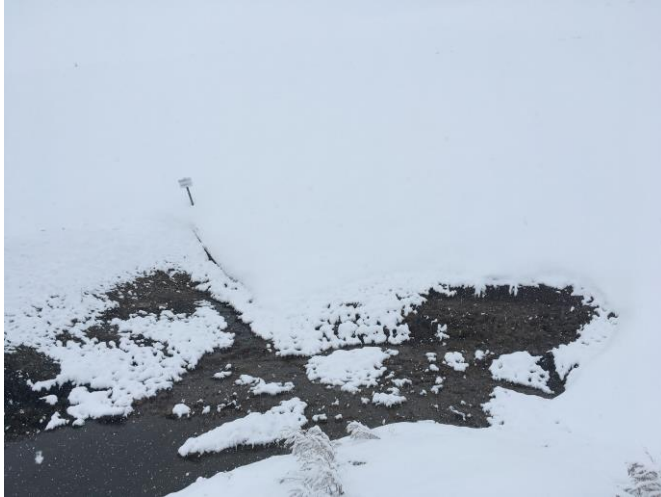
A seepage area at the toe of the northeast end of the refuse pile expansion area, approximately 30 feet northwest of the outlet of the underdrain, developed in fall 2014. At the time of our observations, the seepage was surfacing at the toe of the slope and flowing into the drainage from the undrain outlet then into the existing pond east of the Refuse Pile Expansion Area. The discharge was clear, with no evidence of sediment. No signs of washout, slumps or slope instability were observed at this time. The seepage area will be monitored during future inspections and noted in our inspection reports. Photographs of the seepage area taken at the time of our inspection on March 29, 2024 are attached.

March 29, 2024-Drain Outlet and Seepage Area

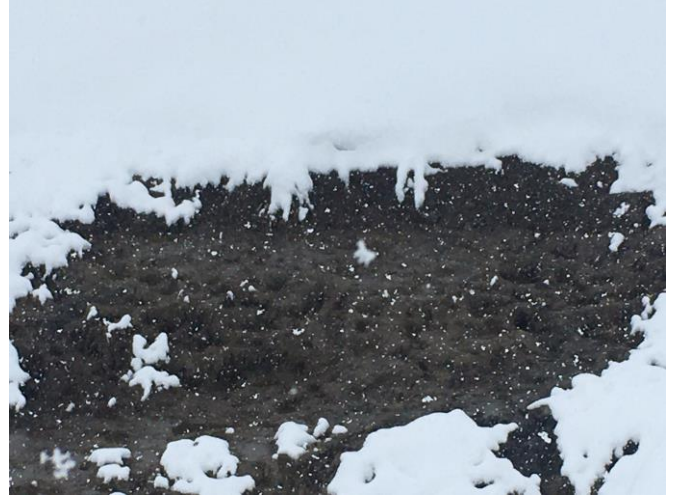
March 29, 2024-Seepage Area

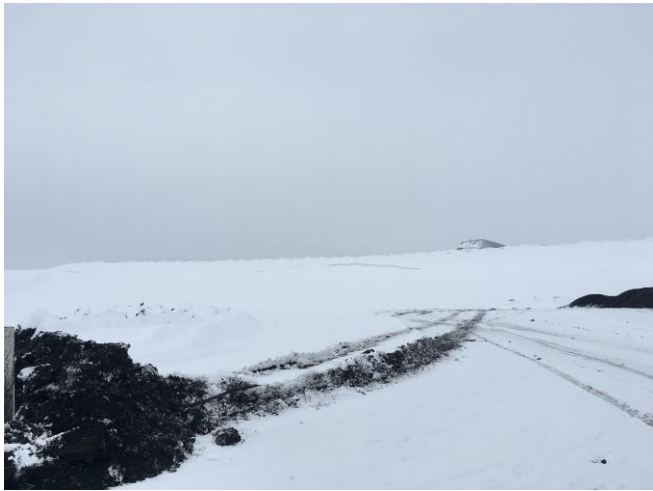
The internal roadways in the new expansion area of the pile are in good condition. The upper haul road to Areas 2, 3 and 4 of the refuse pile was not accessible at the time of our site visit due to snow.

March 29, 2024- Areas 2, 3 and 4 from Expansion Area

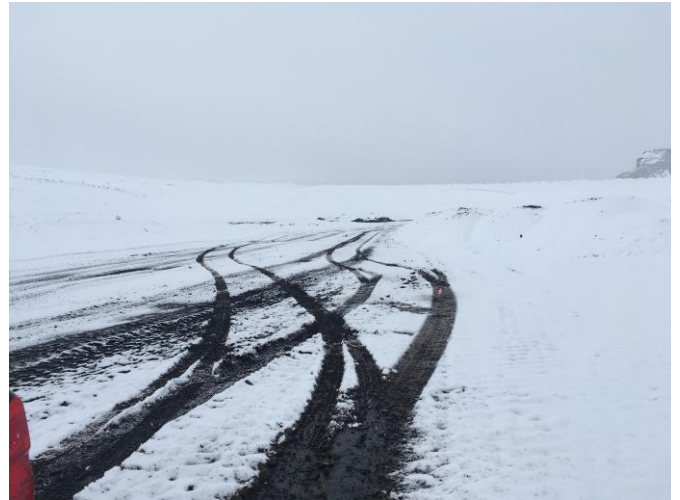
At the time of our site visit on March 29, 2024, NWCC completed a site inspection of the existing refuse pile. Based on our observations made during this visit, it appeared that the contractor was presently stockpiling, grading and compacting refuse coal in the new Expansion Area. At the time of our site visit, the refuse coal had been placed and compacted to an elevation above the third bench situated along the east side of the stockpile.

March 29, 2024- Expansion Area

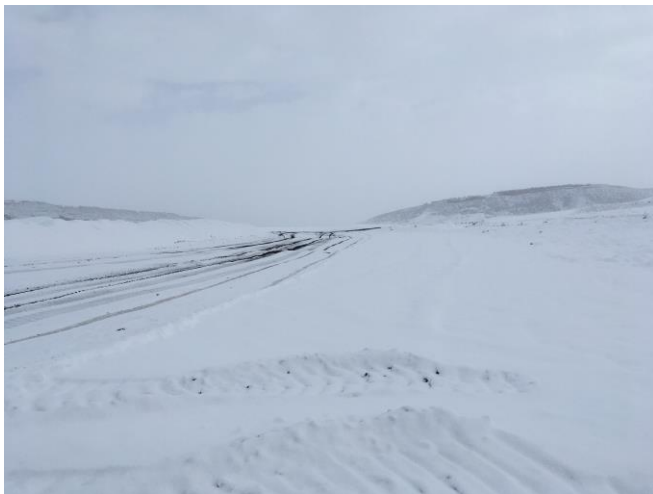
March 29, 2024- Expansion Area

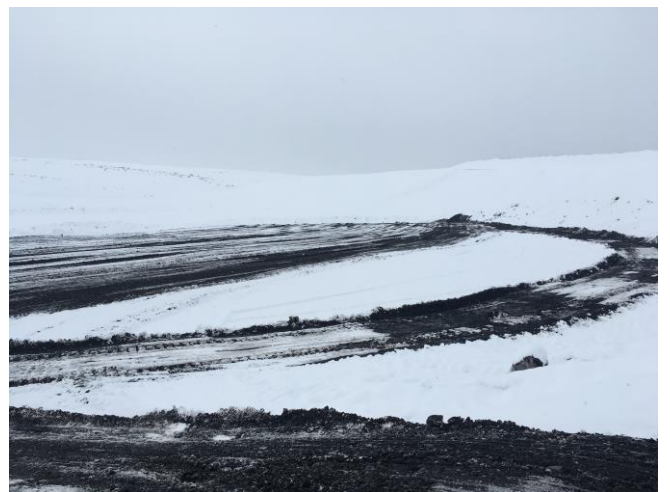
March 29, 2024- Expansion Area
