**Roadside Mine, C-1981-041, June 2024 Bond Compliance Inspection Report**

**PERMIT INFORMATION**

**INSPECTION INFORMATION**

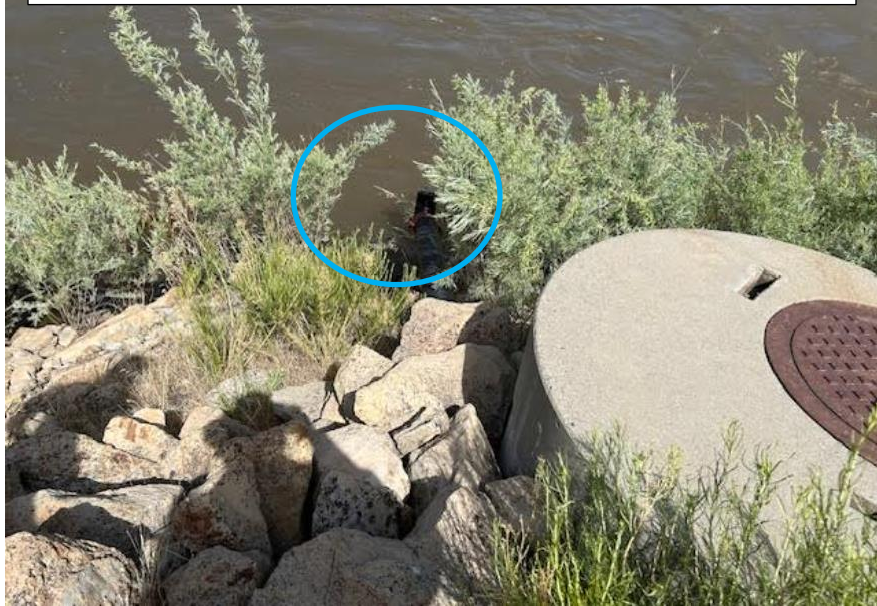
Two remaining discharge points, 002 and 016, remain within the permit. Discharge point 002 is located northwest of the cameo exit off of Interstate 70. The discharge pipe opens into the Colorado River (Photo 1). No discharge was occurring during the inspection. The pipe appeared to be unobstructed. Discharge point 002 serves as a backup to discharge point 016 if 016 became obstructed or the water level in the mine increased. Discharge point 016 is located in the northeastern portion of the permit area. The discharged water from 016 enters a CDOT culvert that transports runoff underneath I-70 to the Colorado River. Discharge was occurring from 016 during the

Photo1: the 002 discharge point outlined in the blue circle.

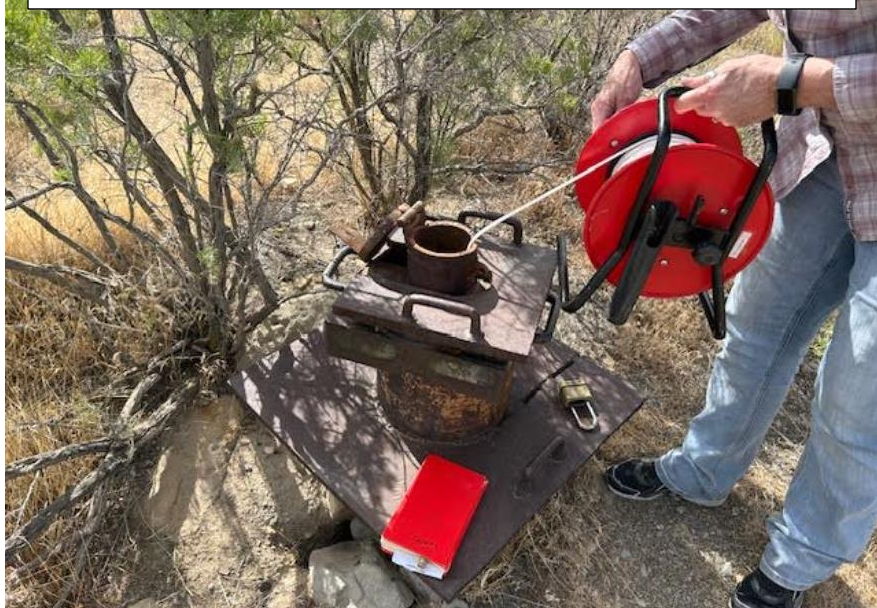
One well, N-1, is located in the northeastern portion of the permit area. The well measures the amount of water within the downgradient portion of the mine workings. During the inspection the depth to the water in the mine was 75.28 feet (Photo 2). This value is within the historical range for this site at this time of the year. The well casing was in good condition with a padlock locking the lid covering the top of the casing.

Photo 2: The N-1 Well.

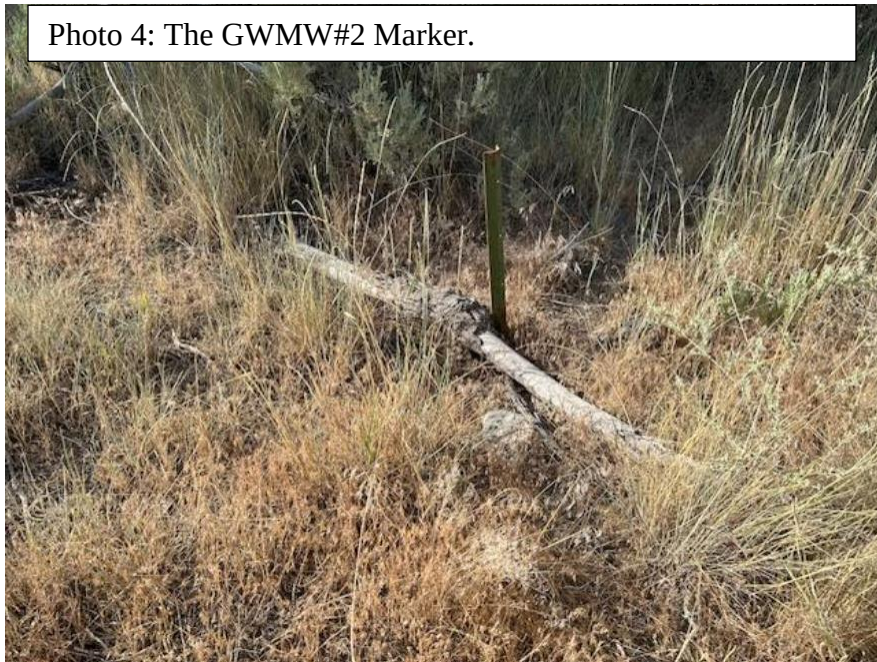
Three groundwater monitoring locations GWMW#1 (Photo 3), GWMW#2 (Photo 4) and GWMW#3 (Photo 5) were located to the south of the permit area and measured groundwater levels on Cottonwood Creek and Rapid Creek. The wells and pads for the wells were reclaimed in August of 2016. The foot print for the pads was released under Bond Release SL-10. Each location consisted of an upper well and a lower well. The well casings were sealed and abandoned. The locations of the wells were marked with wooden stakes. During the inspection GWMW#1 was found by the wooden markers. The monitoring wells were located on Rapid Creek on the south side of Rapid Creek Road below the confluence of Rapid Creek and Cottonwood Creek. There was no evidence of either the upper or lower monitoring wells other than the wooden stakes marking the location of the reclaimed wells. GWMW#2 was located on Cottonwood Creek. The upper and lower wells were reclaimed. The location of the wells was found by the wooden stakes. There were no well casings remaining at the location. GWMW#3 was located on Rapid Creek. The two wells were found by the wooden markers. No well casings remained as the wells have been reclaimed. The Division's Reclamation Task 121 contains the cost of abandoning the 6 groundwater monitoring wells. During the inspection, the 6 wells were found to be abandoned as required by the C-041 permit and the Rules and Regulations of the Colorado Mined Land Reclamation Board for Coal Mining.

Photo 4: The GWMW#2 Marker.

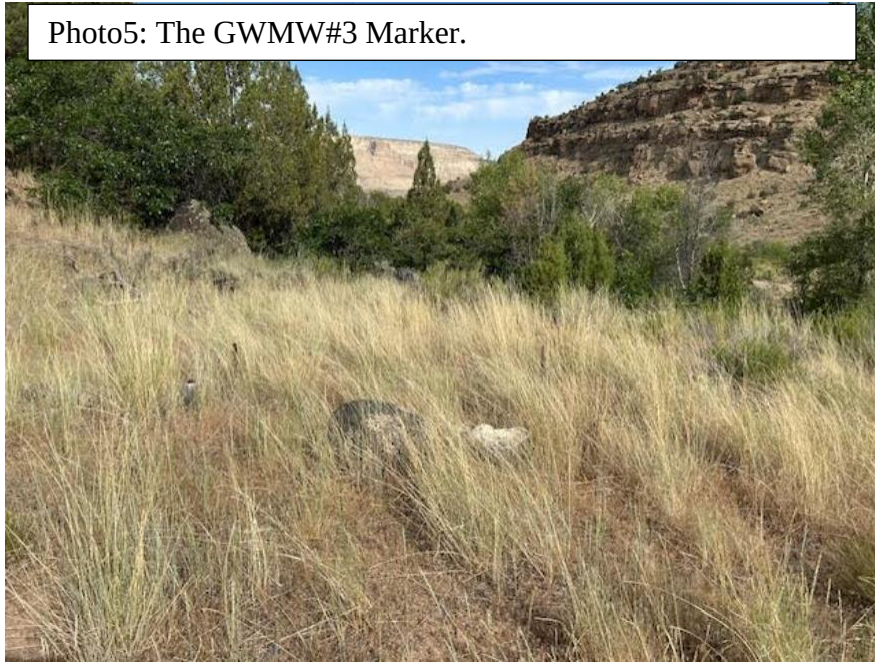
Photo5: The GWMW#3 Marker.

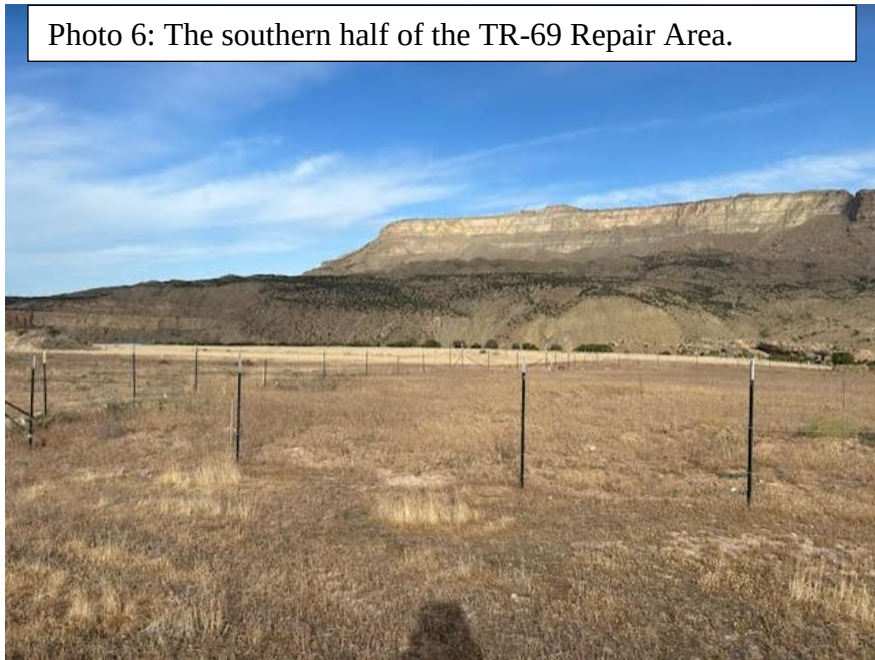
The TR-69 Repair Area was stable with vegetative cover (Photos 6 and 7). The reseeded vegetation from the fall of 2023 was growing well. There were no new weeds identified during the inspection. Weeds that had been sprayed in the spring of this year were withered. There were no erosional features identified. The straw waddles located at the southern and western portions of the disturbed area boundary were in good condition. There was no off site impact observed. The disturbed area is marked by a fence with a mine identification sign posted on one of the southern posts. The sign was easily located and legible.

Photo 6: The southern half of the TR-69 Repair Area.

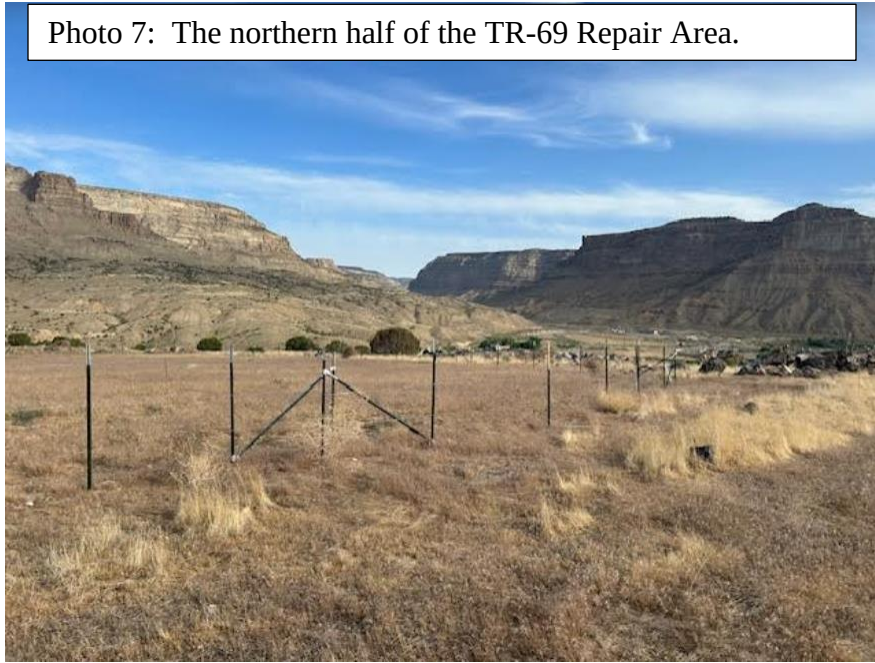
Photo 7: The northern half of the TR-69 Repair Area.
