Restoration and Mitigation Plan

**Two Rivers Mine at Nature's Park
Town of Milliken, Weld County, Colorado**

**First Submission: November 18th, 2020
EPA Review and Comments: July 8th, 2021
Second Submission: September 3rd, 2021
EPA Review and Comments: May 25th, 2022
Third Submission: August 25th, 2023
EPA Review and Comments: January 19th, 2024
Fourth Submission: April 5th, 2024**

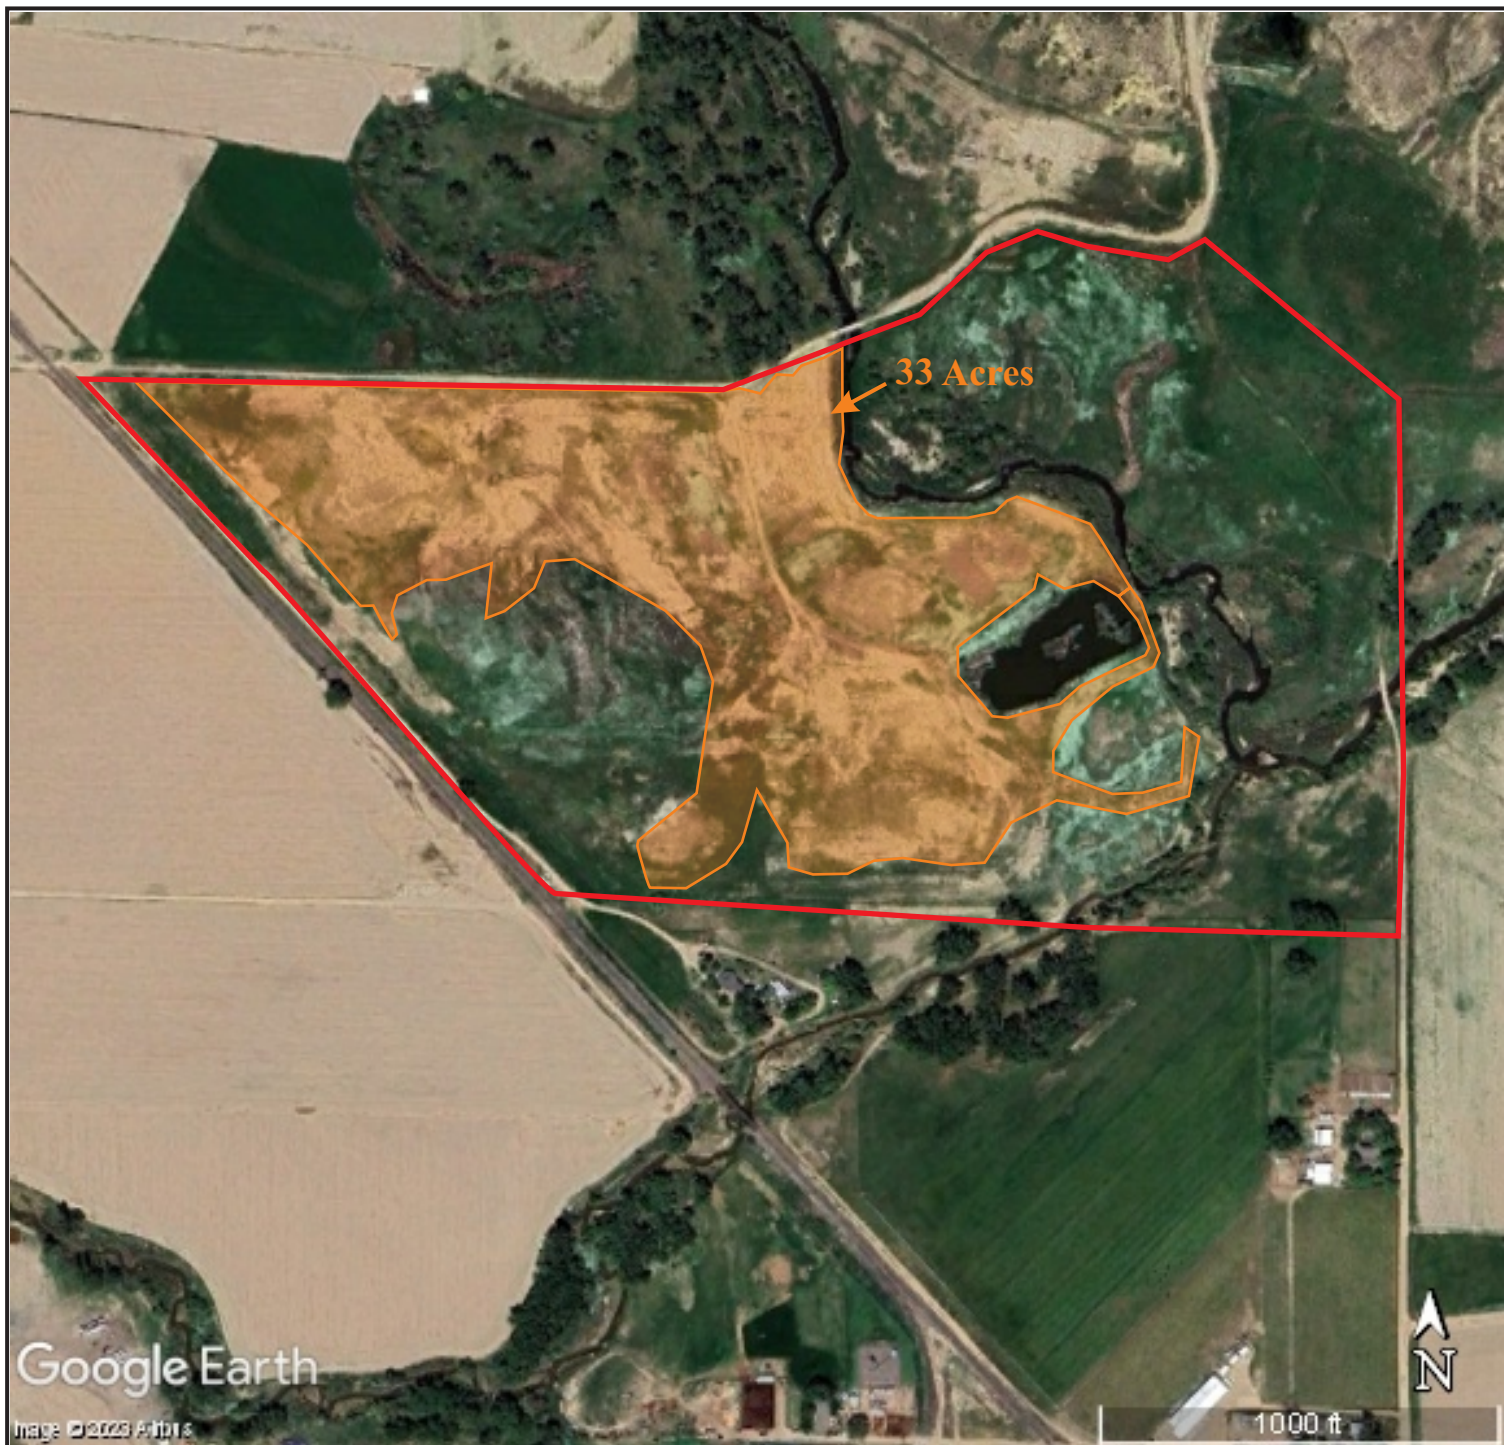
Figure 3 - Fill Material Location Map
23344 County Road 21 3/4
Milliken, Colorado

- Approximate extent of fill material
- Limits of Project Area

On December 12th, 2018, Western Equipment received a Cease and Desist Order from the Town of Milliken regarding the grading and filling activities within the floodplain. On January 10th, 2019 the Town of Milliken sent a Notice of Violation and second Cease and Desist Order, effectively revoking the #FHDP 009 permit. On August 27th, 2019, the Town of Milliken sent a second Notice of Violation and third Cease and Desist Order, which required any activity onsite would require review and approval by the US Environmental Protection Agency (EPA), US Army Corps of Engineers (ACOE), and the US Fish and Wildlife Service (FWS). On November 5th, 2020, an EPA Administrative Order on Consent (Consent Order) was executed and submitted to the EPA.

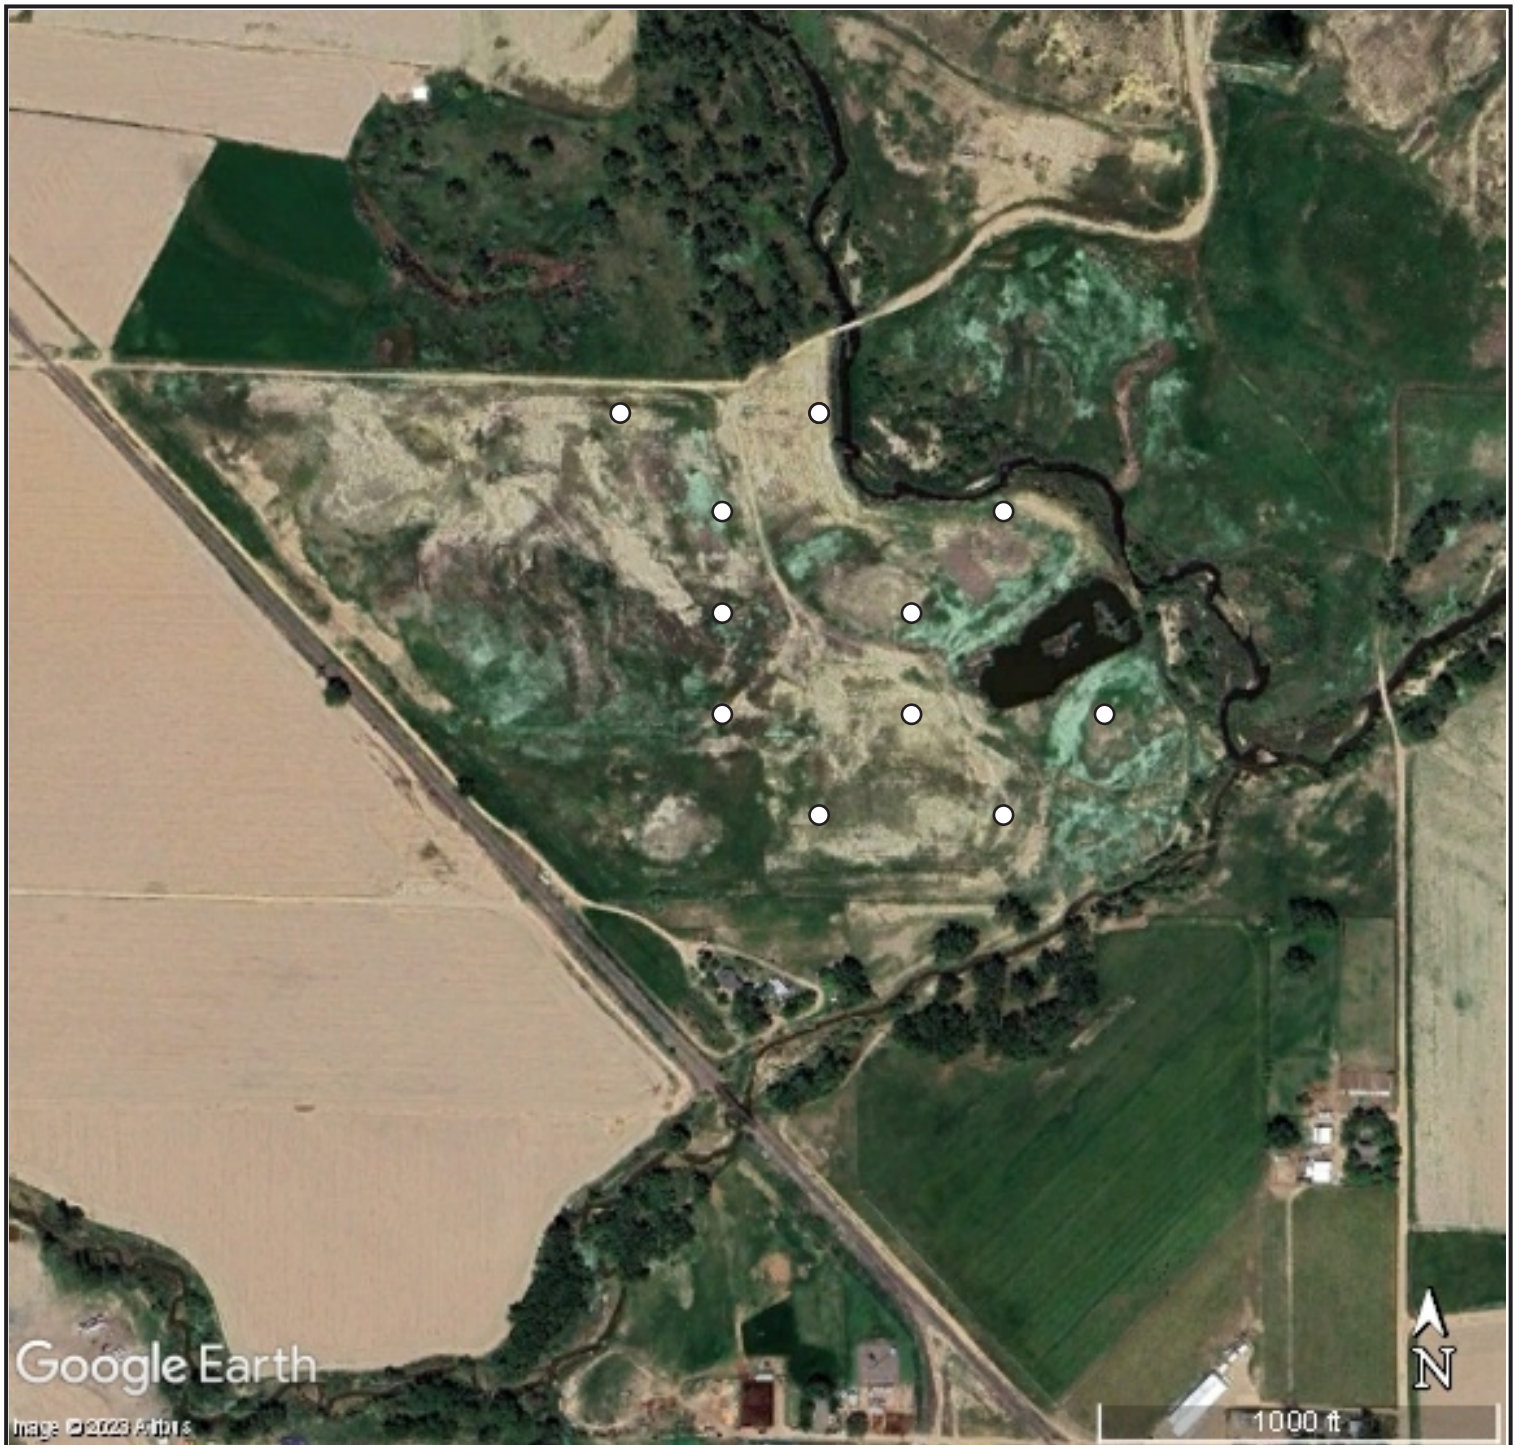
Figure 7 - Replacement Piezometer Well Map
23344 County Road 21 3/4
Milliken, Colorado

● Proposed Replacement Piezometer Well Locations

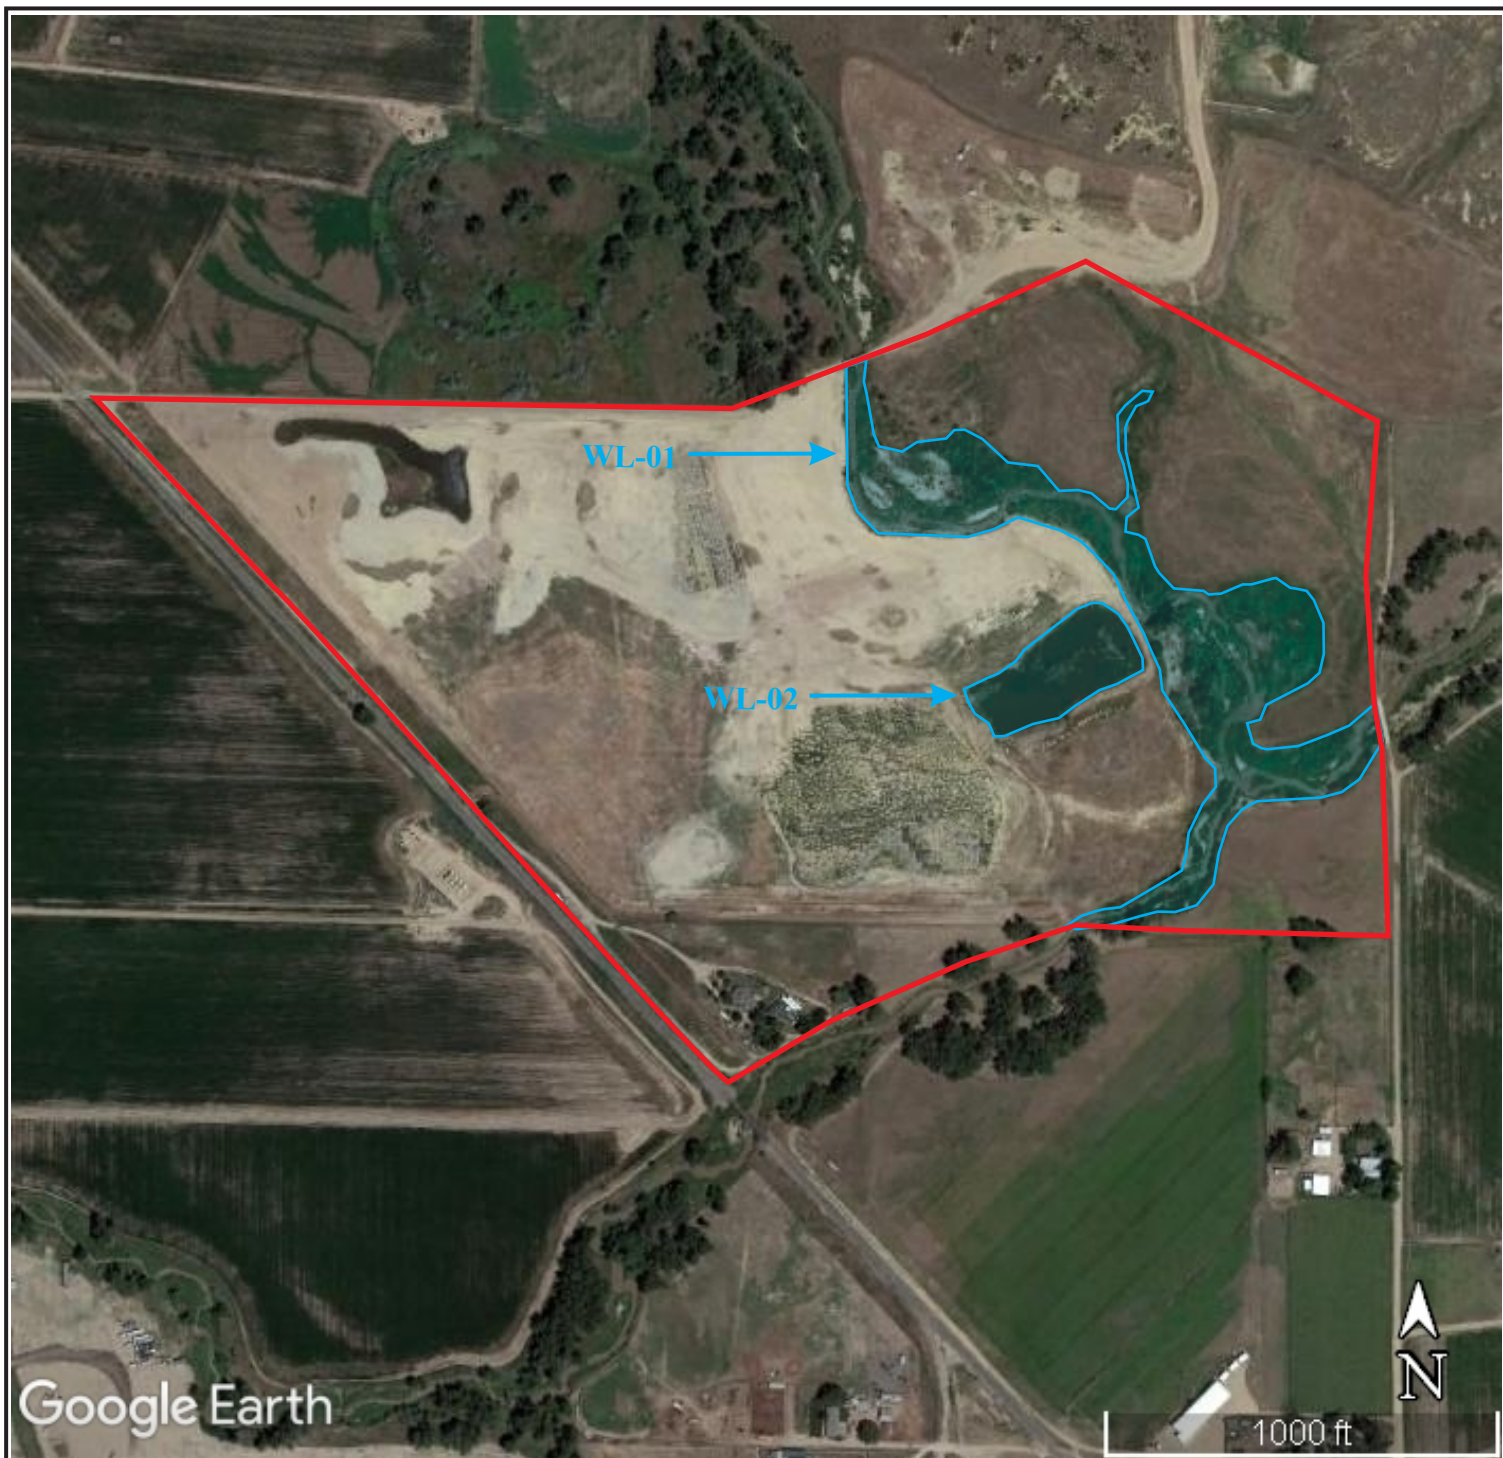
Figure 3 - Existing Wetland Map
23344 County Road 21 3/4
Milliken, Colorado

Existing Wetland

- Wetland-01 (WL-01) was delineated along the Big Thompson and Little Thompson Rivers. The Big Thompson River bisected the property from northwest to east, and continued to the South Platte River approximately 5 miles east. The Little Thompson River bisected the property from the south, and confluenced with the Big Thompson River in the eastern portion of the site. Both Rivers contained wetland components of Ordinary High Water Mark (OHWM), vegetation, hydric soil, and hydrology. No wetland vegetation was observed above OHWM. The Rivers appeared to be mostly unmodified, with a natural meander and bank with no stabilization. WL-01 consists of approximately 10.1 acres.

- Wetland-02 (WL-02) was delineated along a pond south of the Big Thompson River. The pond appeared to be a reclaimed gravel pit. Large rocks placed along the bank provided stabilization. The majority of the pond consisted of open water, with limited vegetation. No wetland vegetation was observed above the banks. WL-02 consists of approximately 1.9 acres.

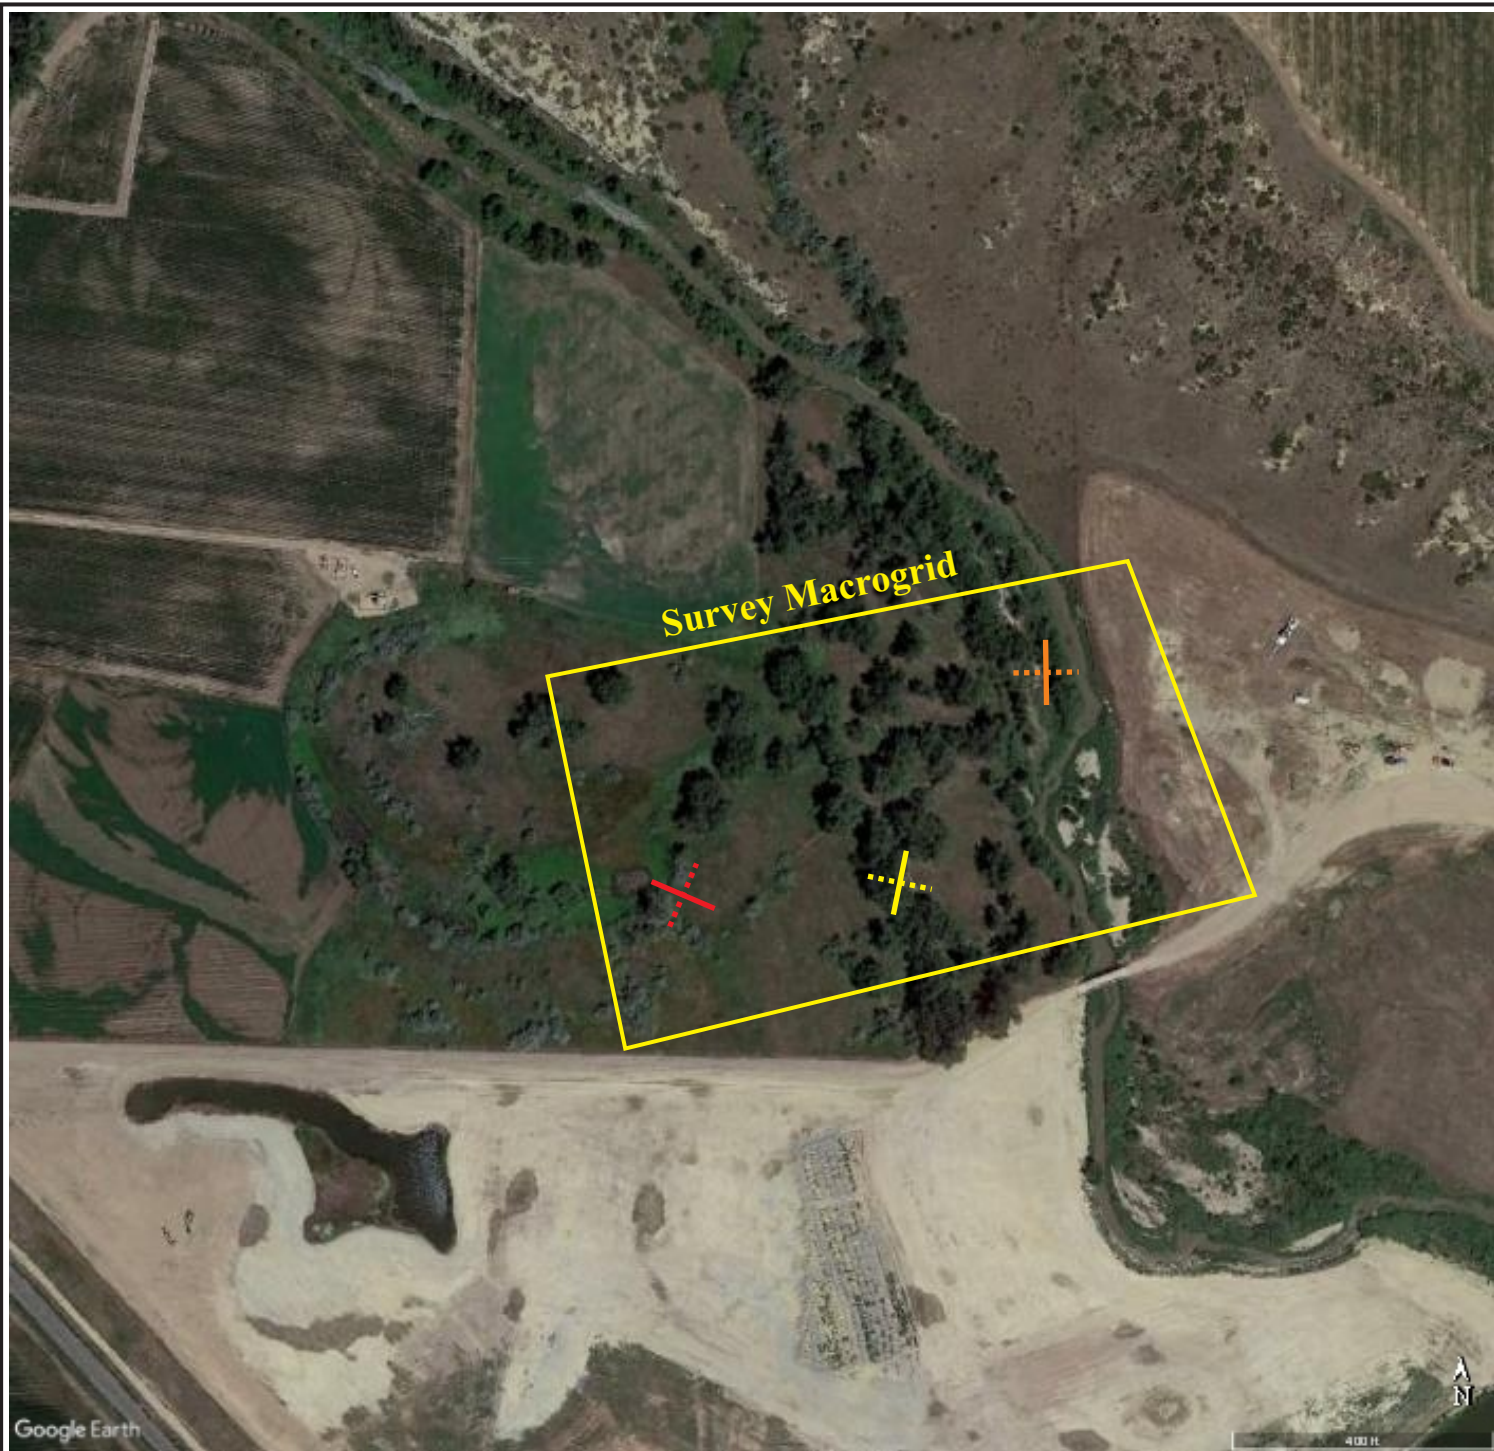
| — Transect 1 | ····· Cross Transect 1 |

Woody vegetation success will be determined using block transects. Total individuals of each woody species will be counted within each transect following planting. Subsequent inspections will determine the success/failure rate of the plantings with the percent of individuals remaining within each transect. The data for all transects will be summed to describe the entire plant community.

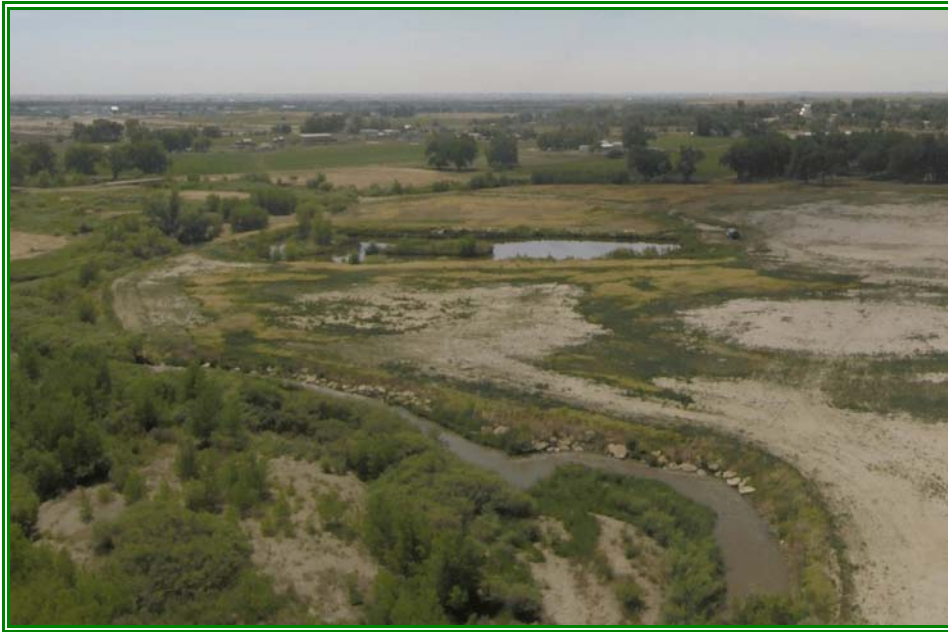
View of disturbed riparian vegetation along Big Thompson River
