Subject: Summary of Instrumentation Monitoring
2nd Quarter 2024
Bowie Coal Waste Disposal Area No. 3
Paonia, Colorado

**SUBJECT: Summary Report, 2nd Quarter 2024, Vibrating Wire Piezometers
April – June 2024, Bowie Mine #2
Coal Waste Disposal Area (CWDA) #3**

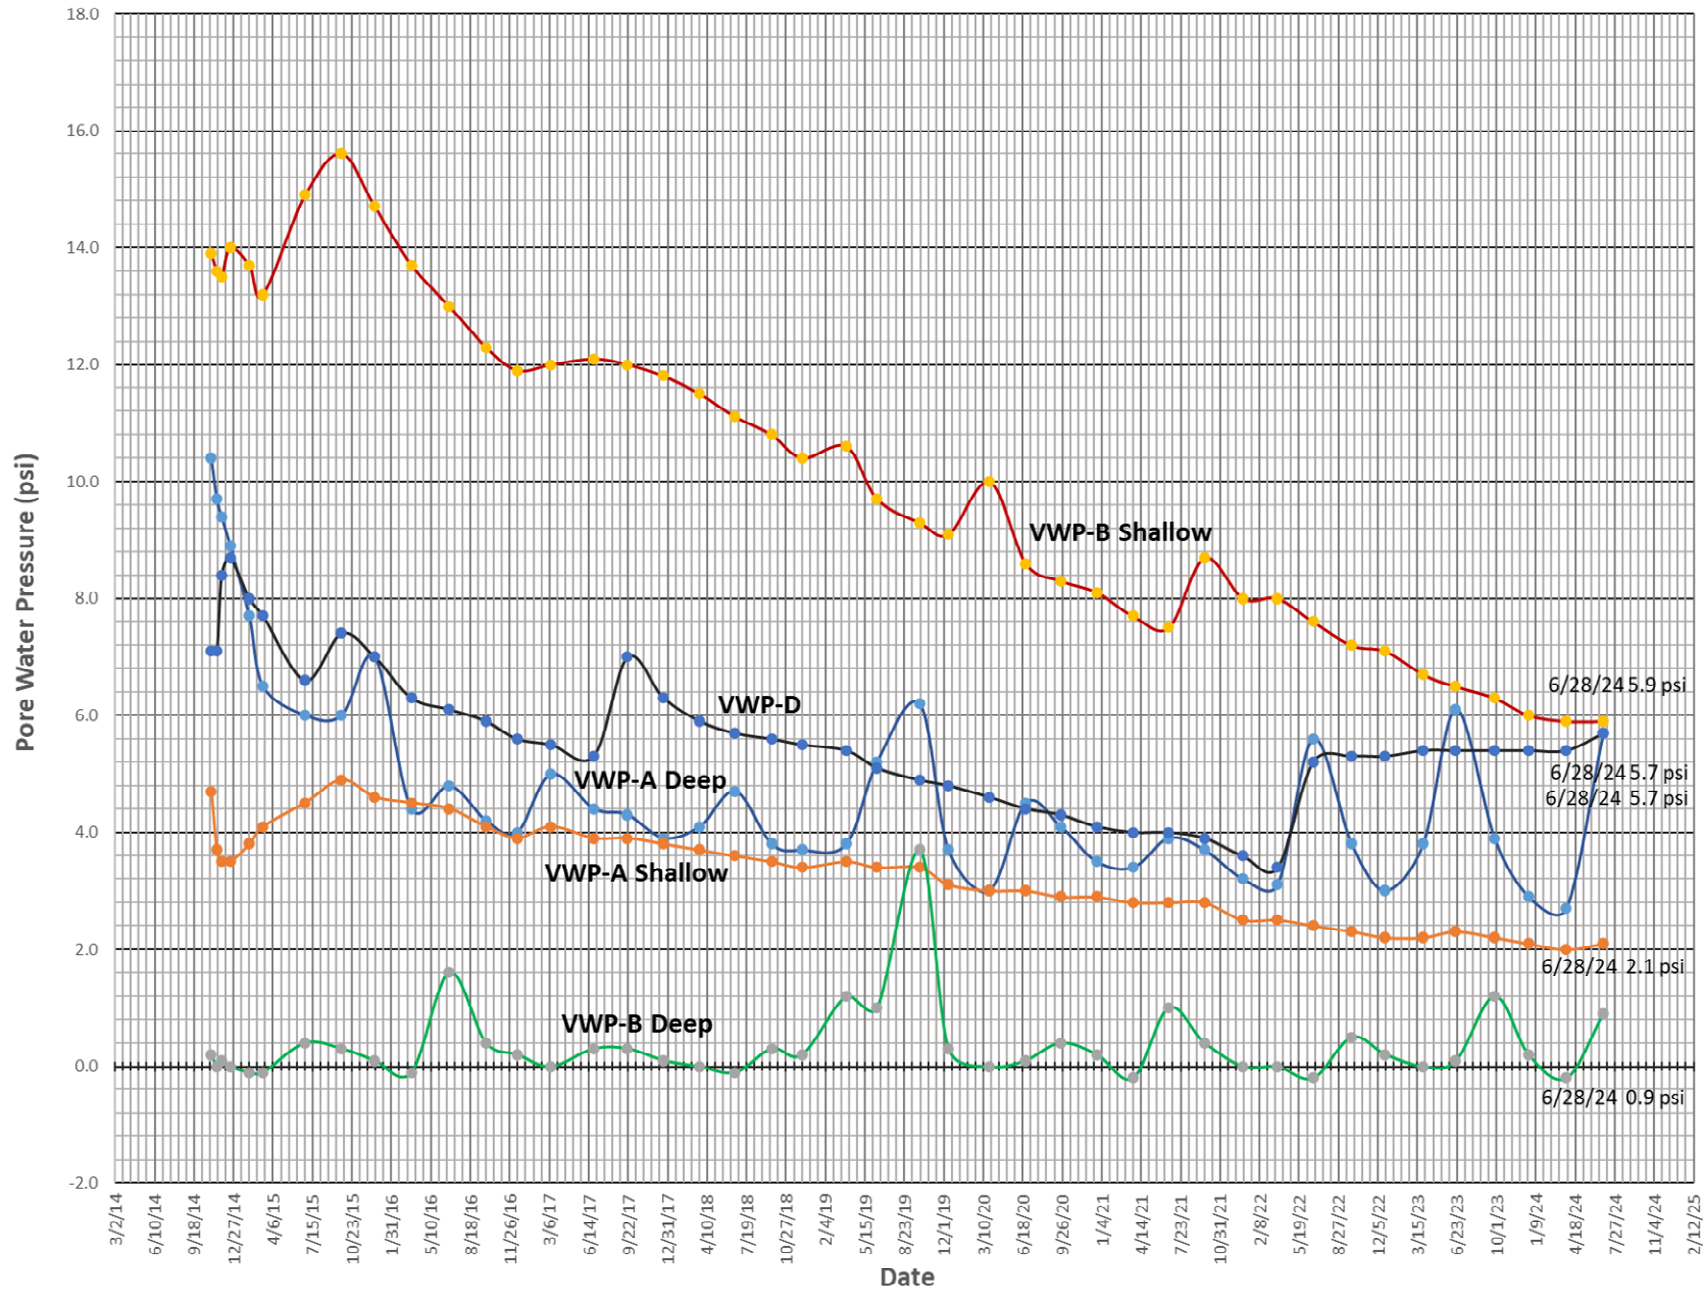
Figure 1 - Bowie Mine #2 - CWDA #3
Vibrating Wire Piezometer Data

We present a graph of measured pore pressures on the attached Figure 1 and numerically in Table 1 below. Table 1 is a summary of the initial, last year, last quarter, and current readings. In addition, we present the difference between the current pore pressures and those at the time of installation, the previous year, and the previous quarter.

As seen on Figure 1 and Table 1, when compared with the previous quarter, two VWP's increased a relatively large amount of 1.1 to 3.0 psi (VWP-B Deep and VWP-A Deep), increased slightly by 0.1 to 0.3 psi (VWP-A Shallow and VWP-D), and one (VWP-B Shallow) had no change in pore pressure. When compared with the 2nd quarter of last year, three VWP's decreased -0.2 to -0.6 psi and two increased 0.3 to 0.8 psi in pore pressure. Since installation in 2014, four VWP's have generally decreased in pore pressure (by -1.4 to -8.0 psi), while VWP-B Deep has increased 0.7 psi in pore pressure. Although there is a general trend of decreasing pore pressure over time, two of the piezometers (VWP-A Deep and VWP-B-Deep) exhibit seasonal fluctuations in pore pressure since 2019 that roughly mirror each other. VWP-D had a general decline in pore pressures through much of its history until the second quarter of 2022 when pore pressures rose and then have stayed at a similar elevated level since then.
