## M1983177, Adams Pit, April 2024 Inspection Report

**MINERALS PROGRAM INSPECTION REPORT**  
**PHONE: (303) 866-3567**

<b>MINE NAME:</b> Adams Pit	<b>MINE/PROSPECTING ID#:</b> M-1983-177	<b>MINERAL:</b> Sand and gravel	<b>COUNTY:</b> Bent
<b>INSPECTION TYPE:</b> Monitoring	<b>WEATHER:</b> Clear	<b>INSP. DATE:</b> April 17, 2024	<b>INSP. TIME:</b> 10:00
<b>OPERATOR:</b> Bent County	<b>OPERATOR REPRESENTATIVE:</b> Robert Darnell, Kevin Van Egmond	<b>TYPE OF OPERATION:</b> 110c - Construction Limited Impact	
<b>REASON FOR INSPECTION:</b> Normal I&E Program	<b>BOND CALCULATION TYPE:</b> None	<b>BOND AMOUNT:</b> \$0.00	
<b>DATE OF COMPLAINT:</b> NA	<b>POST INSP. CONTACTS:</b> None	<b>JOINT INSP. AGENCY:</b> None	
<b>INSPECTOR(S):</b> Leigh Simmons	<b>INSPECTOR'S SIGNATURE:</b>

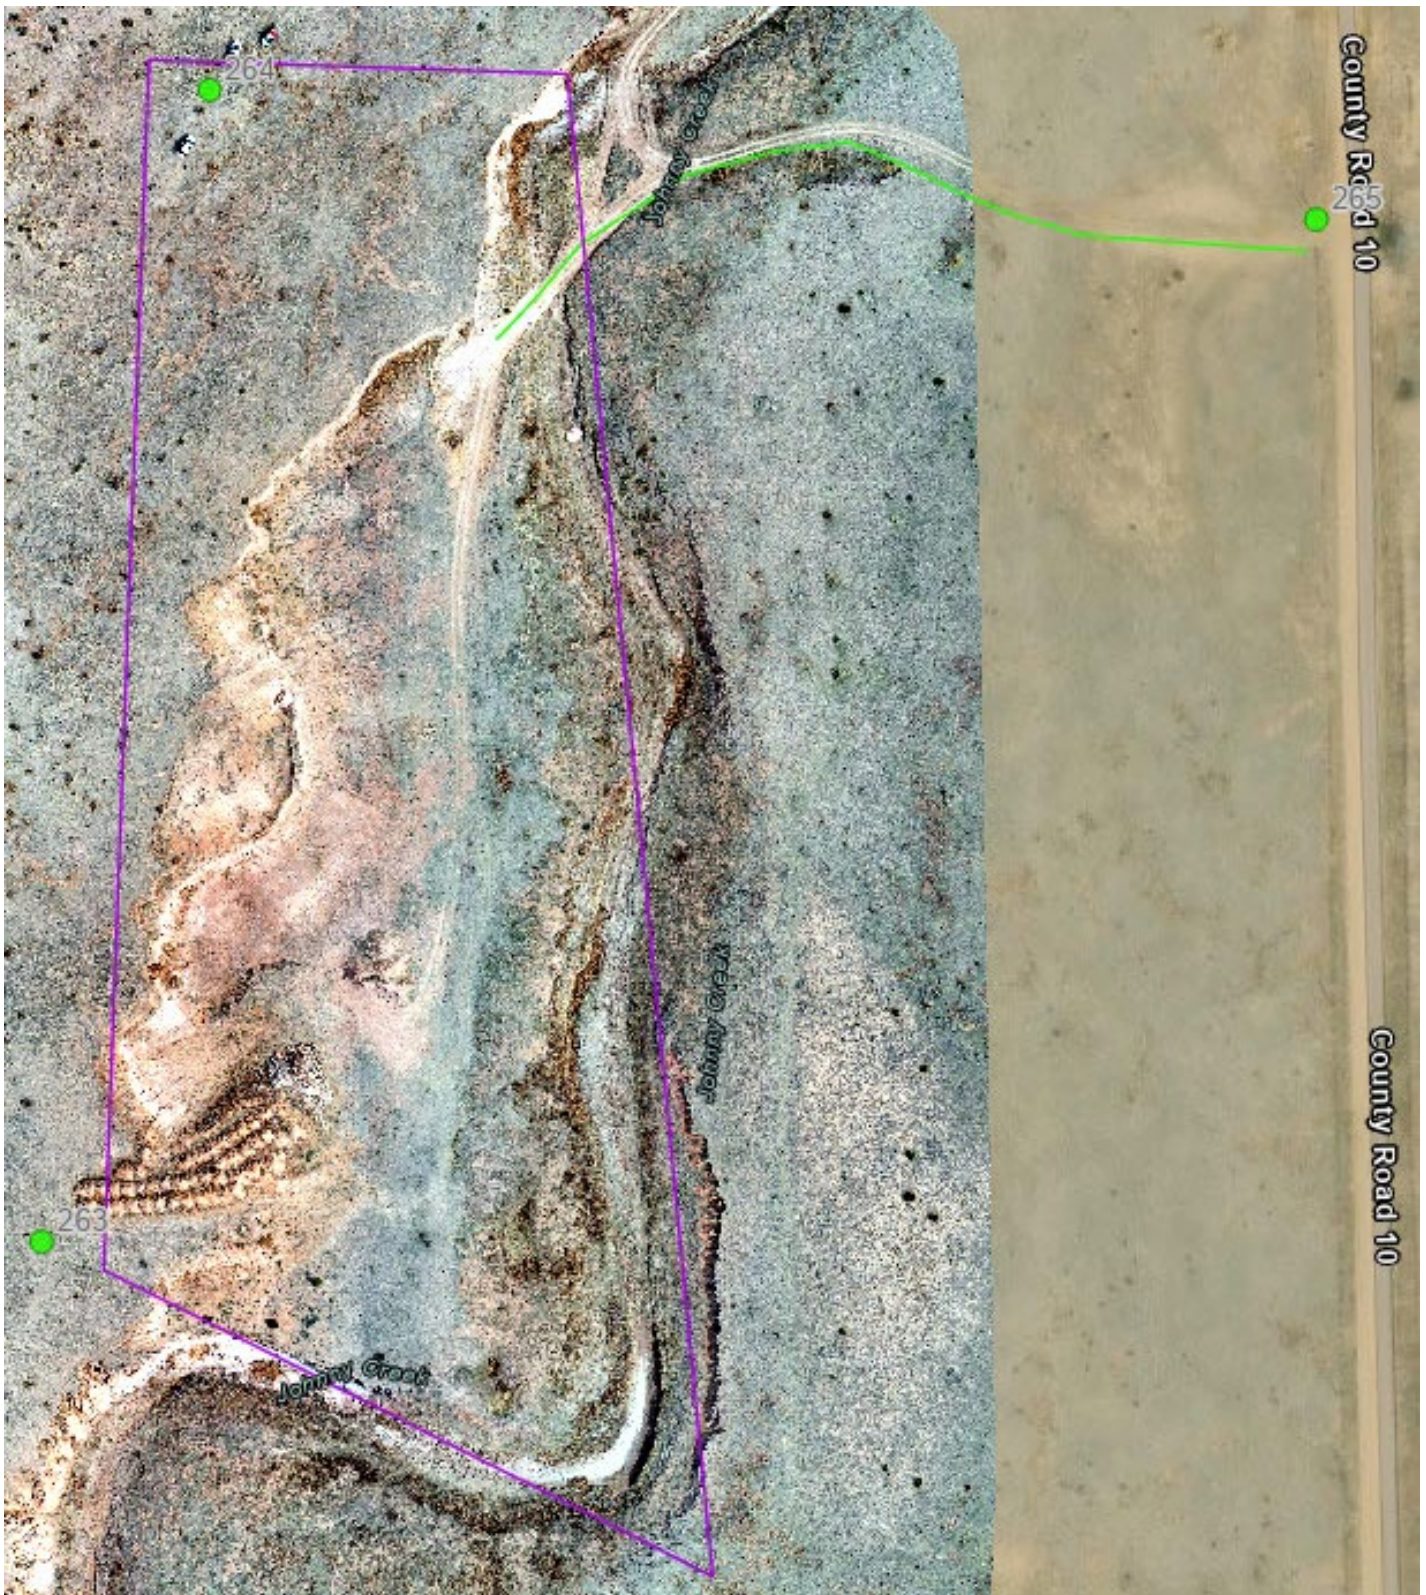
A DJI Mavic 2 Pro drone was used during the inspection. 149 images were captured in the field, and later processed using Pix4D Mapper to generate an orthomosaic of the site. Part of the orthomosaic is shown in Figure 1, together with the approximate permit boundary (in purple), and the locations of photos taken during the inspection (in green).

Figure 1: Screenshot of inspection map, with orthomosaic

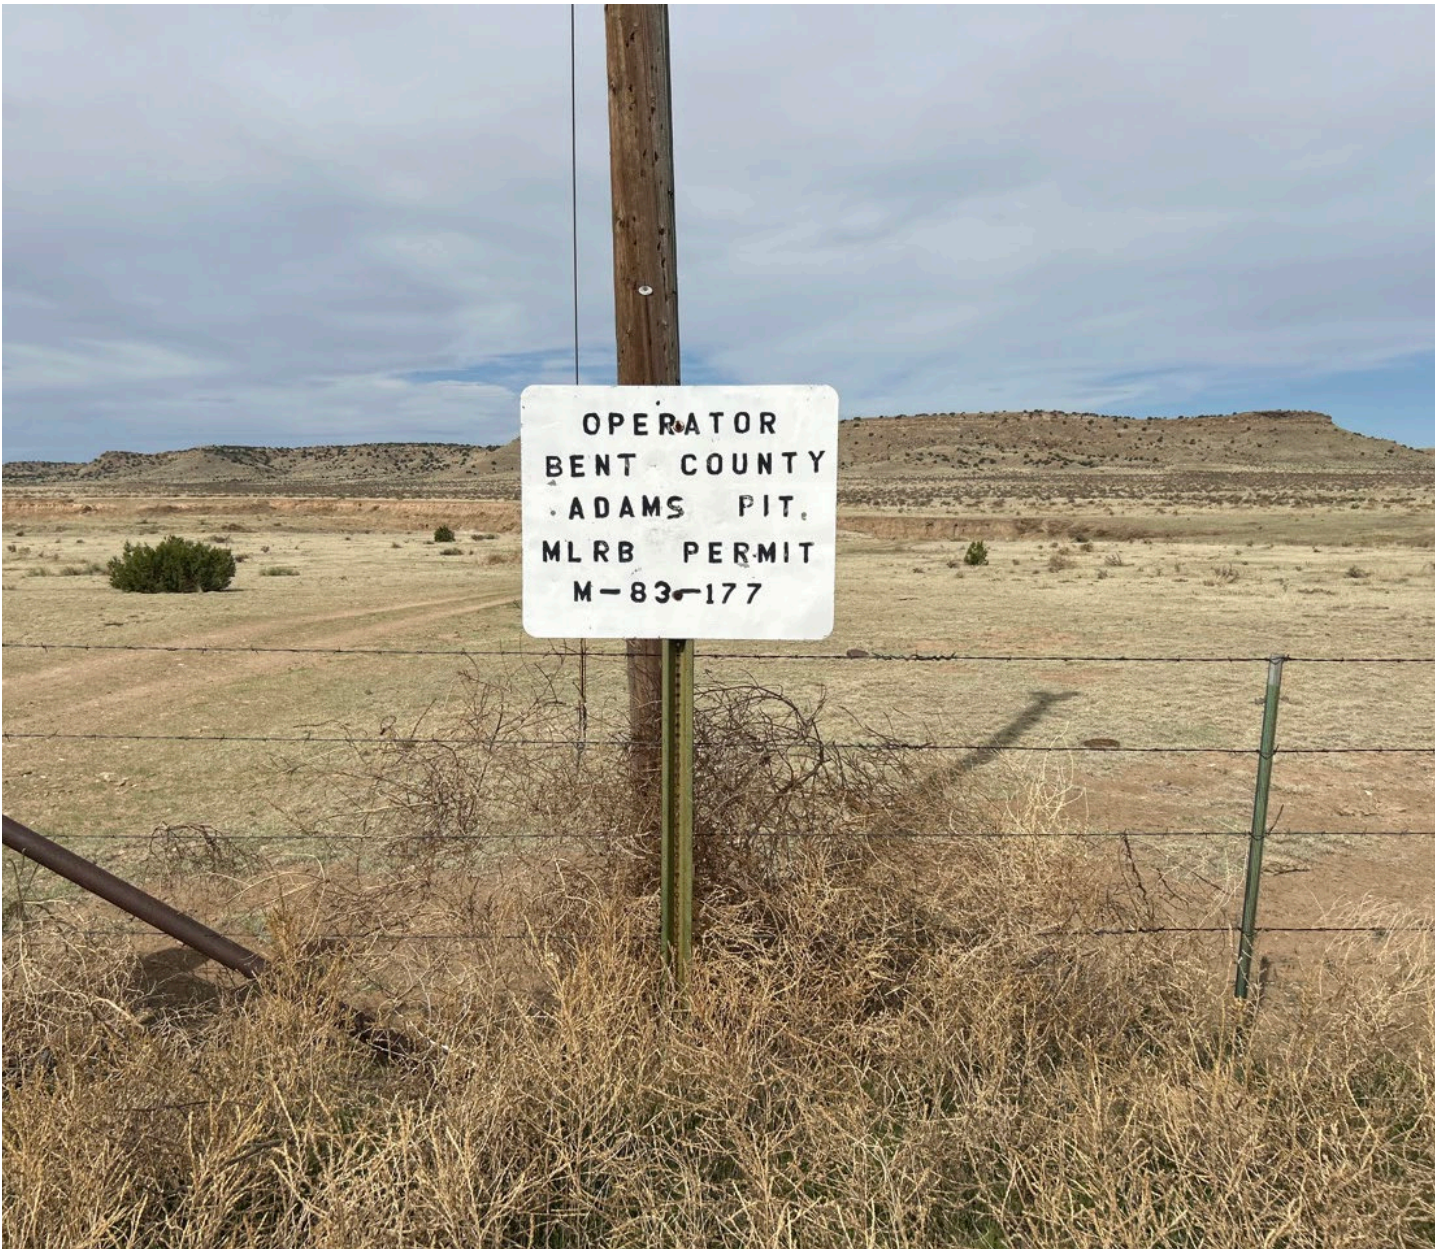
Figure 2: Mine ID sign, (265)

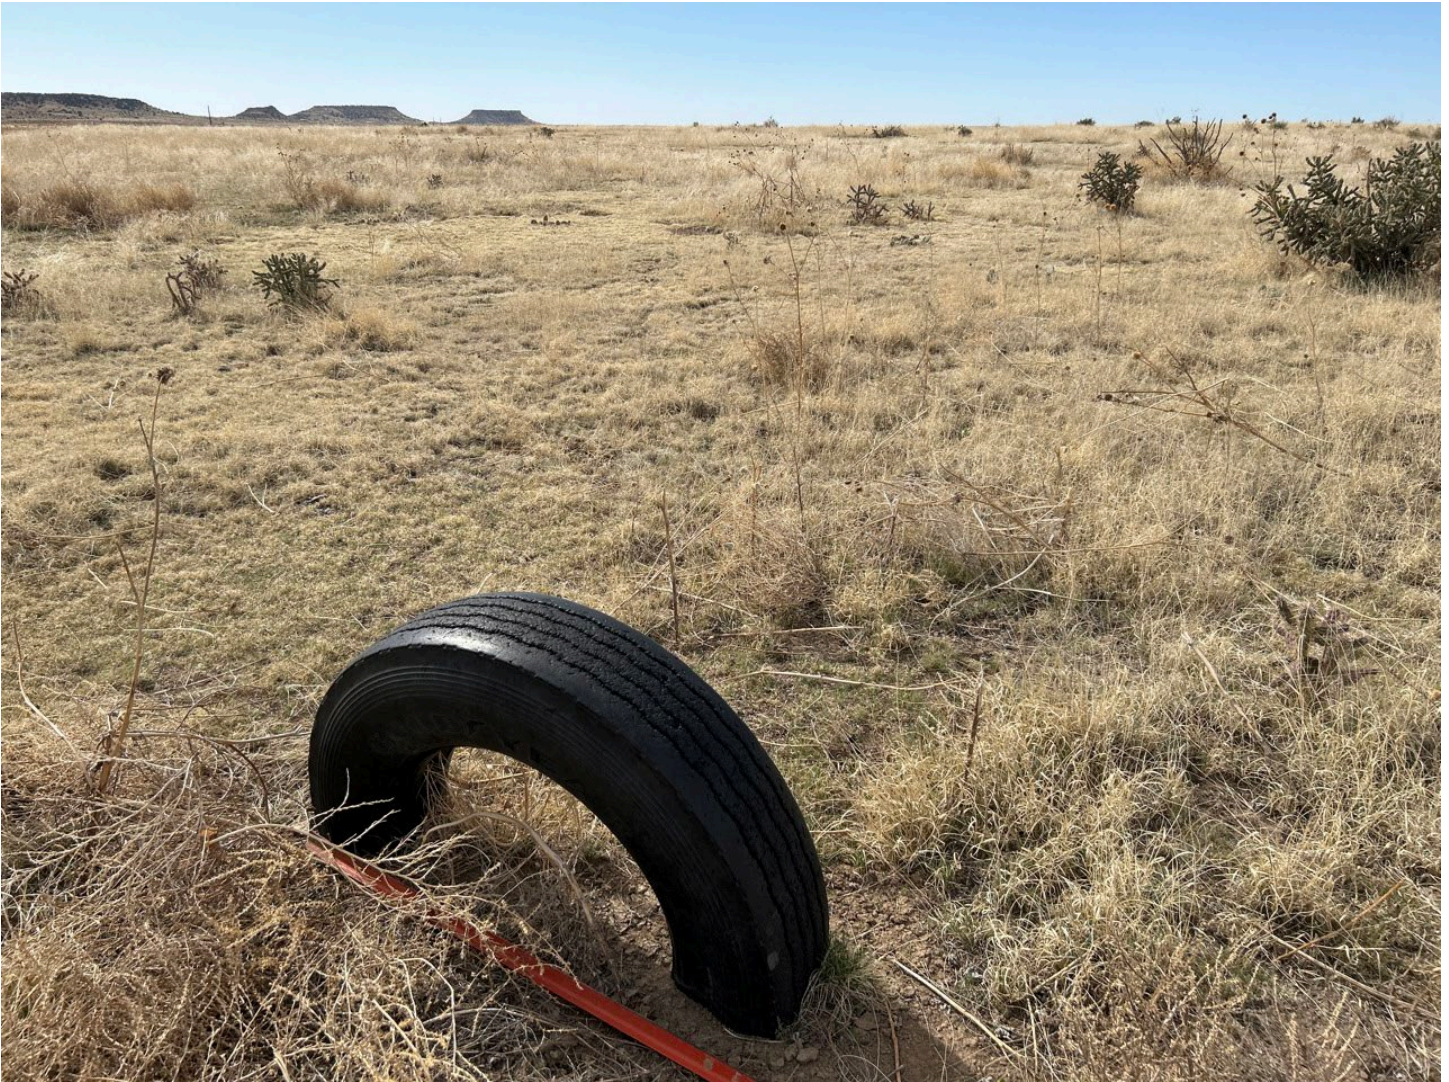
The western corners of the permit area were marked with buried tires, but the eastern corners were not marked as their location in the bed of Johnny Creek would have made the markers susceptible to being washed away during storm events. Permit maps are difficult to georeference accurately, making it difficult to verify that the permit boundary markers are correctly located.

Figure 3: NW permit boundary marker, (264)

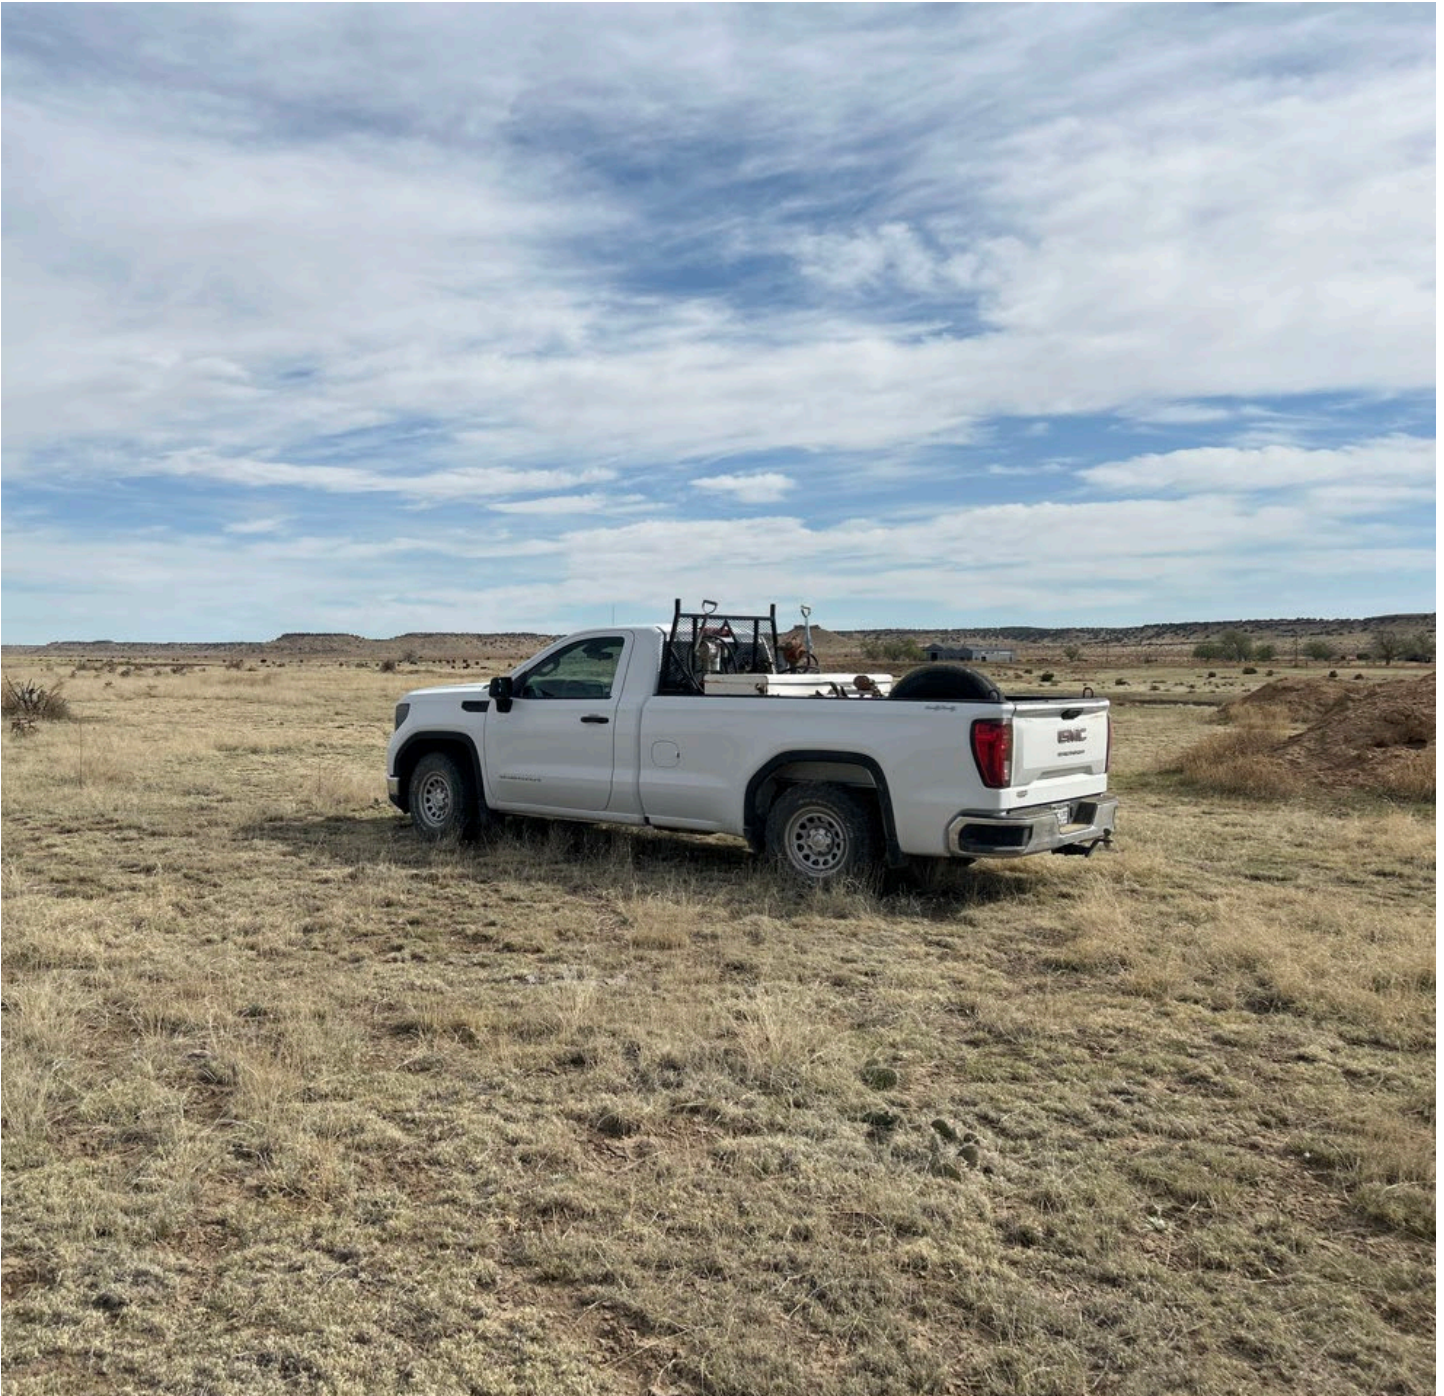
**Figure 4: Stockpiled material (on right of frame) from SW permit boundary marker, (263)**
