# M1983178, Bent County Pit, April 2024 Inspection Report

# MINERALS PROGRAM INSPECTION REPORT PHONE: (303) 866-3567

MINE/PROSPECTING ID#:	MINERAL:	COUNTY:
Bent County Pit		Sand and gravel	Bent
INSPECTION TYPE:		INSP. DATE:	INSP. TIME:
		April 17, 2024	13:00
	OPERATOR REPRESENTATIVE:	TYPE OF OPERATION:	
	Robert Darnell, Kevin Van Egmond	112c - Construction Regular Operation	
	BOND CALCULATION TYPE:	BOND AMOUNT:	
	None	\$0.00	
POST INSP. CONTACTS: JOINT INSP. AGENCY:		ENCY:	
	None	None	
INSPECTOR'S SIGNATURE:		SIGNATURE DA	TE:
LQ1 - 0		July 29, 2024	
7	XY LL		
	INSPE	M-1983-178 WEATHER: Clear  OPERATOR REPRESENTATIVE: Robert Darnell, Kevin Van Egmond BOND CALCULATION TYPE: None POST INSP. CONTACTS: None	M-1983-178  WEATHER: Clear  OPERATOR REPRESENTATIVE: Robert Darnell, Kevin Van Egmond  BOND CALCULATION TYPE: None  POST INSP. CONTACTS: None  INSPECTOR'S SIGNATURE:  Sand and gravel  INSP. DATE: April 17, 2024  TYPE OF OPERA  112c - Construction  BOND AMOUNT  \$0.00  POST INSP. CONTACTS: None  INSPECTOR'S SIGNATURE  SIGNATURE DATE

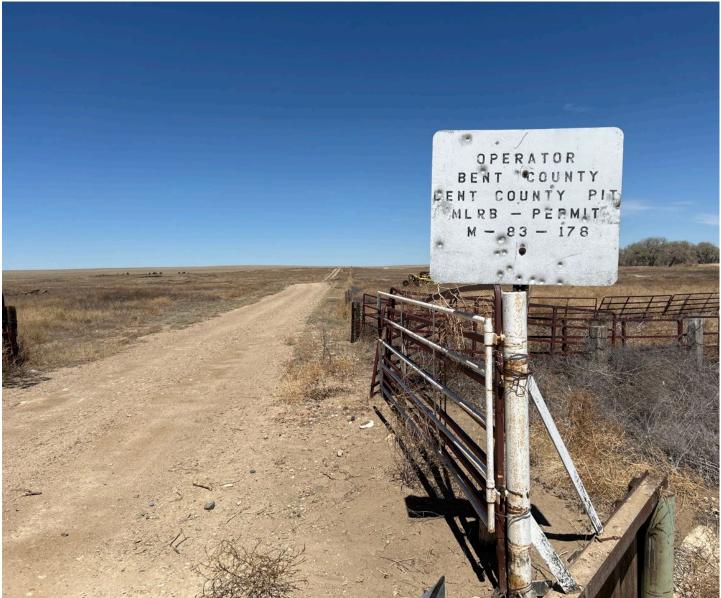
The Mine ID sign was in place, the corners of the permit area were not marked.

Figure 1: Mine ID sign, with reclaimed Bent County Pit beyond

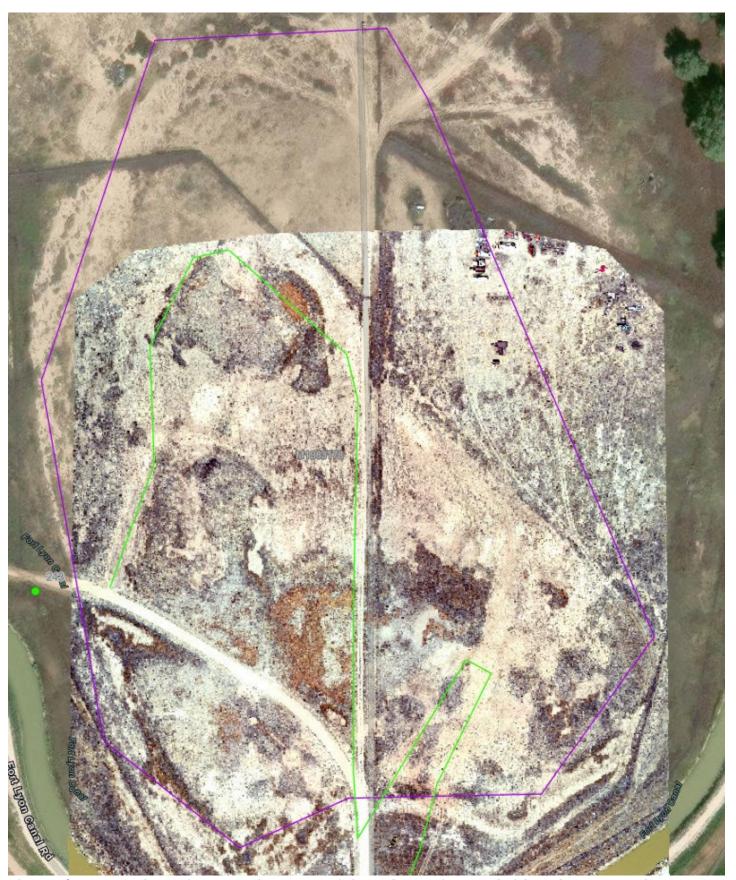
A DJI Mavic 2 Pro drone was used during the inspection. 182 images were captured in the field, from an elevation of 300', and later processed using Pix4D Mapper to generate an orthomosaic of the site.

The pit was reclaimed at around the same time as the Bent County Pit # 2 was permitted, in 2001. Mr Darnell estimated that the pit had been reseeded four times since it was reclaimed. The site had been heavily grazed, (as had most of the land in the rest of the county that was not irrigated cropland); although the grazing puts significant pressure on the vegetative community it is not a mining related impact. Bent County should consider applying for bond release for the Bent County Pit.

Figure 2: Screenshot of Inspection map, with orthomosaic overlaid on basemap and approximate permit boundary (purple) and inspection features (green)
