## Inspection 2024 July PSGCK

**Ins\_CompleteSageCK\_2024\_07July.pdf**

<b>Permit Number:</b> C2009087 <b>Mine Name:</b> Sage Creek  <b>Operator Address:</b> Peabody Sage Creek Mining LLC Ms. Miranda Kawcak 29515 Routt County Road No. 27 Oak Creek, CO 80467	<b>County:</b> Routt <b>Operation Type:</b> Surface <b>Permit Status:</b> Permanent Cessation <b>Ownership:</b> Private  <b>Operator Representative Present:</b>  Miranda Kawcak
<b>Operator Representative Signature: (Field Issuance Only)</b> This report was issued electronically from the Divisions' Denver Office.

<b>Inspection Start Date:</b> 22 July 2024 <b>Inspection Start Time:</b> 2:00 p.m. <b>Inspection End Date:</b> 24 July 2024 <b>Inspection End Time:</b> 10:00 a.m.	<b>Inspection Type:</b> Coal Complete Inspection <b>Inspection Reason:</b> Normal I&E Program <b>Weather:</b> Cloudy
<b>Joint Inspection Agency:</b>  None	<b>Joint Inspection Contacts:</b>
<b>Post Inspection Agency:</b>  None	<b>Post Inspection Contacts:</b>
<b>Inspector(s):</b>  Robin Reilley, M.S. GISP	<b>Inspector's Signature:</b>

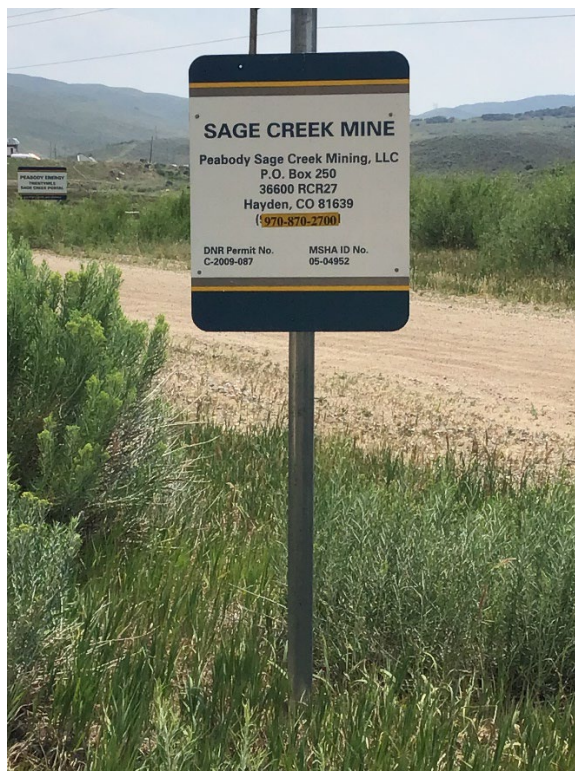
- The mine identification signs were in place at the site entrance. The sign was intact, displaying all required information: mine name, operator name, address, phone number, DRMS permit number and contact information.

***Photo 1: Signage at entry to the site.***

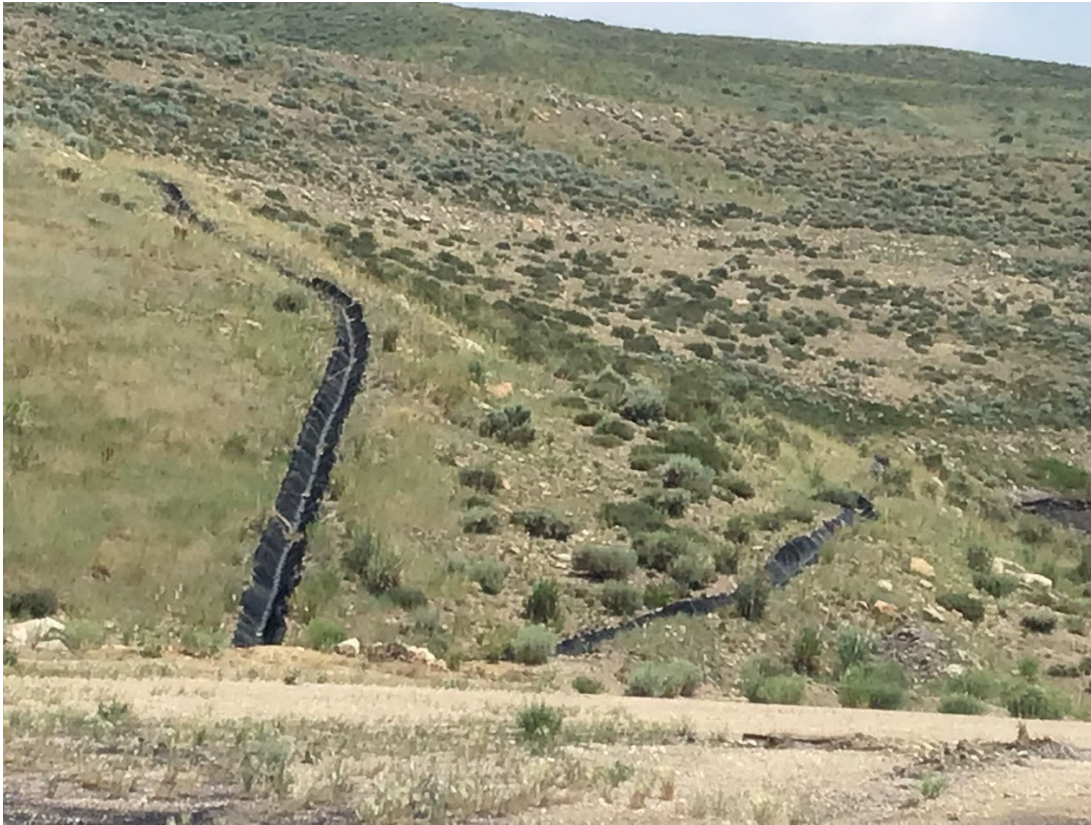
***Photo 2:** “Smart” ditches at the portal, conveying water to Pond 2.*

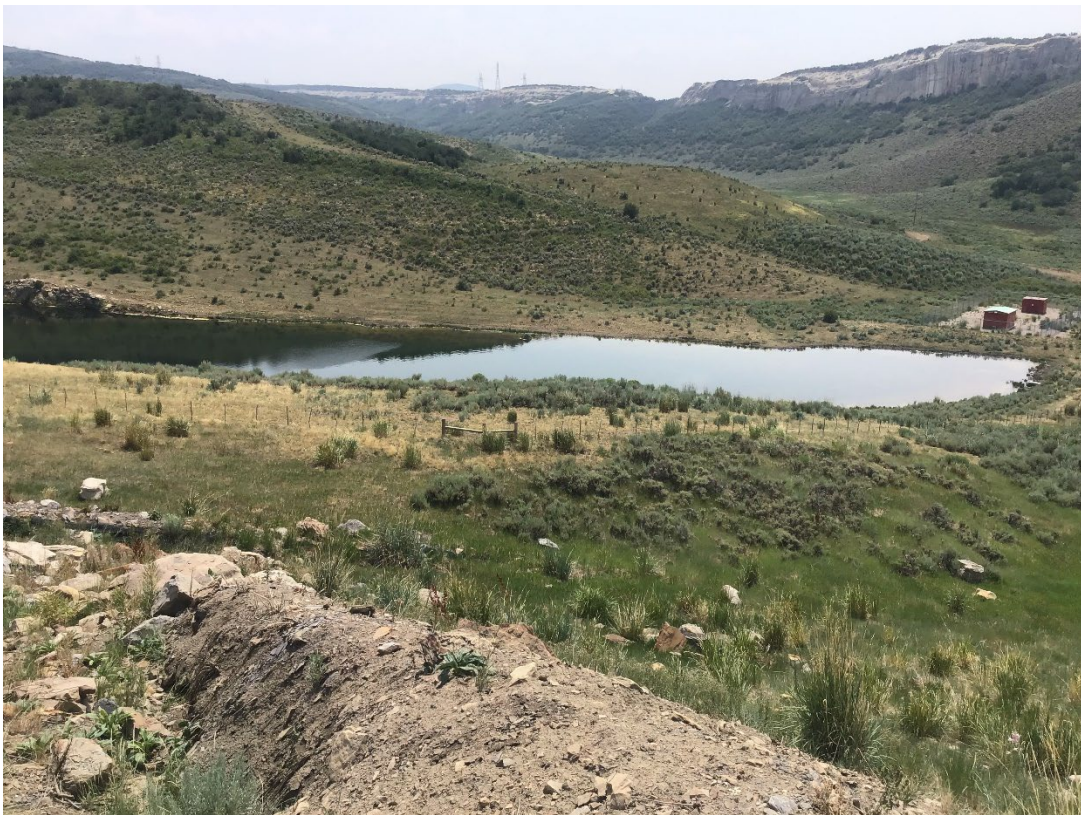
- Sage Creek Pond 2 was holding water at the time of inspection.
- Pond 3 was holding water at the time of inspection.

*Photo 3: Pond 3 and nearby structures.*
