M2005039, Ridley Pit, April 2024 Inspection Report

MINERALS PROGRAM INSPECTION REPORT
PHONE: (303) 866-3567

MINE NAME: Ridley Pit	MINE/PROSPECTING ID#: M-2005-039	MINERAL: Sand and gravel	COUNTY: Bent
INSPECTION TYPE: Monitoring	WEATHER: Clear	INSP. DATE: April 17, 2024	INSP. TIME: 12:00
OPERATOR: Bent County	OPERATOR REPRESENTATIVE: Robert Darnell, Kevin Van Egmond	TYPE OF OPERATION: 112c - Construction Regular Operation	
REASON FOR INSPECTION: Normal I&E Program	BOND CALCULATION TYPE: None	BOND AMOUNT: \$0.00	
DATE OF COMPLAINT: NA	POST INSP. CONTACTS: None	JOINT INSP. AGENCY: None	
INSPECTOR(S): Leigh Simmons	INSPECTOR'S SIGNATURE:

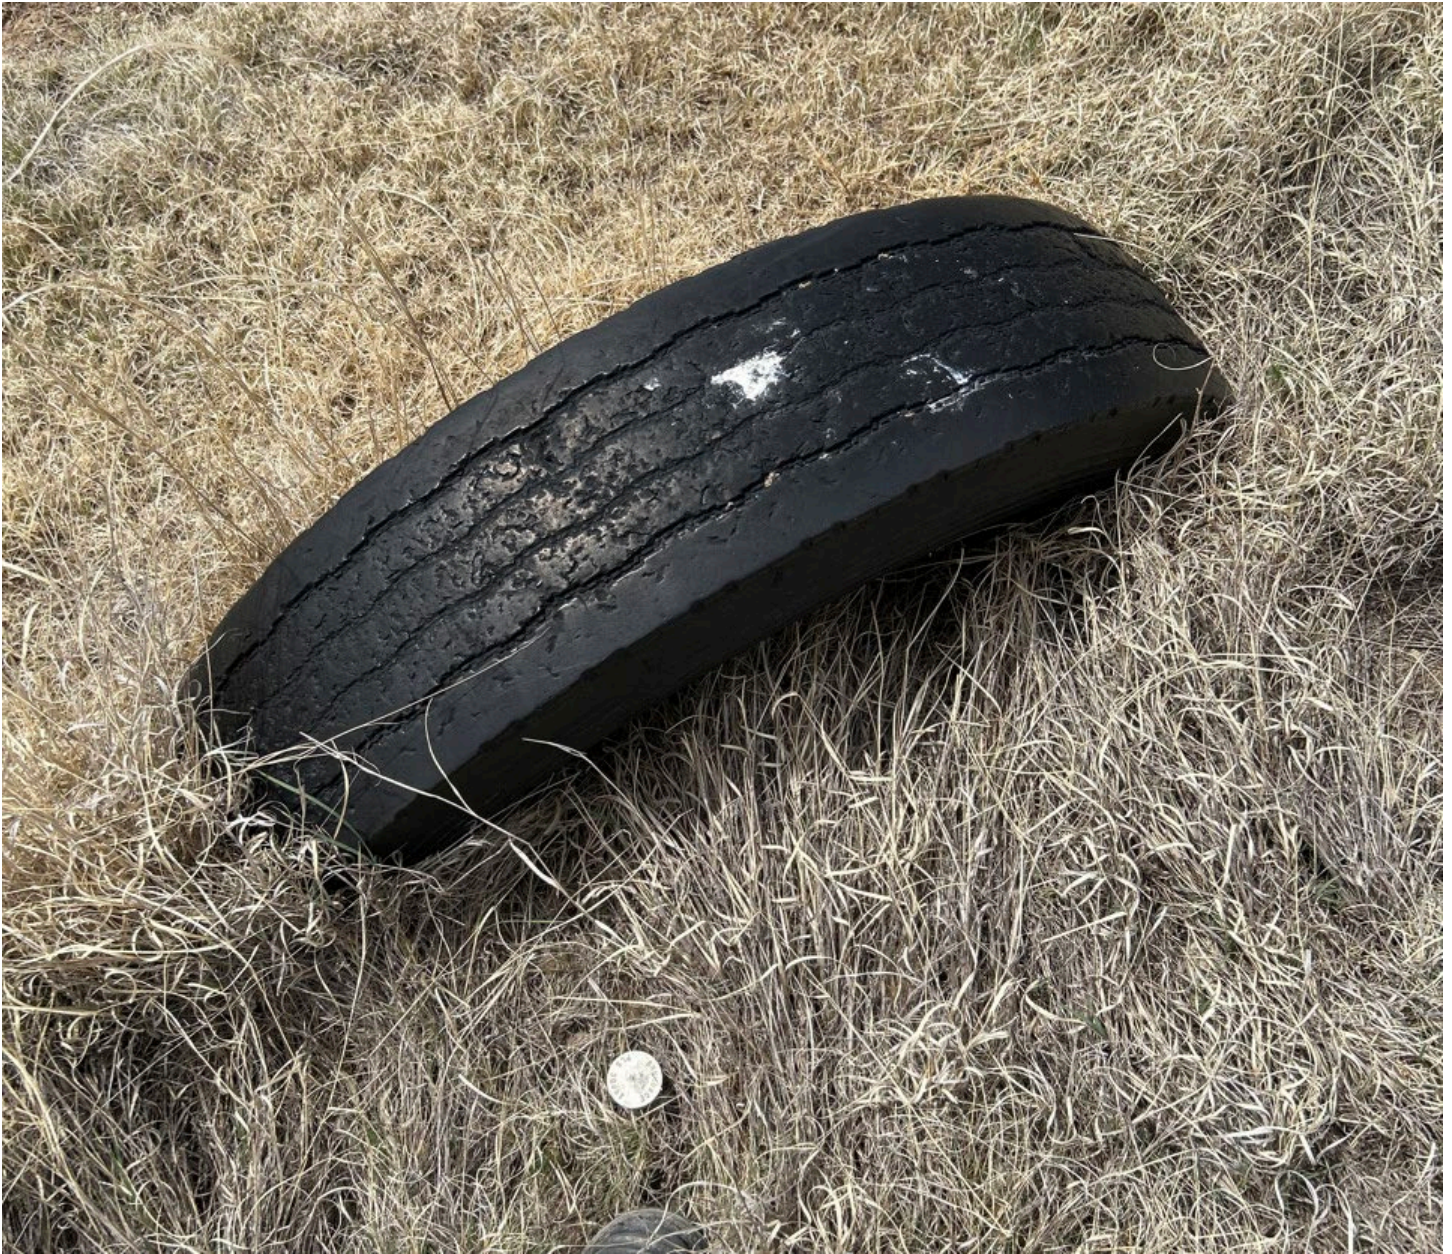
Figure 2: Typical permit boundary corner marker (236)

The Mine ID sign was in place. The corners of the permit area were marked with survey pins protected with buried tires.

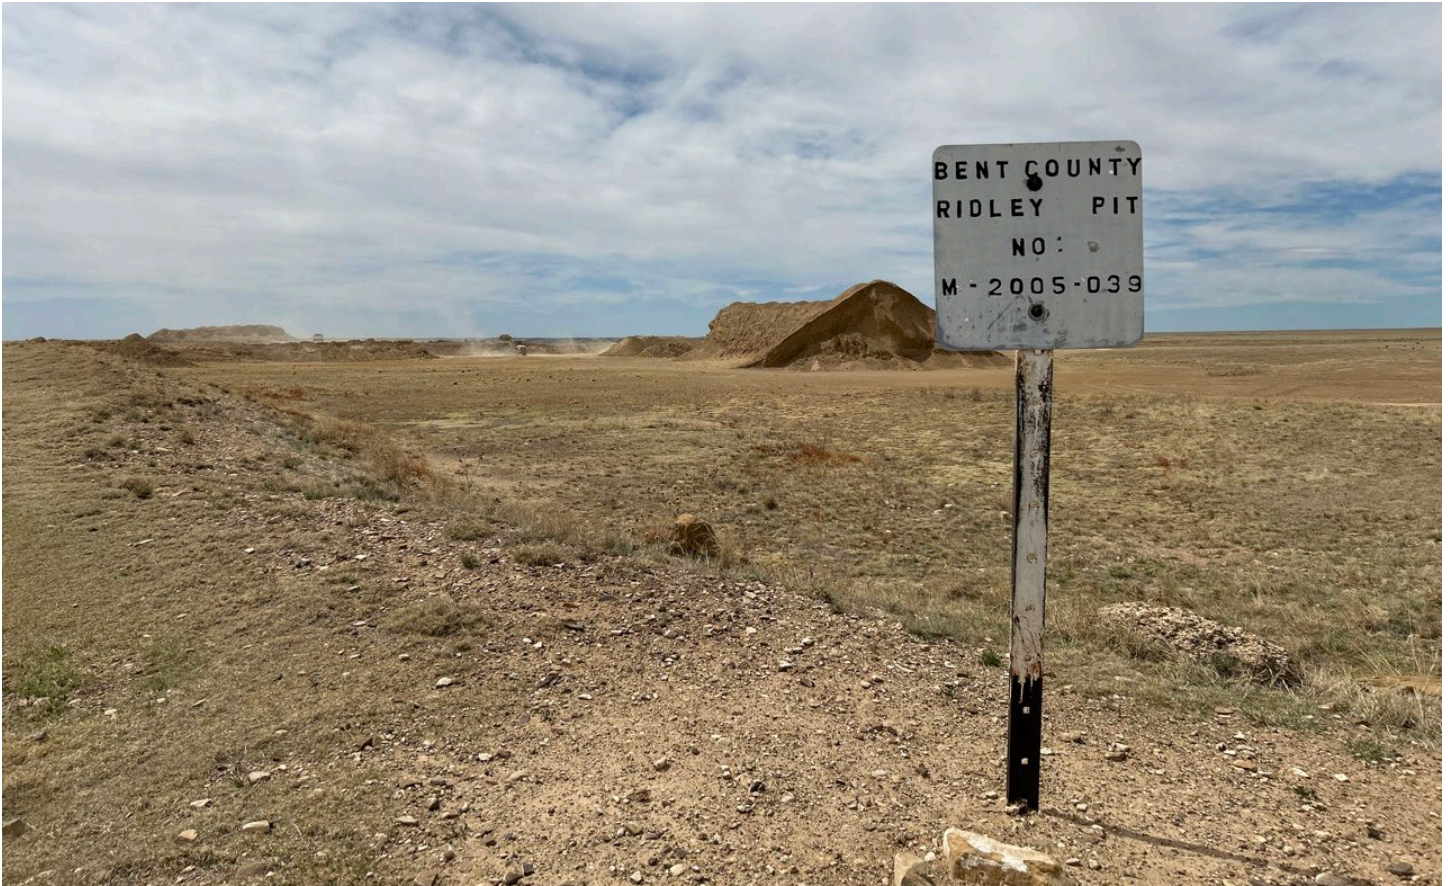
Figure 3: Mine ID sign, with stockpile material behind (240)

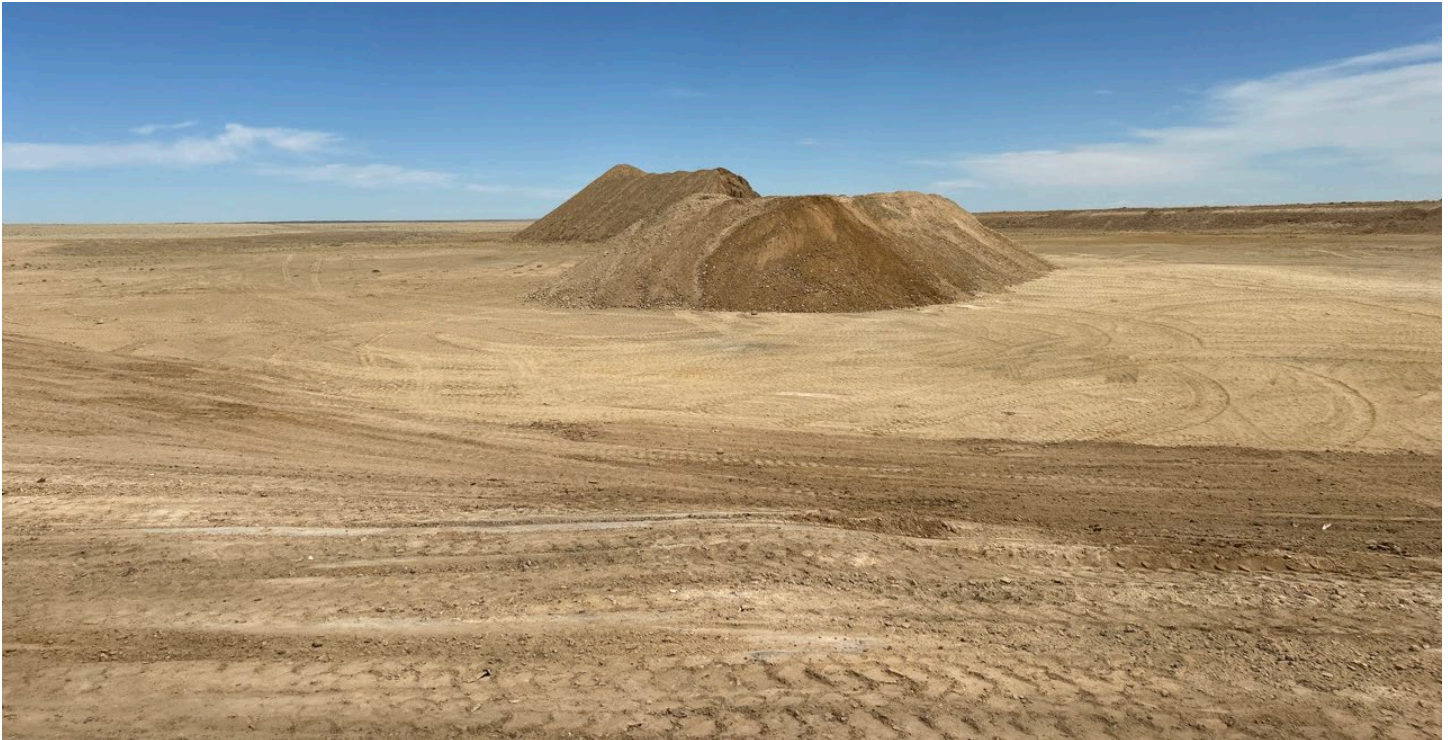
Figure 4: Stockpiled material with regraded slope in foreground (241)

Backfilling, grading and topsoiling of the mined out area had taken place. The reclaimed slope was very shallow (easily less than 3:1, as is required). The slope had not been seeded.

Topsoil had been stockpiled in a shallow windrow.

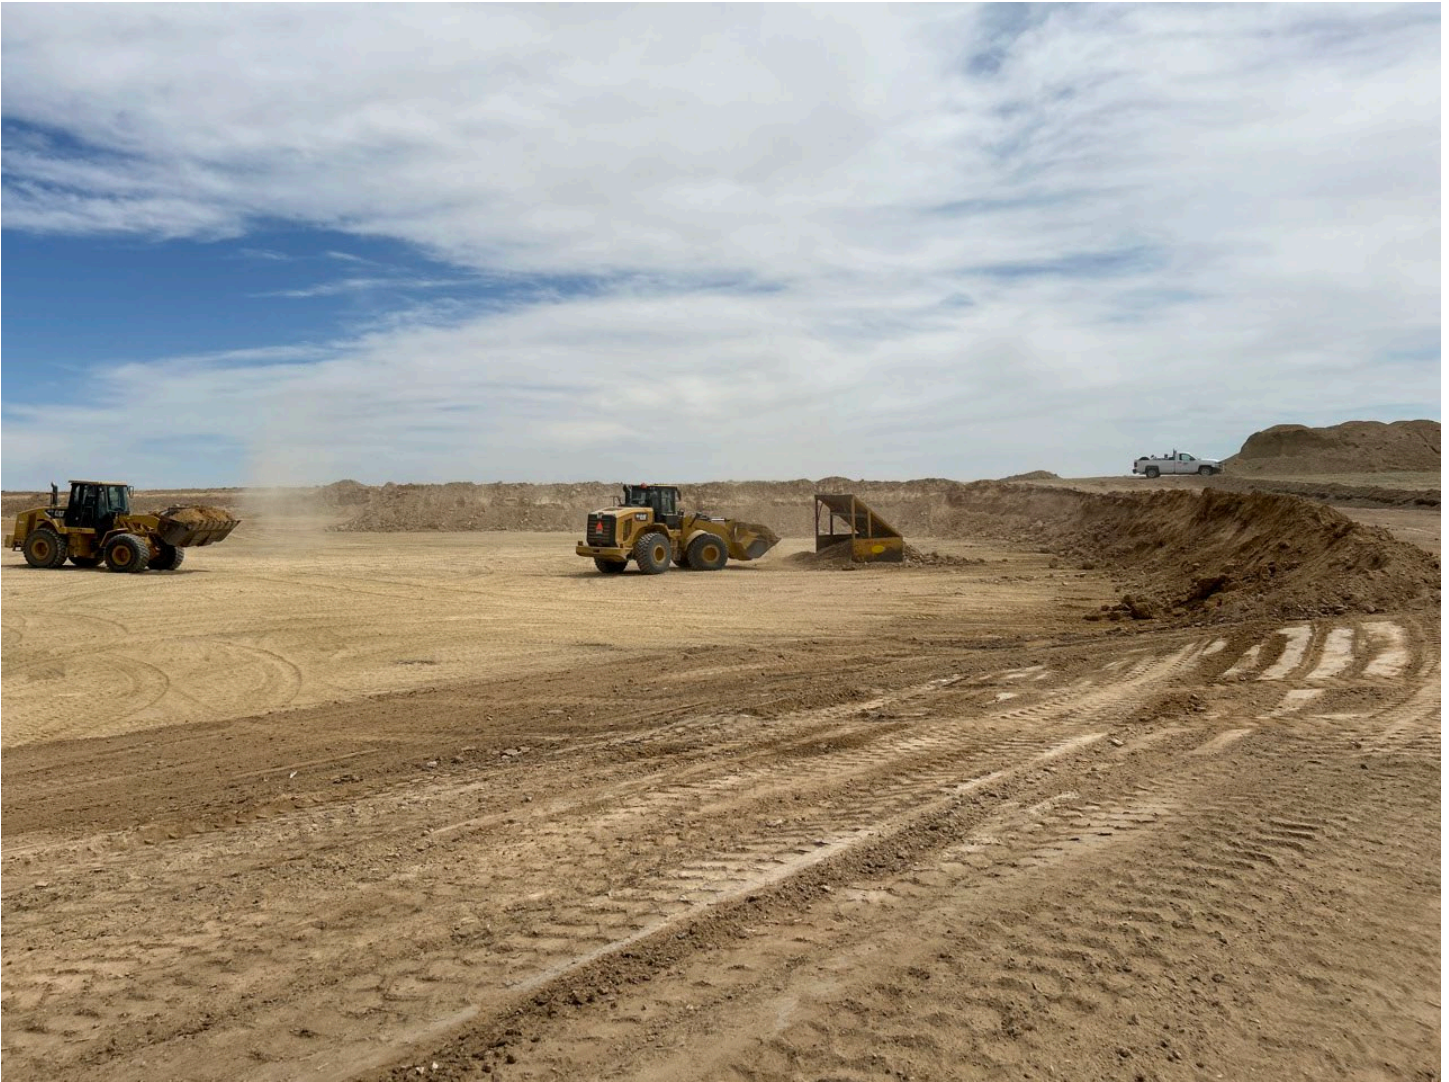
Figure 5: Screening in progress, with recently graded slope in foreground (241)

Mining was by extraction of a shallow strip, proceeding from the west side of the permit area toward the south and east. The county road will be temporarily re-routed to the east (along the green line in Figure 1), while the existing road is mined through. The road will then be re-established on its original course, but lower. Some stockpiled material was on-site, including some crushed material. County workers were able to mine and screen material, but a third party contractor would be hired when crushing was required.
