M2008013, #2 Verhoeff Pit, 2024 Inspection Report

MINERALS PROGRAM INSPECTION REPORT
PHONE: (303) 866-3567

MINE NAME: #2 Verhoeff Pit	MINE/PROSPECTING ID#: M-2008-013	MINERAL: Sand and gravel	COUNTY: Bent
INSPECTION TYPE: Monitoring	WEATHER: Clear	INSP. DATE: April 16, 2024	INSP. TIME: 16:30
OPERATOR: Riverside Aggregates, LLC	OPERATOR REPRESENTATIVE: Mark Carrigan	TYPE OF OPERATION: 110c - Construction Limited Impact	
REASON FOR INSPECTION: Normal I&E Program	BOND CALCULATION TYPE: None	BOND AMOUNT: \$21,603.00	
DATE OF COMPLAINT: NA	POST INSP. CONTACTS: None	JOINT INSP. AGENCY: None	
INSPECTOR(S): Leigh Simmons	INSPECTOR'S SIGNATURE:

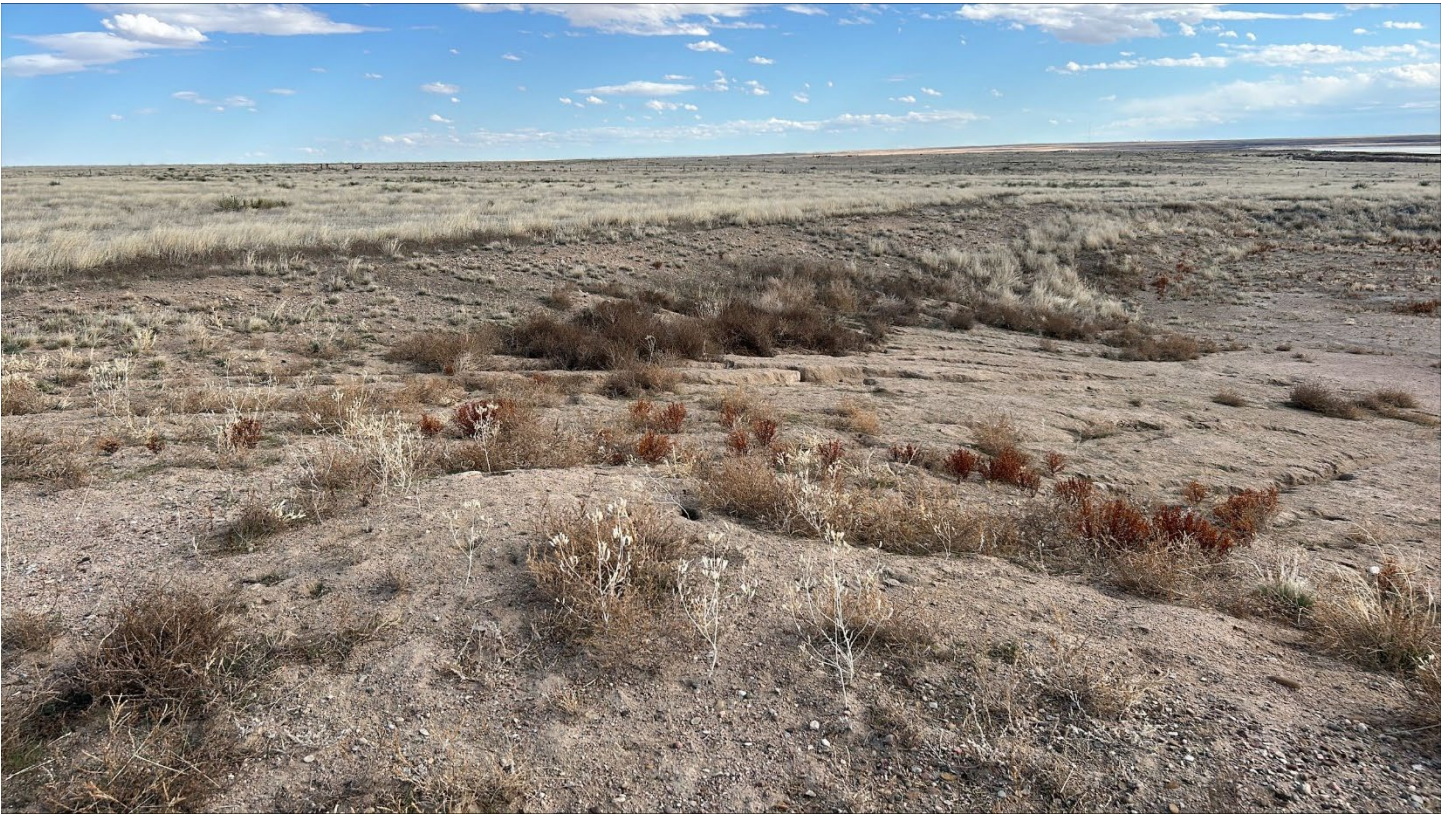
Figure 1

Mining has been completed at the site and it has been reclaimed. Earlier reclamation looks good. But more recent reclamation, reseeded in 2022 was damaged by flashy storms in 2023. Surface erosion will need to be repaired and additional seeding will also be needed, (but some small grass seedlings were visible). The Division strongly recommends that cows are kept off the reclaimed area until the site has been released.
