Job Number: 99-3983

Subject: Quarterly Observation Report,
Refuse Pile, Foidel Creek Mine, Routt
County, Colorado.

TCC Refuse Pile-Quarterly Inspection

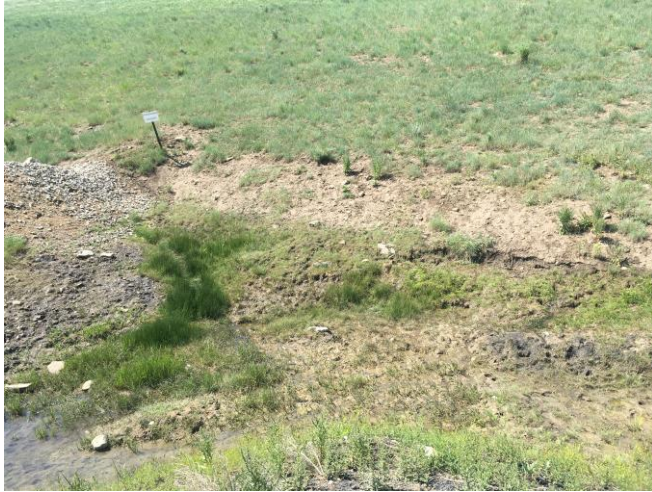
A seepage area at the toe of the northeast end of the refuse pile expansion area, approximately 30 feet northwest of the outlet of the underdrain, developed in fall 2014. At the time of our observations, the seepage was surfacing at the toe of the slope and flowing into the drainage from the undrain outlet then into the existing pond east of the Refuse Pile Expansion Area. The discharge was clear, with no evidence of sediment. No signs of washout, slumps or slope instability were observed at this time. The seepage area will be monitored during future inspections and noted in our inspection reports. Photographs of the seepage area taken at the time of our inspection on June 28, 2024 are attached.

June 28, 2024-Drain Outlet and Seepage Area

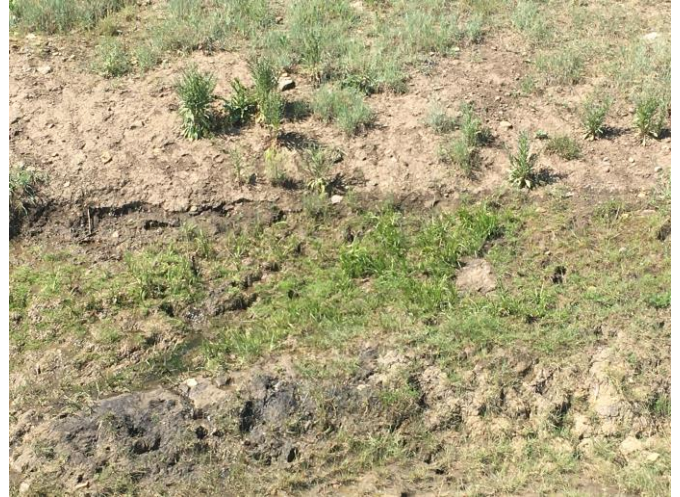
June 28, 2024-Seepage Area

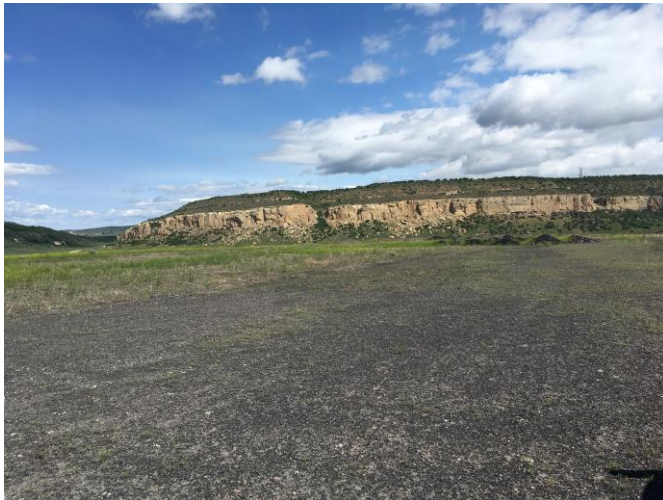
The internal roadways in the new expansion area of the pile are in good condition. The upper haul road to Areas 2, 3 and 4 of the refuse pile was accessible and in good condition.

June 28, 2024- Areas 2, 3 and 4

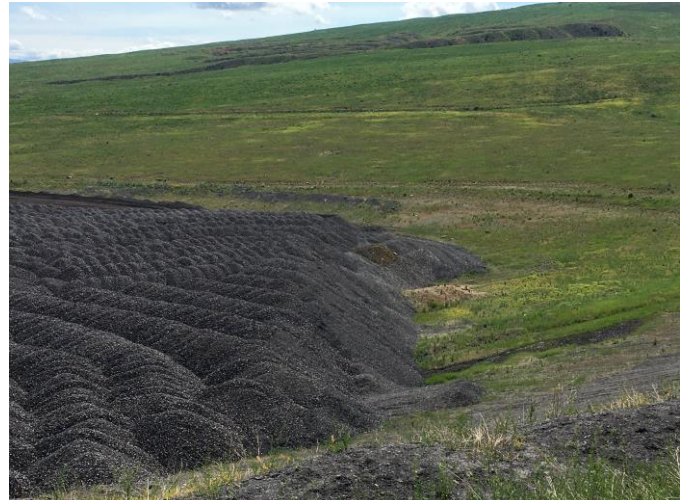
June 28, 2024- Drain Inlet

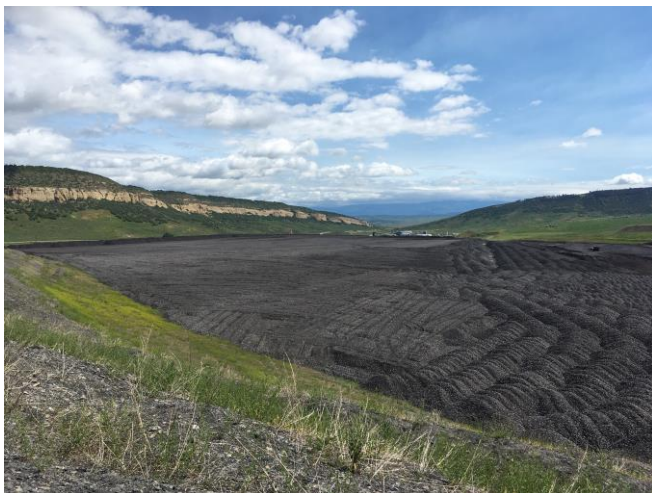
At the time of our site visit on June 28, 2024, NWCC completed a site inspection of the existing refuse pile. Based on our observations made during this visit, it appeared that the contractor was presently stockpiling, grading and compacting refuse coal in the new Expansion Area. At the time of our site visit, the refuse coal had been placed and compacted to an elevation above the third bench situated along the east side of the stockpile. Cover materials were being stockpiled on the third bench to be spread over the slope below the third bench

June 28, 2024- Expansion Area

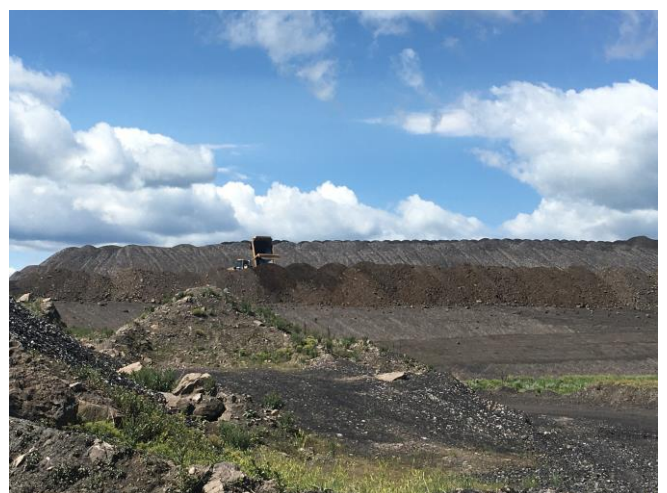
June 28, 2024- Cover Material Stockpiling
