**Re: Turnpike Mining Resource (M-2004-009) – May 10, 2024 Inspection Corrective Actions Completed, Request to Extend Due Date for Re-seeding, and Request to Complete Grading of Drainage Ditch as Part of Overall Site Reclamation**

Attachment 1 – Corrective Action Photograph Log

**Document:**  
Schell Property Cleanup

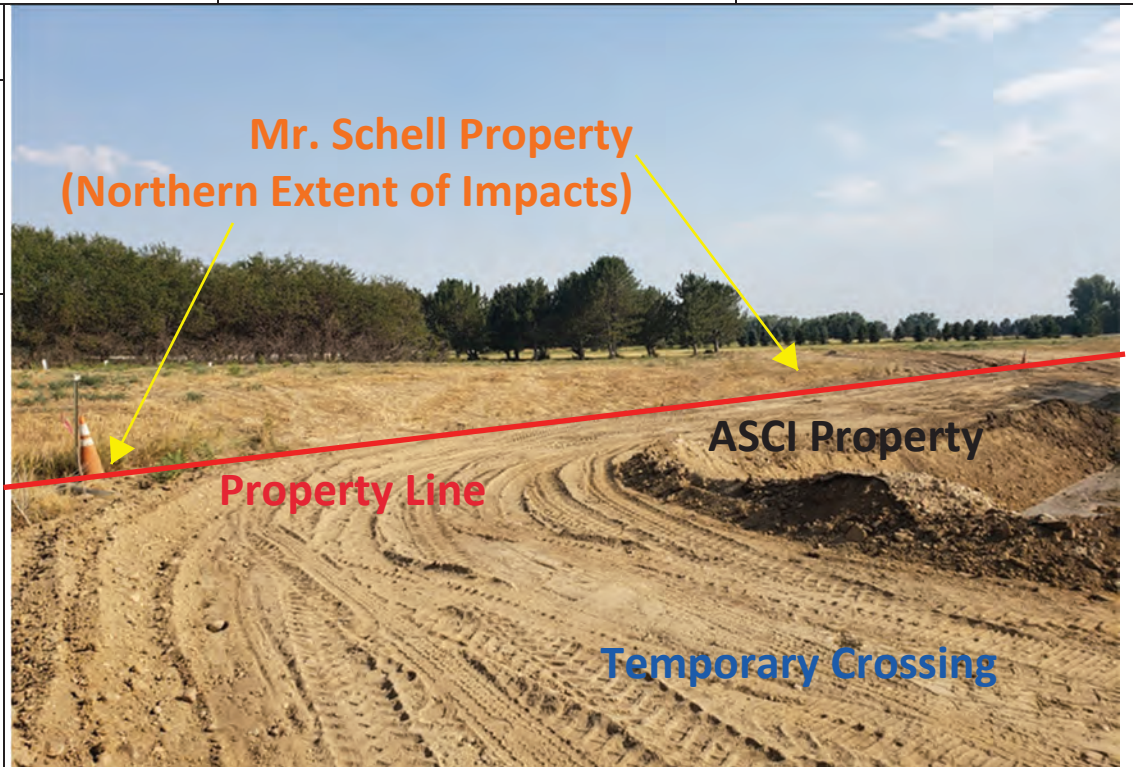
**Photo No.**  
**1**

View of property line and areas of off-site impacts. Off-site mud removal and grading complete. To be re-seeded this fall.

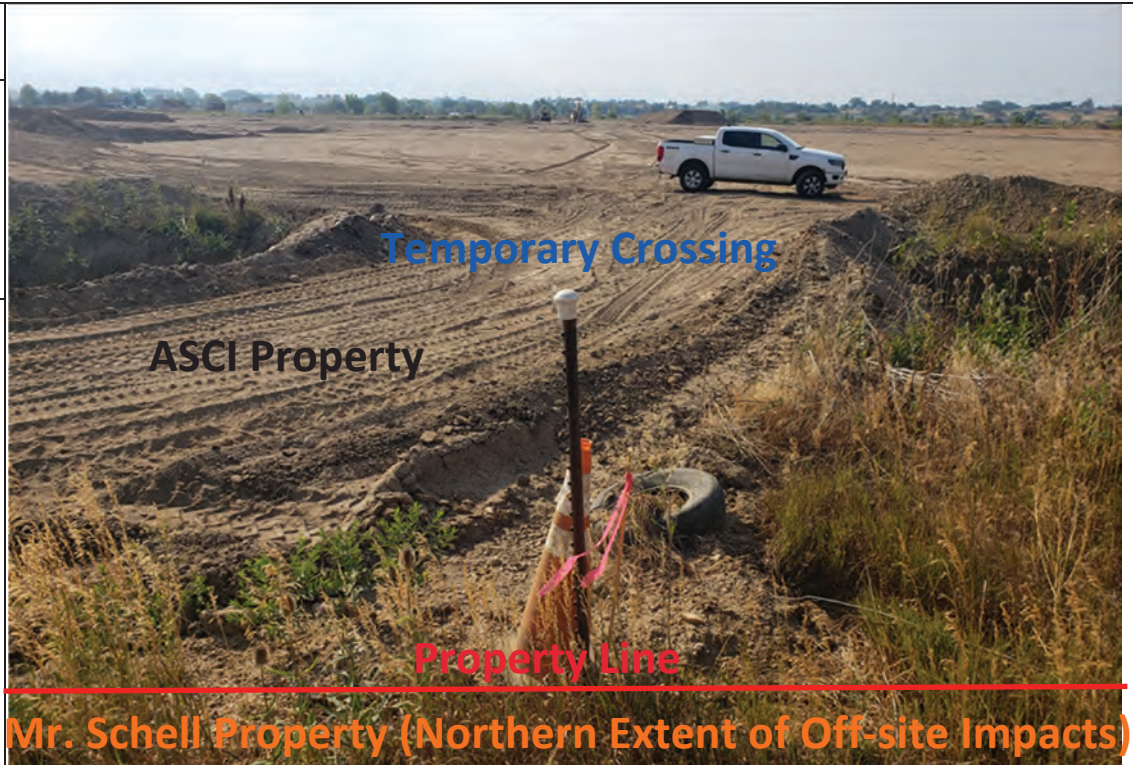
**Photo No.**  
**2**

View of temporary crossing and off-site impacts at property line.

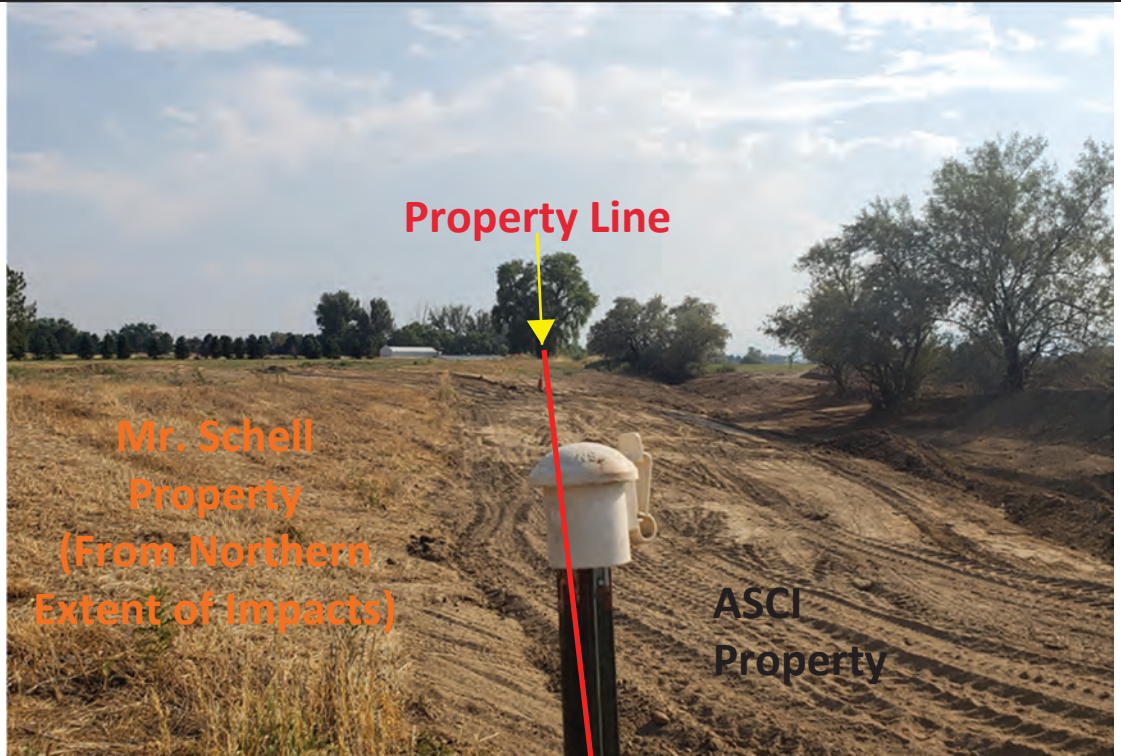
**Photo No.**

View of property line and areas of off-site impacts. Off-site mud removal and grading complete. To be re-seeded this fall. Regrading of drainage ditch complete to-date on ASCI property.

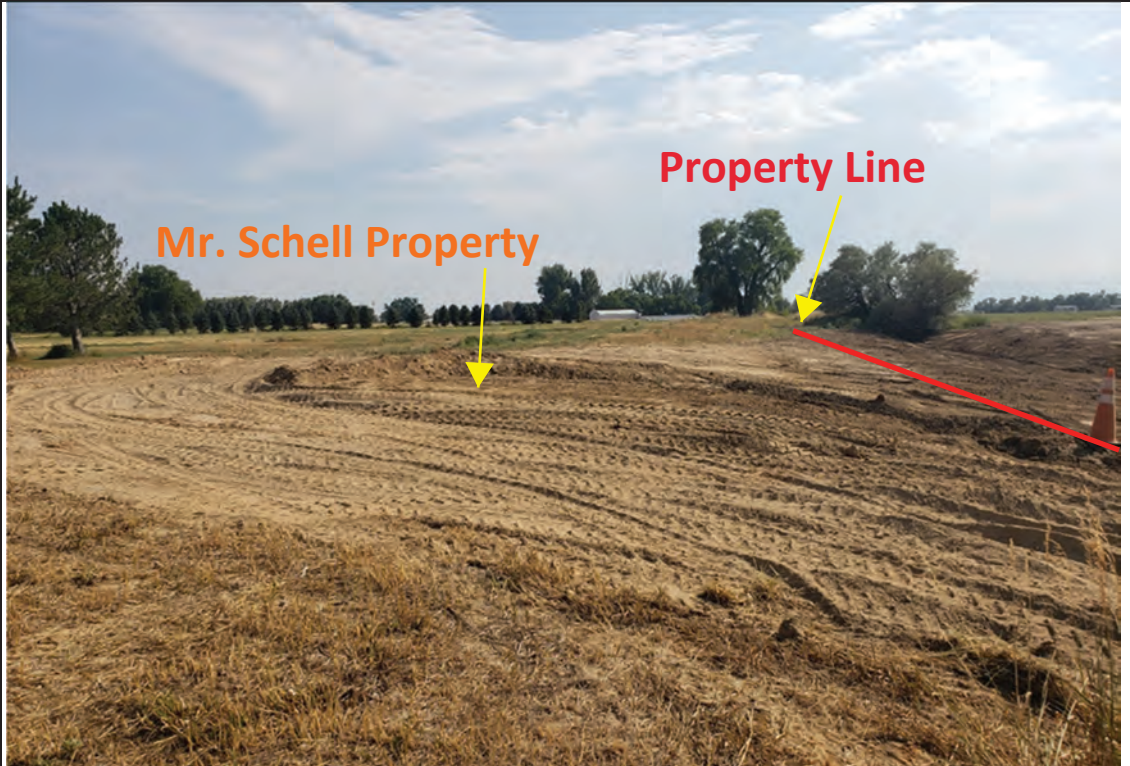
**Photo No.**

View of property line and off-site impacts. Off-site mud removal and grading complete. To be re-seeded this fall.

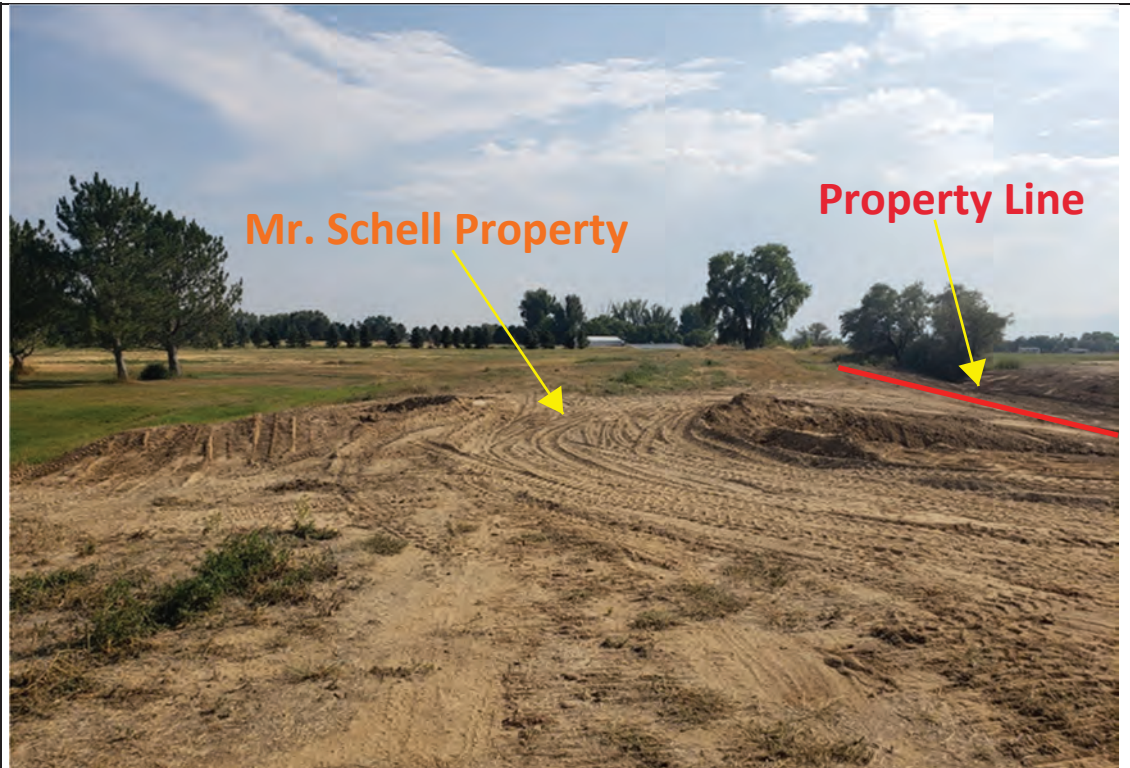
**Photo No.**

View of off-site impacts. Off-site mud removal and grading complete. To be re-seeded this fall.

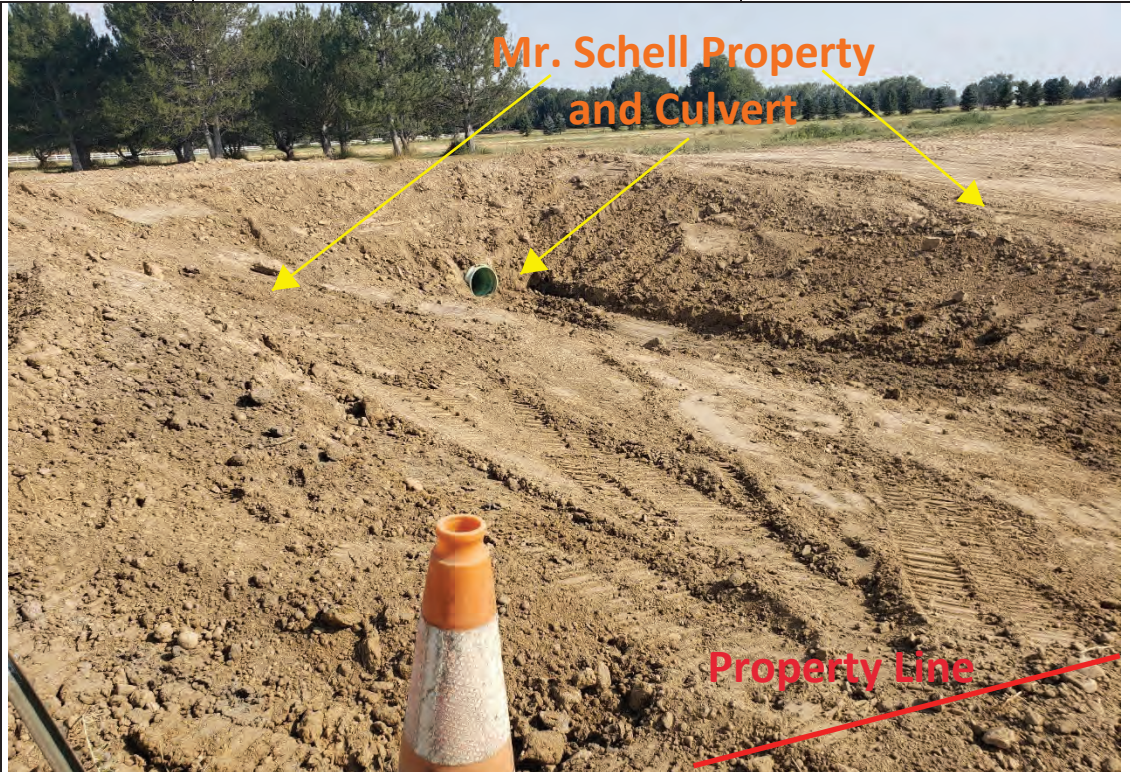
**Photo No.**

View of west end of Mr. Schell culvert found and re-graded. To be re-seeded this fall.

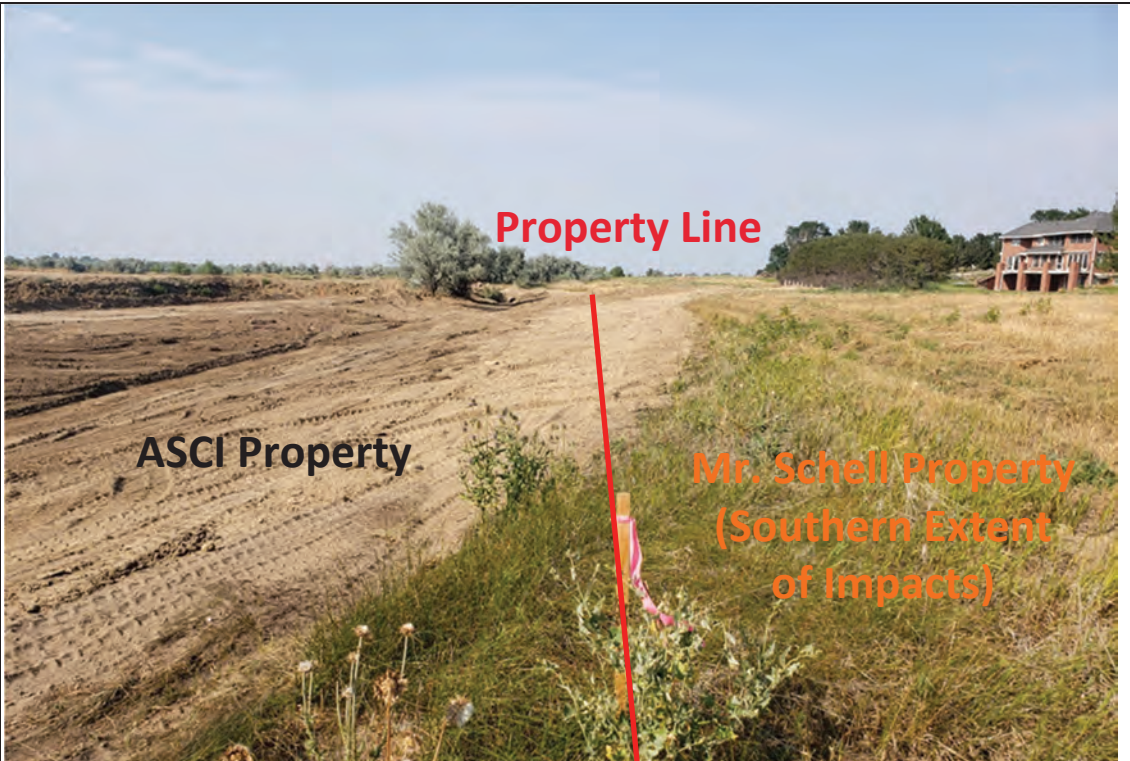
**Photo No.**

View of property line and areas of off-site impacts from southern extent. Off-site mud removal and grading complete. Areas of drainage regraded to-date on ASCI property. To be re-seeded this fall.

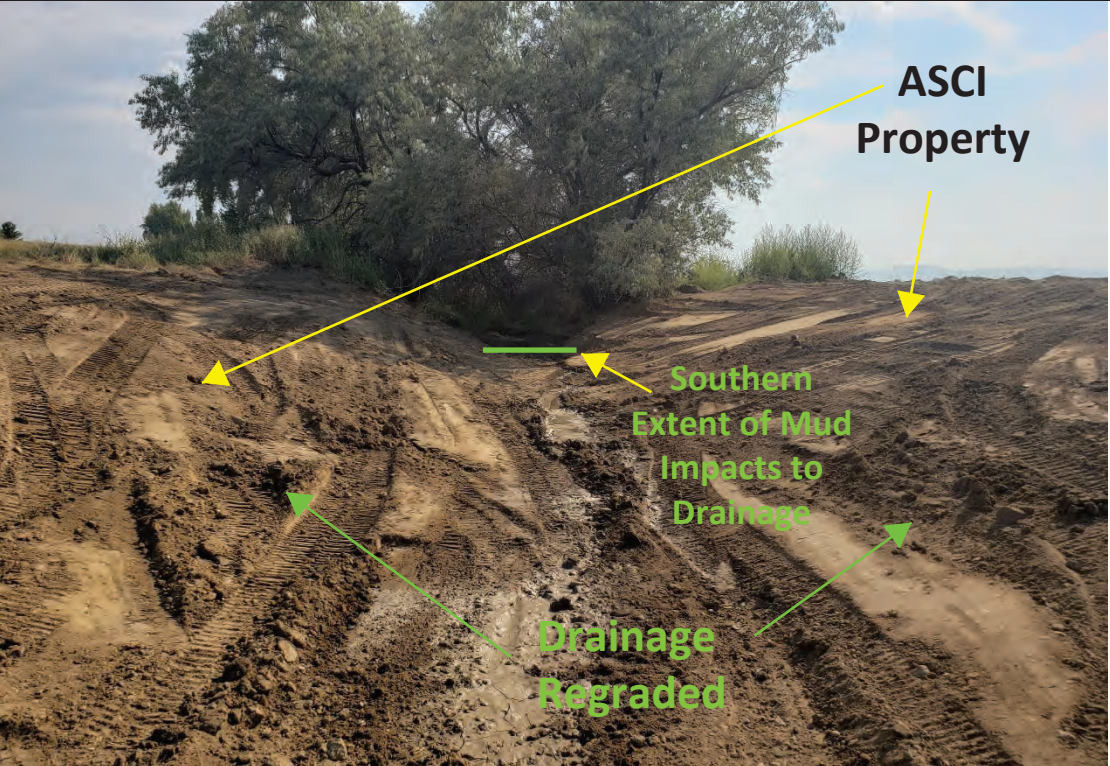
<b>Site Name:</b> Turnpike Mining Resource		<b>Site Location:</b> 599 HWY 52, Erie CO 80516	<b>Document:</b> Schell Property Cleanup
<b>Photo No.</b> <b>9</b>	<b>Date:</b> 8/2/2024

<b>Direction Photo Taken:</b> South			
<b>Description:</b> Southern extent of mud impacts to drainage on ASCI property. Mud removed and drainage regraded. To be re-seeded this fall.

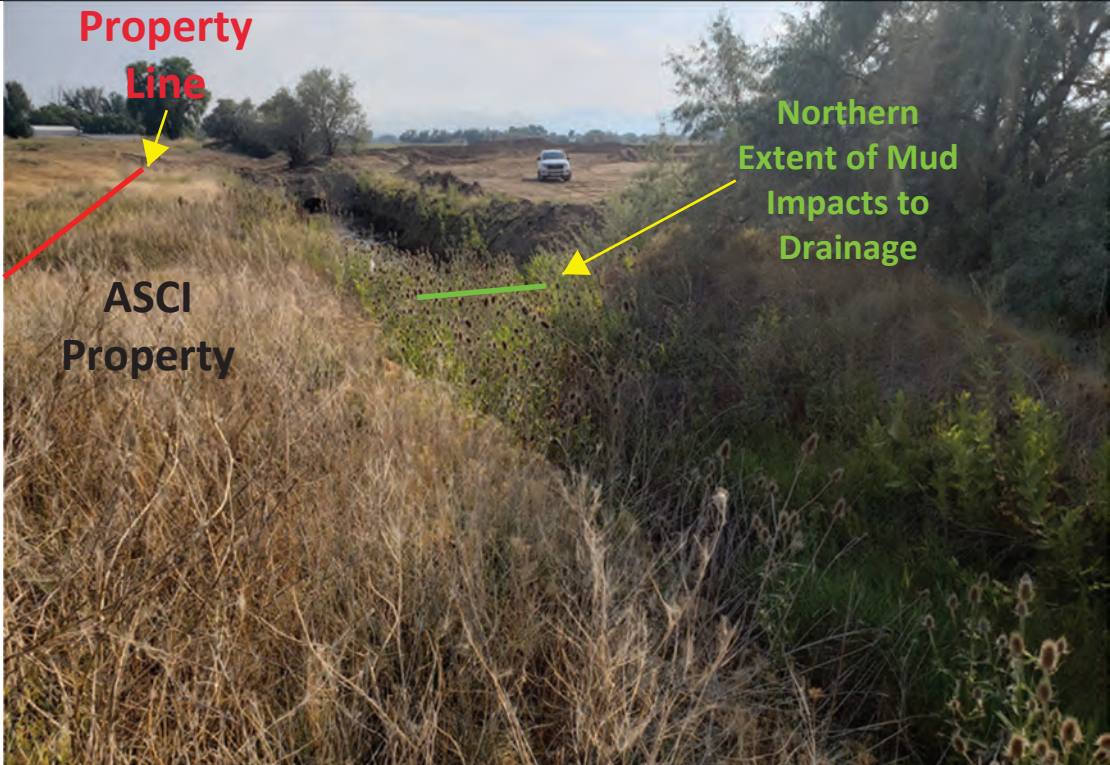
<b>SPECIALTIES CO.</b>		<b>PHOTOGRAPH LOG</b>	
<b>Site Name:</b> Turnpike Mining Resource		<b>Site Location:</b> 599 HWY 52, Erie CO 80516	
<b>Document:</b> Schell Property Cleanup			
<b>Photo No.</b> <b>13</b>	<b>Date:</b> 8/2/2024

<b>Direction Photo Taken:</b> South			
<b>Description:</b> Drainage ditch on ASCI property north of area impacted by mud flow. Historic topography not 3:1 slope.

As discussed, since the drainage ditch is located on ASCI property and the drainage ditch is functional, ASCI respectfully requests to be able to complete Problem #1 Corrective Action “3. *Grade the slope to 3H:1V and blend with the contours of the natural drainage.*” during the overall Site reclamation period since additional grading of ditch slopes beyond the extent of mud impacts may be necessary.

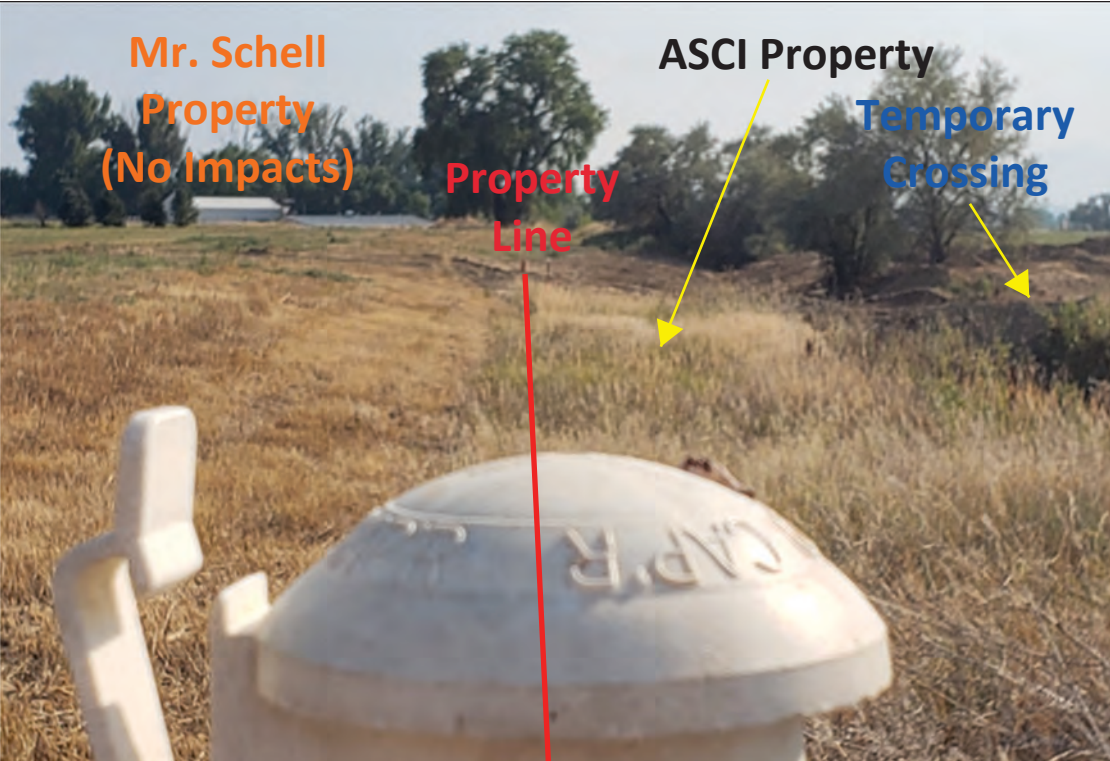
<b>Photo No.</b> <b>14</b>	<b>Date:</b> 8/2/2024

<b>Direction Photo Taken:</b> South			
<b>Description:</b> View of property line from area north of temporary crossing and mud impacts.
