**MINERALS PROGRAM INSPECTION REPORT**  
**PHONE: (303) 866-3567**

<b>MINE NAME:</b> Uncompahgre Pit	<b>MINE/PROSPECTING ID#:</b> M-2013-007	<b>MINERAL:</b> Gravel and sand	<b>COUNTY:</b> Montrose
<b>INSPECTION TYPE:</b> Monitoring	<b>WEATHER:</b> Clear	<b>INSP. DATE:</b> August 13, 2024	<b>INSP. TIME:</b> 10:30
<b>OPERATOR:</b> Lazy K-Bar Land & Cattle Company, LLLP	<b>OPERATOR REPRESENTATIVE:</b> Zane Luttrell	<b>TYPE OF OPERATION:</b> 112c - Construction Regular Operation

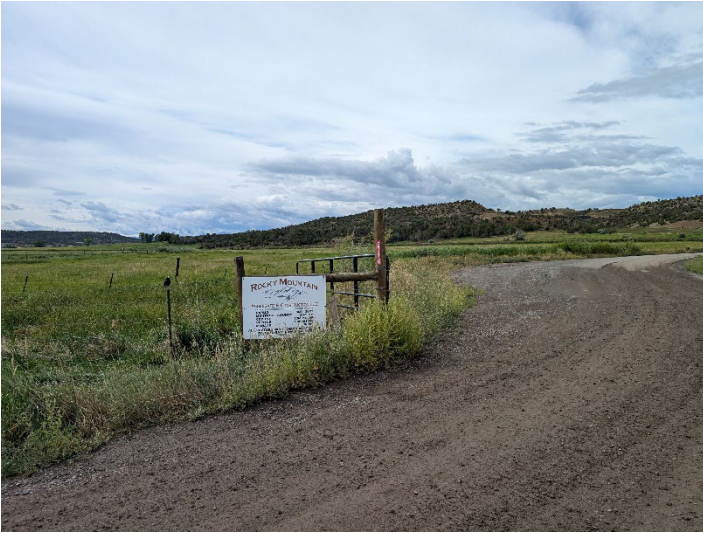
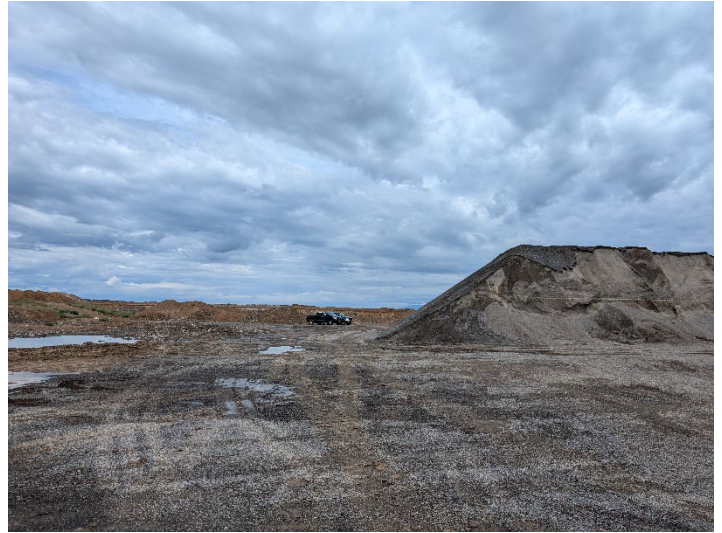
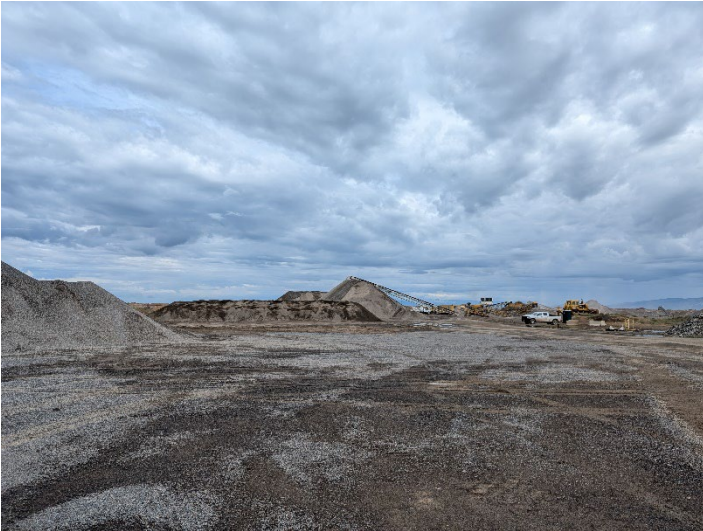
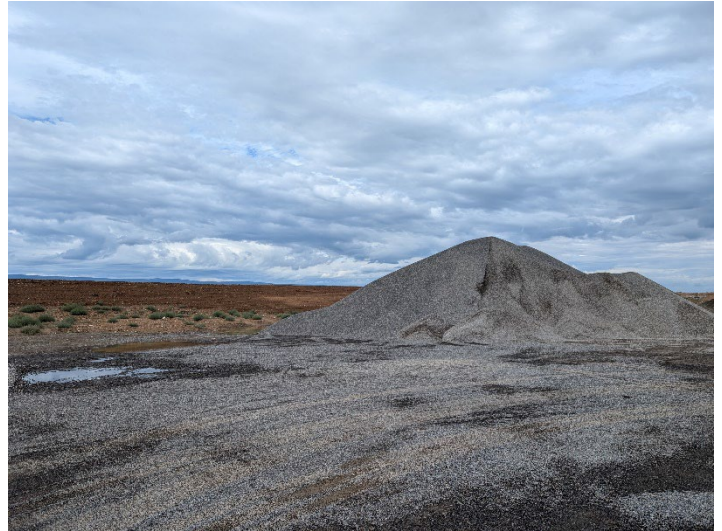
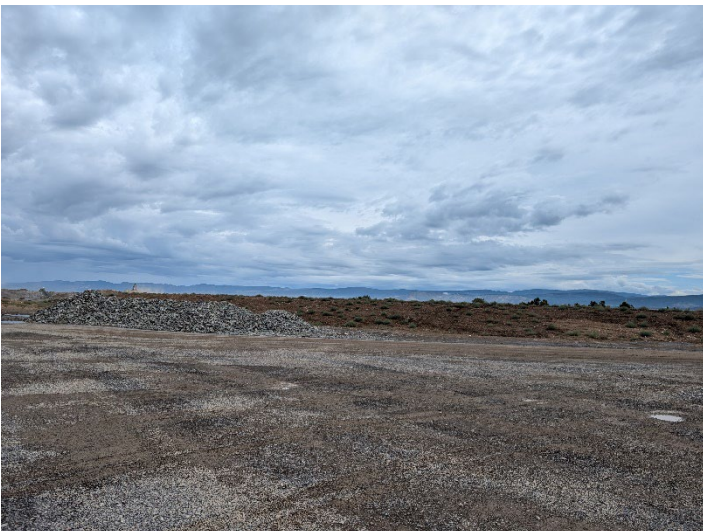
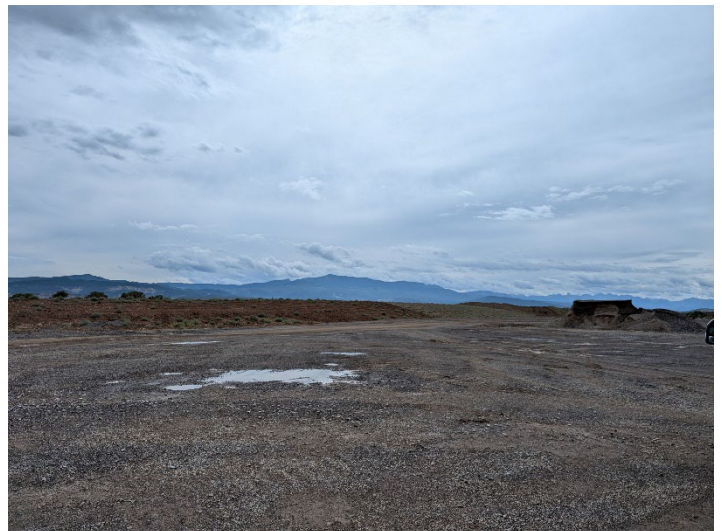
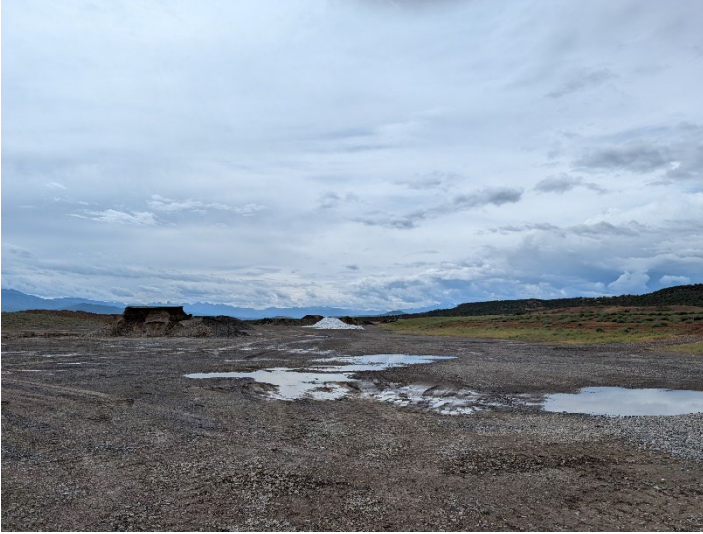
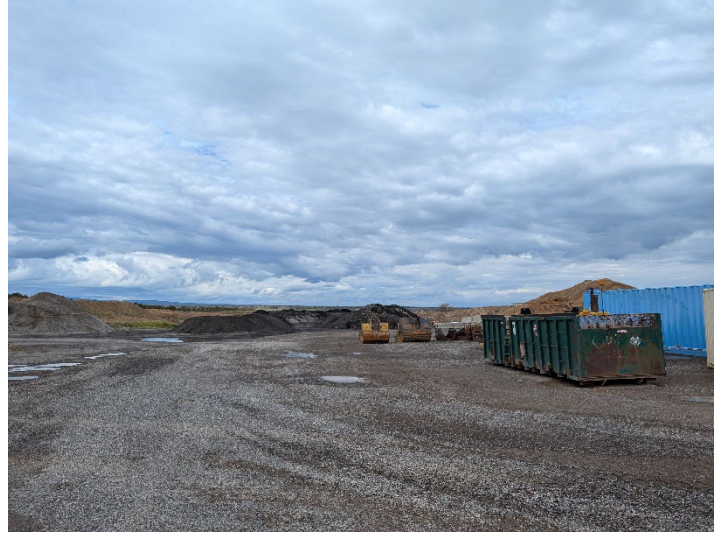
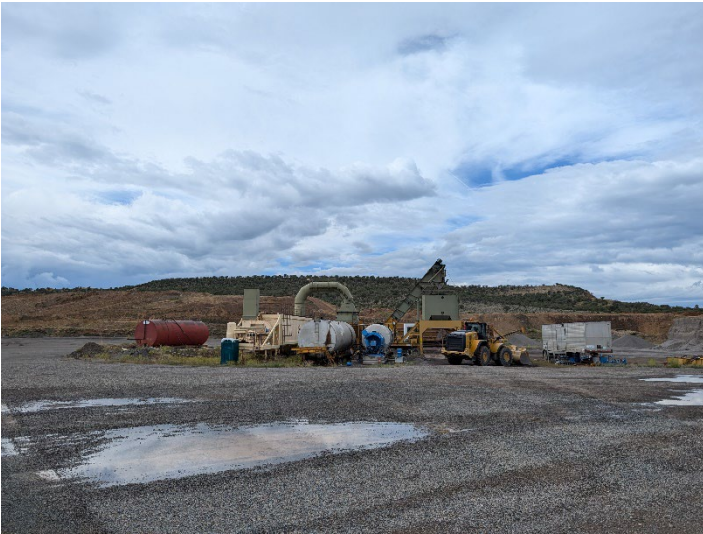
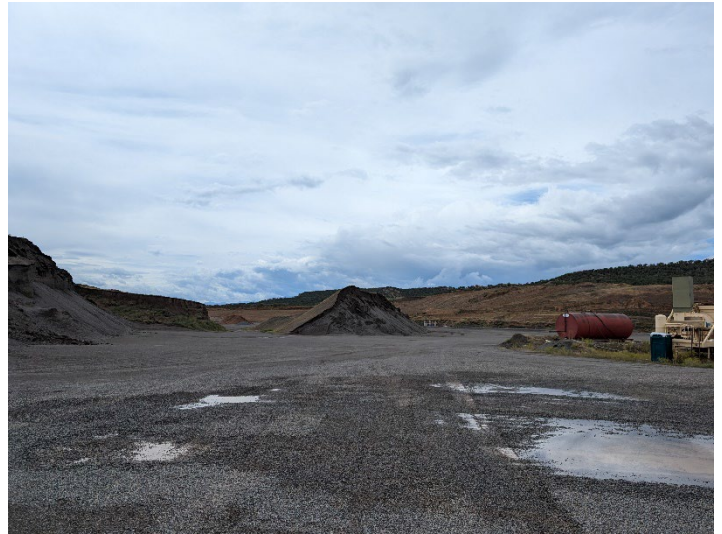
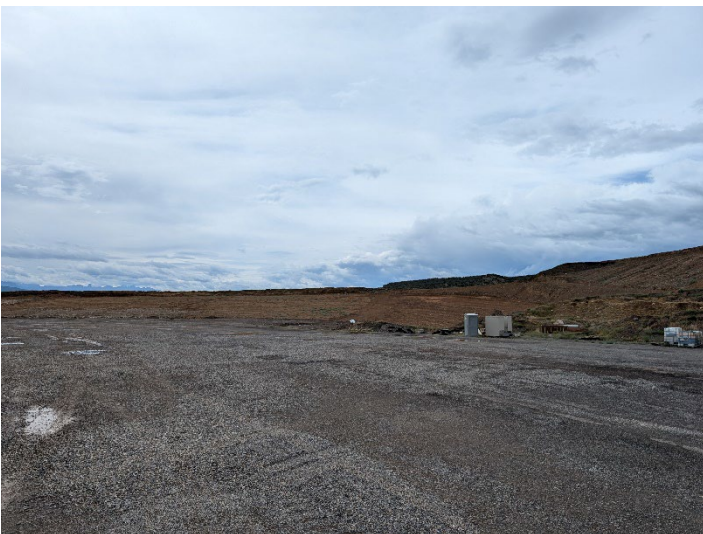
This inspection was conducted as part of the Division of Reclamation, Mining and Safety's (Division) normal monitoring program. Zane Luttrell, representing the Operator, was present during this inspection. Photographs are included with this report to illustrate conditions observed.

Mining at the site is progressing to the north. Materials stockpiles are located throughout the pit. Topsoil is stockpiled in different areas around the pit perimeter. The plant area is set up at the top of the access road, in the southwest part of the pit. Import fill and recycled asphalt are stockpiled north of the plant area.

Since the Divisions last inspection, most of the slopes around the perimeter of the pit have been reduced to 3H:1V.
