Inspection Complete WF 2024 August

Please find DRMS's 2024 August inspection report for the Williams Fork Site. This was a complete inspection.

21 August 2024

Permit Number: C-1981-044 Mine Name: Williams Fork Mines Operator: Moffat County Mining, LLC Operator Address: Ms. Miranda Kawcak 29515 Routt County Road #27 Oak Creek, CO 80467	County: Moffat Operation Type: Underground Permit Status: Active Ownership: Private Miranda Kawcak
This report was issued electronically from the Divisions' Denver Office.

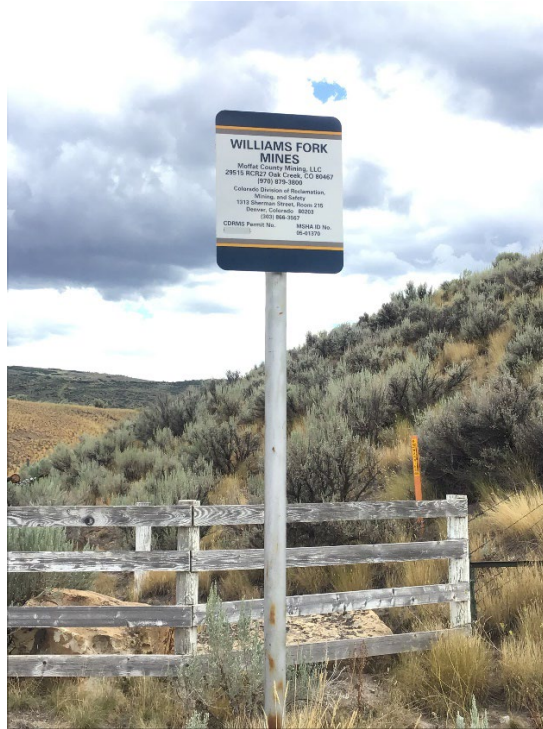
Photo 1: Mine ID sign at the entrance of Highway 13.

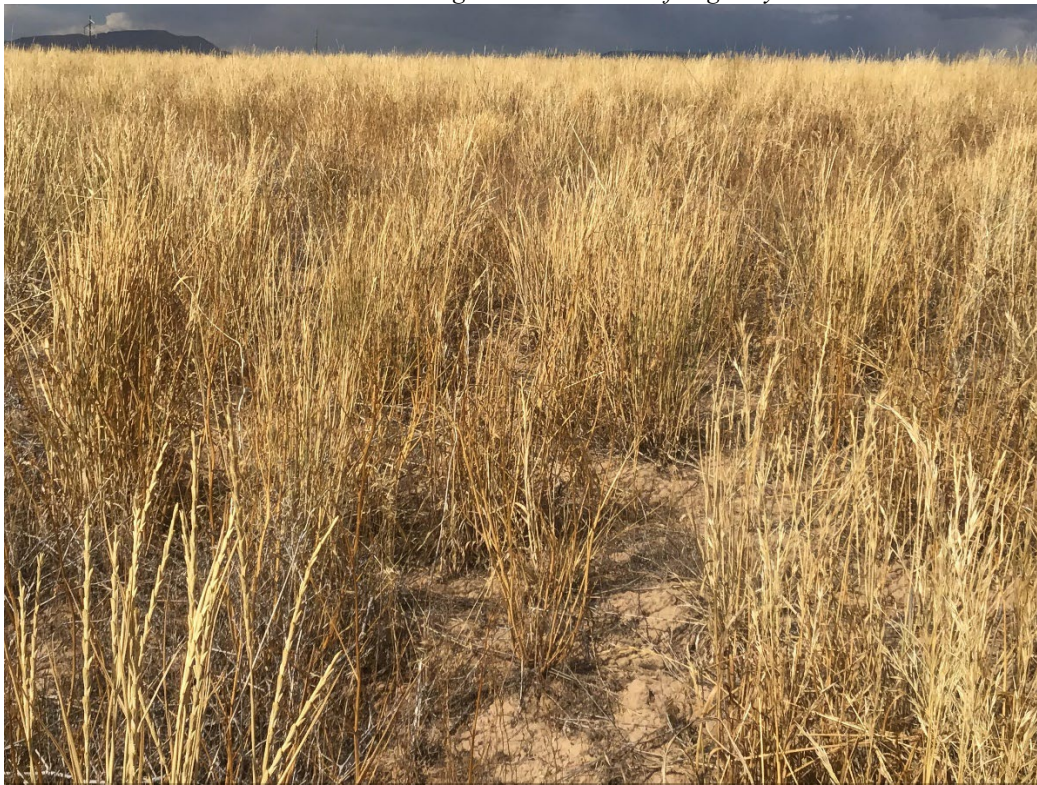
- Slope to Pond 5A-P1 was well vegetated with yellow sweet clover, for the most part obscuring any gullies and rills.

Photo 2. Slope toward the 5AP1 Pond below the shop area comprises some grasses and a plethora of dormant yellow sweet clover.

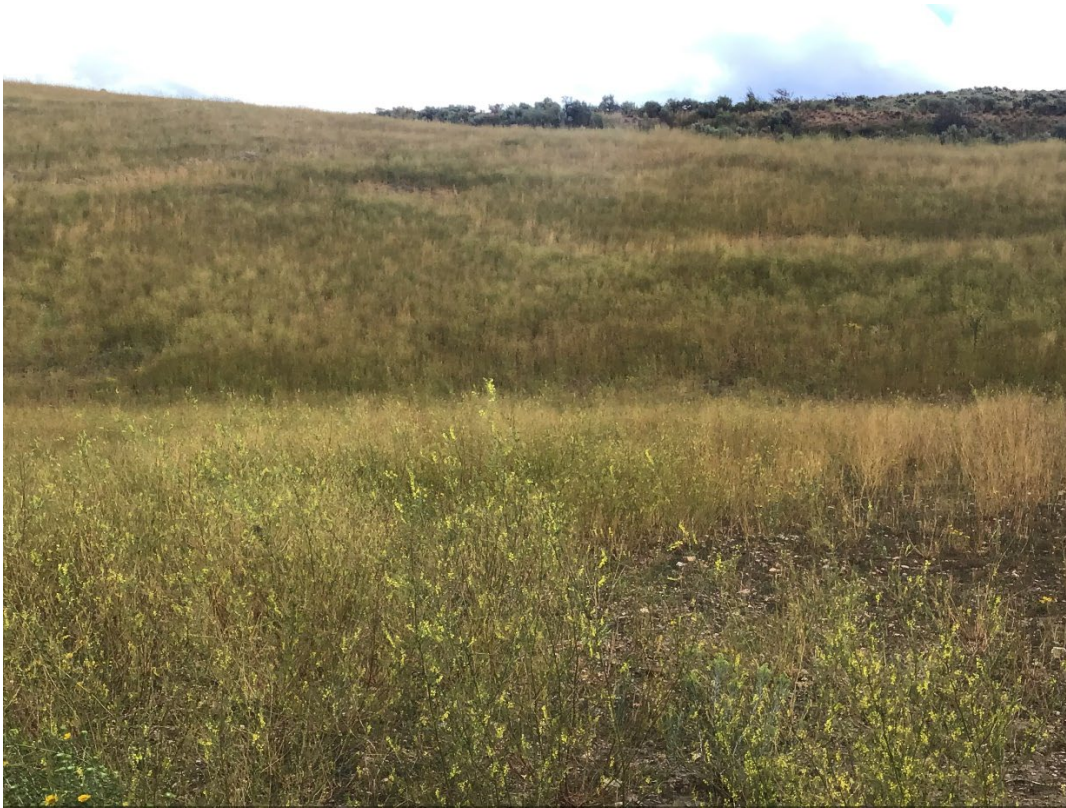
- Reclamation of the 5A Portal area is complete.
- Backfilling, grading, topsoil and seeding occurred in 2023 at the 5A Portal.

- Revegetated areas of reclamation appeared stable at the time of inspection.
- 5A Portal area exhibits grasses, and a dense stand of yellow sweet clover. A formidable number of small sage and chamisa shrubs are establishing on the portal slopes.
- The three different soil amendments applied in fall of 2023 do not appear to exhibit any differences in vegetation cover or species diversity at this time.
- Croplands exhibited dry stubble having been harvested in early July. Alfalfa was prevalent in some places exhibiting dark green patches in the fields.
- 2600 bales of hay were cropped in July.

Photo 3: Backfilled and graded 5A Portal slopes, looking east.

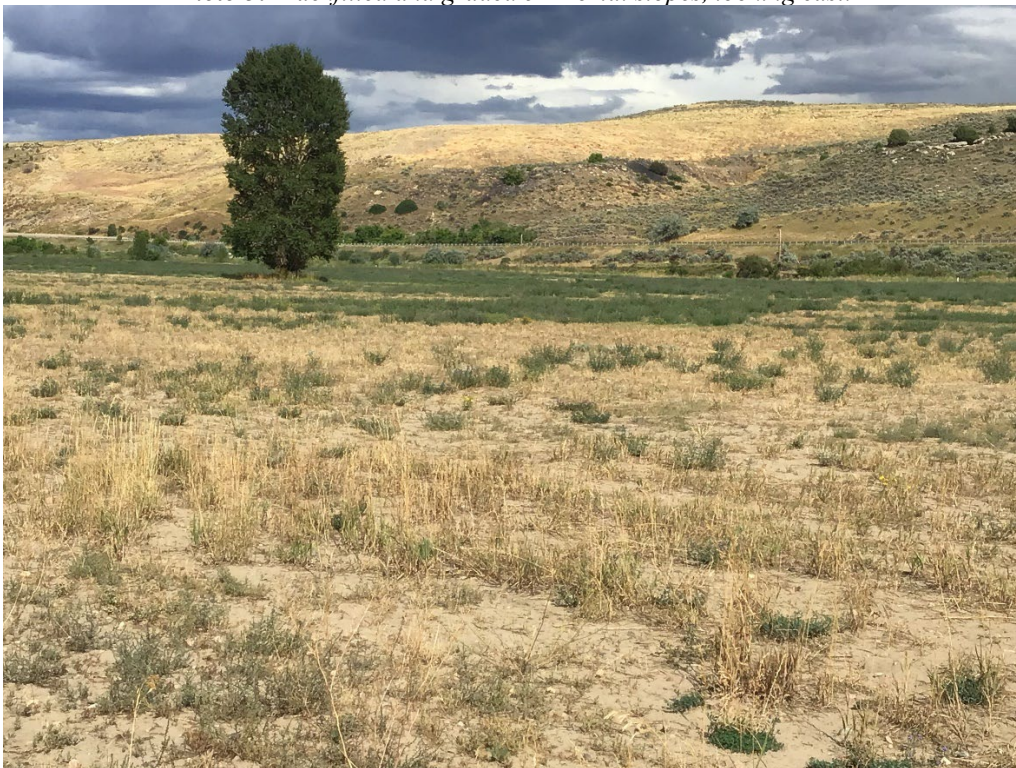
Photo 4: Overview of cropland area adjacent to the Williams Fork River, looking north east. Note the green patches of alfalfa throughout the hay stubble.

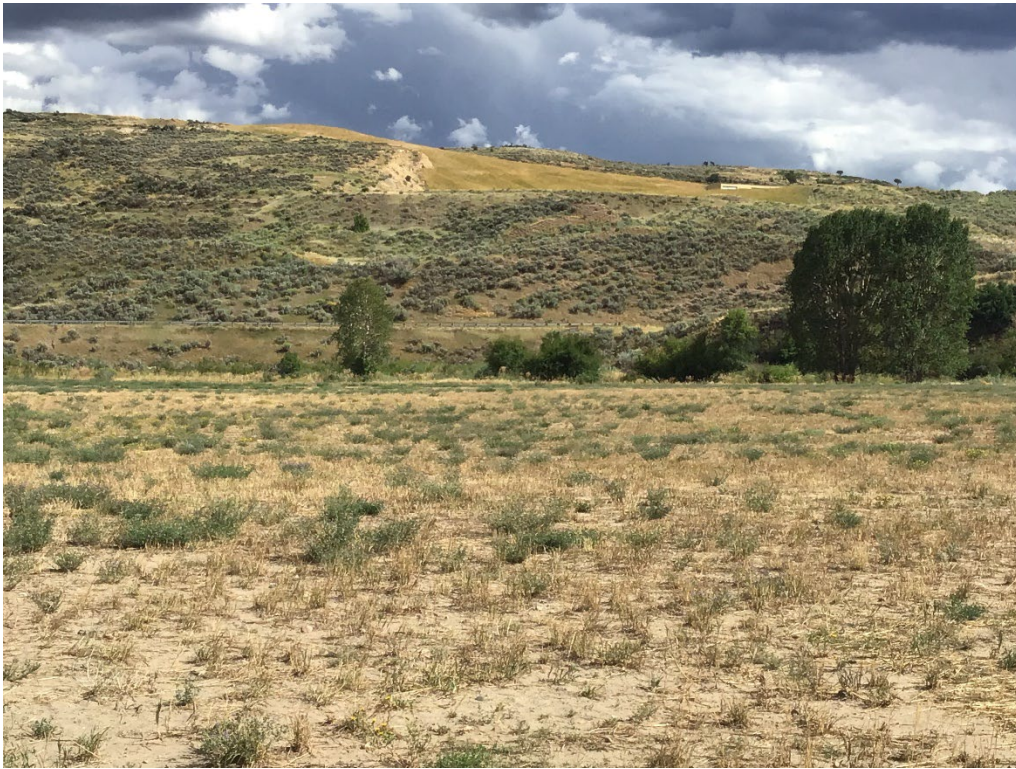
Photo 5: Overview of cropland area and backfilled and graded 5A Portal slopes and service building, viewed from bottomland below looking east.
