## Pre op inspection Lockhart Pit

**MINERALS PROGRAM INSPECTION REPORT**  
**PHONE: (303) 866-3567**

<b>MINE NAME:</b> Lockhart Pit	<b>MINE/PROSPECTING ID#:</b> M-2024-017	<b>MINERAL:</b> Sand and gravel	<b>COUNTY:</b> Grand
<b>INSPECTION TYPE:</b> Preoperation Inspection	<b>WEATHER:</b> Clear	<b>INSP. DATE:</b> August 15, 2024	<b>INSP. TIME:</b> 13:00
<b>OPERATOR:</b> Kremmling All Season Rentals LLC	<b>OPERATOR REPRESENTATIVE:</b> Mitch Lockhart	<b>TYPE OF OPERATION:</b> 112c - Construction Regular Operati	
<b>REASON FOR INSPECTION:</b> Preoperation Inspection	<b>BOND CALCULATION TYPE:</b> Complete Bond	<b>BOND AMOUNT:</b> \$92,194	
<b>DATE OF COMPLAINT:</b> NA	<b>POST INSP. CONTACTS:</b> None	<b>JOINT INSP. AGENCY:</b> None	
<b>INSPECTOR(S):</b> Robin Reilley, M.S. GISP	<b>INSPECTOR'S SIGNATURE:</b>

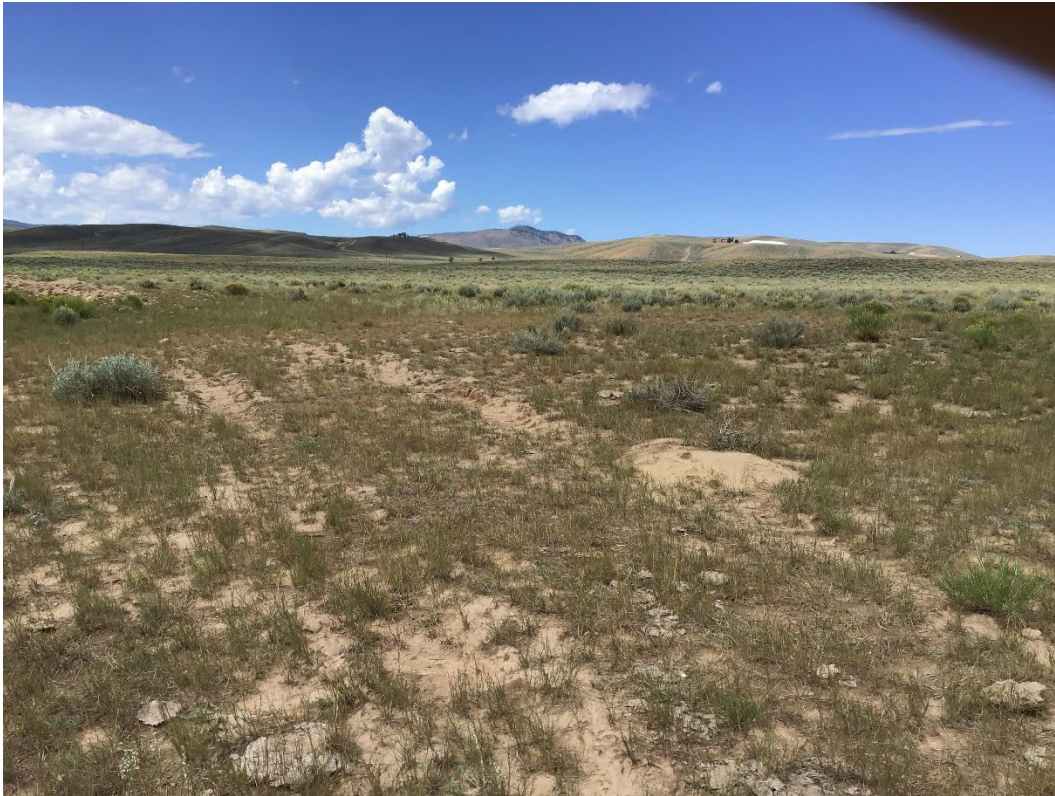
*Photo 1:* The rangeland ecosystem of the permit and post mining land use comprised of artemisia and various short bunch grasses.

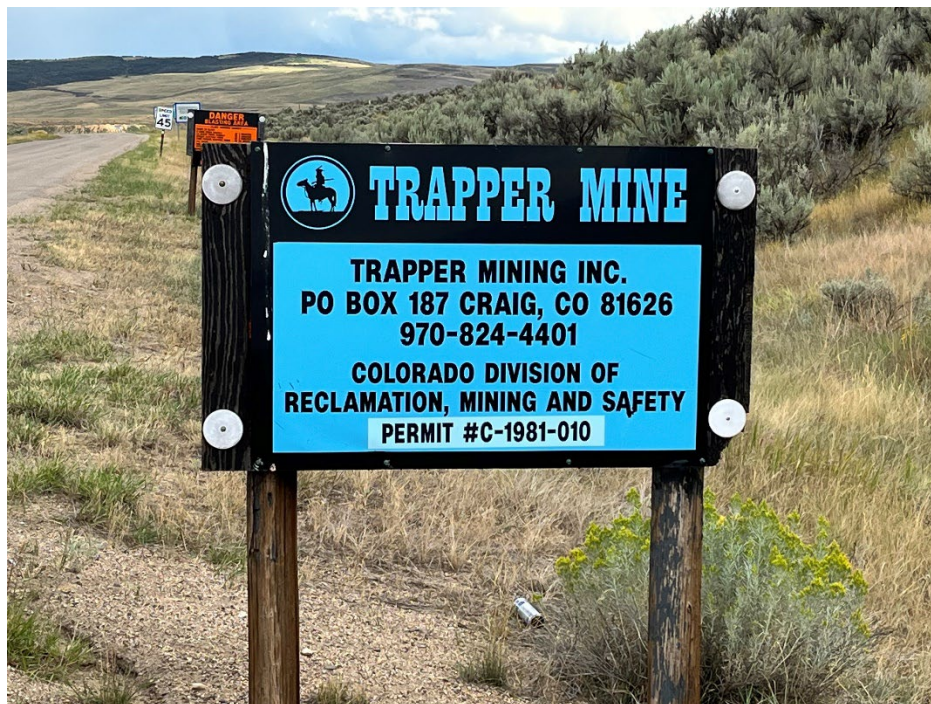
Signs and Markers: The permit sign and application notice were not properly posted at the time of inspection. DRMS has provided an example of a required permit identification sign. The sign should exhibit the following information as illustrated in Photo 2:

<b>mine name</b>	<b>phone number</b>
<b>operator name</b>	<b>DRMS permit number</b>
<b>address</b>	<b>contact information</b>

*Photo 2:* Example of a Mine identification sign:
