MINERALS PROGRAM INSPECTION REPORT
PHONE: (303) 866-3567

MINE NAME: Leone Huerfano Gravel Pit	MINE/PROSPECTING ID#: M-2010-004	MINERAL: Gravel and sand	COUNTY: Huerfano
INSPECTION TYPE: Monitoring	WEATHER: Clear	INSP. DATE: July 31, 2024	INSP. TIME: 10:45
OPERATOR: Leone Sand & Gravel LLC	OPERATOR REPRESENTATIVE: Wayne Leone and Brian Brown	TYPE OF OPERATION: 112c - Construction Regular Operation

Inspection Map 2024: Leone Huerfano Gravel Pit, Permit No. M-2010-004

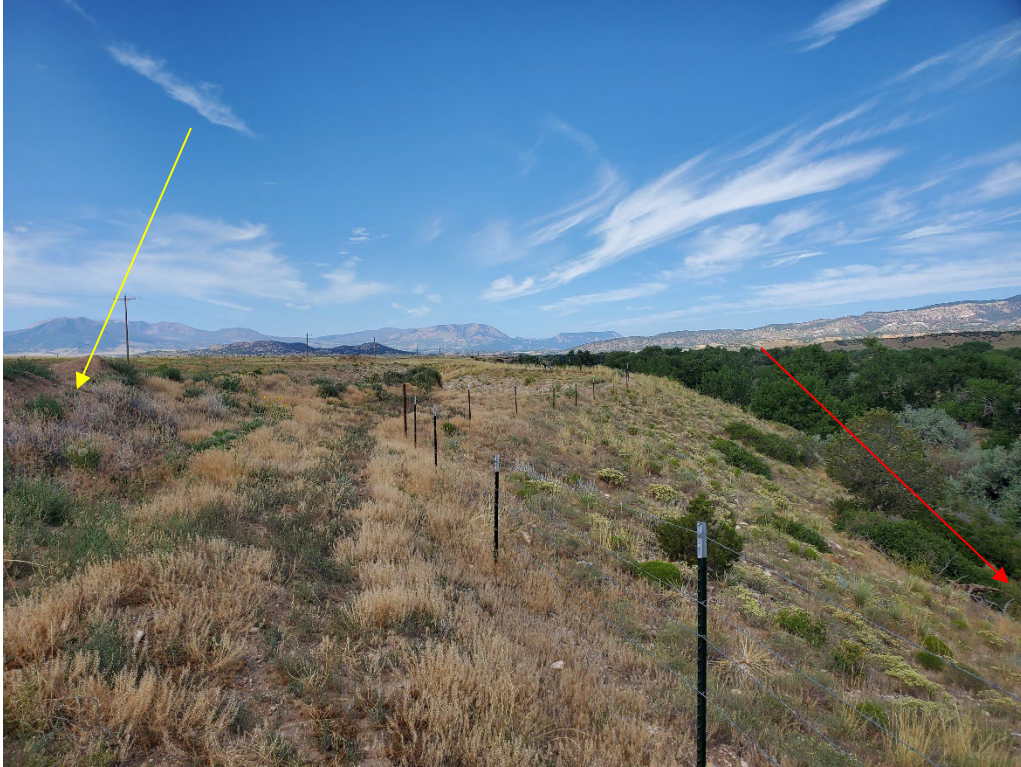
No standing water was observed during the inspection. No signs of run-off leaving the pit were observed. The Operator maintains earthen diversion berms around the pit and processing areas (in compliance with the Operator's mining plan, Storm Water Management Plan, and Spill Prevention, Control, and Countermeasure plan) to prevent excess sediment generated from surface water from leaving the site. The Operator also maintains a buffer between the mining disturbance and the north-slope, located along the northern permit boundary (Photo 1; Maps 1 and 2; Attached Approved Mining Plan Map). The Huerfano River is located downslope, and to the north, of the permit boundary. No signs of disturbance to the hydrologic balance were observed during the inspection.

Photo 1: Looking west along the northern boundary fence. The yellow arrow points to the diversion berms. The red arrow points to the location of the Huerfano River.

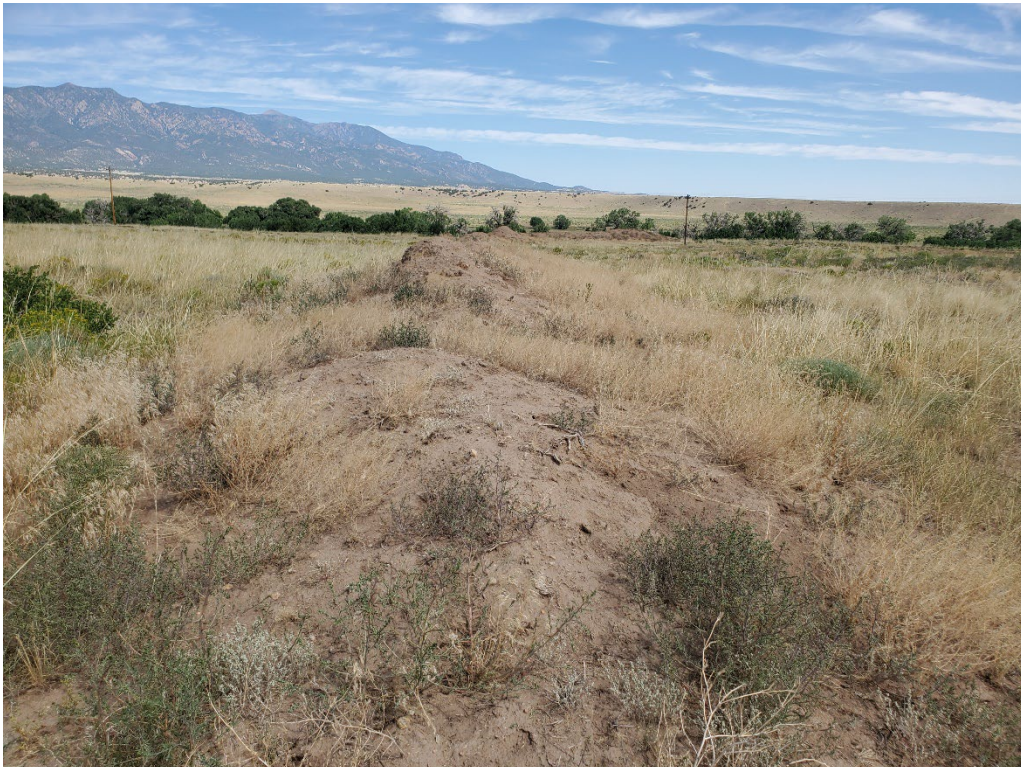
Photo 2: Looking north along the stockpiled material along the western disturbance boundary.

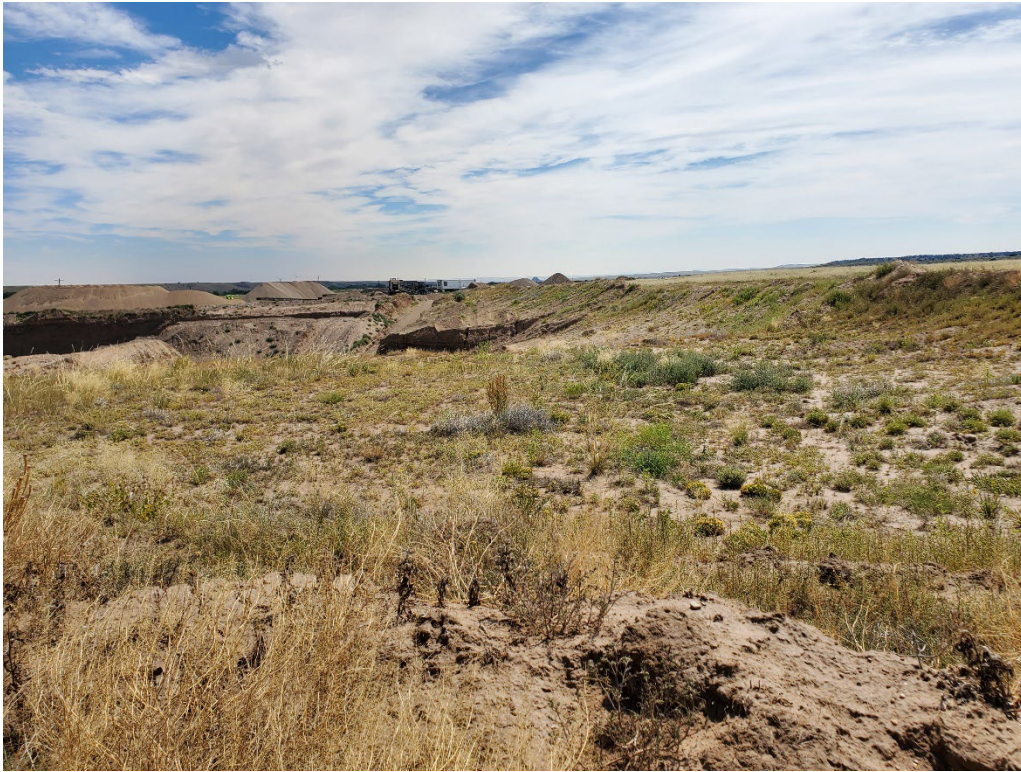
Photo 3: Standing along the western disturbance boundary, looking southeast at the south-west corner of the pit.

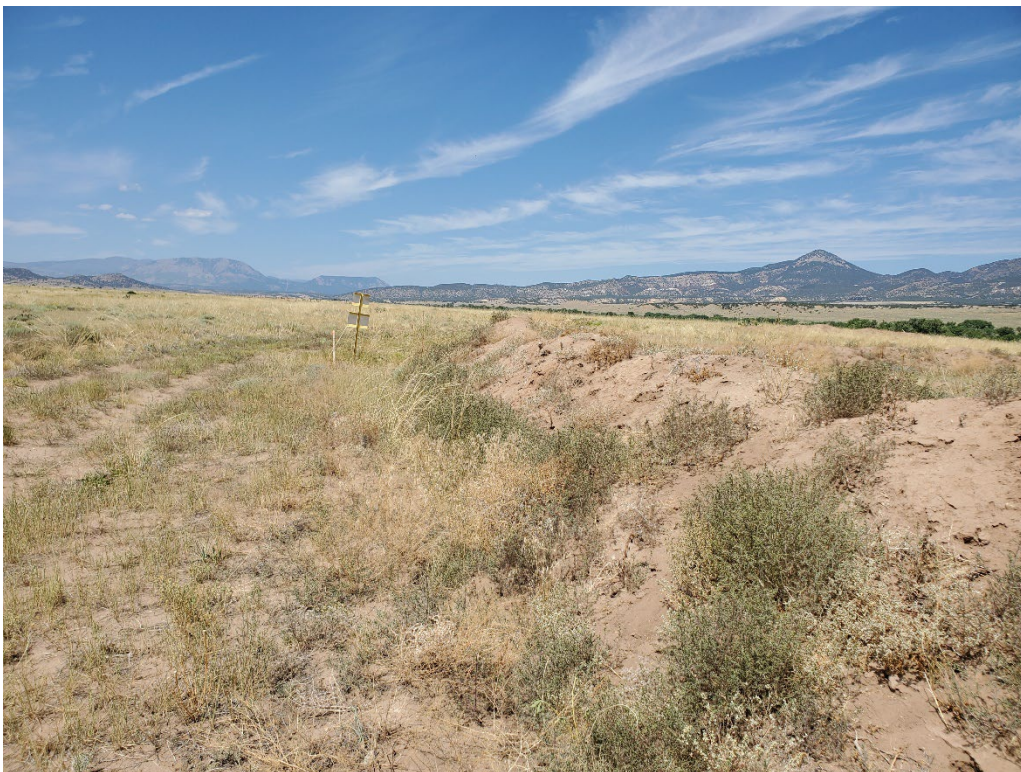
As mentioned in the introduction, the entrance to the pit is at the junction of County Road (CR) 611 and CR 611.1. However, it should be noted that although CR 611.1 is designated as a road, it is more of a two track path that eventually fades into the surrounding landscape. Mining disturbance started to the north of CR 611.1, and has now extended to the south and has crossed over the original road. The road has been re-routed around the pit disturbance (Maps 1 and 2; Photo 4). The currently approved reclamation plan states that CR 611.1 will not be mined, removed, or changed by the [Applicant] (See excerpt from the approved reclamation plan below).

Additionally, the Operator's map (titled "Exhibit A: San Isabel Elec. Assoc.") depicts a cross section view around CR 611.1, and indicates that pit slopes will begin outside of the north and south boundaries of the road. **This issue is included in the problem cited above**. **Prior to updating the road orientation on the mining plan maps, the Operator shall provide the Division with documentation that indicates that the Operator has permission**

to re-route and mine through the existing County Road 611.1. If the Operator is granted permission by the County, they must also subsequently update the Reclamation Plan narrative and any associated affected maps and/or exhibits. The Division would like to remind the Operator that per the currently approved Reclamation Plan and Reclamation Plan Map, County Road 611.1 will be in its pre-mining location and orientation once reclamation has ceased.

Photo 4: Looking west at the re-routed section of County Road 611.1.

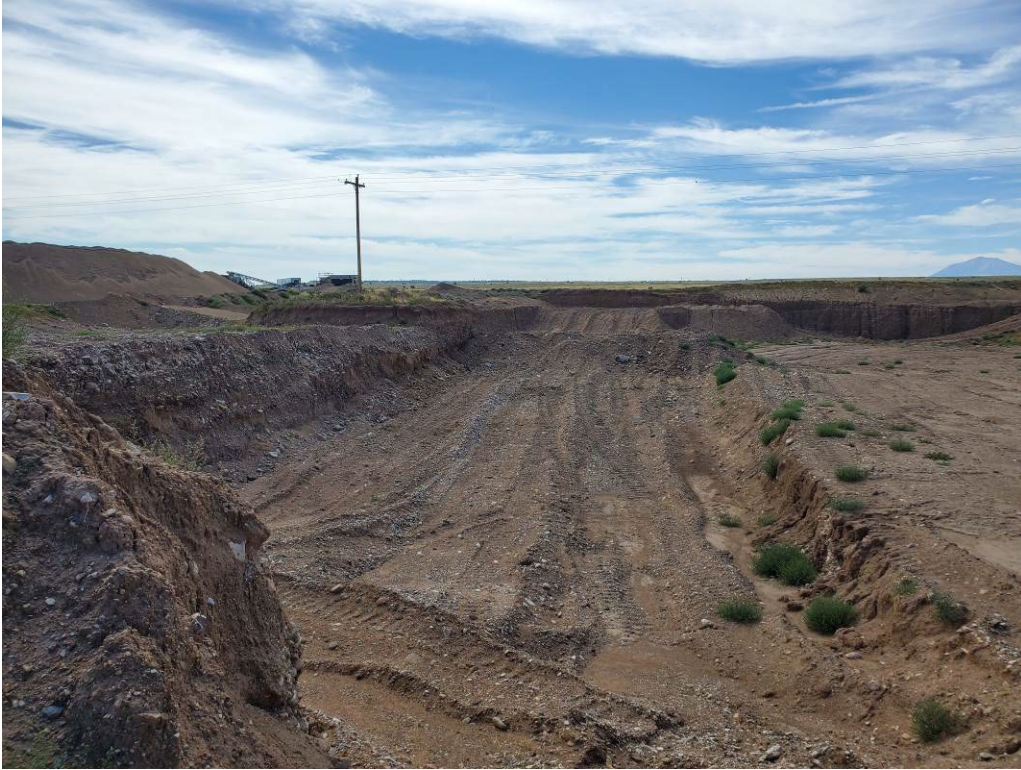
The maximum depth of excavation was increased to 40 feet, through the approval of Technical Revision 1 (TR1), from the previously approved 18 foot maximum. Highwalls onsite range from a small section of approximately 6-8' high, 1H:1V slopes to a series of 1H:1V slopes ranging from ~20-40' high (Photos 5-7: Map 2). The highwall/pit heights appear to be in compliance with the currently approved plan, but the highwall length has far exceeded the 400' maximum length approved through TR1. The Division walked the lengths of the highwalls and collected measurements with the Field Maps application, and estimates that the total current highwall length is approximately 1,454 feet (Map 2).

Photo 5: Looking south at highwalls in the open pit.

These issues have been collectively **cited as a problem above**. **The Operator shall submit a technical revision to update the mining plan and mining plan maps to reflect the current and anticipated mining operations, the current and anticipated road configurations (see Roads section below), maximum allowed disturbance acreages, and maximum highwall lengths by the corrective action date.**

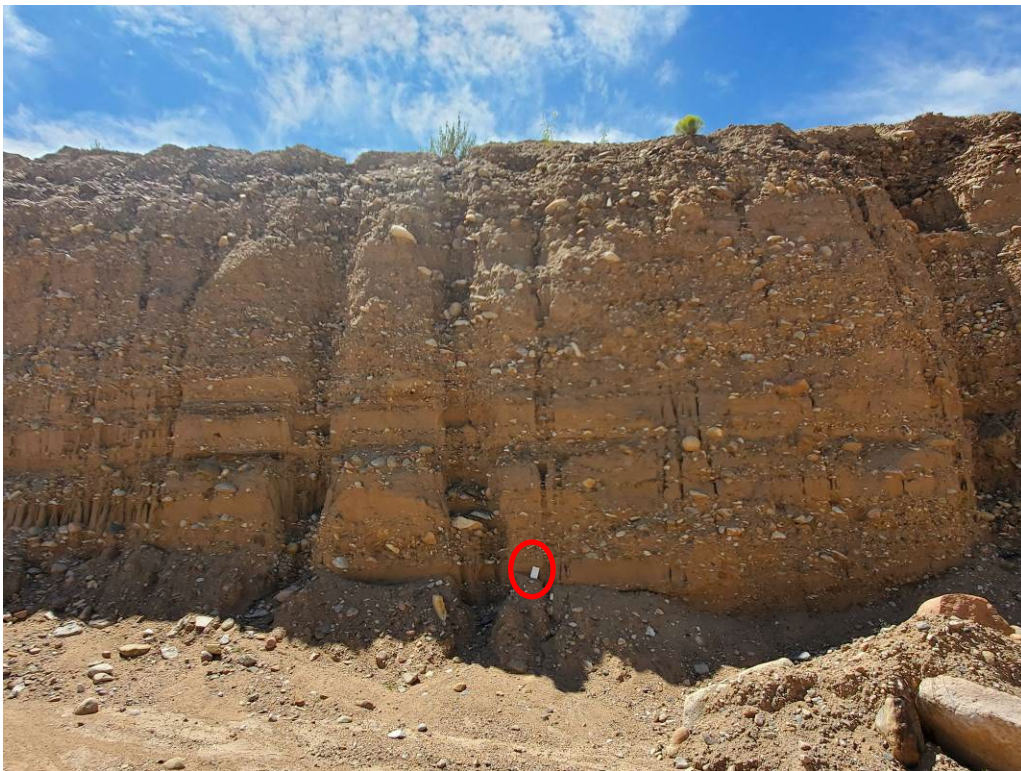
Photo 6: Looking south at the southern highwall in the open pit. Circled is a 5" x 3" notebook for scale.

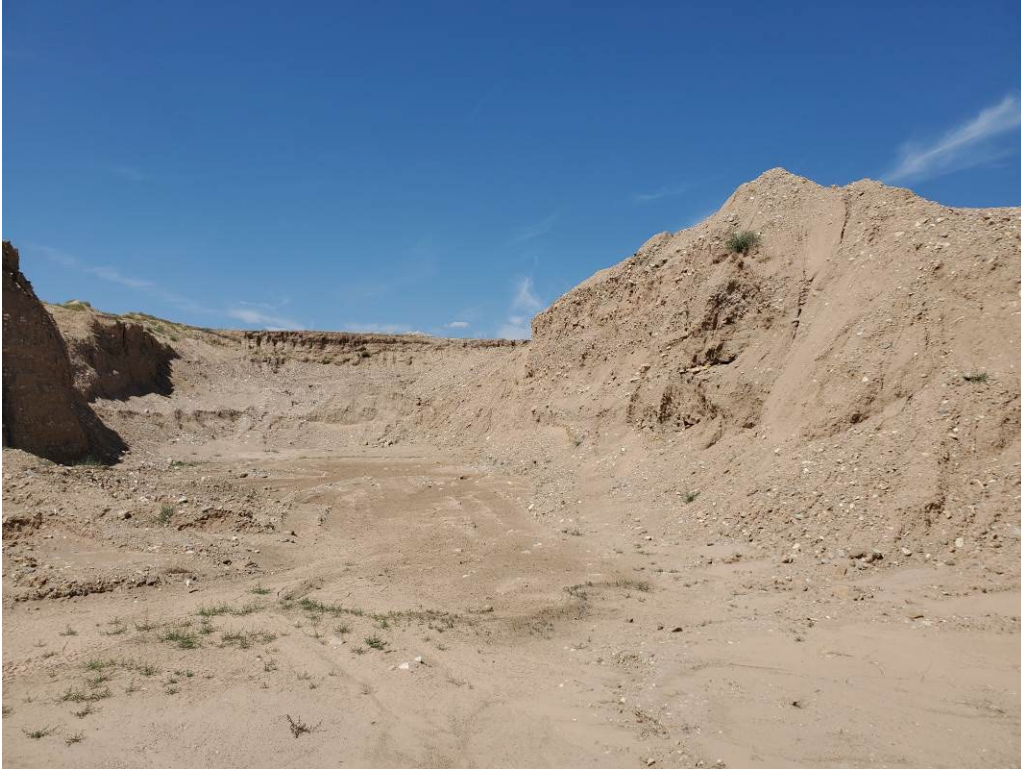
Photo 7: Typical section of pit highwalls.

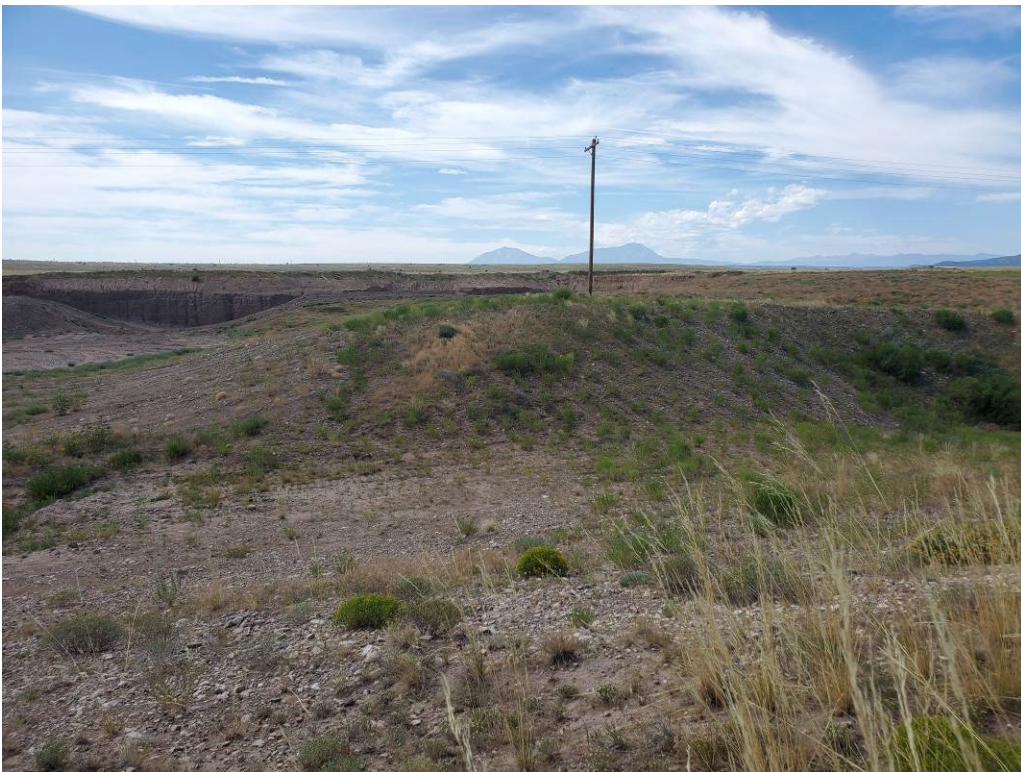
The Operator has conducted contemporaneous reclamation throughout the life of the mine. During this inspection, approximately 9.22 acres of the 35.27 currently disturbed acres have been backfilled, graded, and seeded (See Maps 1 and 2; Photo 8). The reclaimed slopes have been graded to a slope flatter than 3H:1V. The Operator has been mining the pit walls while purposefully maintaining a buffer between the disturbance boundary and the permit boundary, as to better facilitate using a cut-fill method to backfill slopes upon reclamation.

Photo 8: Looking south at the reclaimed slopes.

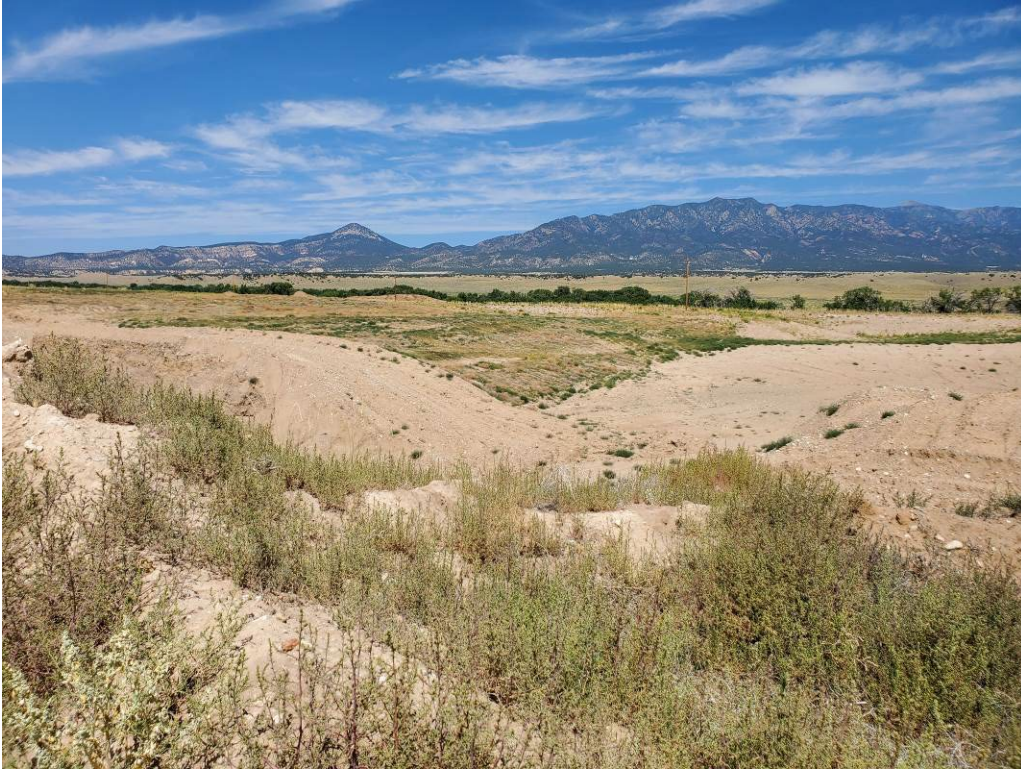
The reclaimed slopes have been seeded once, but will be re-seeded later this year to increase the quality and quantity of the desired species. Some vegetation has already begun to grow on the slopes, and appears to already be aiding in slope stabilization (Photo 9).

Photo 9: Looking north-west at the reclaimed slopes with some vegetation starting to grow on them.

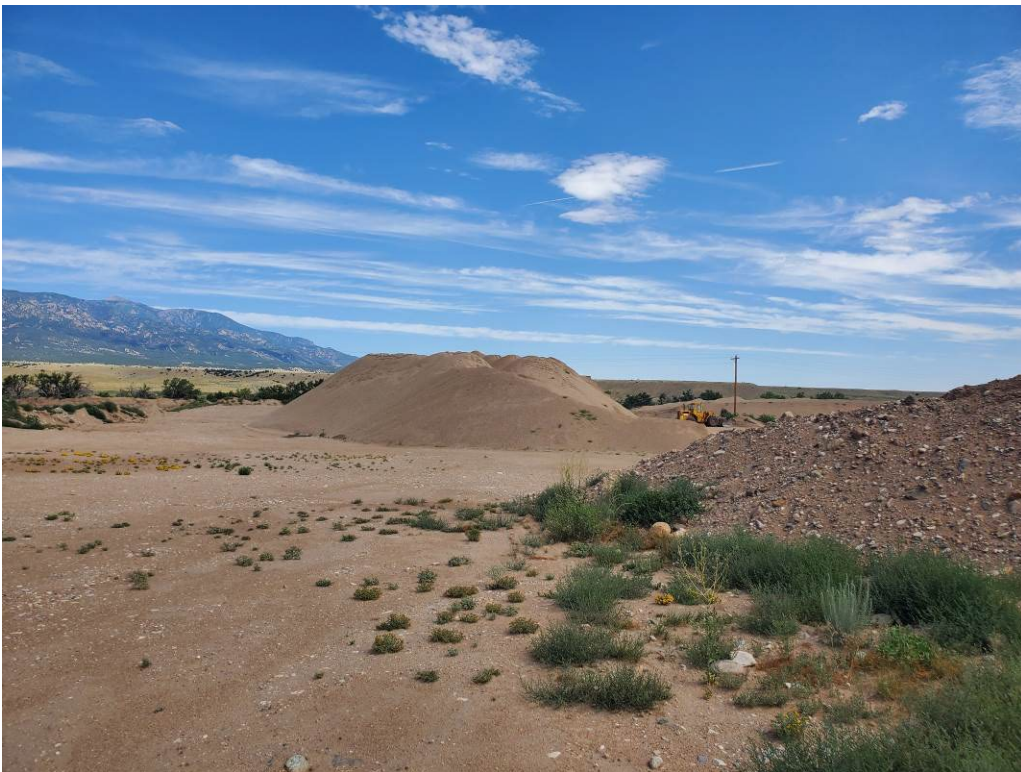
Upon entering the site, the processing area is encountered first. A truck scale, various portable equipment and structures, and product stockpiles (Photo 10) were observed throughout the processing area. As noted in the Division's 2016 and 2020 inspection reports, all above ground fuel storage tanks either had adequate secondary containment or were double walled tanks (Photo 11).

Photo 10: Looking north at some product stockpiles and equipment in the processing area.

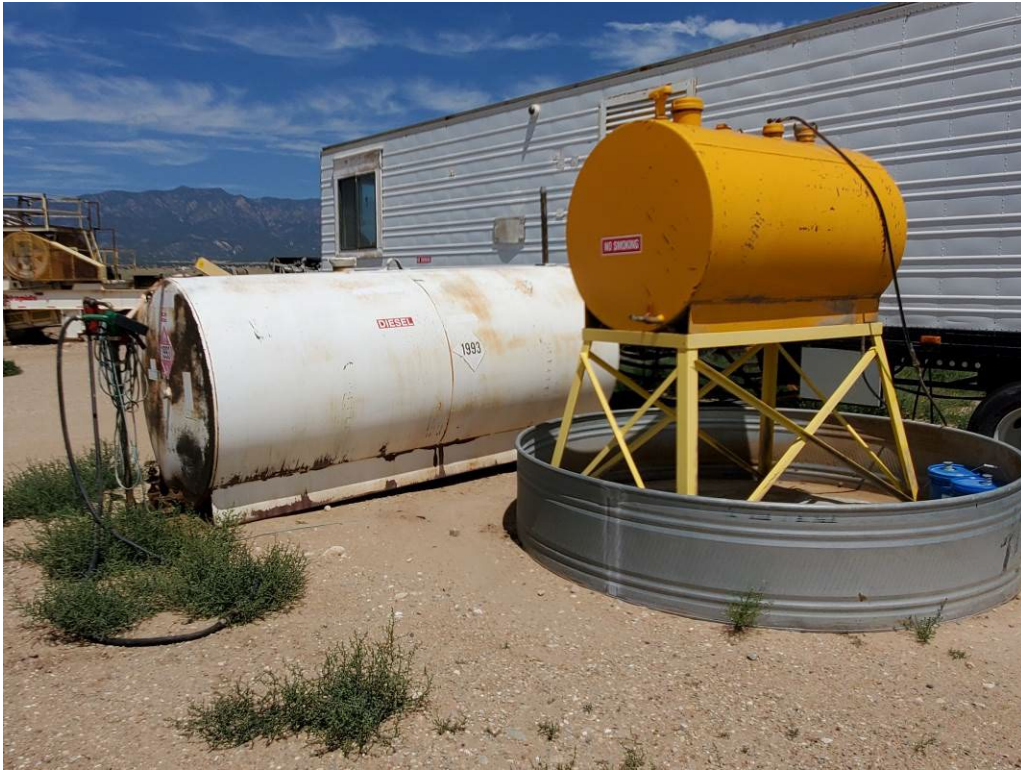
Photo 11: Double walled and secondarily contained fuel storage.

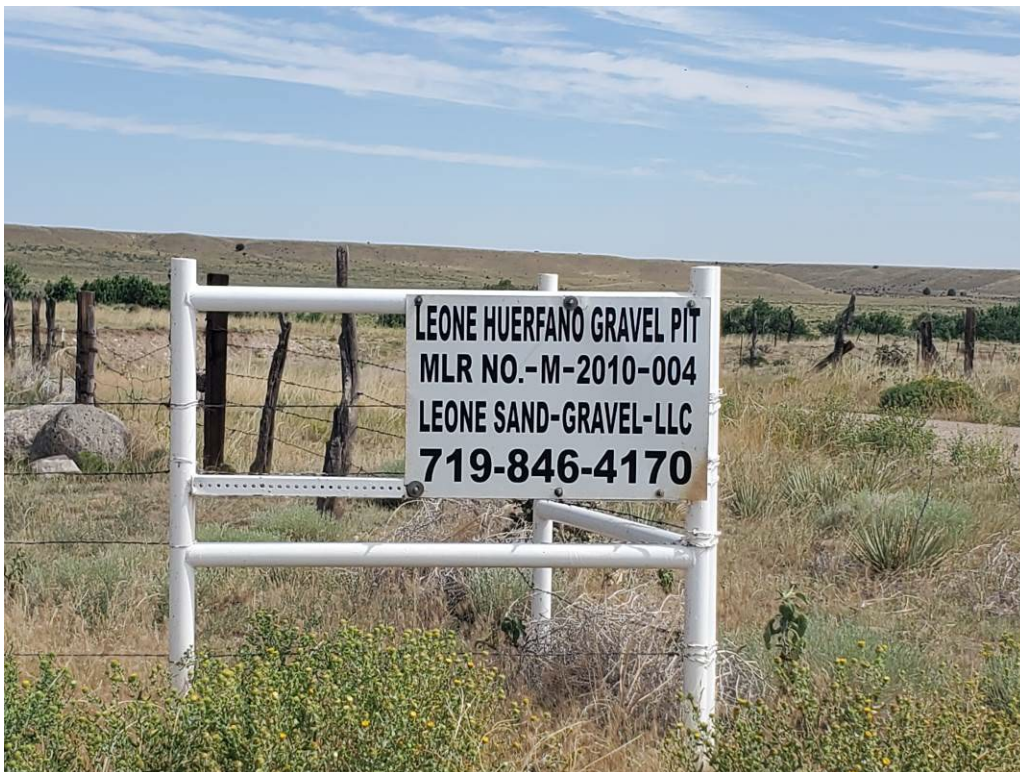
Coordinate points for the permit boundary markers were collected during the Division's 2020 inspection, and were observed during the 2024 inspection. A sign was posted at the entrance to the site -- off of County Road 611 (Photo 12), in compliance with Rule 3.1.12(1).

Photo 12: Mine sign posted at the entrance.

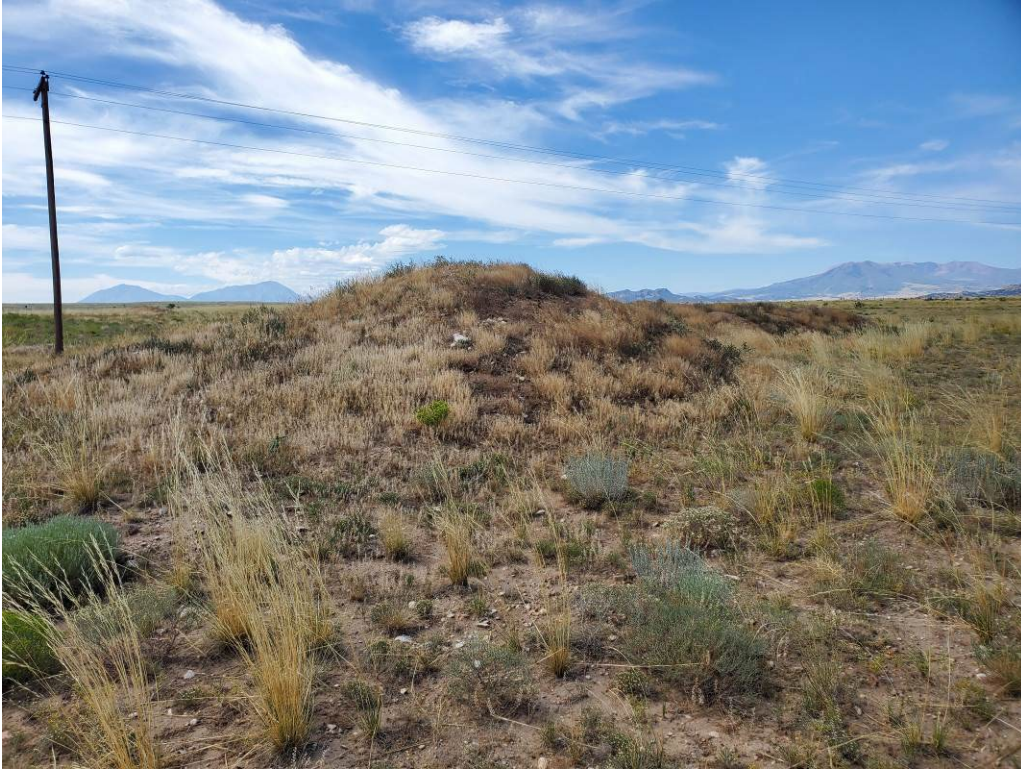
Topsoil stockpiles were observed along the western disturbance boundary (Map 2). Topsoil has been stripped and placed outside of the pit boundaries, and out of the way of ongoing mining disturbance, in compliance with Rule 3.1.9(3). Overburden piles were also observed along the northern and southern boundaries of the pit, separated from the topsoil stockpiles, in compliance with Rule 3.1.9(1). Topsoil has been systematically used to reclaim the slopes in the areas of the pit that have been deemed as mined-out. The current stockpiles have volunteer vegetation growing on them and appear stable (Photo 13).

Photo 13: Vegetated topsoil pile.

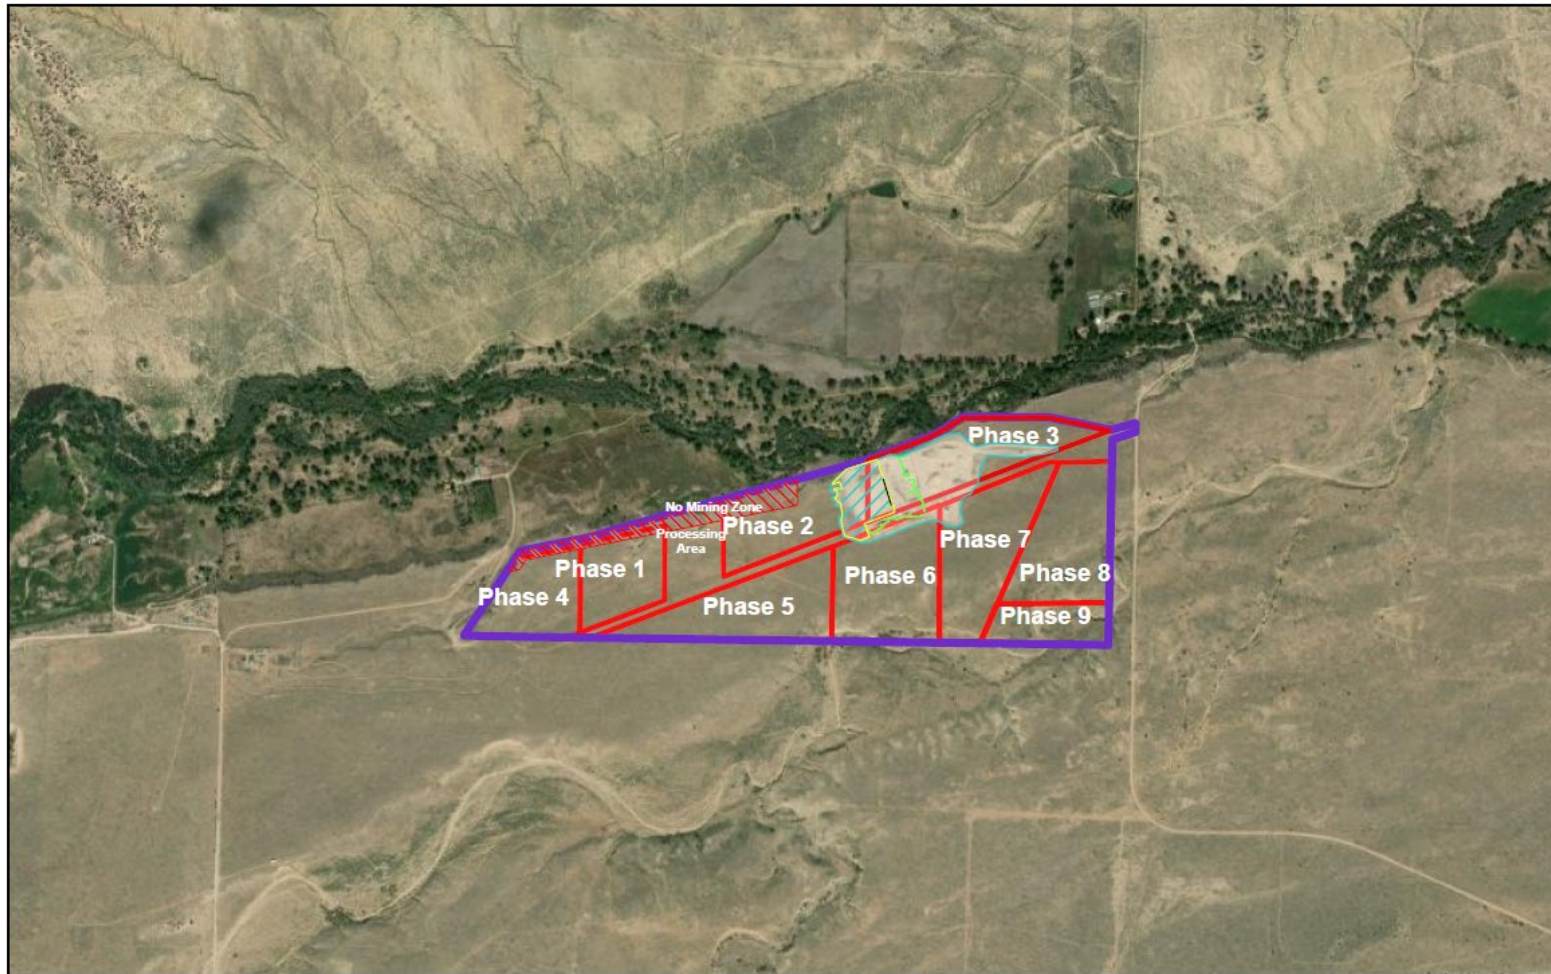
to have begun in Phase 3 initially, and has expanded to Phases 2, 6, and 7 (See Maps 1 and 2). The processing area is located in the eastern portion Phase 3, opposed to the currently approved location between Phases 1 and 2.

Additionally, the maximum allowed disturbance is currently limited to 22.5 acres at any time – including haul roads and processing areas. The Division used the Esri Field Maps application to gather measurements for the western and southern extents of the disturbance boundaries and the reclamation boundary (Photos 2-4: Maps 1 and 2). After the inspection, these measurements were synced to ArcOnline and used in combination with recent aerial imagery to calculate area measurements of the disturbance boundaries (see polygons on Map 2). The Division estimates that approximately 35.27 acres are currently disturbed, including approximately 9.22 acres of unreleased reclaimed areas.

Map 1: Inspection Map generated from data collected in the field, aerial imagery, and the approved maps. The purple line is an approximate representation of the permit boundary, the red lines are approximate phase boundaries, the blue polygon is the disturbance boundary, the blue hatched polygon is the reclaimed disturbance boundary, and the green lines are the highwall measurements taken in the field. The area labeled as a "No Mining Zone" is from the Operator's approved Pre-Mining Plan Map.

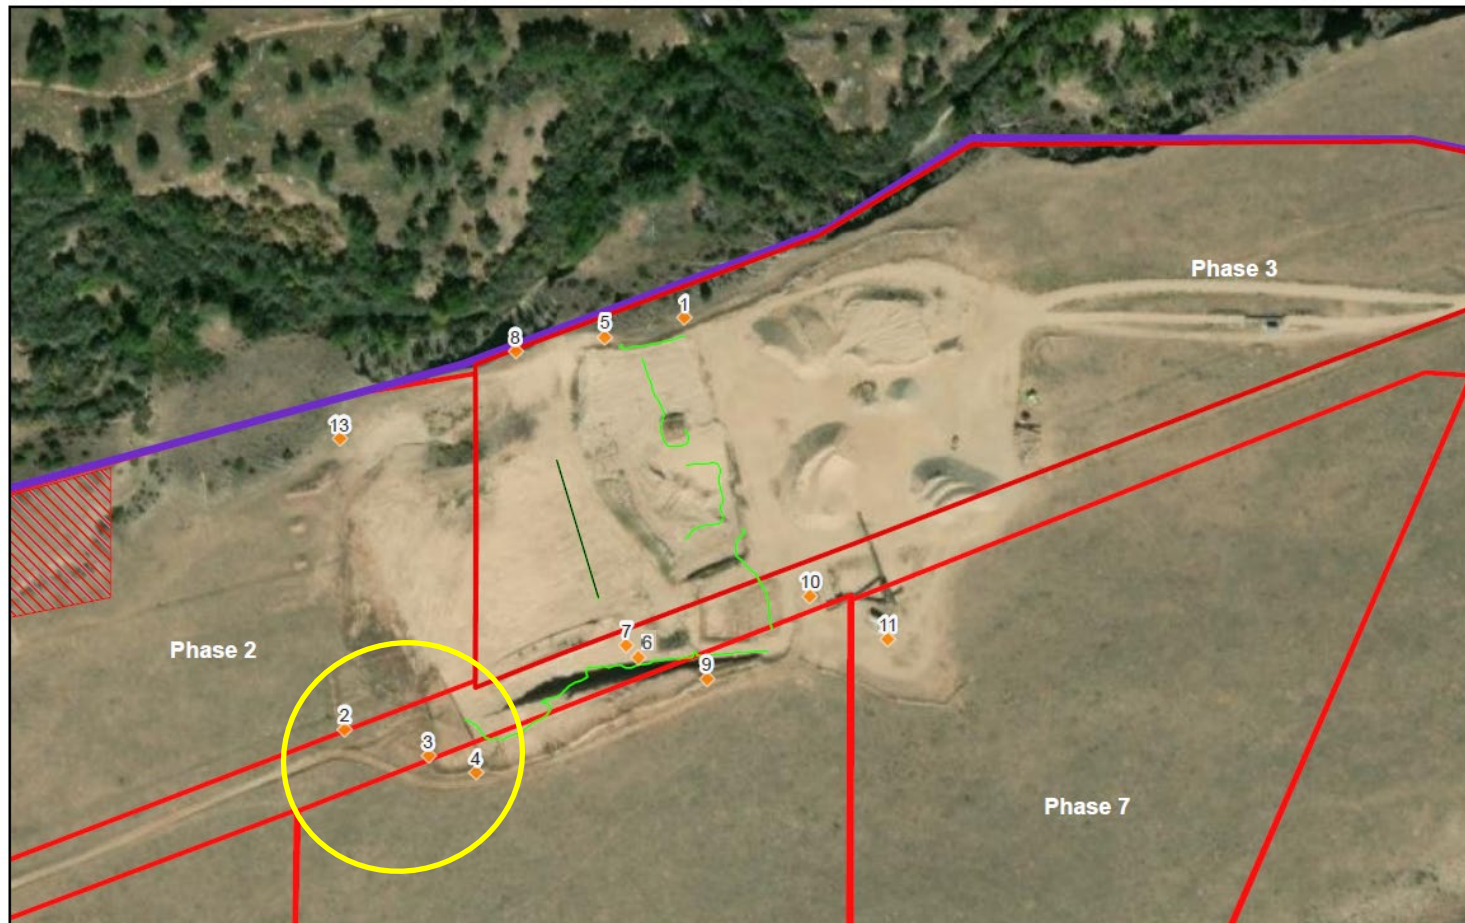
Inspection Map 2024: Leone Huerfano Gravel Pit, Permit No. M-2010-004

Map 2: Inspection Map generated from data collected in the field, aerial imagery, and the approved maps. The orange diamond icons indicate where the corresponding inspection photos were taken. The black line indicates the eastern boundary of the reclaimed slopes. The yellow circle indicates where County Road 611.1 has been diverted around the disturbance. As with Map 1--the purple line is an approximate representation of the permit boundary, the red lines are approximate phase boundaries, the blue polygon is the disturbance boundary, the blue hatched polygon is the reclaimed boundary, and the green lines are the highwall measurements taken in the field.
