Inspection report for September 2024

PERMIT INFORMATION

Permit Number: C-1981-028 Mine Name: Keenesburg Strip Mine Operator: Coors Energy Company Operator Address: Mr. Ben Moline P.O. Box 4030 Golden, CO 80402	County: Weld Operation Type: Surface Permit Status: Permanent Cessation Ownership: Private
	Operator Representative Present: None
Operator Representative Signature: (Field Issuance Only)

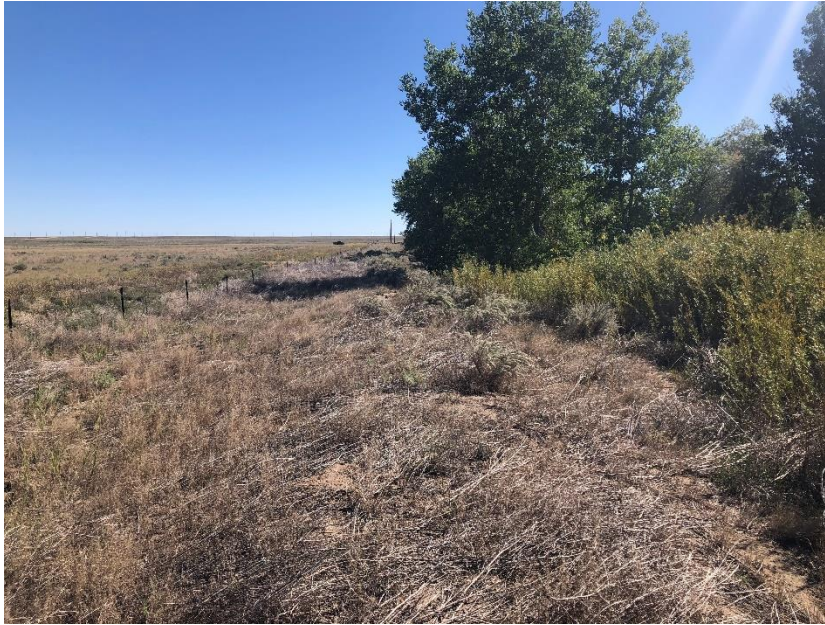
Sediment Pond 2 and the Dugout Pond contained no visible water. In both ponds the bottom is obscured by heavy vegetation. They were not discharging during the inspection. There were no signs that either pond had discharged recently. No problems were observed.

Embankment of Sediment Pond 2

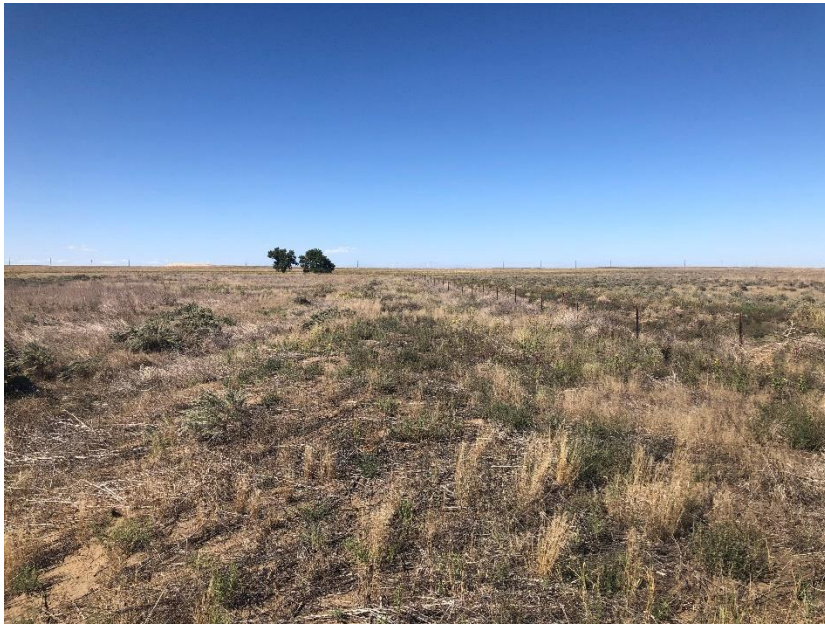
The northern boundary of the site (the down gradient side) was observed, and no signs of pollutant loading from the mine site, or any other problems, were seen. All other sides were also observed, and no problems were seen.

North boundary, looking west from Sediment Pond 2

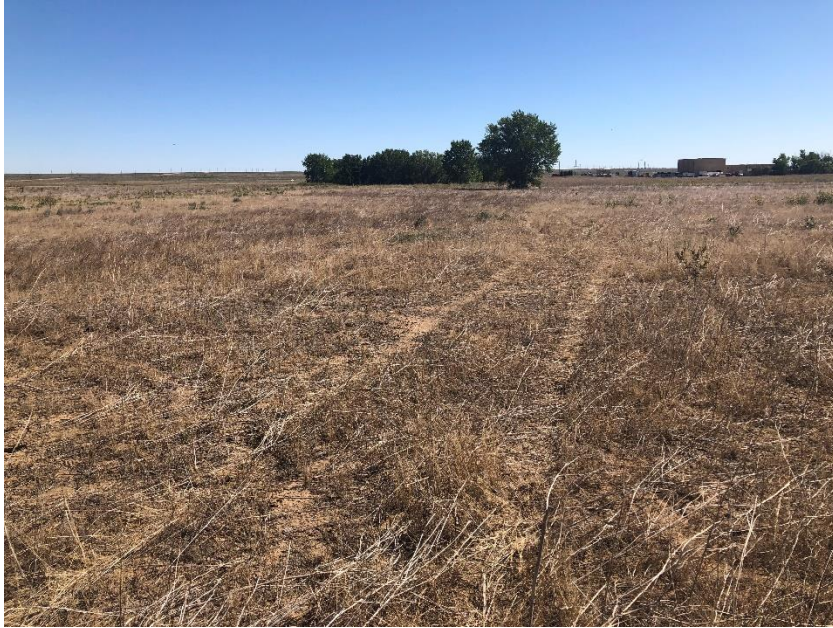
Area 42 – In the area west of Area 26, near the north end of the permit area, most of the vegetation is brown, and a large amount of cheat grass was seen.

Brown vegetation in Area 42 (west of Area 26)

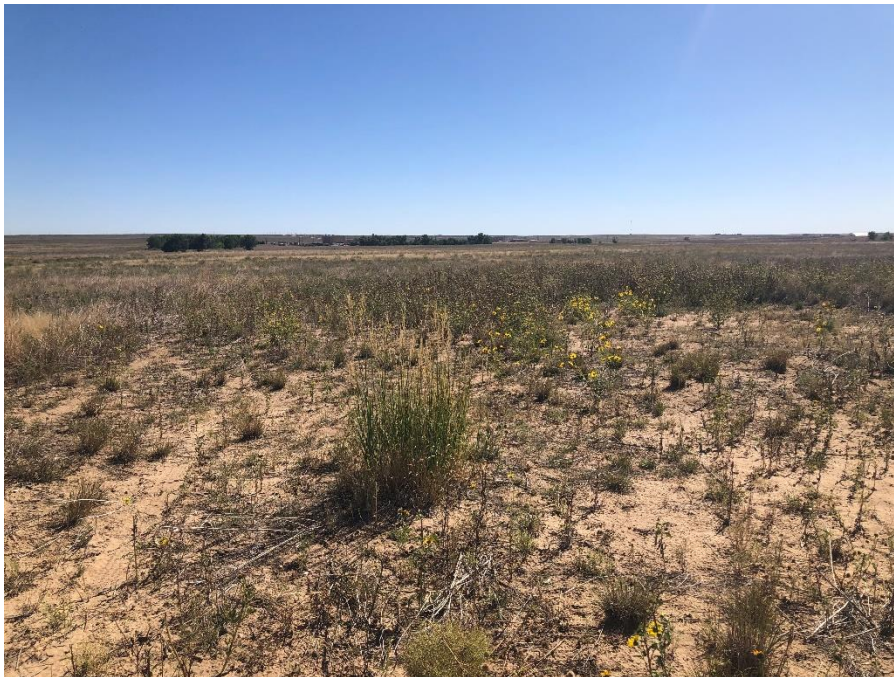
Area 36 (Long-Term Spoil Area) – Vegetation cover is mediocre.

Looking east at reclaimed Long Term Spoil Area

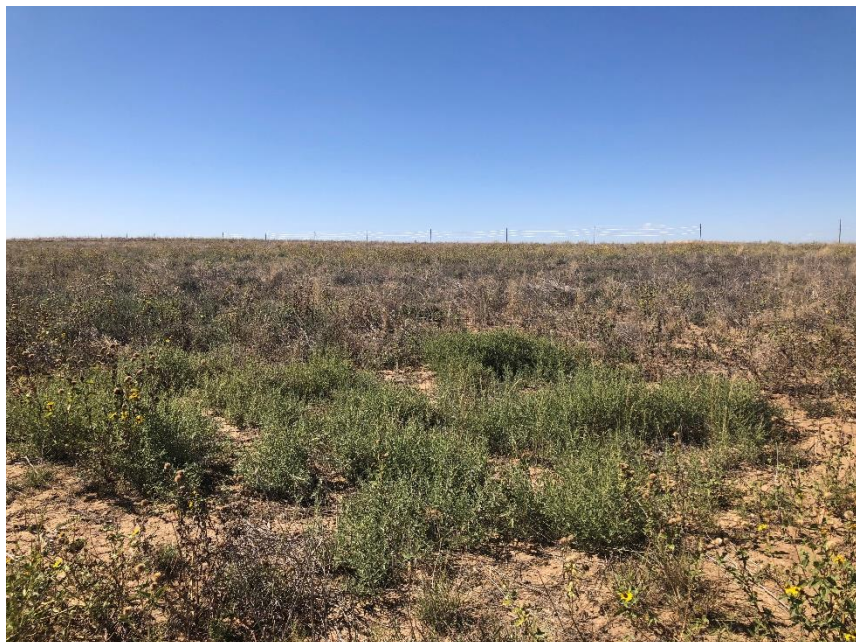
Area 35 (B Pit) – Vegetation cover is mediocre. Many sunflower plants were seen.

Area 35, looking southwest

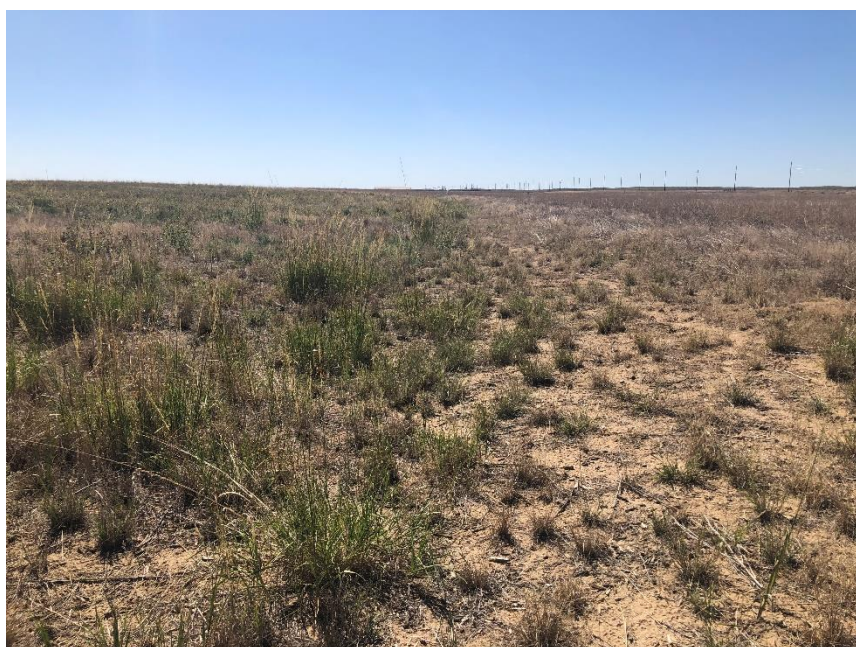
Area 44 - Vegetation cover is mediocre. Many sunflower plants were seen.

The vegetation around the site compares favorably to the surrounding undisturbed area, especially at the west end of the site.

West end of site, looking south from Area 44 – better vegetation in disturbed area on left
