MINE SITE INSPECTION NARRATIVE

COMPANY: Oxbow Mining LLC

SITE: Terror Creek Loadout

PERMIT NO: C-1983-059

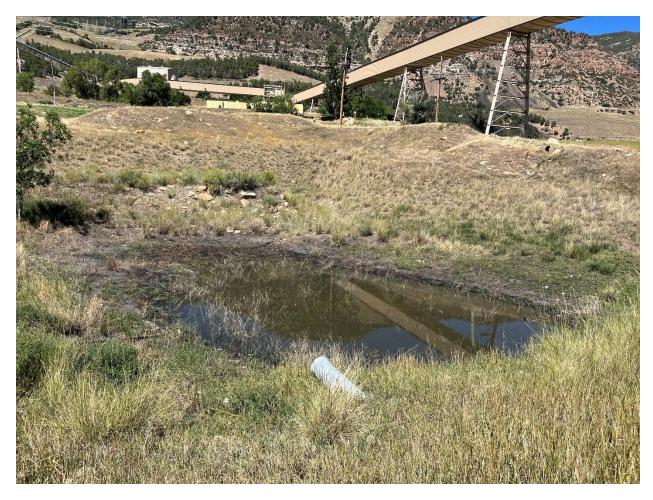
Ponds and Ditches. All ponds and ditches were stable and fully functional at the time of inspection. One pond, the Sedimentation Pond, was holding water but not discharging at the time of inspection (Figure 1).

Figure 1 - The Sedimentation Pond, stable, holding water, and fully functional at the time of inspection.

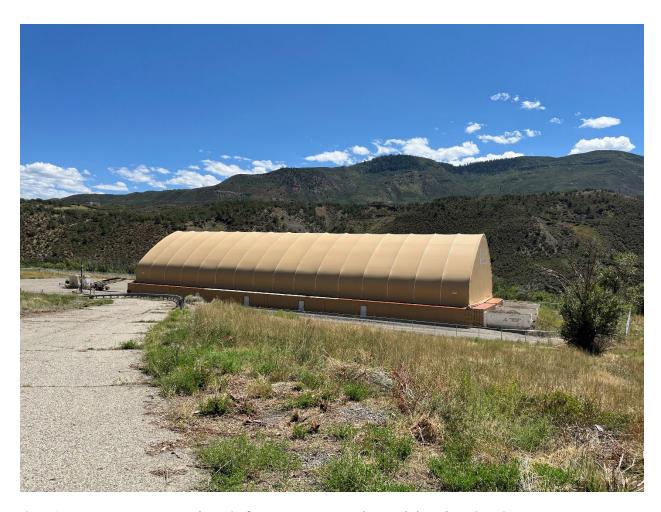
Figure 2 - A temporary structure and security fence on a concrete pad currently leased to private interests.

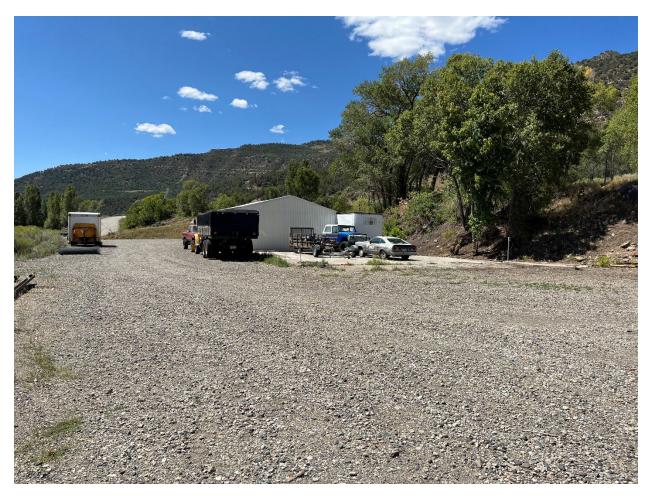
Figure 3 - A concrete pad leased by a general contractor at the time of inspection.

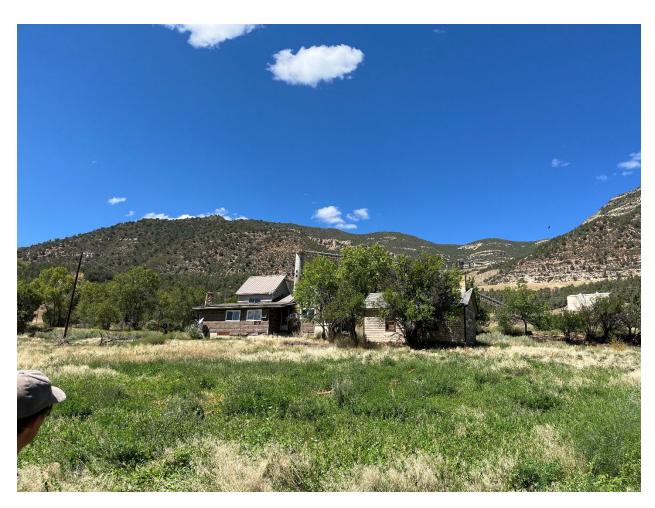
Figure 4 - A vacant house within the permit boundary.

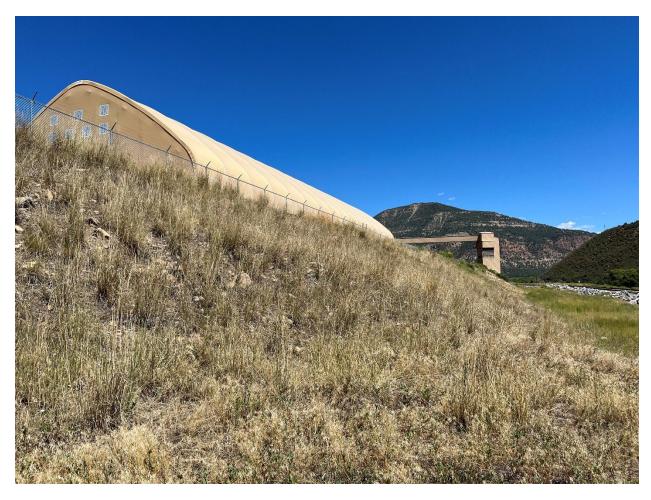
Vegetation and Topsoil Storage. The site is well vegetated; however, non-desired plant species persist in some areas (e.g. cheatgrass along a concrete pad slope, Figure 5). The topsoil storage pile is stable with ample vegetation present (Figure 6).

Figure 3 - A stable slope with cheatgrass present.

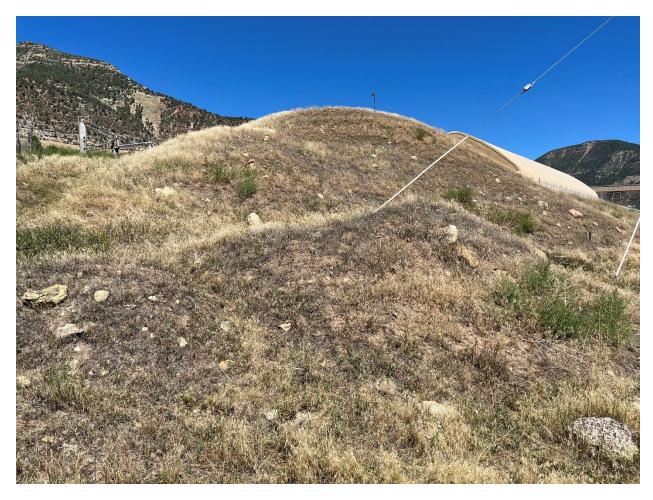
Figure 4 - The topsoil pile with sign on its crest. This storage pile was stable and well-vegetated at the time of inspection.
