MINE SITE INSPECTION NARRATIVE

COMPANY: Bowie Resources LLC

SITE: Bowie No. 2 Mine

PERMIT NO: C-1996-083

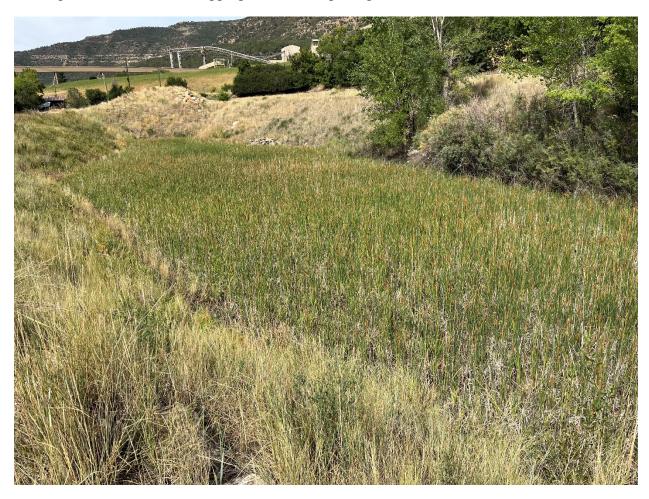
Ponds and Ditches. Both the F and J (Figure 1) ponds were stable and functional at the time of inspection. All ditches surrounding Gob Pile 3 were stable; the operator and the state discussed a temporary ditch in the area where the operator is planning on removing subsoil and topsoil for reclamation. A newly constructed ditch directing water off Gob Pile 2 was stable at the time of inspection (Figure 2). The operator stated that recent precipitation was a good test for this ditch, which did not require any maintenance after the rain events. The operator also stated it plans to install larger riprap at the top of the ditch to help slow the velocity of surface flow entering the ditch.

Figure 1 - Pond J, stable and fully functional at the time of inspection.

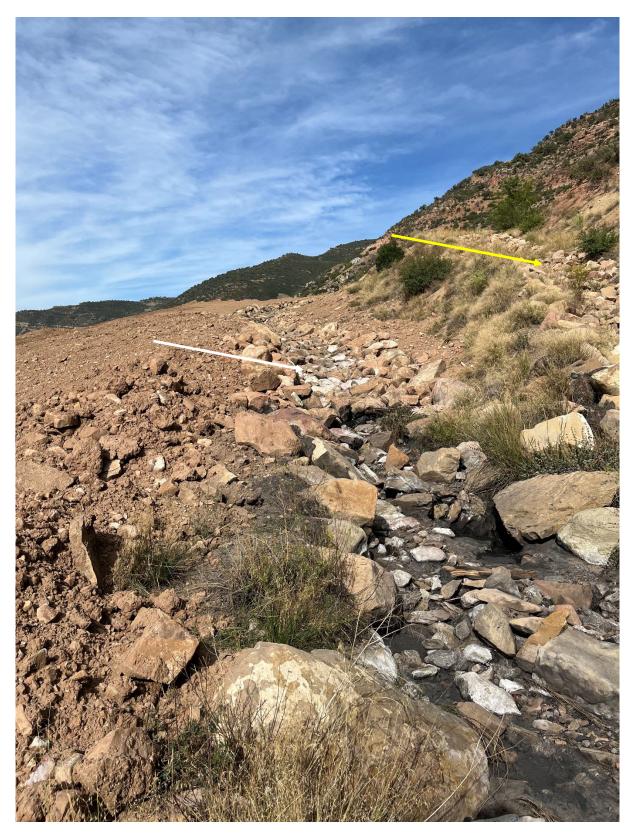
Gob Pile 2 was found to be stable without issue at the time of inspection. Recent reclamation included laying coverfill (Figure 4) and constructing a drainage ditch (Figure 2, described in the ponds and ditches section above).

Figure 2 - The recently installed drainage ditch at Gob Pile 2 (white arrow). A diversion ditch (yellow arrow) can also be seen in the picture.

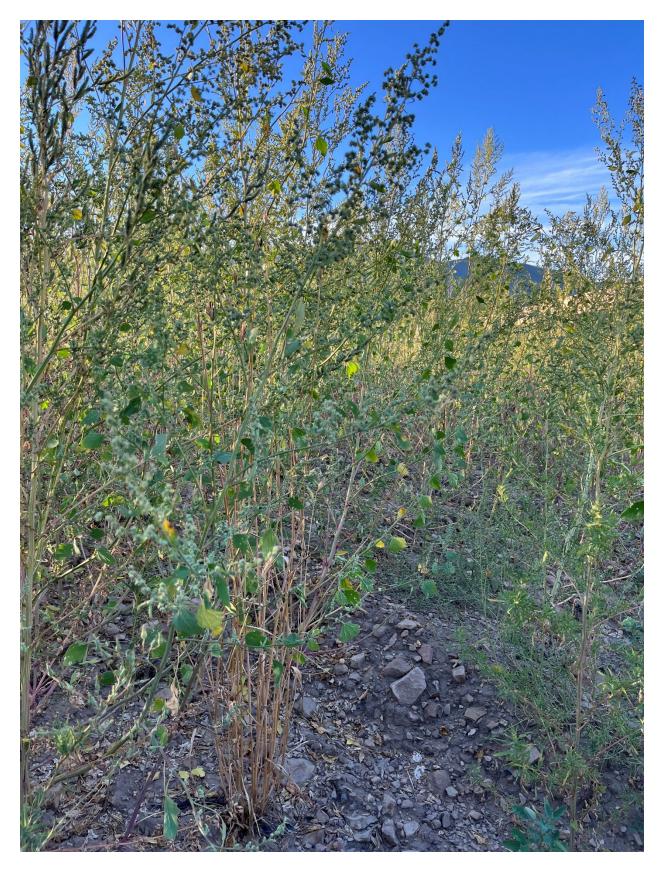
Gob Piles. Gob Pile 3 was reclaimed and covered with vegetation, mostly lambsquaters (*Chenopodium album* and *Chenopodium ficifolium*, Figure 3). The operator dug six holes in the pile so the state could measure the depth of the coverfill before spreading the topsoil: the depths ranged from 36-44 inches. As the minimum acceptable depth is 36 inches, the operator has successfully demonstrated its responsibility according to the permit. The state also approximated the slope of the pile (required to be 3:1) at seven locations around the pile. Five of the seven were acceptable, and the other two were only slightly above the 3:1 requirement. The state

Figure 3 - A sample of the abundant lambsquarters observed growing on Gob Pile 3. Some plants were as tall as 8 feet.

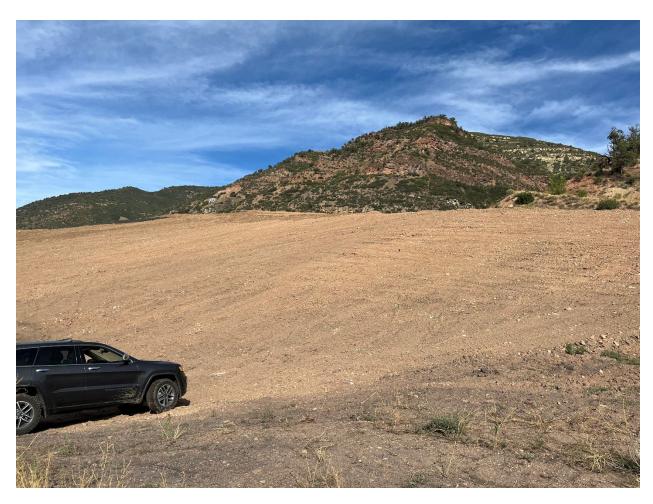
Figure 4 - The front face of Gob Pile 2, sable at the time of inspection.

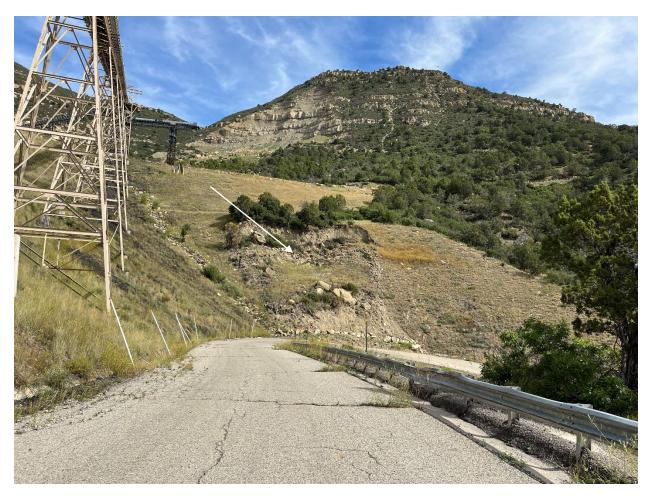
B Portal Bench and Surrounding Area. This area was largely stable at the time of inspection. Two areas are slumping; one around Curve 10 (Figure 5) and another at the portal faceup area (Figure 6). Both are routinely monitored by the operator and the state. The state determined that the operator recently treated several non-desirable species of plants and also marked areas that still required treatment at the appropriate time of plant growth.

Figure 5 -The slumping around curve 10 (white arrow). Both the state and operator routinely monitor this site.

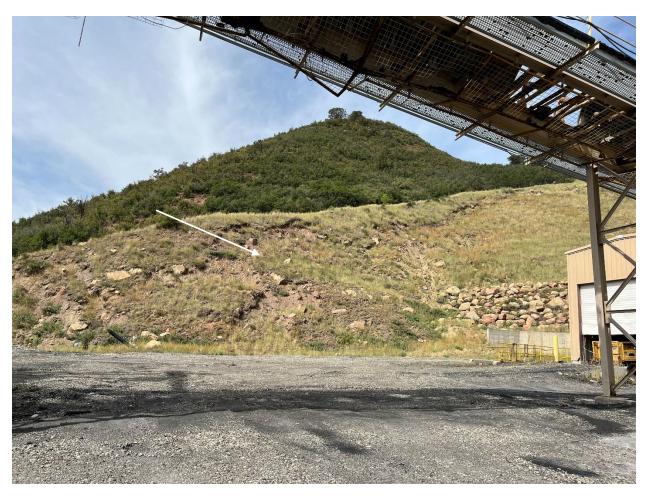
Figure 6 - The slumping at the portal faceup area (white arrow). Both the state and operator routinely monitor this site.
