MINERALS PROGRAM INSPECTION REPORT
PHONE: (303) 866-3567

MINE NAME: Sokol Pit	MINE/PROSPECTING ID#: M-1980-193	MINERAL: Sand and gravel	COUNTY: El Paso
INSPECTION TYPE: Monitoring	WEATHER: Windy	INSP. DATE: October 3, 2024	INSP. TIME: 12:00
OPERATOR: Rocky Mountain Materials and Asphalt, Inc.	OPERATOR REPRESENTATIVE: Phil Courtney	TYPE OF OPERATION: 112c - Construction Regular Operation	
REASON FOR INSPECTION: Normal I&E Program	BOND CALCULATION TYPE: Complete Bond	BOND AMOUNT: \$113,757.00	
DATE OF COMPLAINT: NA	POST INSP. CONTACTS: None	JOINT INSP. AGENCY: None	
INSPECTOR(S): Hunter Ridley	INSPECTOR'S SIGNATURE:

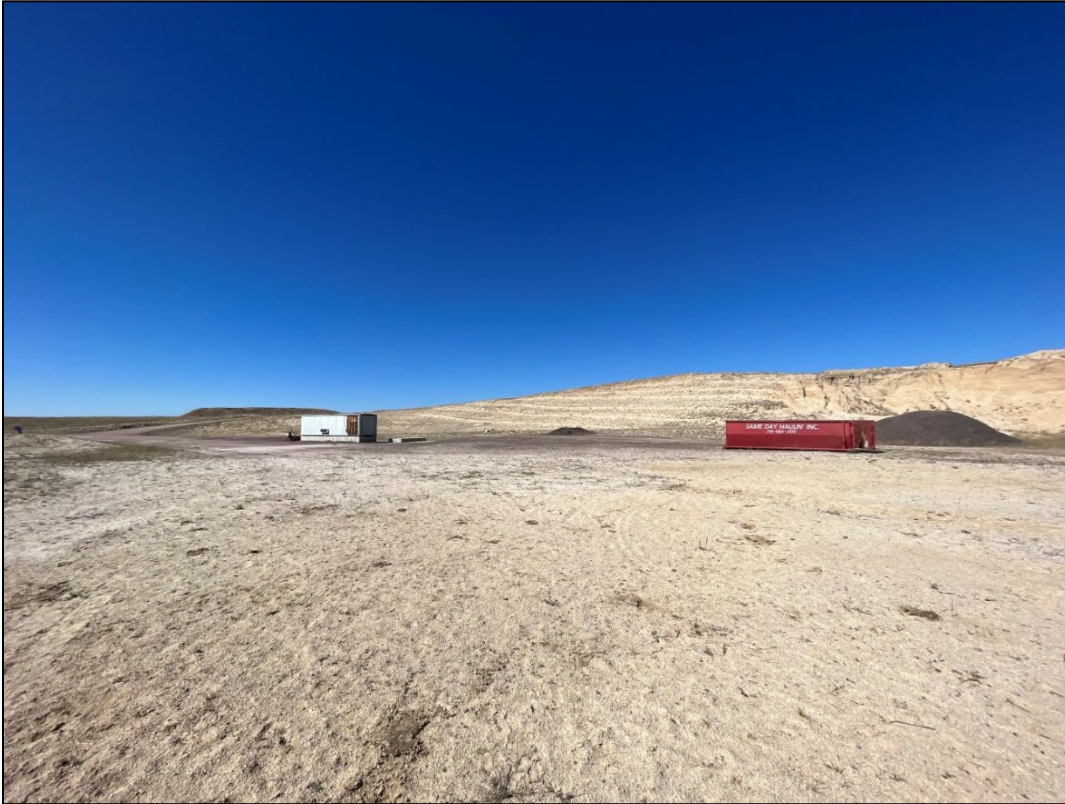
The approved mine plan (AM-01) allows the highwalls to be excavated at 1H:1V slopes, then backfilled to 3H:1V for reclamation. High walls were estimated to vary between 20 and 40 feet in height and showed signs of erosion. However, the Division was not concerned that this had the potential for offsite impacts. Several stockpiles of material were piled throughout the site, along with a pile of milled asphalt (Photo 1).

Support Facilities On-site: No processing equipment was located onsite. The scale had been removed and the scale house remained, though this had been abandoned (Photo 1).

Photo 1: An empty scale house remains; the scale has been removed.

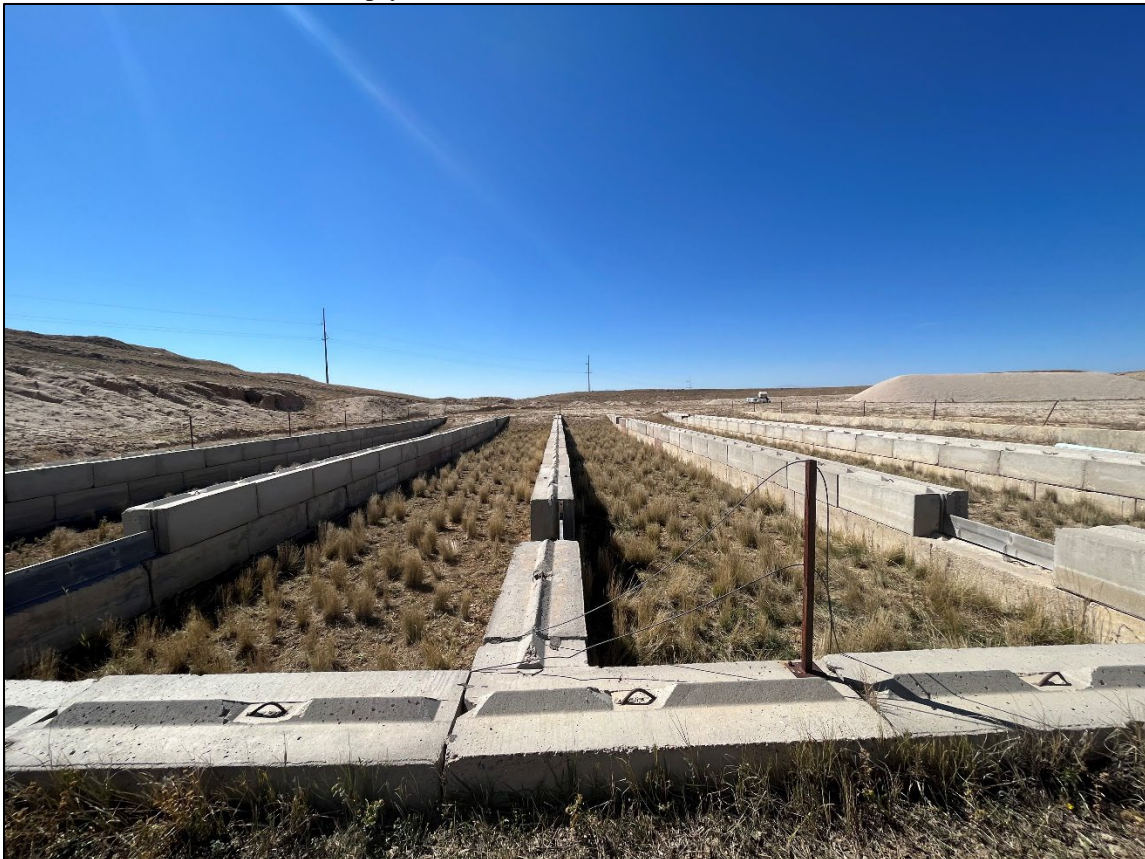
Hydrologic Balance: No standing water was observed in the pit and no exposed groundwater was observed. Several wash ponds are approved under the permit. These ponds are allowed to vary in size but should not be any larger than 100' wide by 200' long. Ponds would start out at approximately 15' to 20' deep. During the inspection, the concrete lined ponds were noted to be within the approved size limits. Ponds were dry and growing vegetation (Photos 2 and 3). An abandoned pump house is located in the middle of the main pit area (Photo 5).

Photo 2: View west of the overgrown and dry wash ponds.

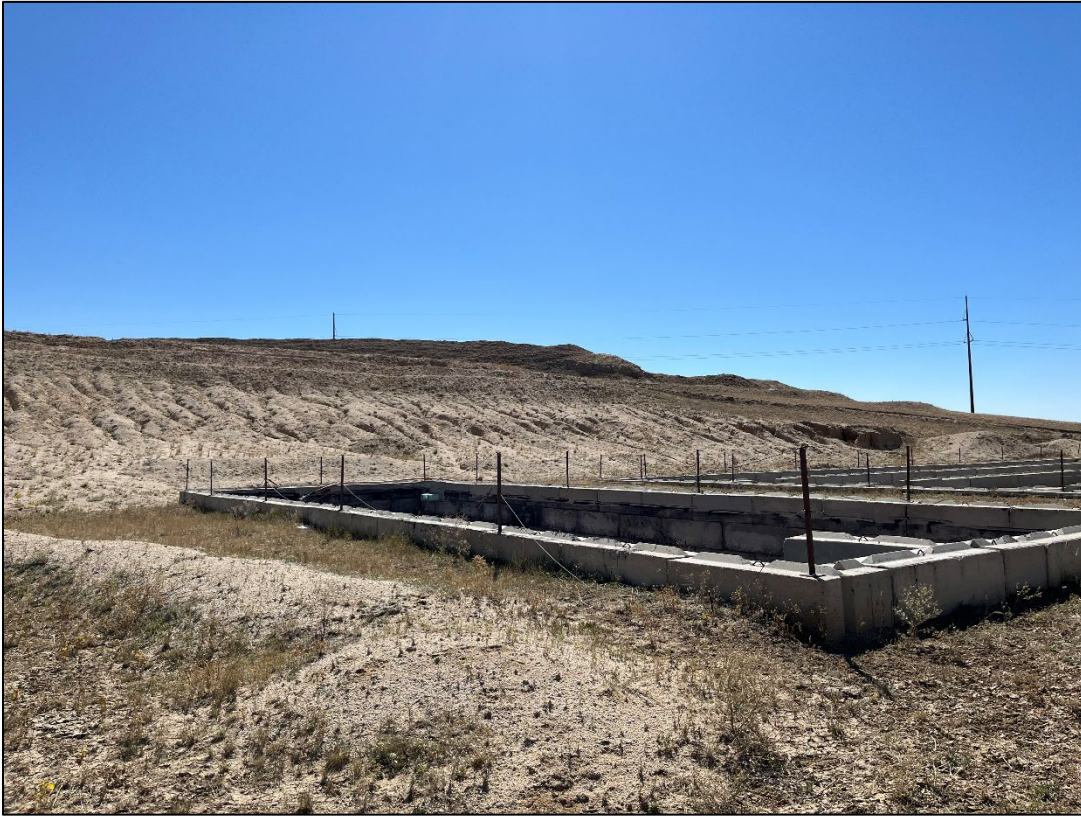
Topsoil: Topsoil, not distinct from overburden has been stripped and stockpiled for reclamation in several areas, but mainly along the southeastern and northwestern corners of the main pit area (Photo 3). These are labeled 'reclamation piles' on the site's annual map.

Photo 3: View southeast of a topsoil / overburden pile in the background, wash ponds are in the foreground.

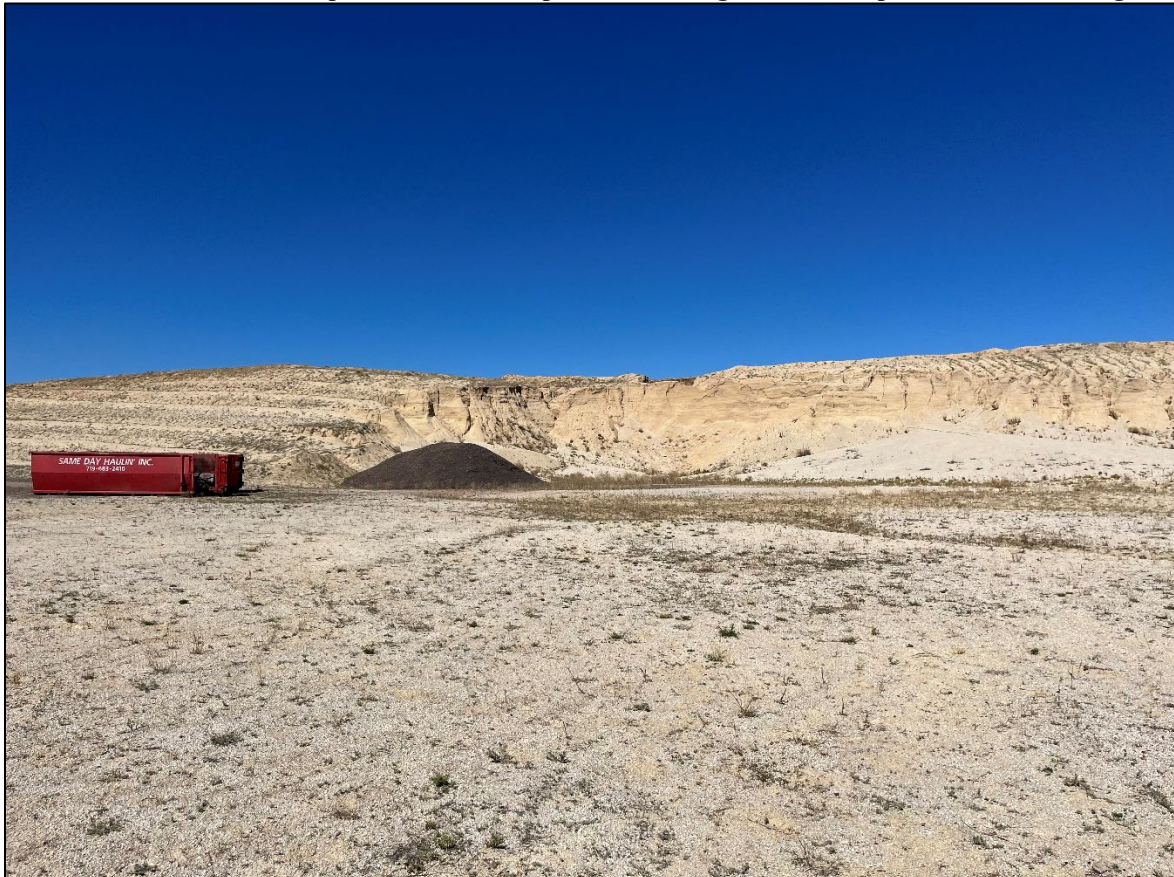
Sediment Control: Erosion rills and gullies were observed along all the highwalls onsite (Photos 4,7, and 8). However, this erosion had not progressed much since the Division's last inspection in 2020 and did not appear to be a source where sediment could be tracked offsite. Thus, no BMPs were needed at the time of the inspection.

Photo 4: View north of a highwall area.

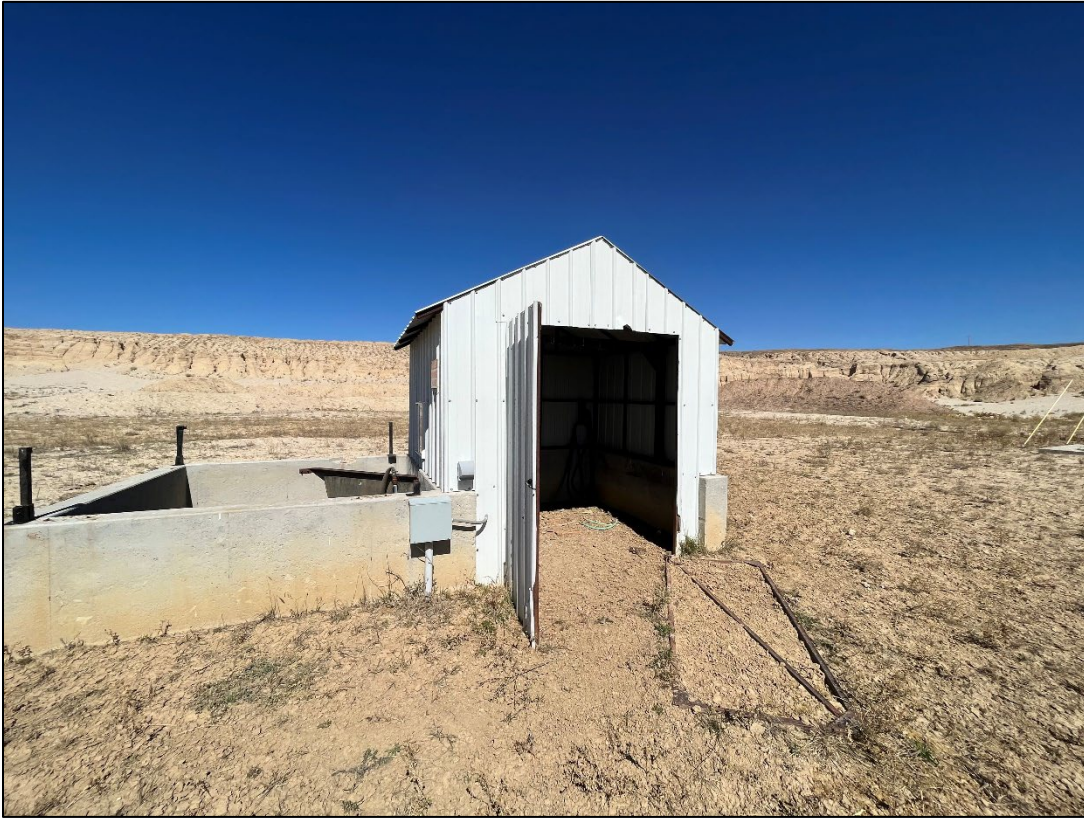
Photo 5: View north of an abandoned pump house.

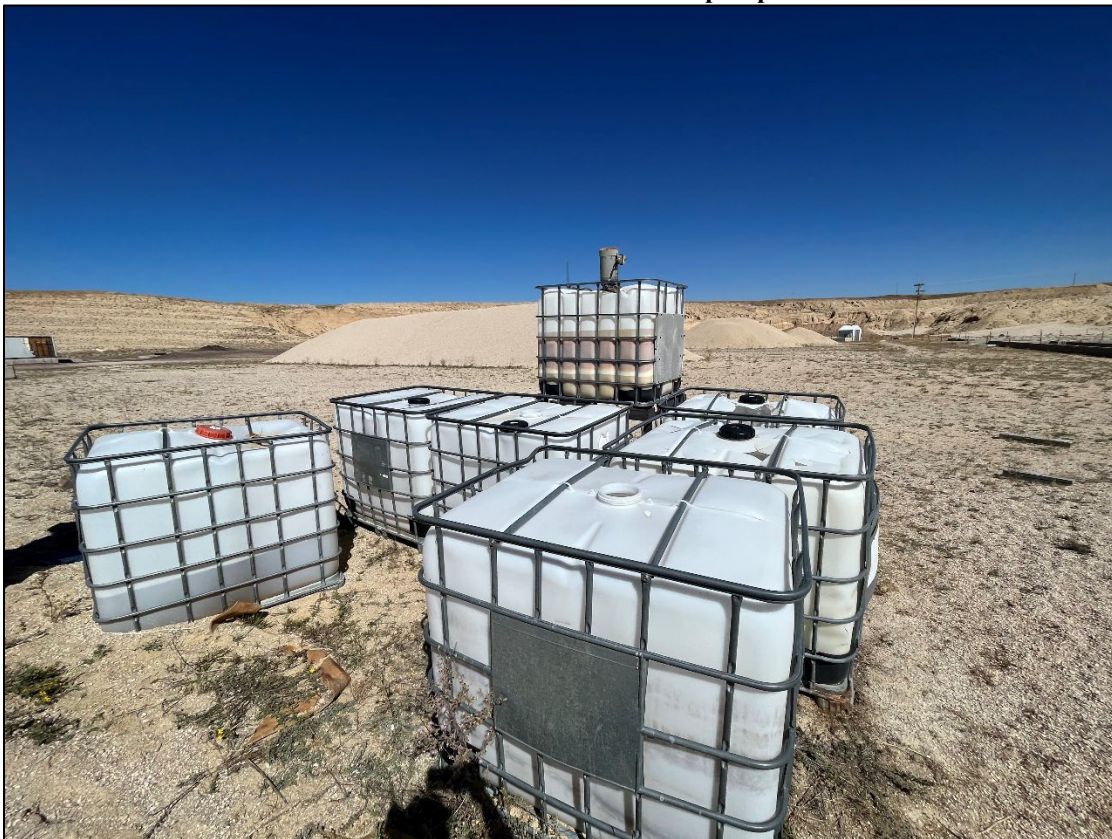
Storm Water MGT Plan: No oil or fuel spills observed. Empty and dried out flocculant storage tanks were located in the corner of the main pit (Photo 6). The Division does not consider flocculant to be a hazardous chemical and therefore does not require secondary containment. Stormwater drains to the pit and infiltrates within a sediment pond area (Photo 7).

Photo 6: Empty and partially empty tanks of flocculant in the southwest corner of the open pit area.

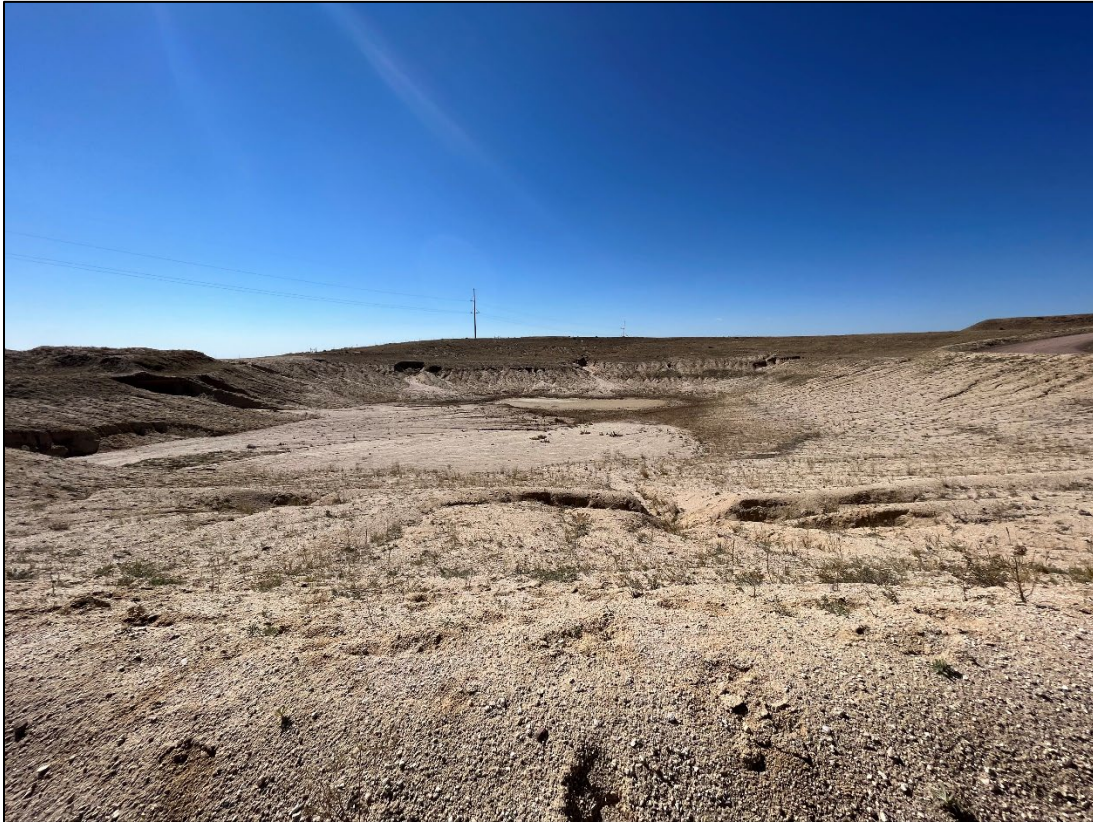
Photo 7: View of the sediment pond area to the west of the wash pond area.

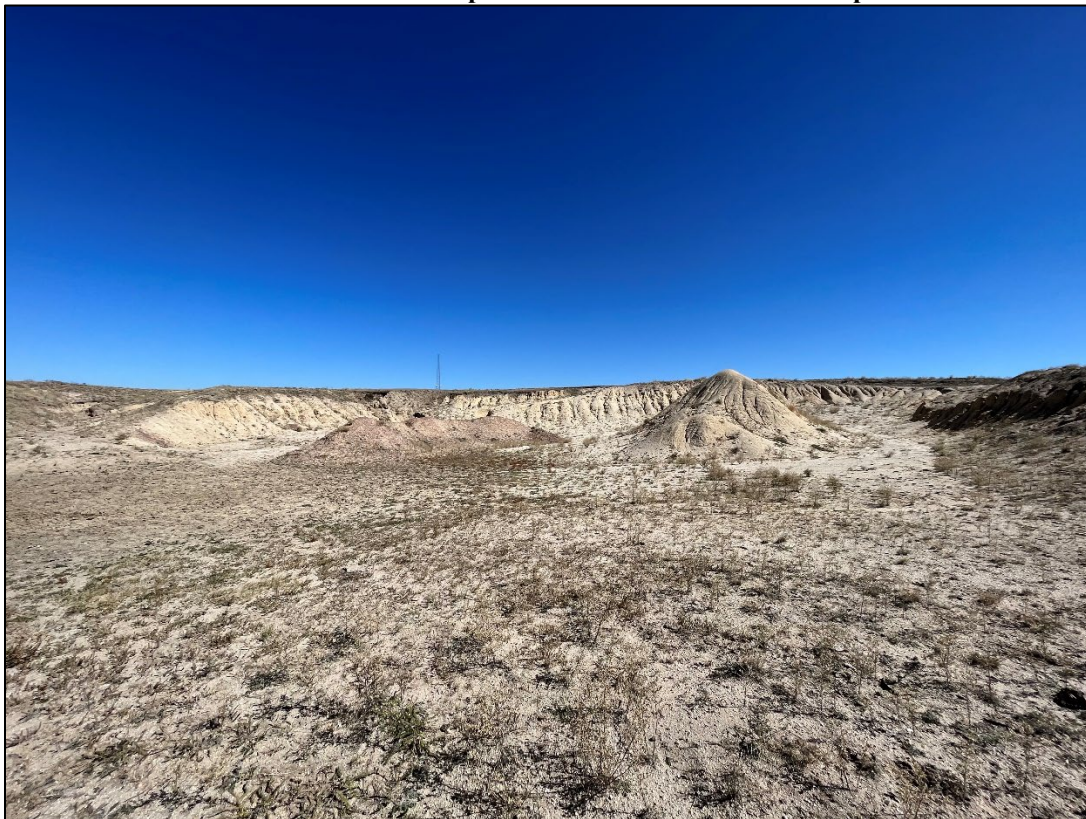
Photo 8: View north from within the site's western-most pit area.
