## J-Rude Pit (M-1989-009) Inspection Report

**MINERALS PROGRAM INSPECTION REPORT**  
**PHONE: (303) 866-3567**

| <b>MINE NAME:</b><br>J-Rude Site | <b>MINE/PROSPECTING ID#:</b><br>M-1989-009 | <b>MINERAL:</b><br>Sand and clay (general) | <b>COUNTY:</b><br>Prowers |

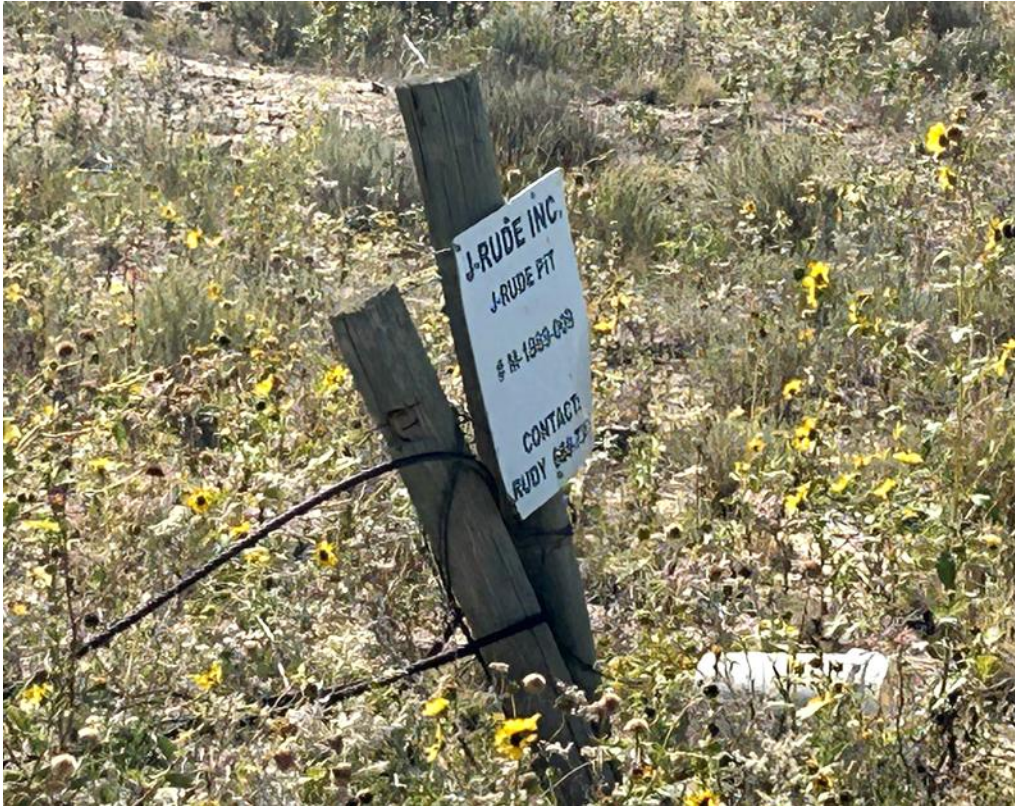
At the time of the inspection, the weather was clear, warm, and dry. A permit sign was posted at the entrance to the site off Co Rd Ff. The permit sign has the name of the operator, the operation name, and the permit number. However, it does not include a statement that a reclamation permit for the operation has been issued by the Colorado Mined Land Reclamation Board, as required by Rule 3.1.12(1). A problem is cited for this issue; see Problem #1 in this report for the required corrective actions.

**Photo 1.** View looking west showing the posted mine identification sign.

**PROBLEM #1:** A proper mine identification sign was not posted at the entrance of the mine site. This is a problem for failure to post a mine identification sign in accordance with Rule 3.1.12(1).

**CORRECTIVE ACTIONS:** The Operator shall, at the entrance of the mine site post a sign, which shall be clearly visible from the access road, with a minimum size equaling one hundred and eighty-seven (187) square inches, such as eleven (11) inches in height and seventeen (17) inches in width, with appropriate font size, with the following: the name of the Operator, the operation name, a statement that a reclamation permit for the operation has been issued by the Colorado Mined Land Reclamation Board, and the permit number. The operator shall submit photo documentation that a proper sign has been posted by the corrective action date.

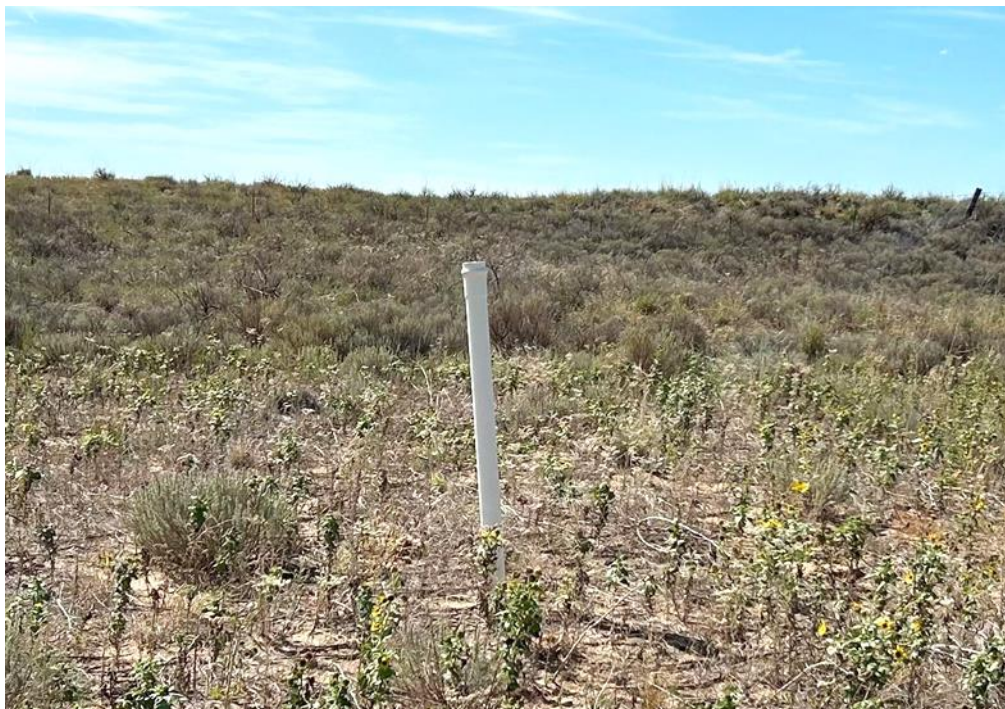
The four corners of the 4-acre permit boundary were marked with PVC pipes. The Division was unable to collect GPS data from all boundary markers due to the dense vegetation and high rattlesnake activity in the area. The Division did collect GPS coordinates for the southwestern corner marker. However, this location appears to be approximately 100 feet east and 100 feet south of where the Division believes the southwestern corner should be located based on approved maps. After the inspection, the operator sent the Division GPS coordinates for what they indicated was the southeastern permit boundary corner. However, this point plots closer to the southwestern corner marker, and it does not correlate with the location of the southeastern corner marker observed during the inspection. A Google Earth image of the site that depicts the information described above is enclosed with this report. The boundaries of the affected area must be marked by monuments or other markers that are clearly visible and adequate to delineate such boundaries, per Rule 3.1.12(2). While the operator has placed markers to delineate the corners of the permit boundary, it appears that some or all of the markers are not in the correct location. A problem is cited for this issue; see Problem #2 in this report for the required corrective actions.

**Photo 2.** View looking west at the southwestern PVC permit boundary marker.

**PROBLEM #2:** The affected area boundary markers are missing or incorrectly placed. This is a problem for failure to maintain boundary markers around the affected area as required by Rule 3.1.12(2).

**CORRECTIVE ACTIONS:** The operator shall conduct a survey and replace the boundary markers in the correct location(s). The operator shall provide proof to the Division that this has been done by the corrective action date. Such proof shall be in the form of photo documentation and GPS coordinates of the boundary markers.

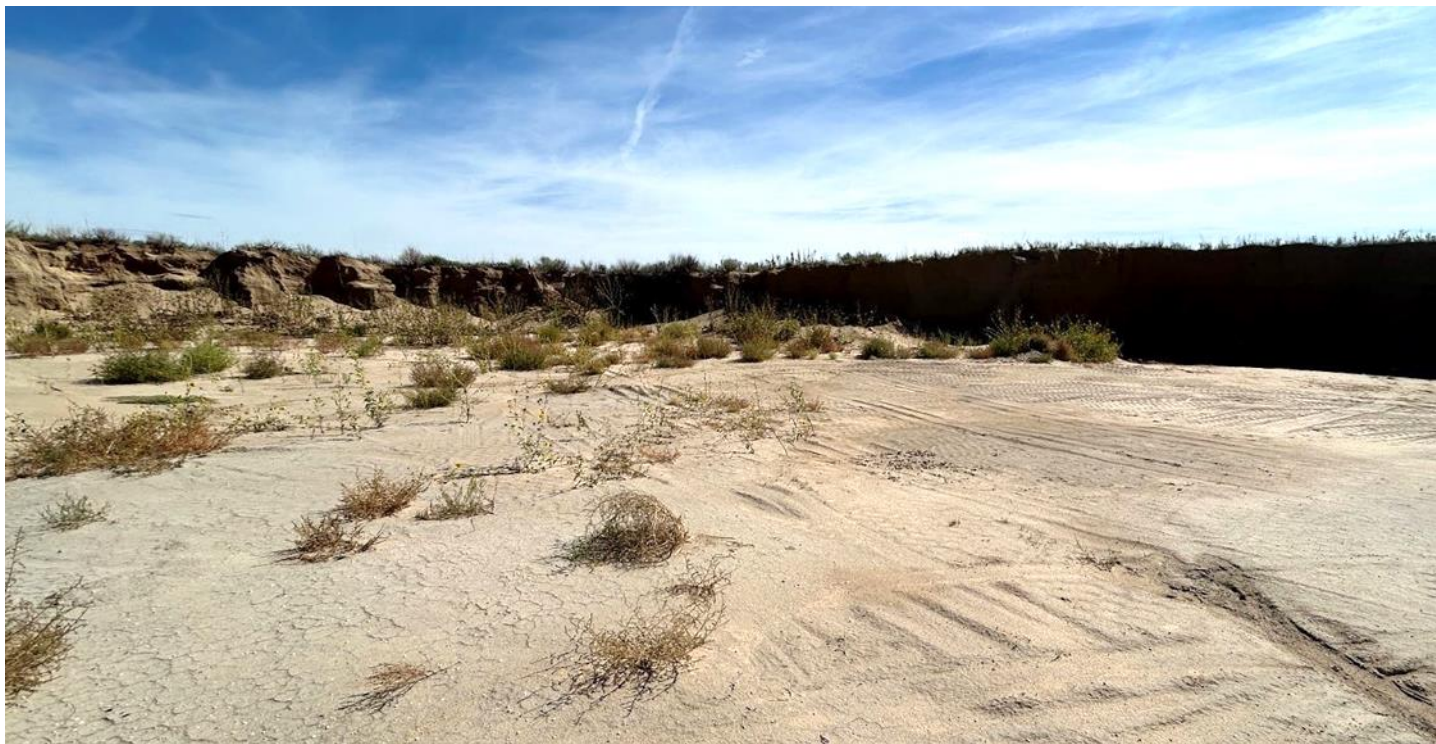
The site was not active during the inspection. However, additional disturbances have been created at the site since the Division last inspected it on September 12, 2019. The horseshoe-shaped pit has been expanded to the south. The pit wall is approximately 300 feet in length and 10 feet in height, with near vertical slope gradients. No product stockpiles or mining equipment were present on site. The pit area is mostly bare in vegetative cover, with some sparse weed growth consisting primarily of Russian thistle and wild sunflowers. There are a few brush piles stored in the western portion of the permit area, near the access road. The operator explained to the Division these brush piles help discourage the public from illegally dumping trash in the pit. The operator is not approved to use this material for reclamation of the mine. After conducting the 2019 inspection, the Division

estimated the unreclaimed disturbance at the site to cover 0.2 acre. After conducting the recent inspection, the Division estimates current disturbance to cover approximately 1.5 acres.

**Photo 3.** View looking southeast across recent disturbance near center of permit area. Note this area is mostly bare in vegetative cover and includes pit walls in a horseshoe-shaped pattern.

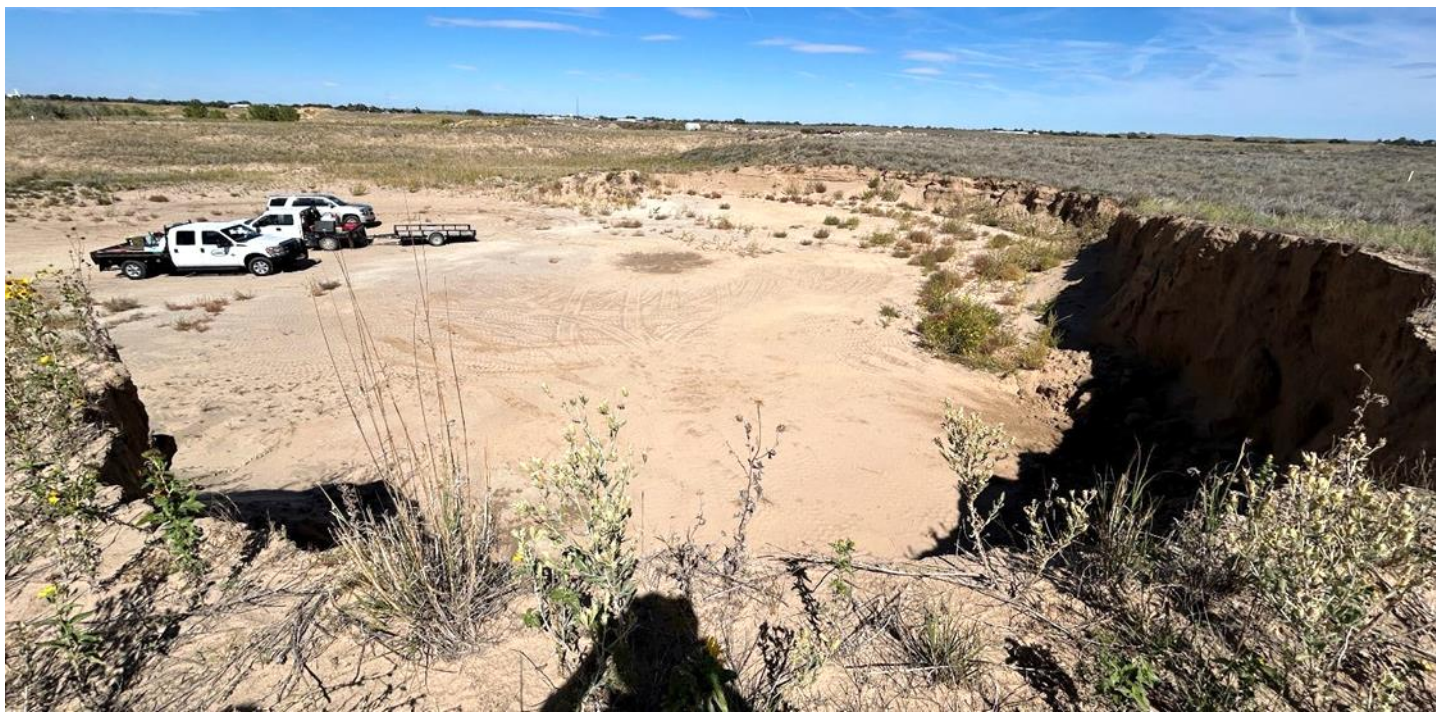
**Photo 4.** Above view of the recent disturbance area shown in Photo 3 (looking north).

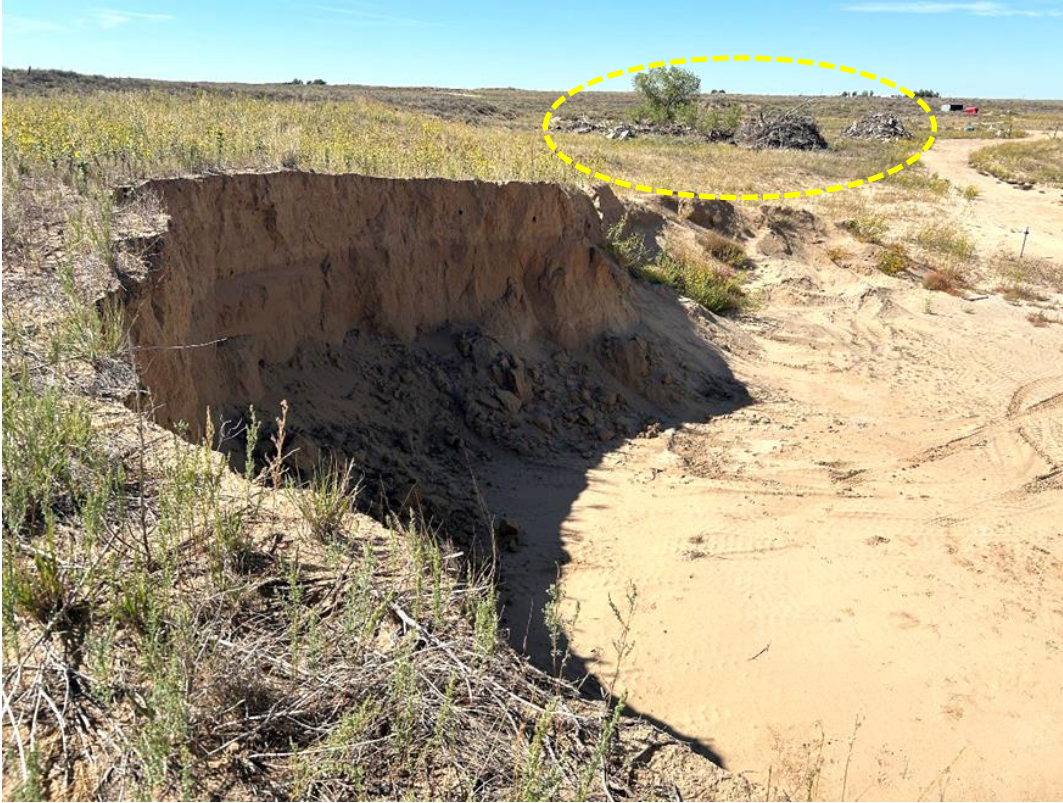
**Photo 5.** View looking west at the western section of the pit highwall. Note the brush piles in the western area (circled).

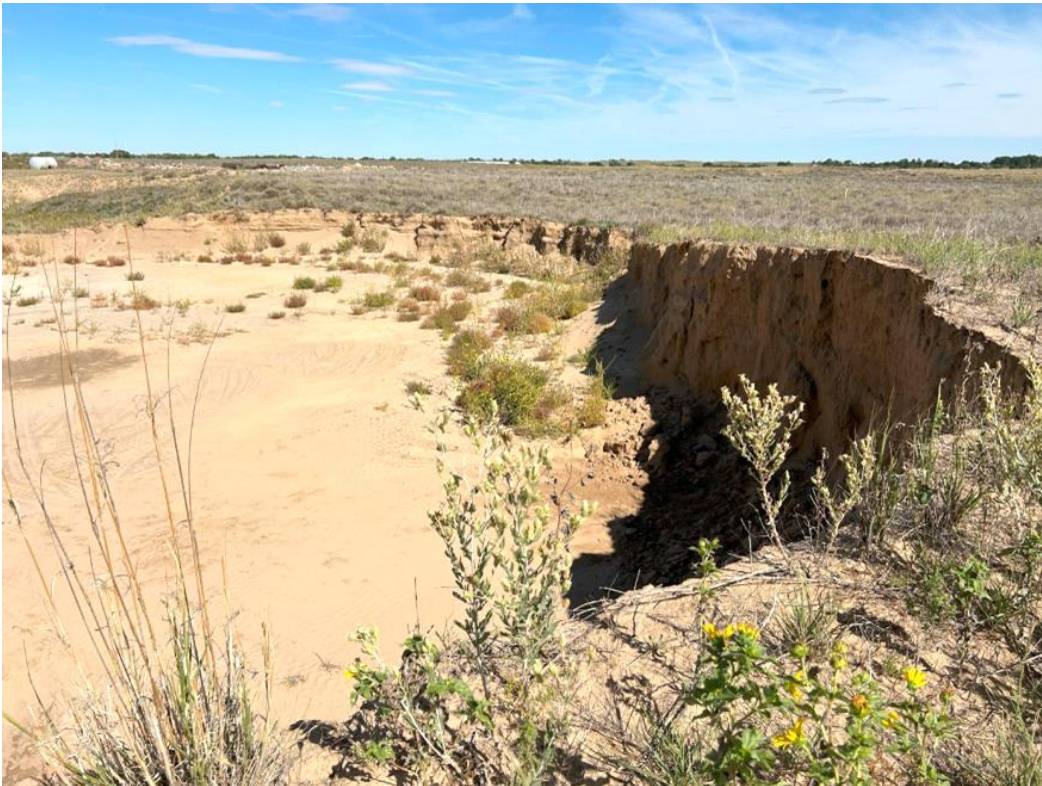
**Photo 6.** View looking northeast at the eastern section of the pit highwall.
