MINERALS PROGRAM INSPECTION REPORT
PHONE: (303) 866-3567

MINE NAME: Peat Mine	MINE/PROSPECTING ID#: M-1994-081	MINERAL: Peat, sand and gravel	COUNTY: Alamosa
INSPECTION TYPE: Monitoring	WEATHER: Clear	INSP. DATE: September 6, 2024	INSP. TIME: 10:00am
OPERATOR: Mortensen's Landscape & Irrigation LLC	OPERATOR REPRESENTATIVE: Brandon Garrison	TYPE OF OPERATION: 112c - Construction Regular Operation

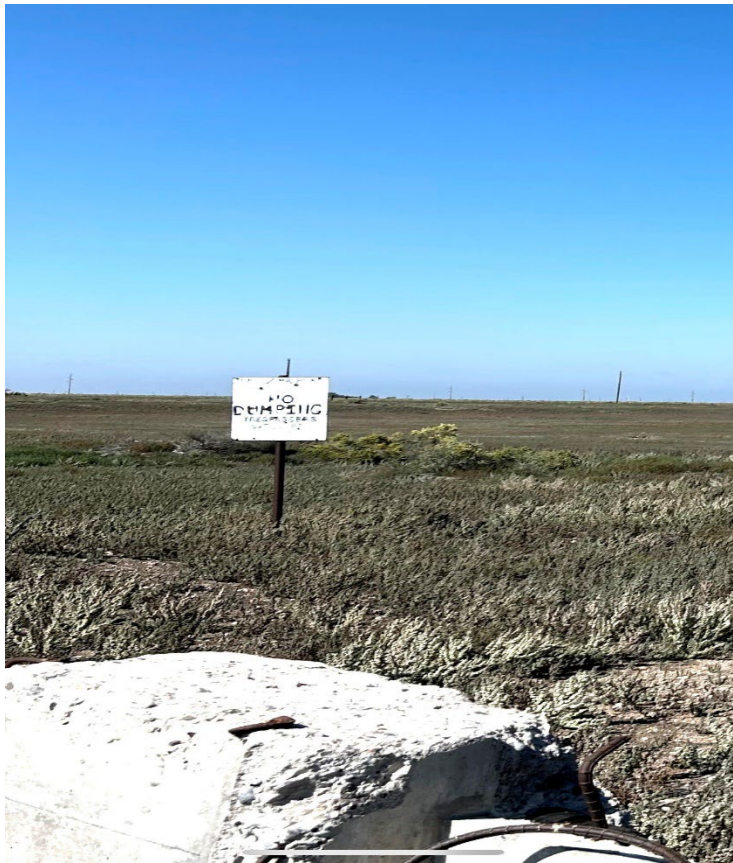
There was no mine sign present. In the northwest portion of the site, the DRMS observed a faded sign that read "Mr. Peat, Warning, No Dumping" (see photo 1). In accordance with Rule 3.1.12(1) of the Construction Materials Rules and Regulations, the DRMS will require the Operator to post a sign that contains the name of the Operator, a statement that a reclamation permit for the operator has been issued by the Colorado Mined Land Reclamation Board, and the permit number. There were no boundary markers along the northern and southern permit boundary, making it difficult to discern the permit boundary. The permit area is divided into Three separate parcels designated as Parcel B, Parcel C, and Parcel D (see attached map on page 11). A parcel known as "Parcel A" was located west of Parcel B and Meadowlake Blvd. This parcel was removed from the Permit Boundary when the permit was applied for in 1994. Parcel B and C are combined on the attached map. Clearwater Blvd bisects the site and separates Parcels C and D. Boundary markers were observed along Clearwater Blvd on the eastern edge of Parcel C and the along the western edge of Parcel D. The lack of fully marking the affected area with boundary markers is cited as a problem at the beginning of this report. The Operator will need to conduct a survey and clearly mark the affected area boundary around the site.

Photo 1: "No Dumping" sign on the east side of Parcel A, a significant Halogeton infestation is noted.

CORRECTIVE ACTIONS: In accordance with Rule 3.1.12, the Operator must post a sign at the entrance to the mine site which shall be clearly visible from the access road and specify the following; the name of the operator, indicate the permit number, and indicate the reclamation permit for the operation has been issued by the Colorado Mined Land Reclamation Board. Conduct a survey and mark the approved affected land. The boundaries of the affected area must be marked by monuments or other markers that are clearly visible and adequate to delineate such boundaries. Please provide the Division a notice when this has been completed.

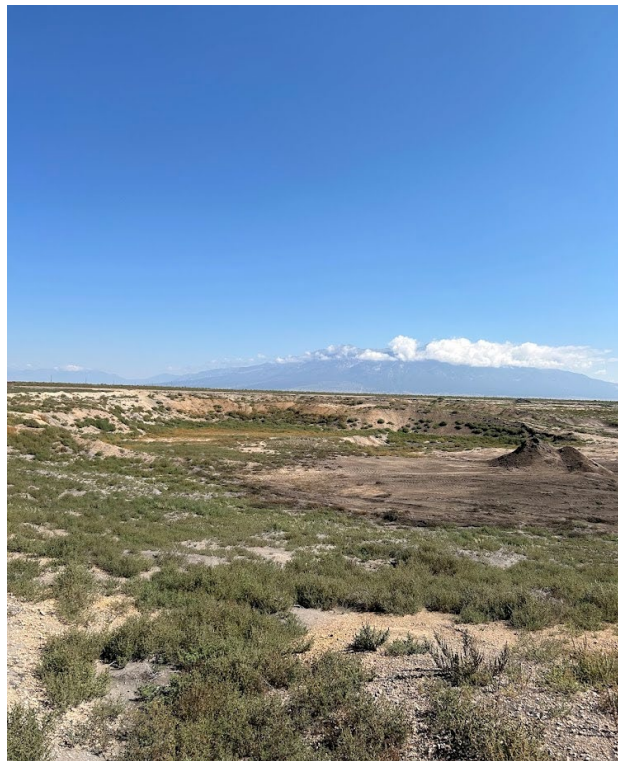
The site was inactive at the time of the inspection. The site consists of undulating topography, hills, and pockets of vegetation. No equipment or permanent structures were observed. The approved mining plan is to mine peat, sand, and gravel in 10-acre phases. A six (6) to twelve (12) inch layer of peat is layered on top of a sand and gravel seam. The sand and gravel seam may be mined until groundwater is exposed and then needed to backfill 2 feet above the groundwater table. A pit excavation was observed southeast of Clearwater Blvd along the western edge of Parcel D (see Photos 2-3). The pit floor contained wetland vegetation, indicating the pit floor sits above the groundwater table. The pit highwall was approximately 415 feet in length and no more than twelve (12) in depth.

Photo 2: Facing north at sand/gravel pit in Parcel D

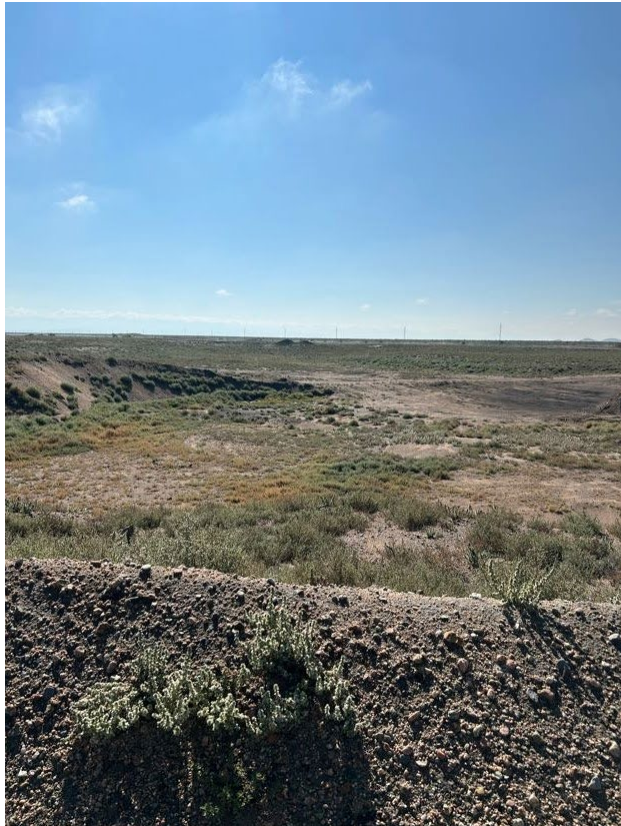
Photo 3: Facing southeast at sand/gravel pit in Parcel D

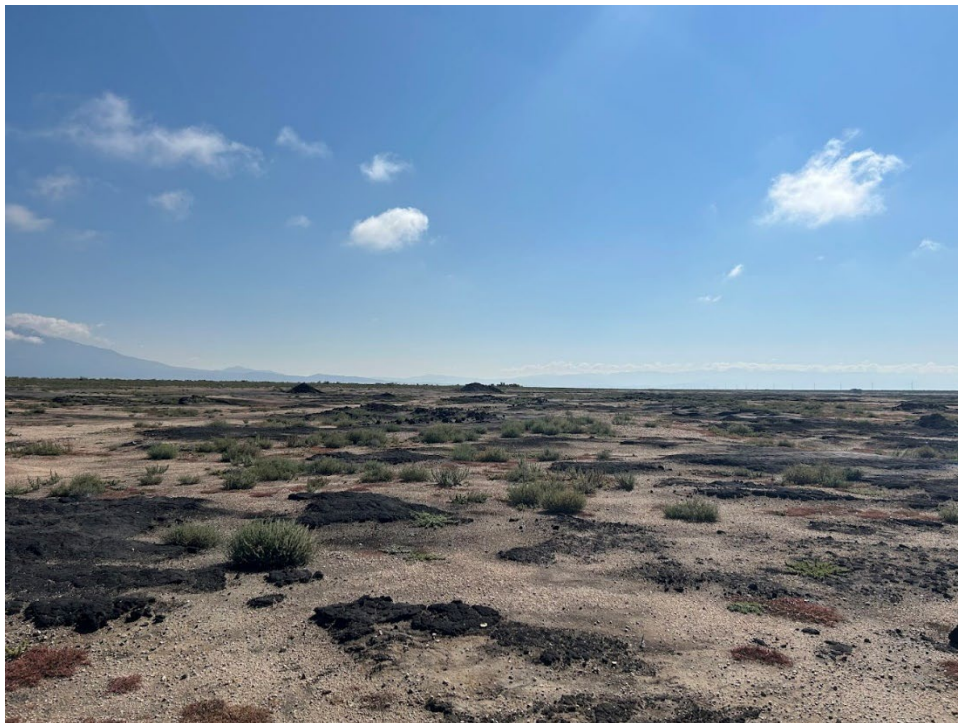
As previously stated, the approved mining plan is to mine peat, sand, and gravel in 10-acre phases. Dozens of black peat stockpiles of varying size were observed throughout the site (see Photos 4-7), indicating that mining is not being conducted as per the approved mining plan. The Division estimates about 30 acres have been affected by the operation. The current mine plan needs to be updated and clarified pursuant to C.R.S. 34-32.5-112 (1)(c)(VI). The Operator must provide sufficient information to describe or identify how the operator intends to conduct the operation if they intend to disturb more than 10 acres at once time. This needs to be accomplished through the submittal of a Technical Revision (TR) to update the mining plan.

portion of the site along Parcels B, C, and D. The DRMS observed peat stockpiles (see Photos 4-5) that may be located outside of the approved permit area, but it is unclear exactly where that boundary is located. The lack of affected land boundaries has been cited as a problem. The Division will require the Operator hire a licensed-surveyor to conduct a land survey of the approved affected area boundary, and subsequently install new boundary markers to adequately delineate the approved affected land.

Photo 4: Facing east at disturbed land in the vicinity of Parcel D.

CORRECTIVE ACTIONS: The Operator shall submit a Technical Revision (TR) to update the mining plan, with the required \$216 revision fee, to update and clarify the current approved mine plan to reflect existing and proposed activities by the corrective action date.

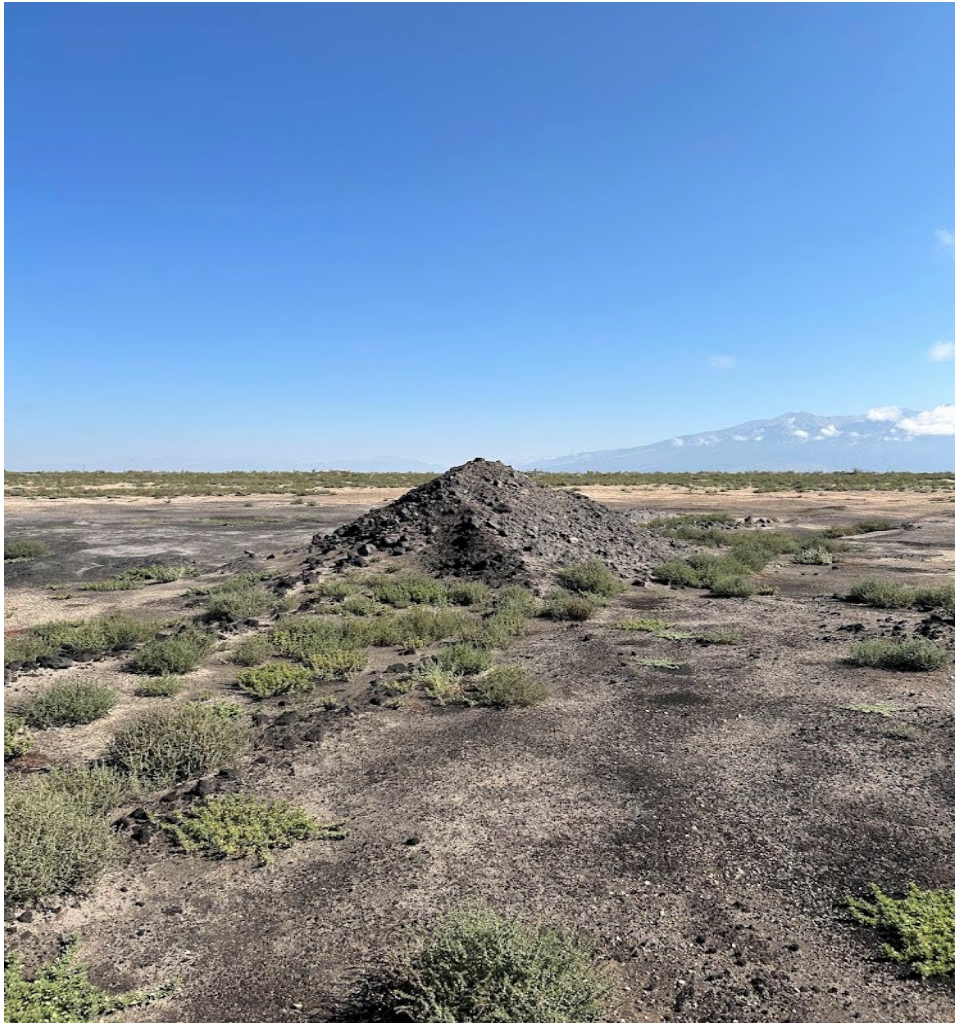
Photo 5: Facing north at stockpile potentially north of Parcel D.

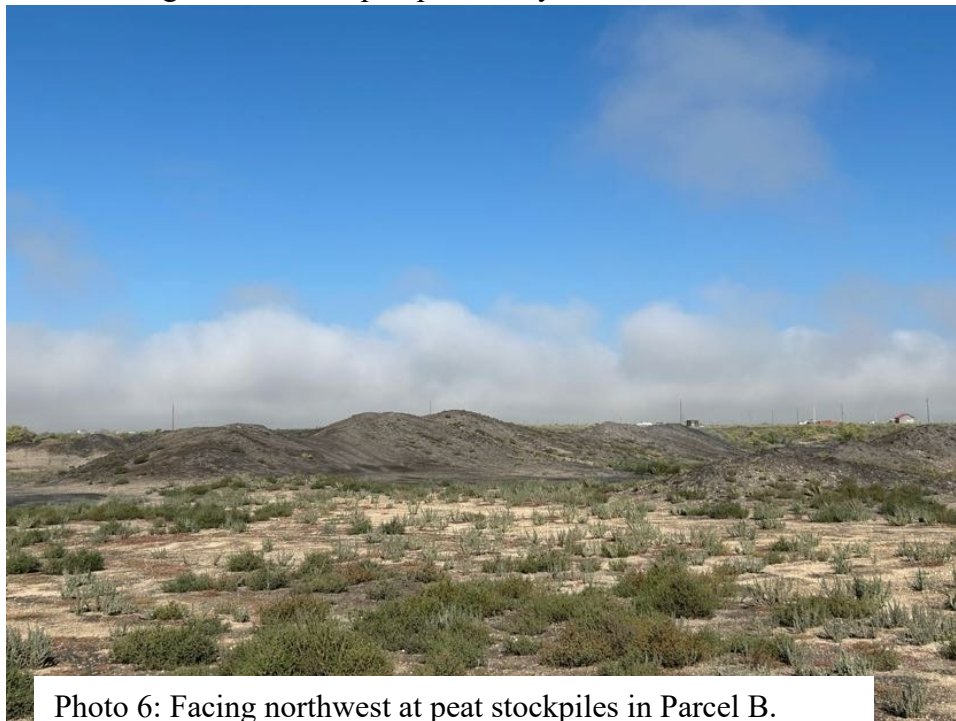
Photo 6: Facing northwest at peat stockpiles in Parcel B.

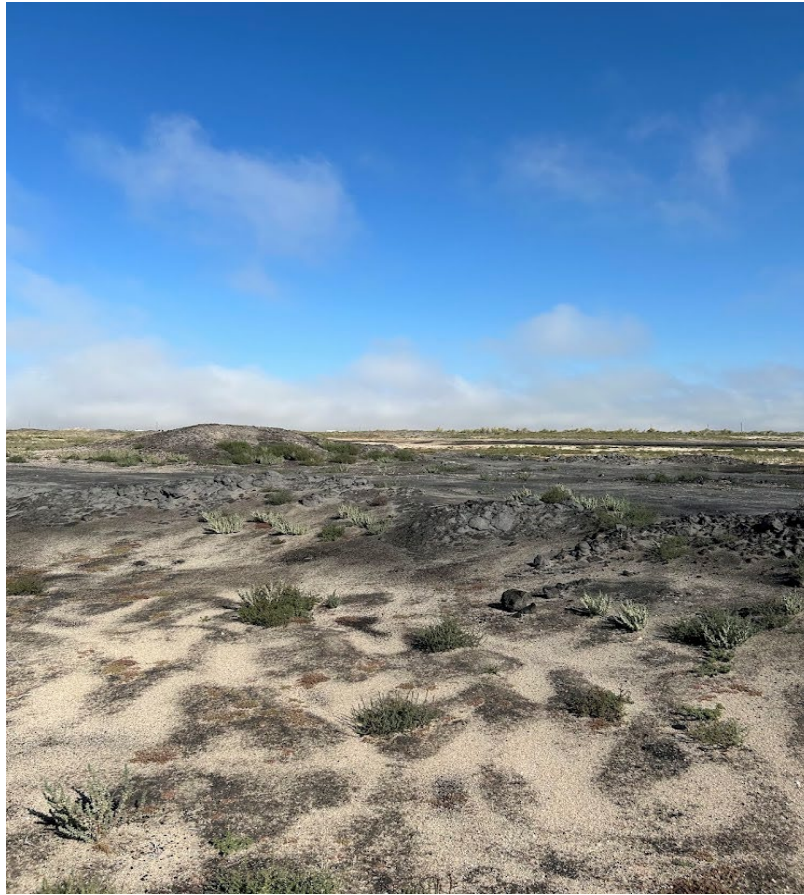
Photo 7: Facing north at peat stockpiles in Parcel C.

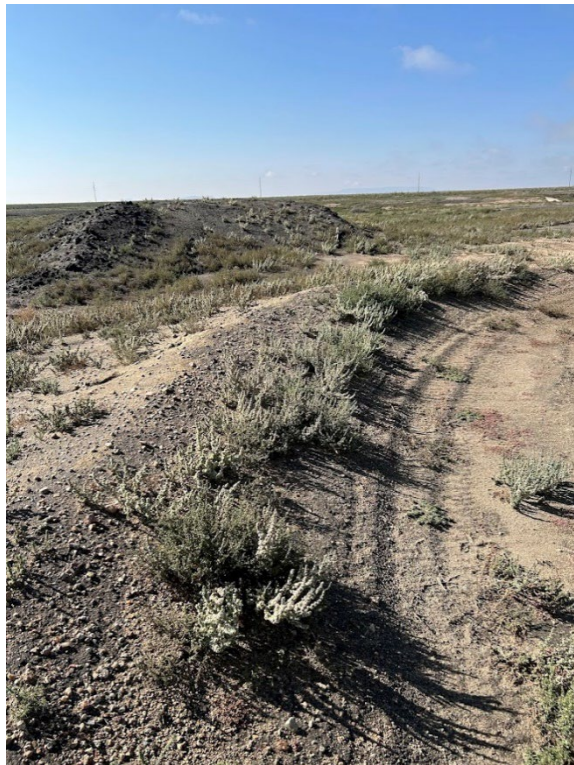
PROBLEM: There are state-listed noxious weeds present on site. This is a problem for failure to employ weed control methods for state listed noxious weed species within the permitted area, and to reduce the spread of weeds to nearby areas as required by Section 3.1.10 (6) of the rule.

Several thick patches of Halogeton were observed in the Parcel B, C, and D (see Photo 9). This has been cited as a problem. In accordance with Rule 3.1.10(6) of the Construction Materials Rules and Regulations governing weed control, the DRMS will require the Operator to initiate the weed control plan approved in Technical Revision (TR-1) to control the current infestation and prevent the spread of weeds to the surrounding area.

Photo 9: Facing south at Halogeton weed in Parcel C.

CORRECTIVE ACTIONS: Implement approved weed control plan and provide proof to the Division that this has been done. The DRMS approved a Technical Revision (TR-1) on 12/19/2016, which was a Weed Management Plan. Per the approved plan, if weeds have been identified, the Operator is required to use a backpack sprayer or a 4-wheeler using chemicals approved by and after consultation with Alamosa County and the San Luis Valley Weed Management Association. Please provide a written response to the Division that identifies a timeline for implementing the approved weed management plan.
