Division of Reclamation,
Mining and Safety

Permit Number: C-1982-057 Mine Name: Seneca IIW Mine Operator: Seneca Property LLC Operator Address: Ms. Miranda Kawcak 29515 Routt County Road 27 Oak Creek, CO 80467	County: Routt Operation Type: Surface Permit Status: Permanent Cessation Ownership: Private
	Operator Representative Present: Michael Howard
Operator Representative Signature: (Field Issuance Only) This report was issued electronically from the Divisions' Denver Office.

Inspection Start Date: 4 Nov 2024 Inspection Start Time: 13:30 p.m. Inspection End Date: 5 Nov 2024 Inspection End Time: 9:30a.m.		Inspection Type: Coal Complete Inspection Inspection Reason: Normal I&E Program Weather: Snowing	
Joint Inspection Agency: None		Joint Inspection Contacts:	
Post Inspection Agency: None		Post Inspection Contacts:	
Inspector(s): Robin Reilley, M.S. GISP	Inspector's Signature:

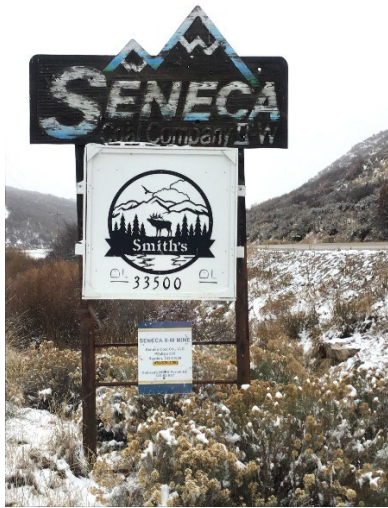
- The mine identification sign was in place at the site entrance from the County Road. The sign was intact, displaying all required information: mine name, operator name, address, phone number, DRMS permit number and contact information.

Photo 1: Mine Identification sign at site entrance.

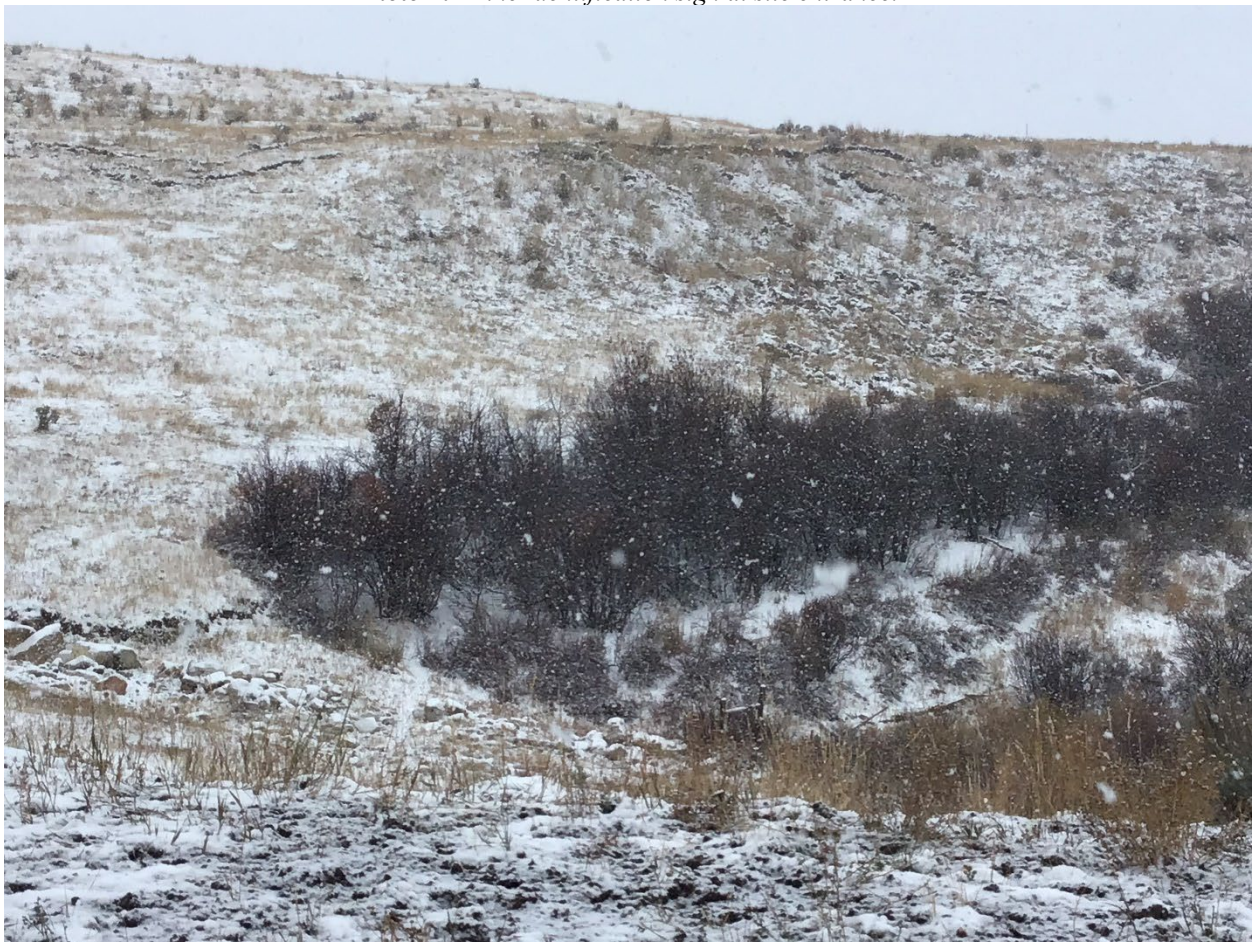
The two slumps and associated crack between them at Pond 6 were documented. No new movement was noted at the time of inspection.

Photo 2: Pond 6 with crack going across the slope.

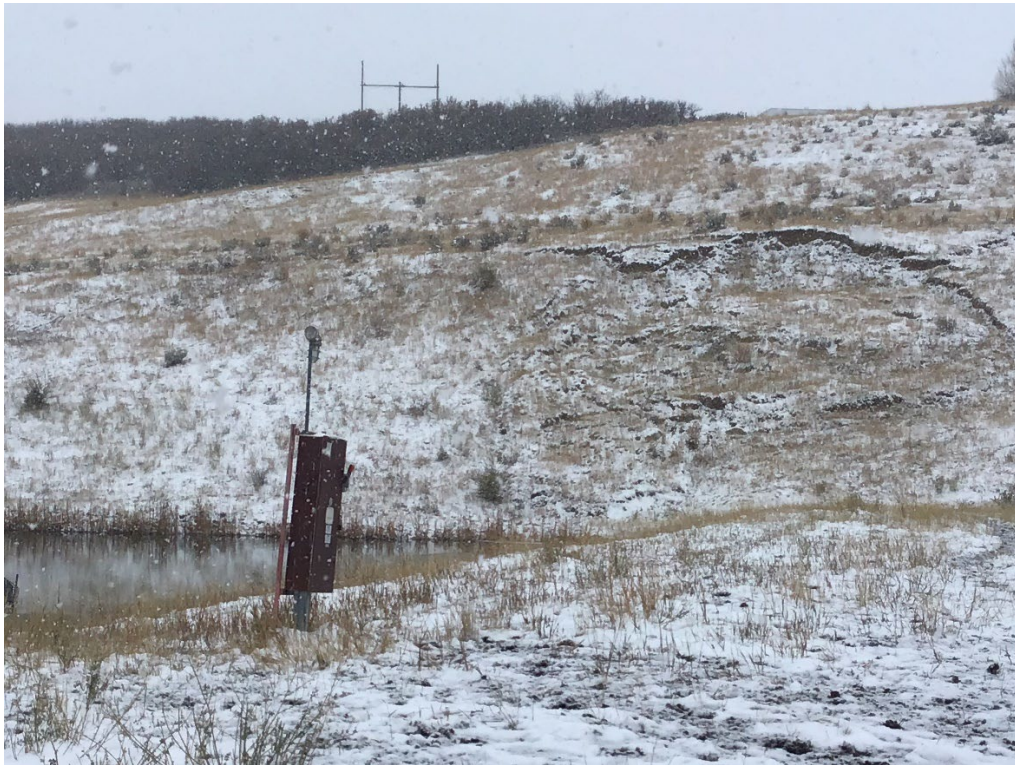
Photo 3: Pond 6 with historic slump above.

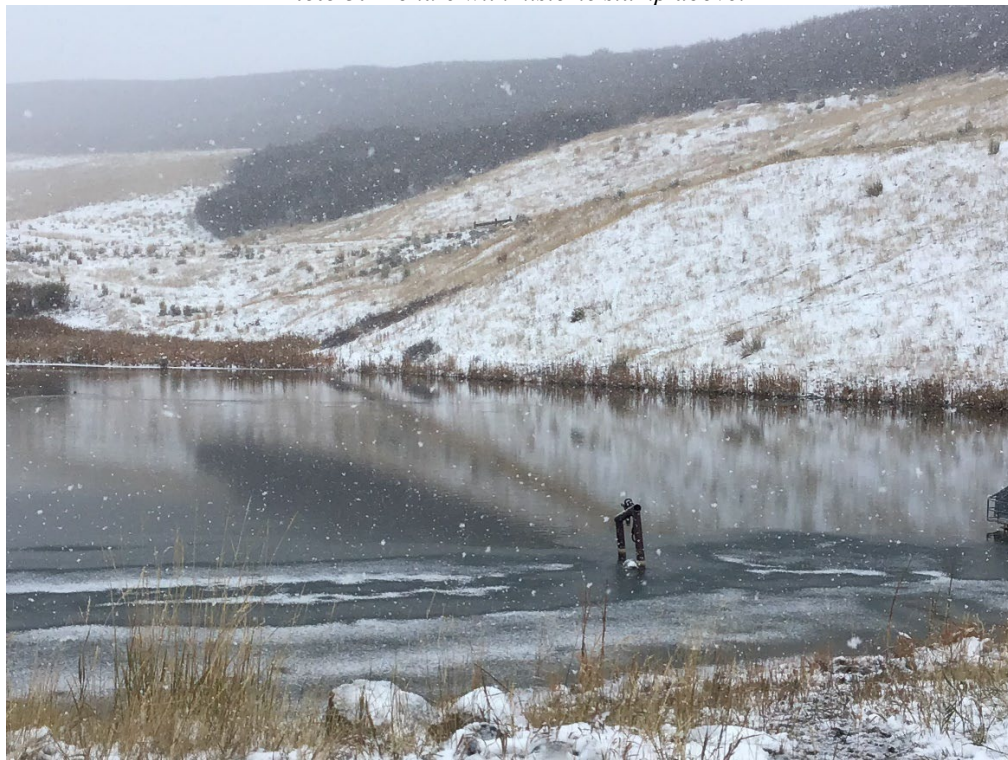
- Pond 6 was discharging clear water.
- Pond 16 was discharging.
- Pond 17 was not accessible due to hazardous winter driving conditions and heavy snow.

Photo 4: Pond 6 beginning to ice over.

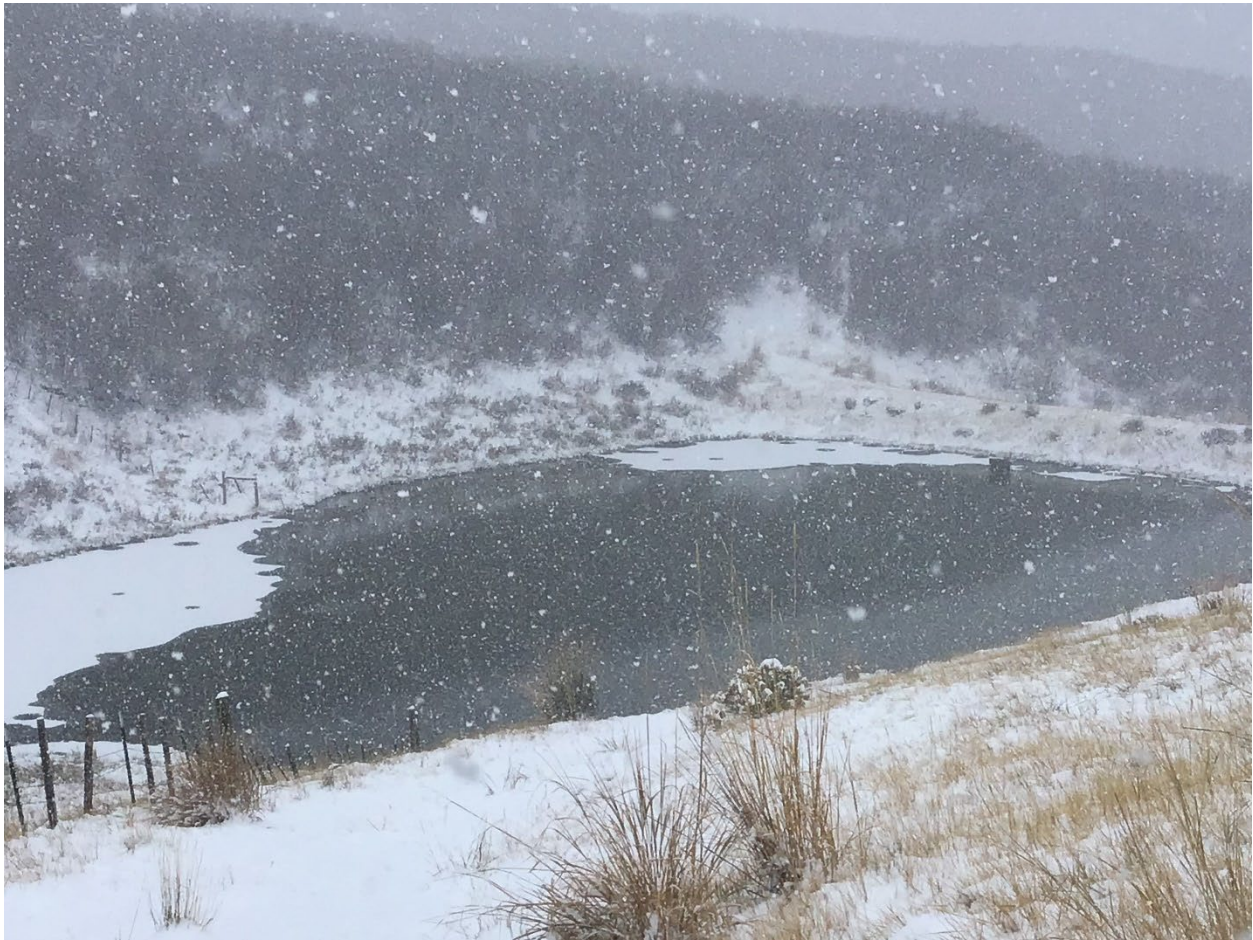
Pond banks appeared stable and vegetated. Spillways appeared in good repair and clear at the time of inspection. Ponds visited comprised ponds 6, and 16 and both ponds held water.

Photo 5: Pond 16 from the main haul road above.
