Inspections Complete 2024 Nov Yoast and Seneca IIW

Permit Number: C-1994-082 Mine Name: Yoast Mine Operator Address: Seneca Property LLC Ms. Miranda Kawcak 29515 Routt County Road No. 27 Oak Creek, CO 80467	County: Routt Operation Type: Surface Permit Status: Permanent Cessation Ownership: Private Operator Representative Present: Michael Howard
Operator Representative Signature: (Field Issuance Only) This report was issued electronically from the Divisions' Denver Office.

Inspection Start Date: 4 Nov. 2024 Inspection Start Time: 2:00 p.m. Inspection End Date: 5 Nov. 2024 Inspection End Time: 10:30 a.m.	Inspection Type: Coal Complete Inspection Inspection Reason: Normal I&E Program Weather: Snowing
Joint Inspection Agency: None	Joint Inspection Contacts:
Post Inspection Agency: None	Post Inspection Contacts:
Inspector(s): Robin Reilley, M.S. GISP	Inspector's Signature:

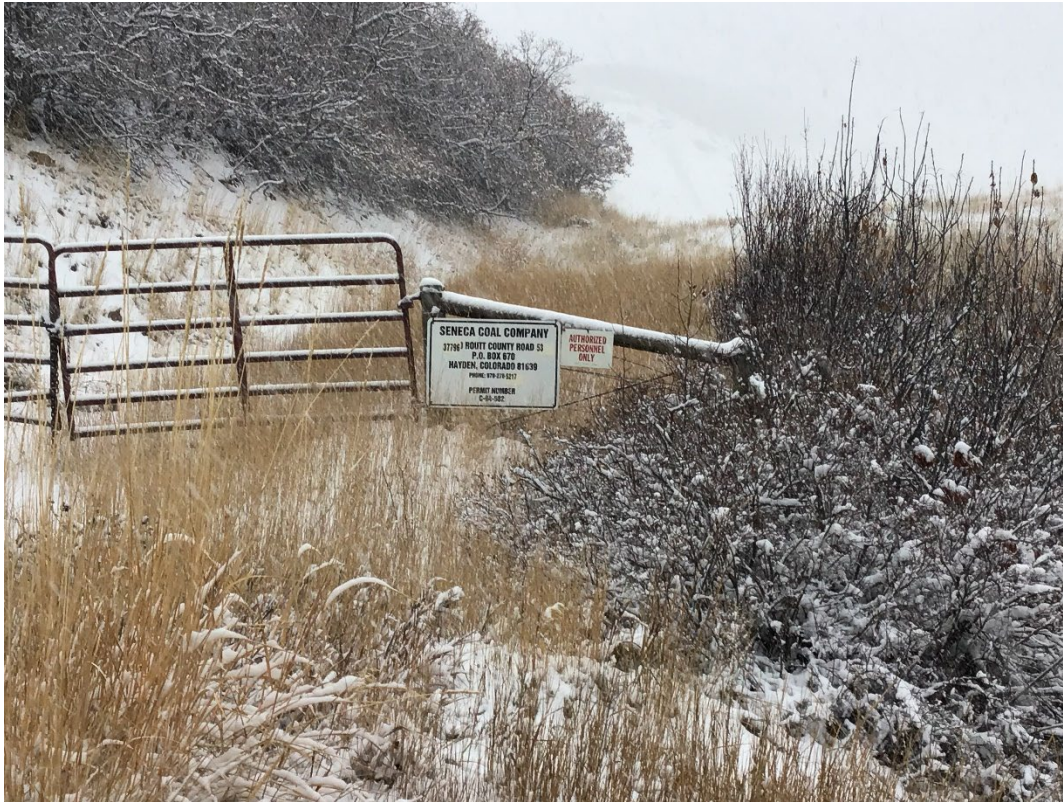
Photo 1: Yoast permit identification sign below pond 12 on County Road 37.

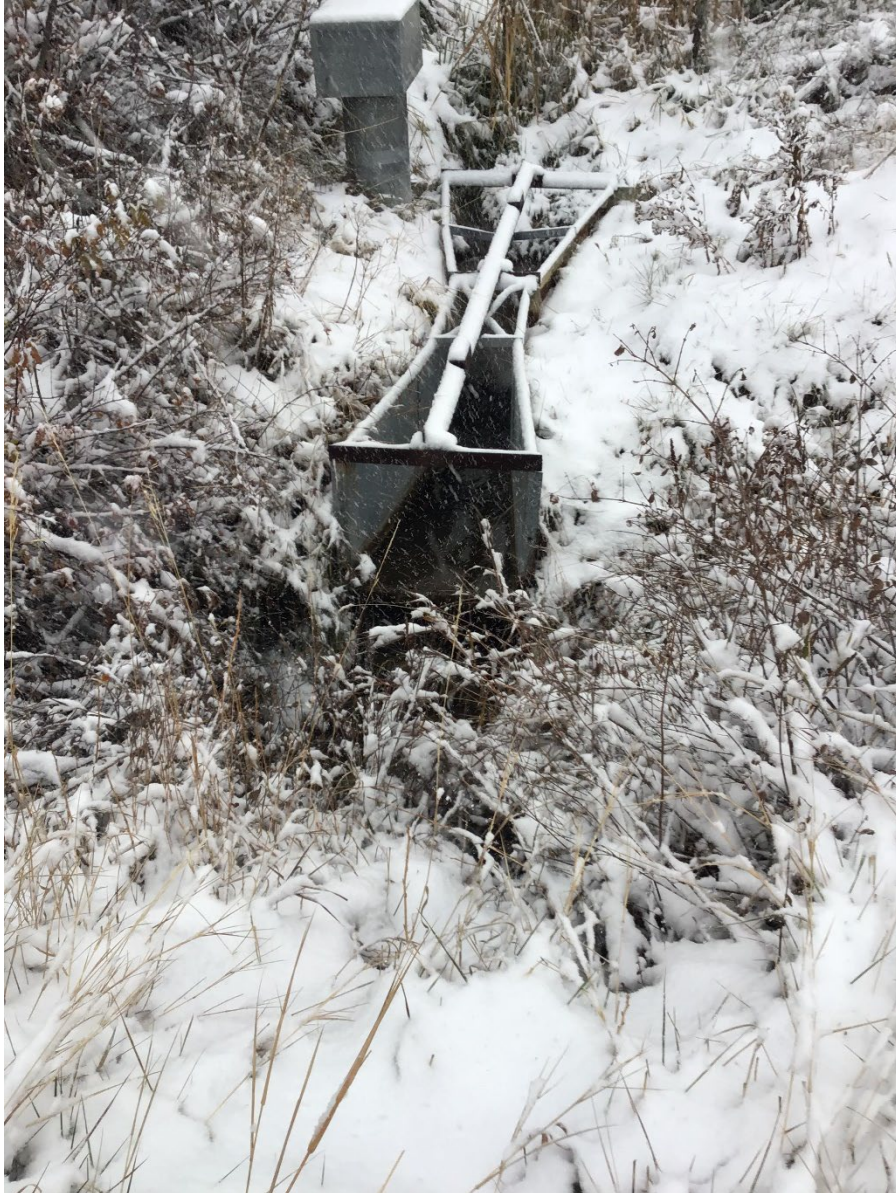
- Pond 12 was discharging clear water through the flume at the time of inspection.
- Pond 13 was not discharging at the time of inspection.
- Pond 14 held water at the time of inspection. The decant structure had been replaced.

Photo 2: Pond 12 flume discharging clear water.
