ANNUAL REPORT M-2013-031 NEW HAY CAMP PIT

Four States Aggregates LLC PO Box 1525 Dolores CO 81323 2024 Annual Report

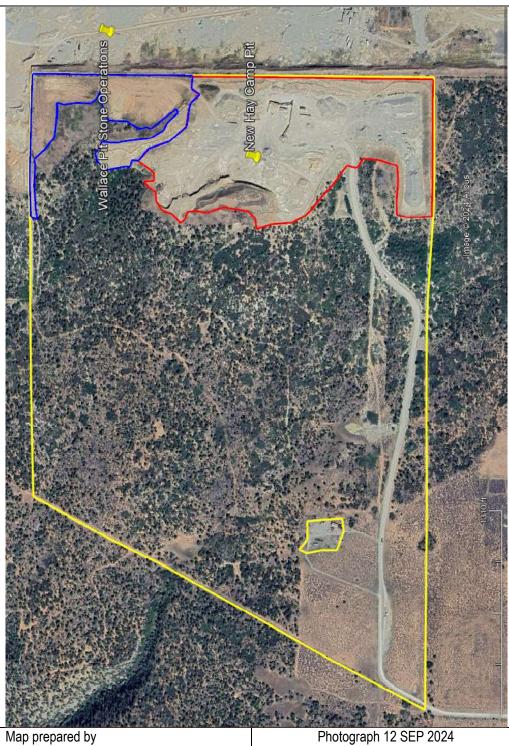
MAP #1

Entire Permit Area (bright yellow boundary) See Map 2 for expanded view of actual affected area.

Note: Access Road and WAPA maintenance trail are permanent, post-mining features.

Some areas not affected by mining were cleared of trees by landowner.

Access to CR-S (SE corner of site and map uses an easement across the Wallace Pit and is a permanent post-mining feature.

Mining activities continue to be intermittent based on seasonal weather and conditions. Areas previously graded to final grade may be disturbed now and in the future as mining progresses. The irregular yellow area near the south end of the permit area is used for equipment storage and is not mined nor proposed for mining. Scalehouse and road width at that point may remain post-mining to support future non-mining activities on the site.

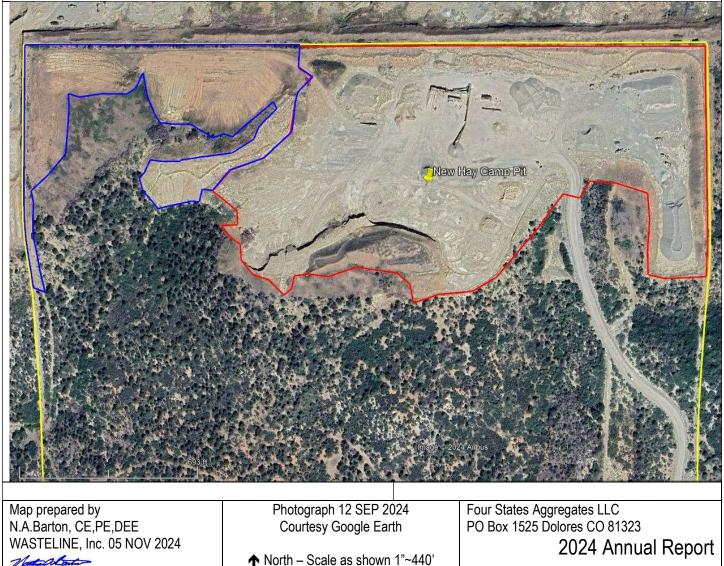
MAP #2

Currently Affected Area (bright yelllow is permit boundary).

Red area of 28.0 acres was affected up to 2022 and is at final grade except for soil and soil stockpiles. Blue area of 8.16 acres was affected 2022-2024 and currently being mined.

No expansion of affected areas is proposed in 2025. Minor grading to be done and spread of soil on up to 20 ac. All areas protected by storm water best management practices. All potential surface discharge of water from affected areas is retained by basins along the access road. There is no discharge of process water, and no exposure of ground water. Wallace Pit (Stone Sand & Gravel) is located to the west, north, and east.

There is presently equipment located and operating at the location but it may be deployed to other pits based on customer demand.
