Re: Activities Being Conducted at the Yocam Borrow Pit, Permit No. M-2018-020

On November 14, 2024, the Division of Reclamation, Mining and Safety (Division/DRMS) performed a routine monitoring inspection of the Yocam Borrow Pit (M2018-020). During that inspection it was determined that Frontier Environmental Services was transporting material from a river restoration project to the Yocam permit area.

South Platte Mitigation Bank

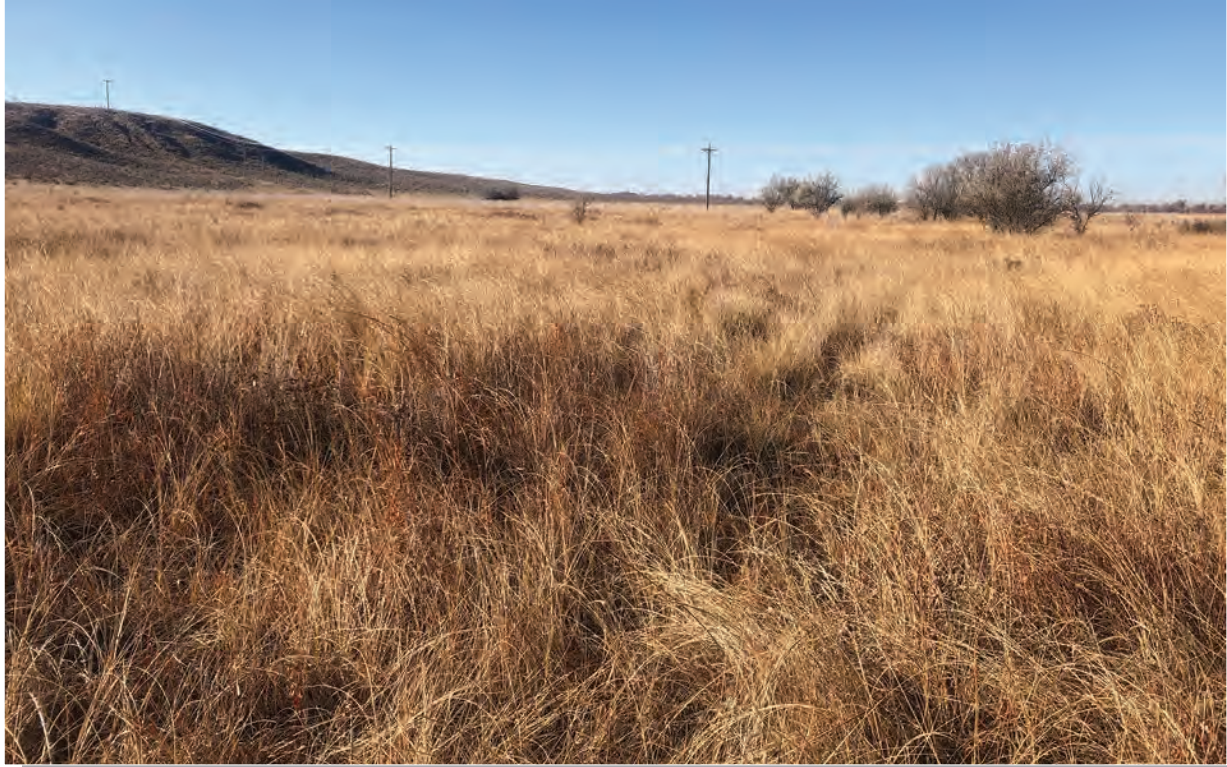
Photo 1 - Overview of intermediate wetland/upland area in the western portion of the project area.
View is to the southwest.

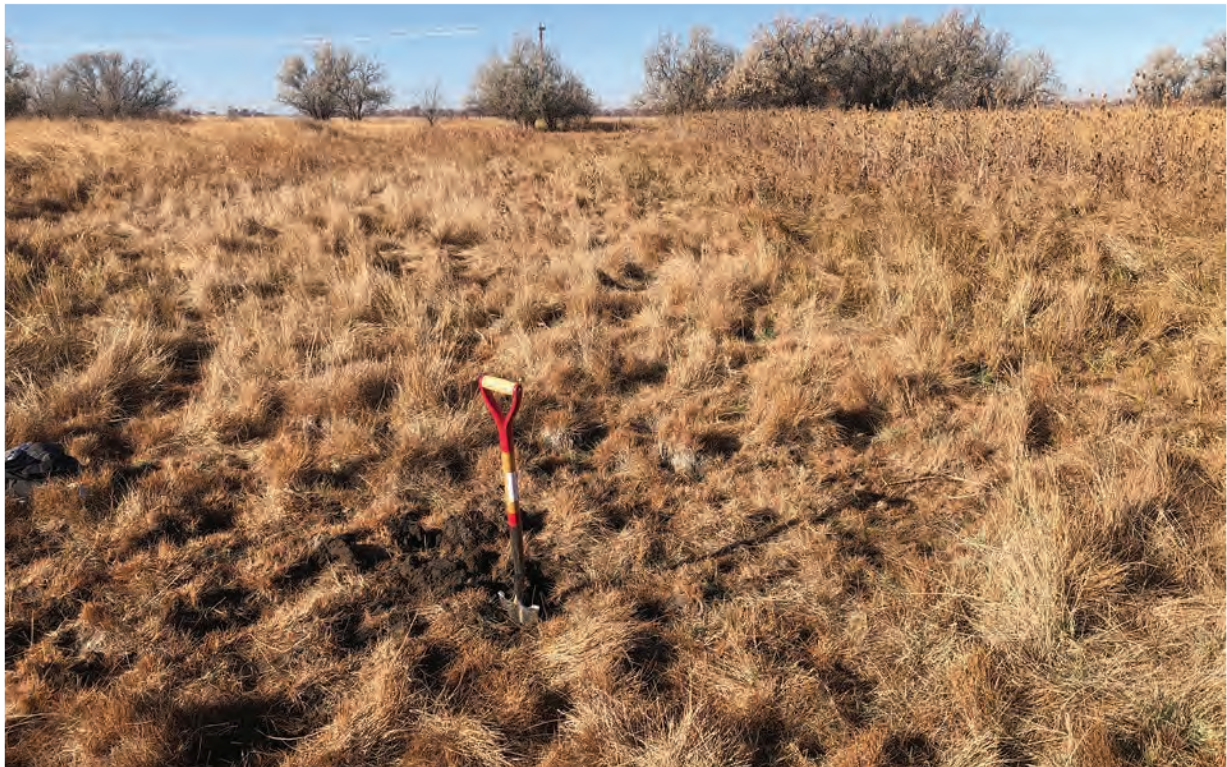
Photo 2 - Overview of DP3 and the southern lobe of Wetland A in the western portion of the project area.
View is to the west.

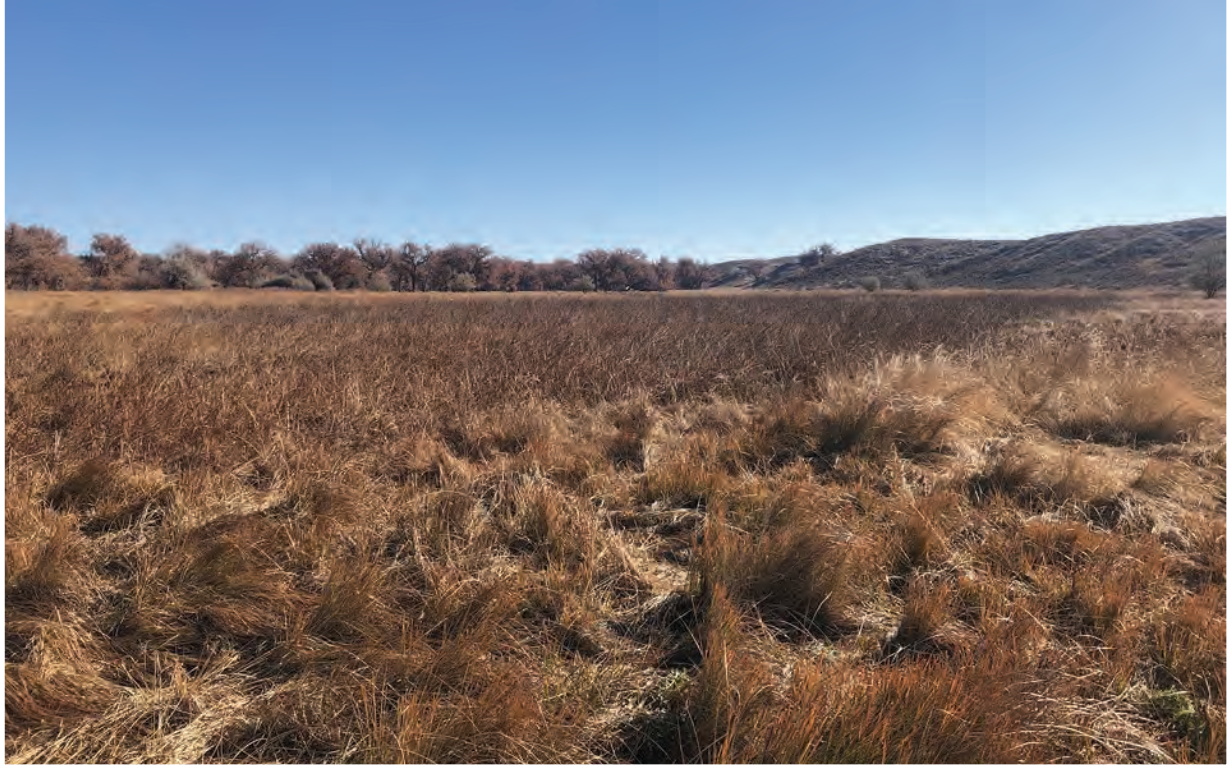
Photo 3 - Overview of the eastern portion of Wetland B in the western portion of the project area.
View is to the southeast.

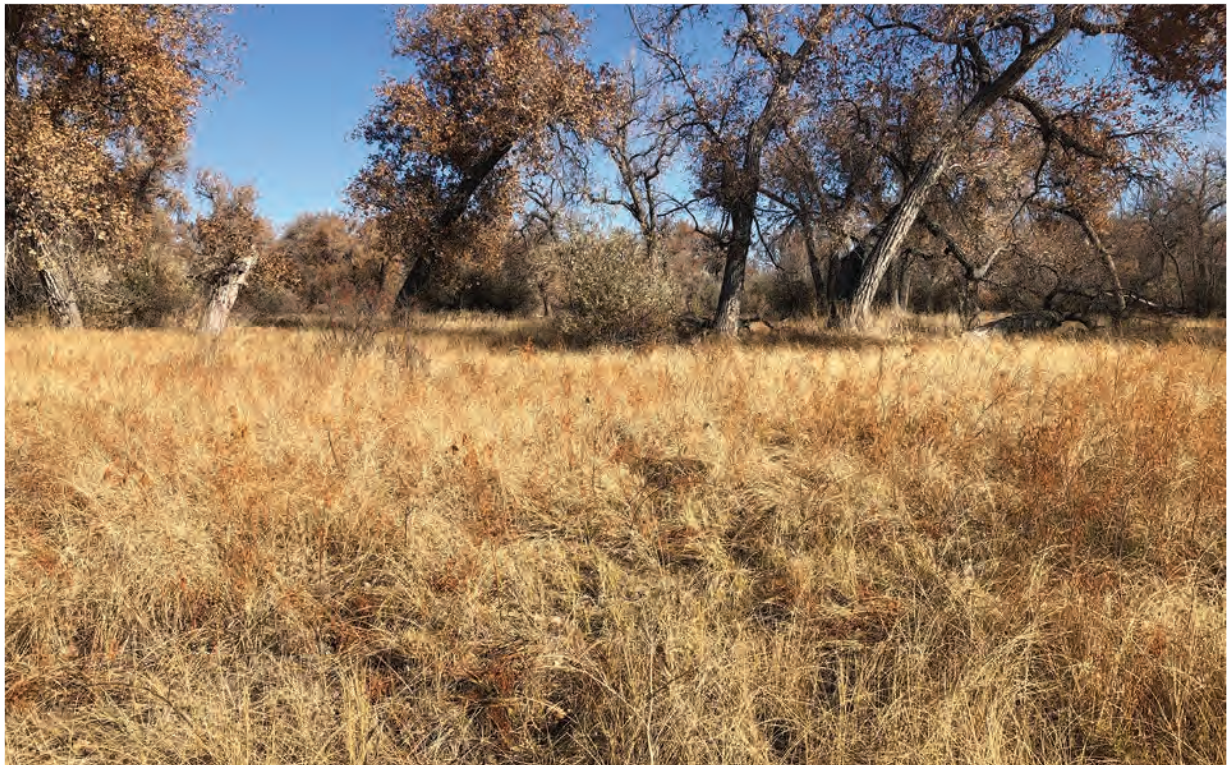
Photo 4 - Overview of uplands adjacent to Wetland E in the western portion of the project area.
View is to the north.

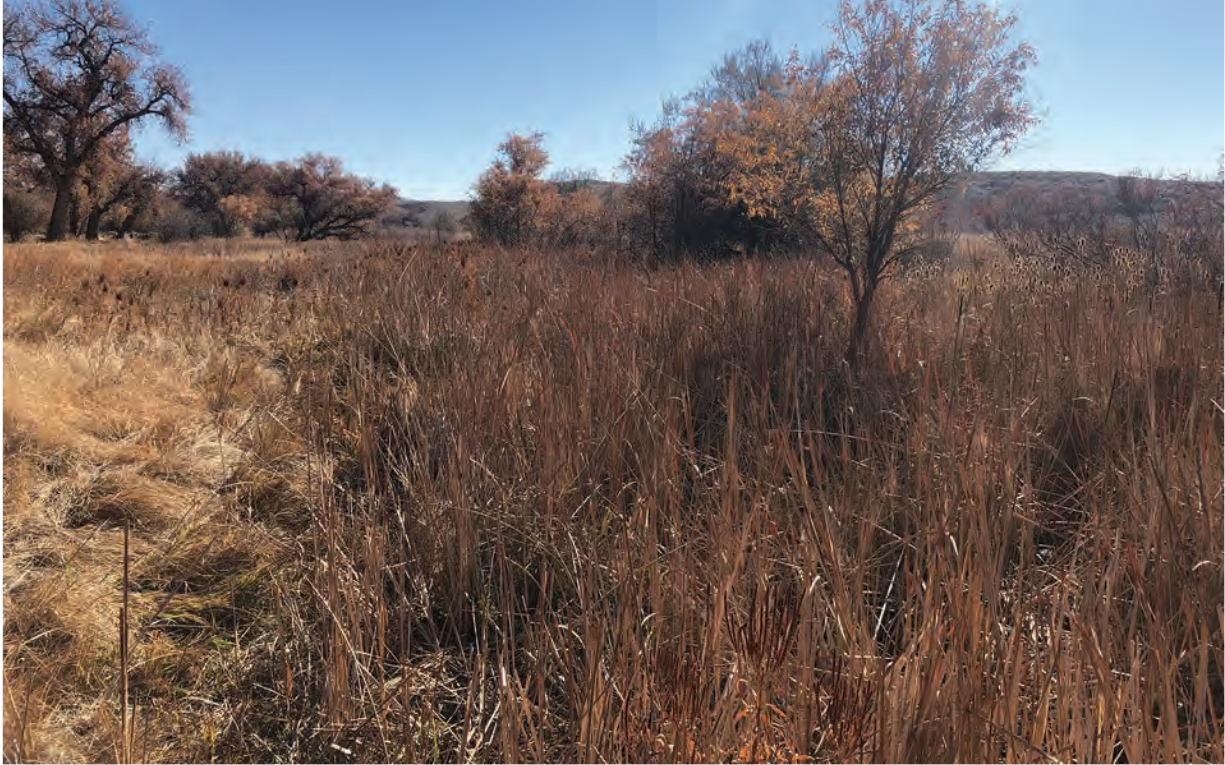
Photo 5 - Overview of the southern channel of Wetland E in the western portion of the project area.
View is to the southeast.

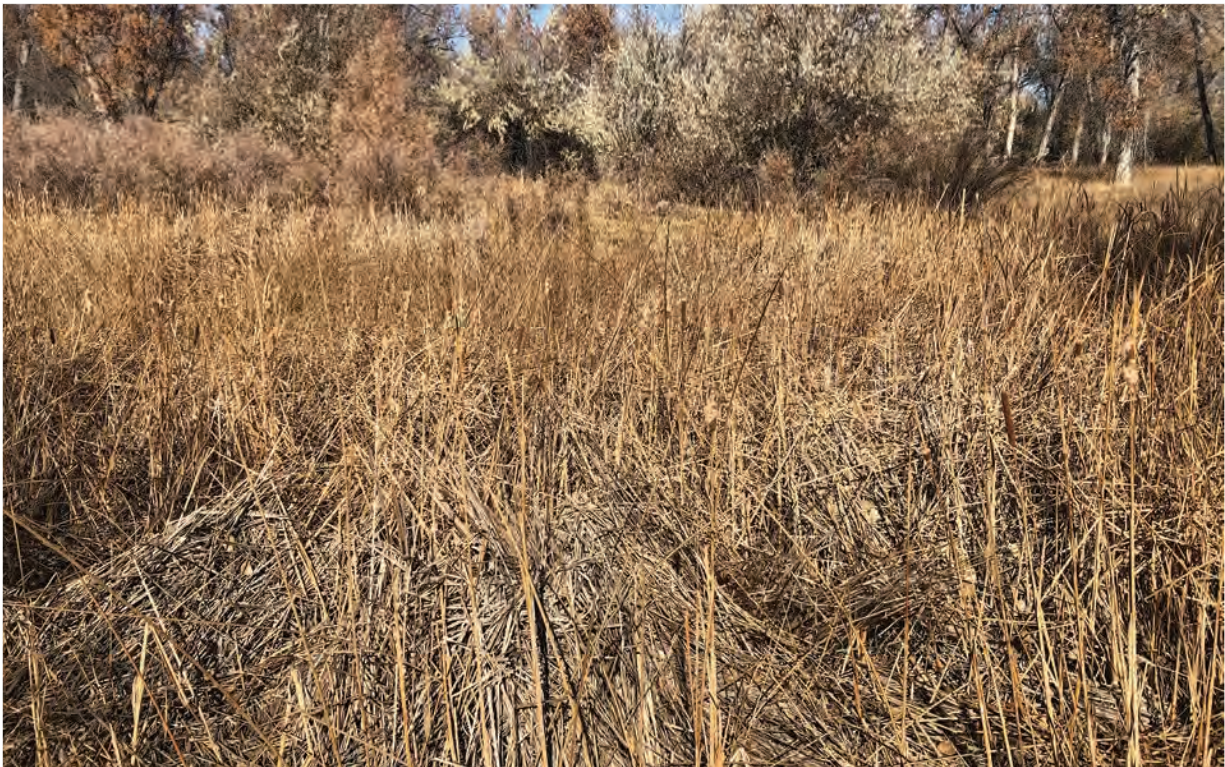
Photo 6 - Overview of the northwestern portion of Wetland F in the western portion of the project area.
View is to the northwest.

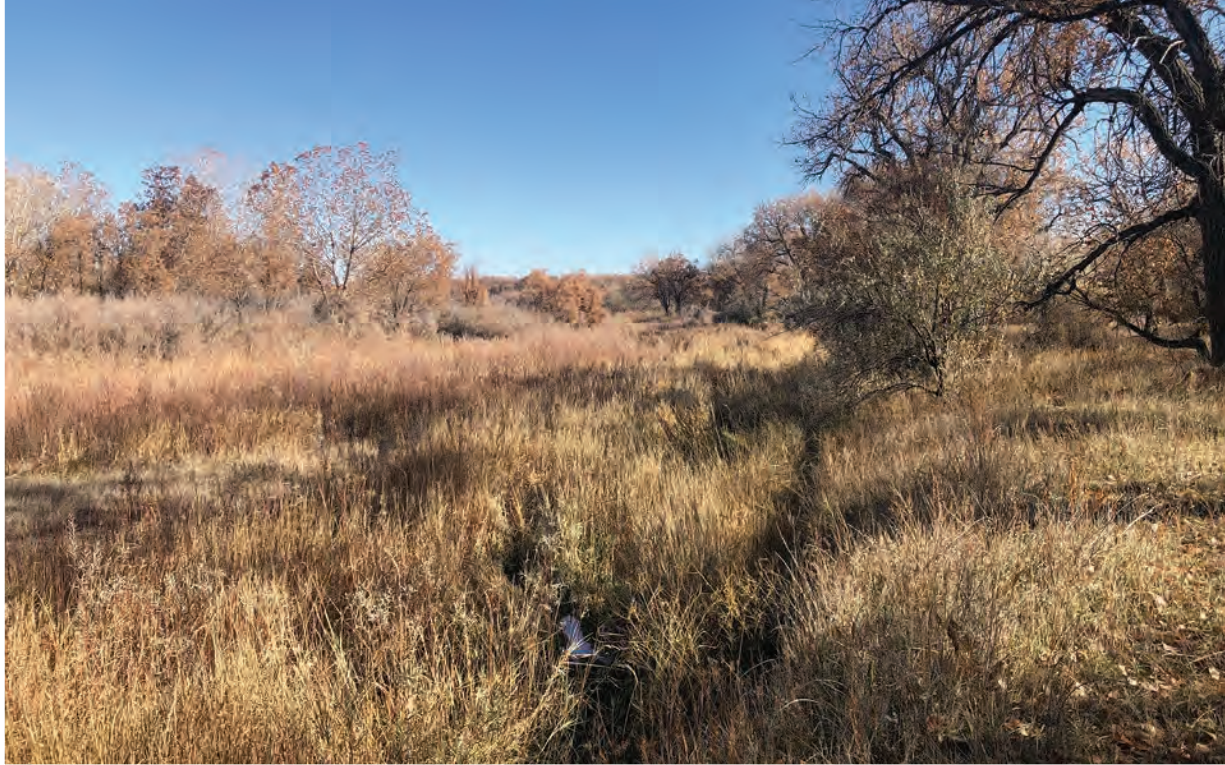
Photo 7 - Overview of the South Platte River side channel adjacent to the northern project area boundary. The channel appears to have dried up and is completely vegetated. View is to the east.

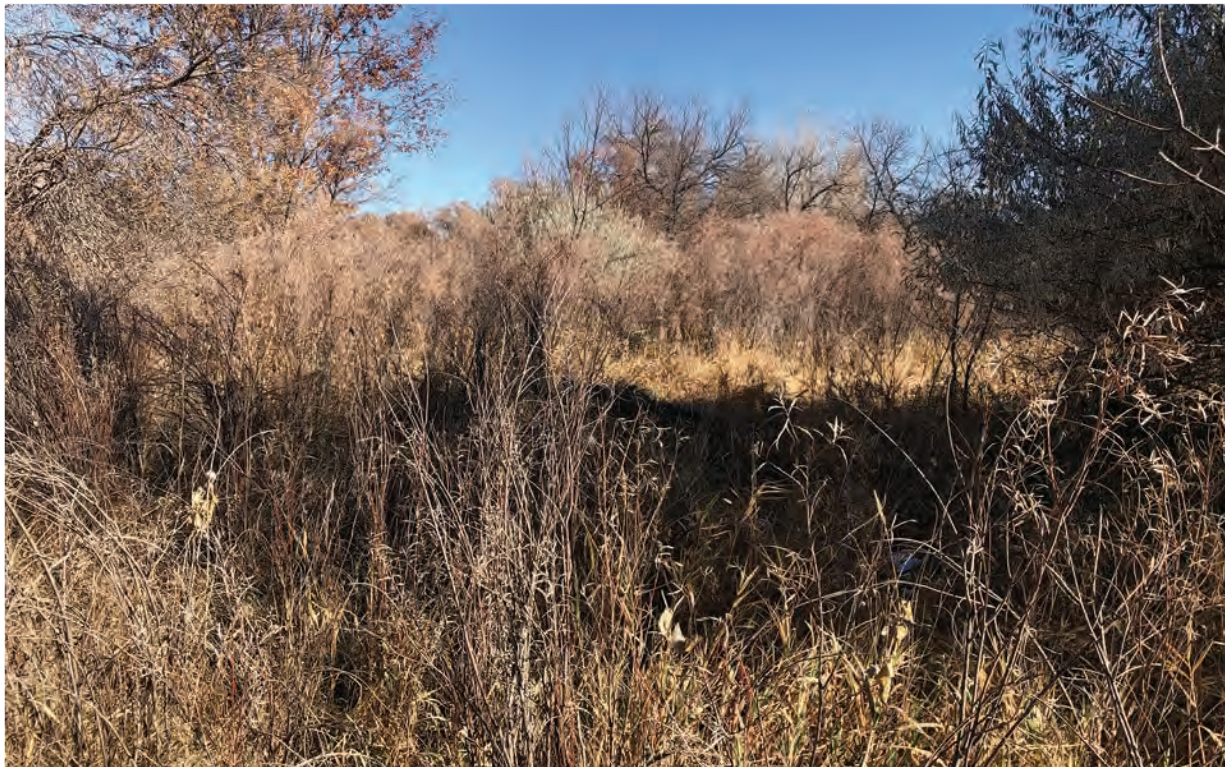
Photo 8 - Overview of the center portion of Wetland F in the center portion of the project area. View is to the northeast.

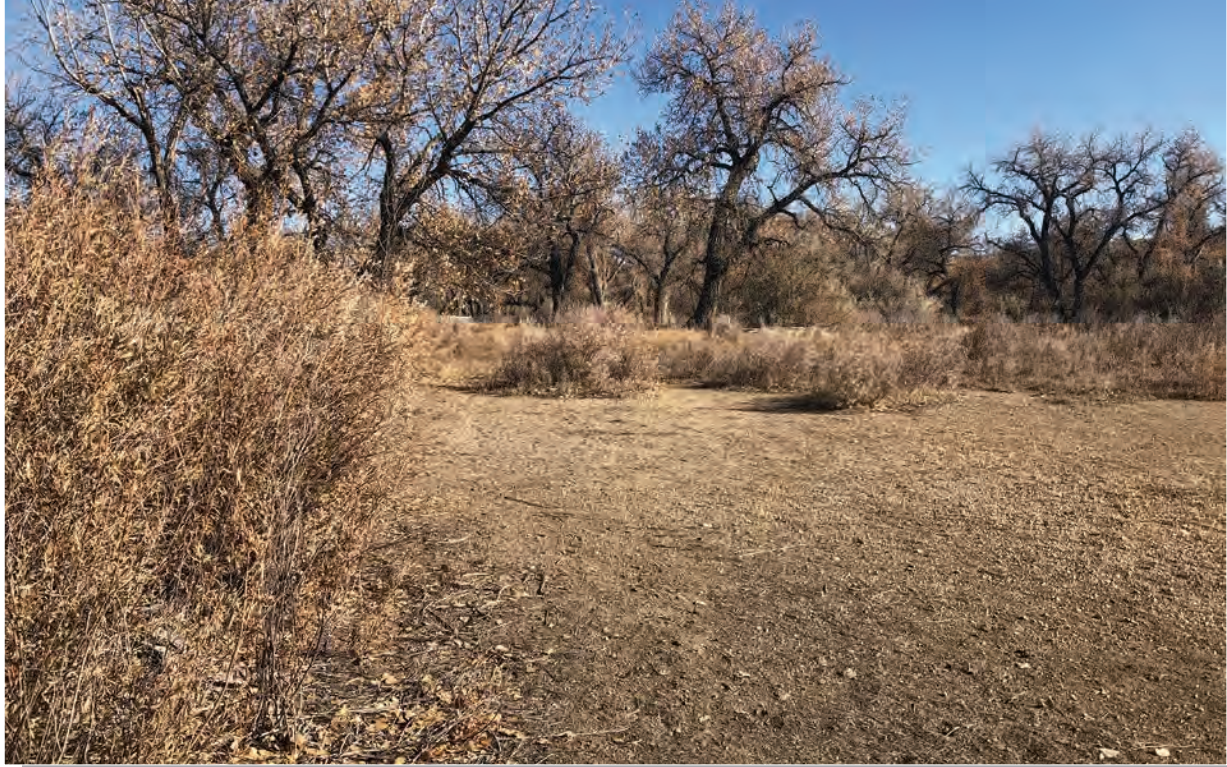
Photo 9 - Overview of upland area in the center portion of the project area. View is to the east.

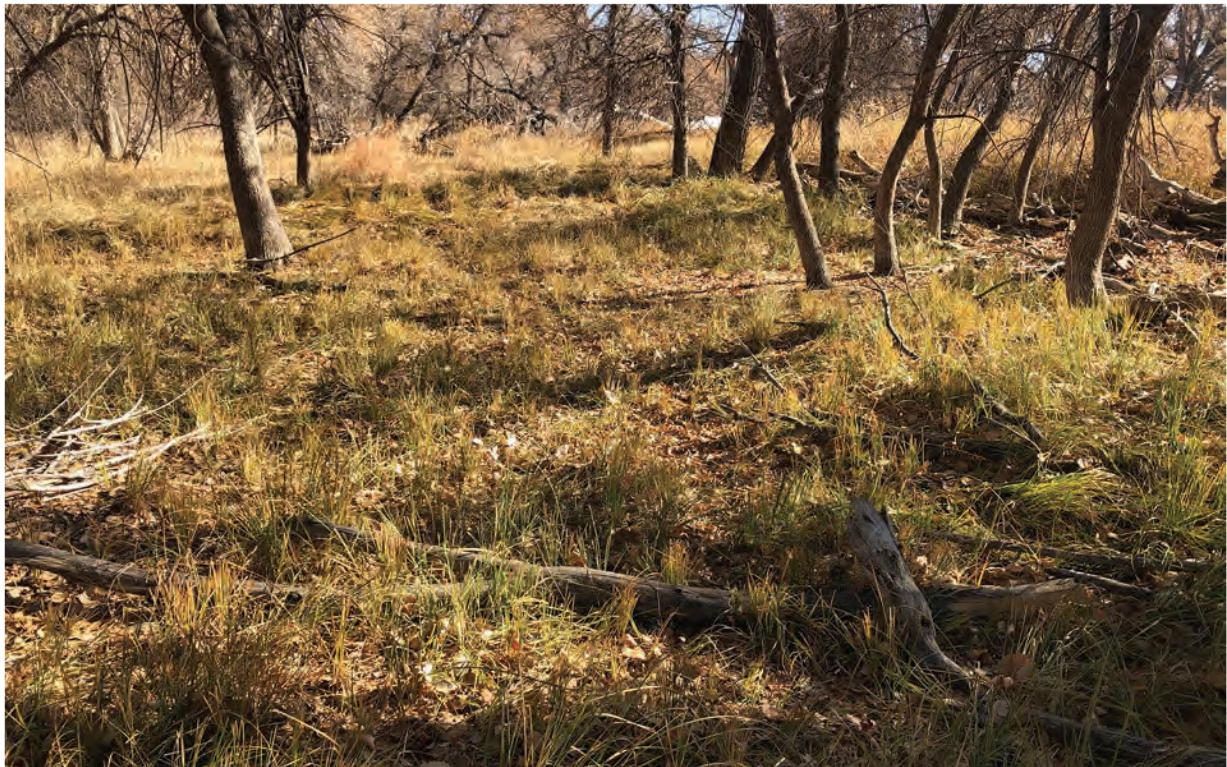
Photo 10 - Overview of Wetland G in the center portion of the project area. View is to the east.

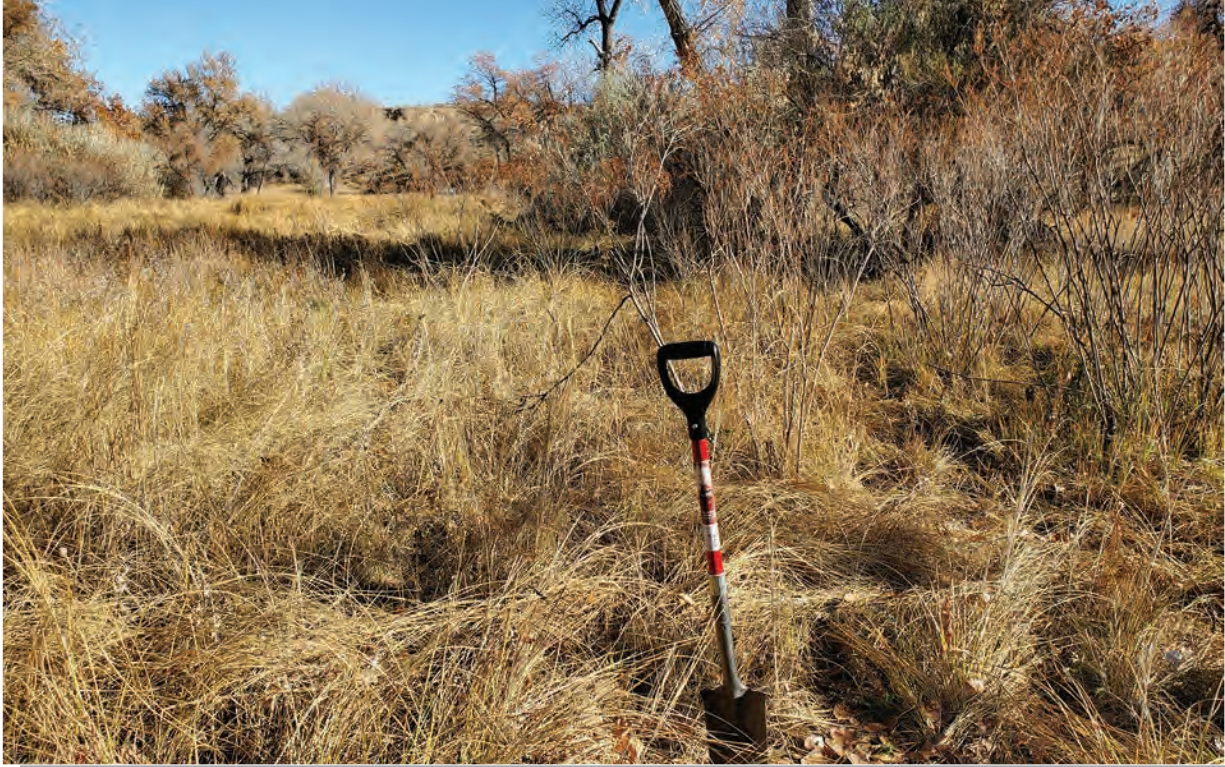
Photo 11 - Western portion of Wetland I in the south-central portion of the project area. View is to the east.

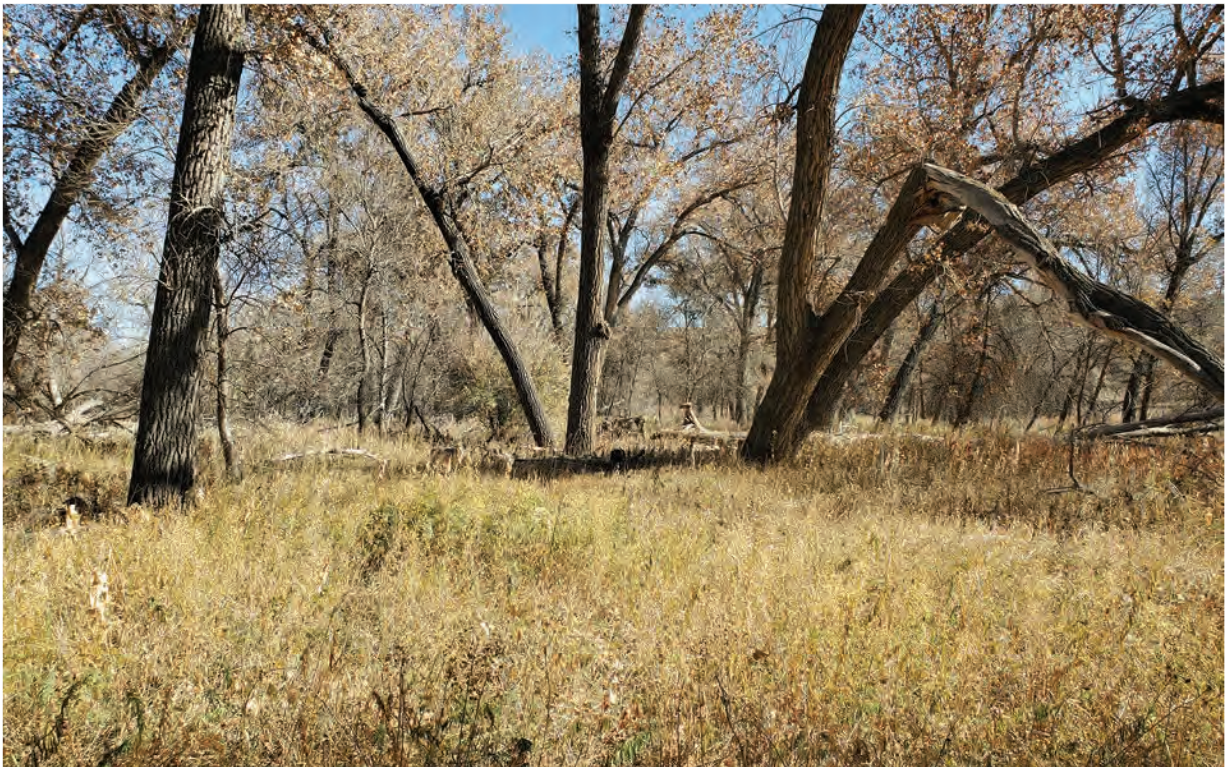
Photo 12 - Overview of upland woods in the eastern portion of the project area. View is to the east.

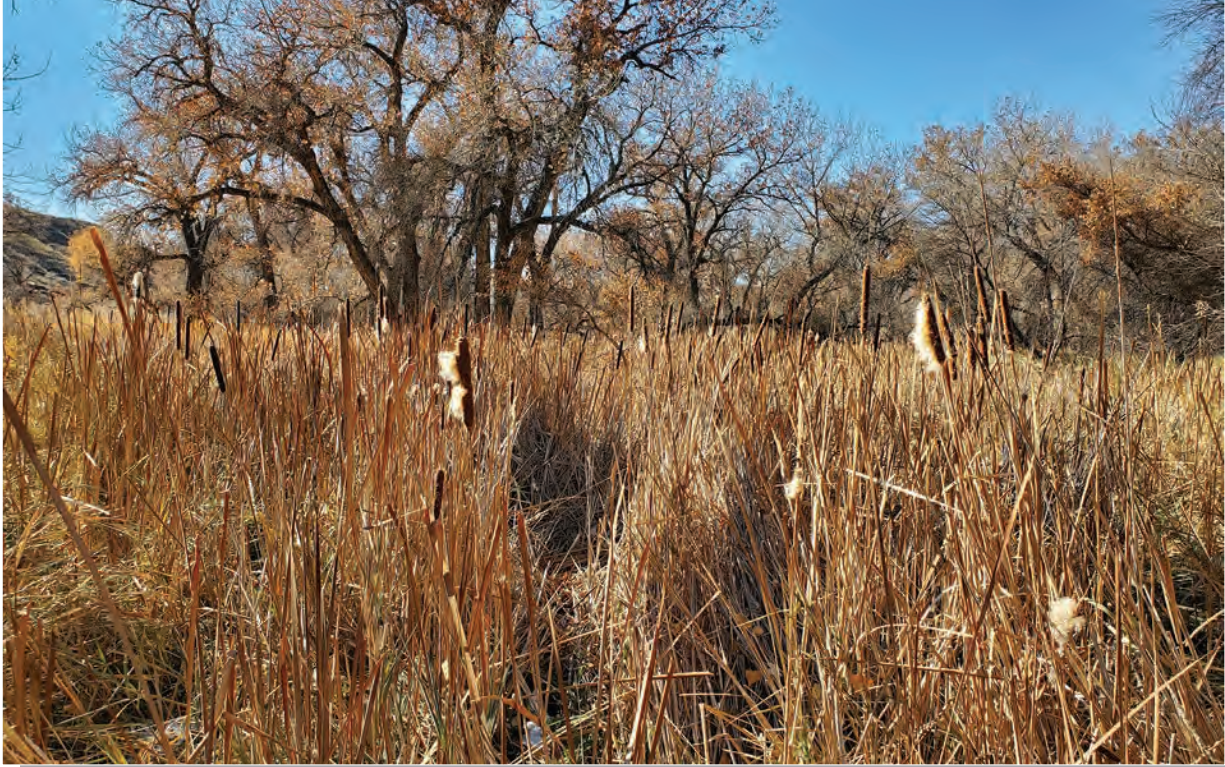
Photo 13 - Overview of the central portion of Wetland I in the eastern portion of the project area. View is to the west.

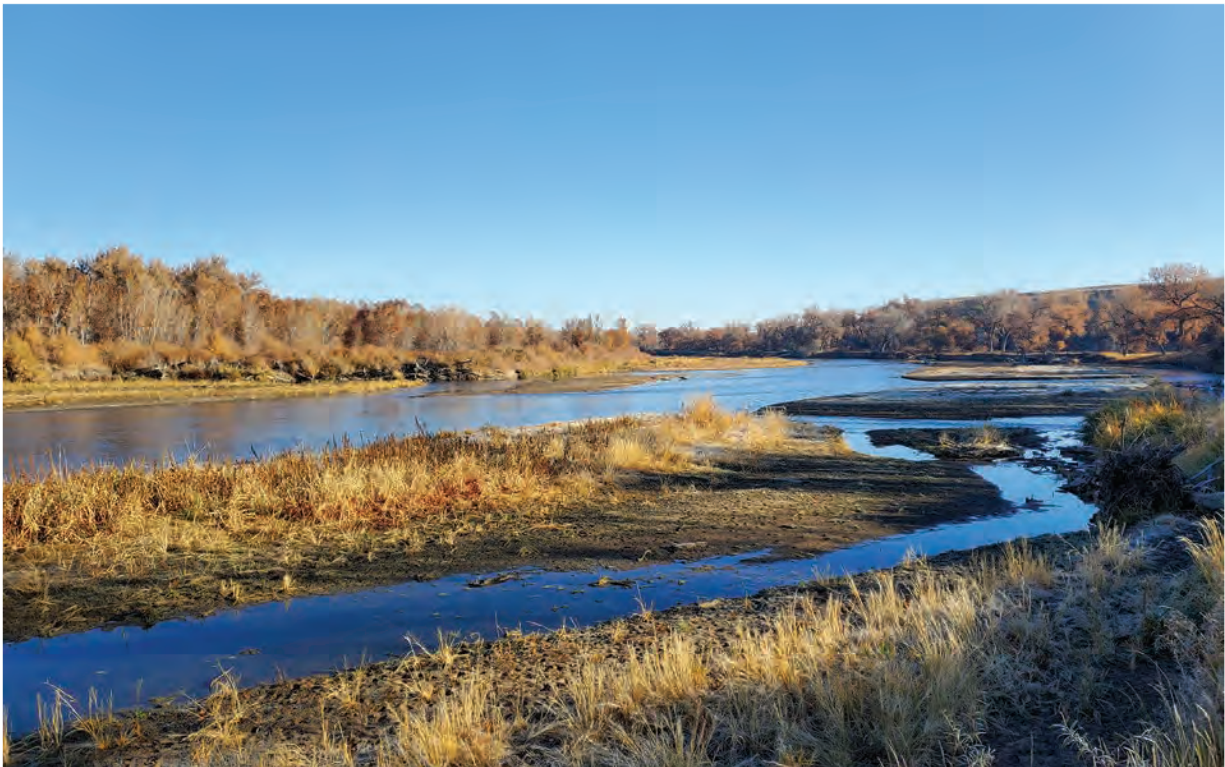
Photo 14 - Overview of the South Platte River. View is to the northeast.

Wetlands occur throughout the project area (Figure 2). The southwestern portion of the project area consists of emergent wetlands within upland grasslands that are dominated by prairie cordgrass (*Spartina pectinata*). The remaining (majority) of the project area consists of cottonwood forest within the South Platte River floodplain, with an overstory dominated by plains cottonwood (*Populus deltoides*) and green ash (*Fraxinus pennsylvanica*) trees and an understory dominated by prairie cordgrass and showy milkweed (*Asclepias speciosa*). Wetlands occur along the South Platte River and throughout the project area. The wetlands in the project area are generally dominated by prairie cordgrass, foxtail barley (*Hordeum jubatum*), Baltic rush (*Juncus balticus*), common threesquare (*Schoenoplectus pungens*), Emory's sedge (*Carex emoryi*), and reed canarygrass (*Phalaris arundinacea*), with areas of scrub-shrub wetland dominated by narrowleaf willow (*Salix exigua*), reed canarygrass, and narrowleaf cattail (*Typha angustifolia*) (Photos 1, 2, 3, 5-8, 10-11, 13, and 15). The wetlands are located within depressions or swales and appear to be fed by groundwater from and the flooding of the South Platte River (Photo 14).

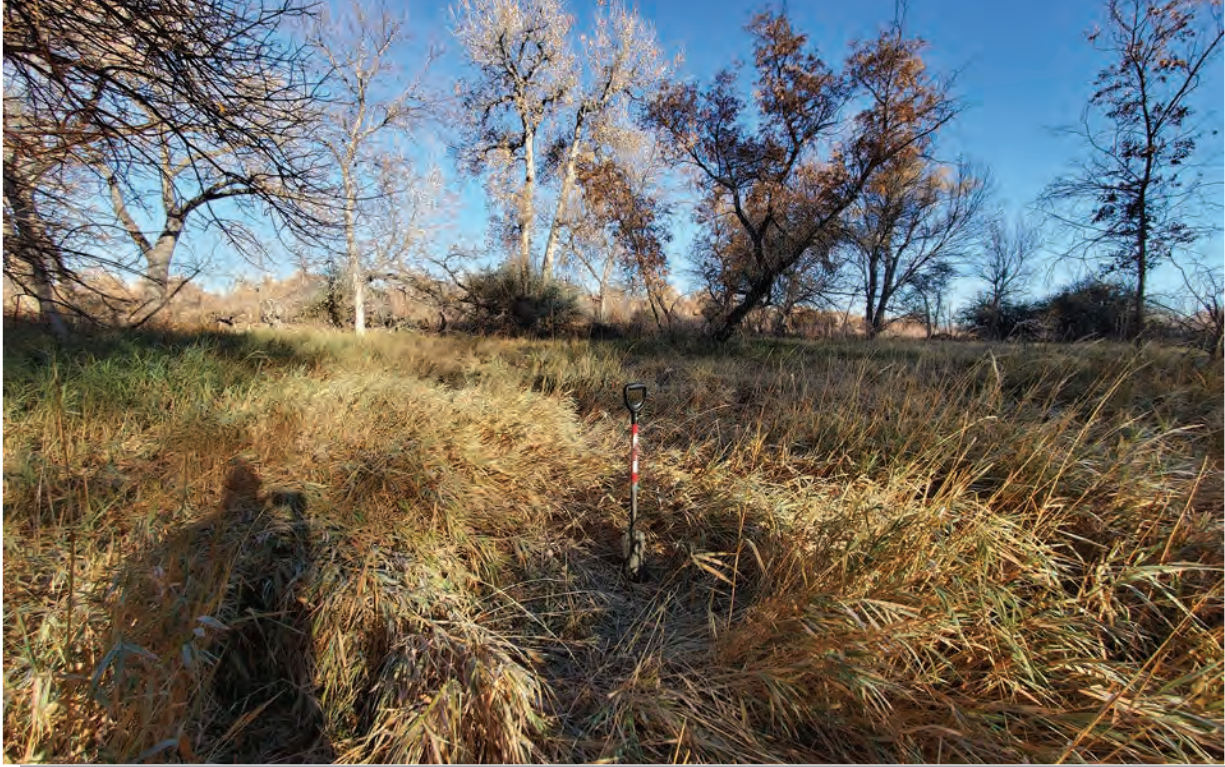
Photo 15 - Overview of the eastern portion of Wetland I in the eastern portion of the project area.
View is to the northeast.

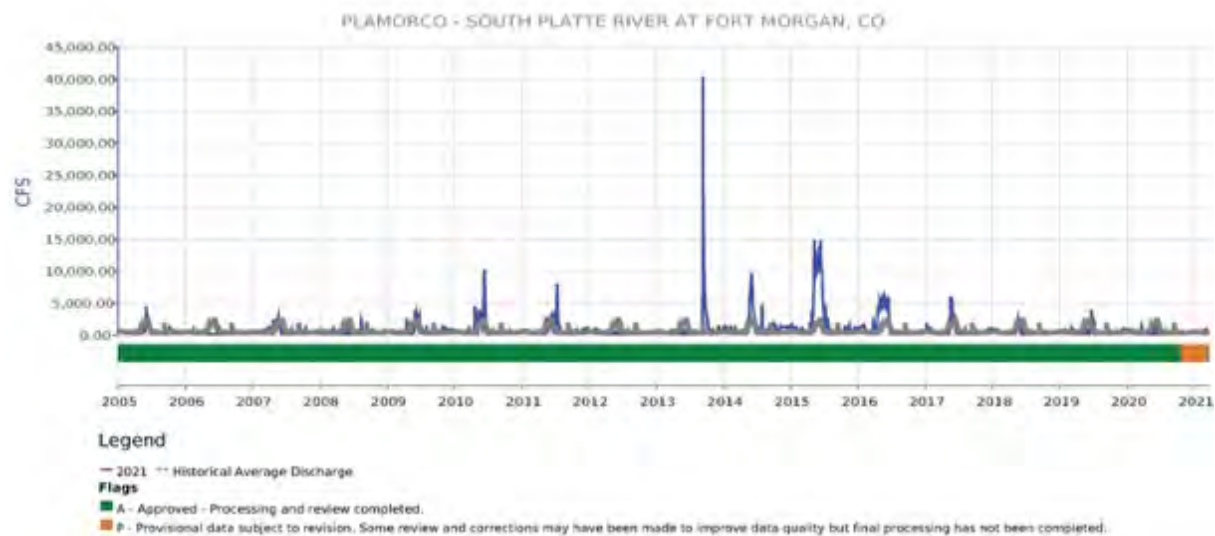
Figure 4: SOUTH PLATTE RIVER STREAM GAGE AT FORT MORGAN, CO 2005-2021 PEAK FLOWS

Figure 4 shows the peak Cubic Feet Per Second (CFS) water flows from the gage station on the South Platte at Fort Morgan from 2005-2021. As you can see the blue line peaks statistically high in 2013 and again in 2015 correlating to the flooding events in those years. This figure was created at:

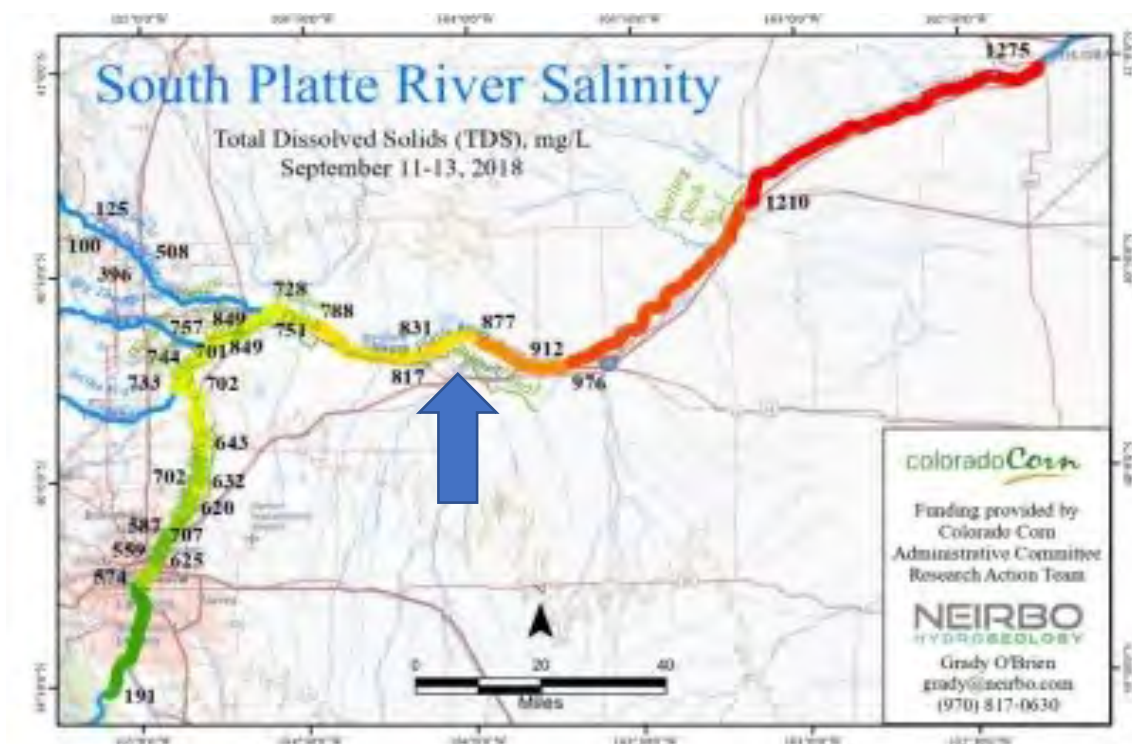
Figure 8: Salinity in the South Platte

Figure 8 showing salinity levels increasing along the South Platte River more and more as it flows east.

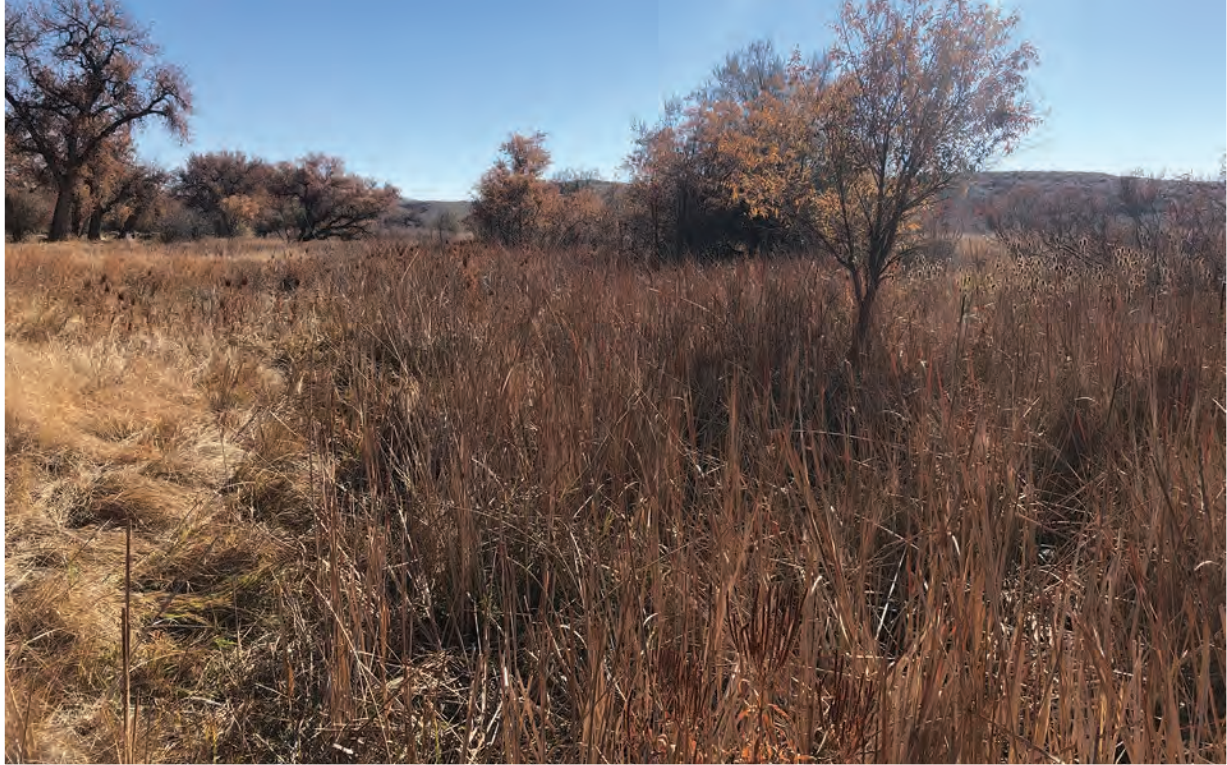
Photo 5 - Overview of the southern channel of Wetland E in the western portion of the project area.
View is to the southeast.

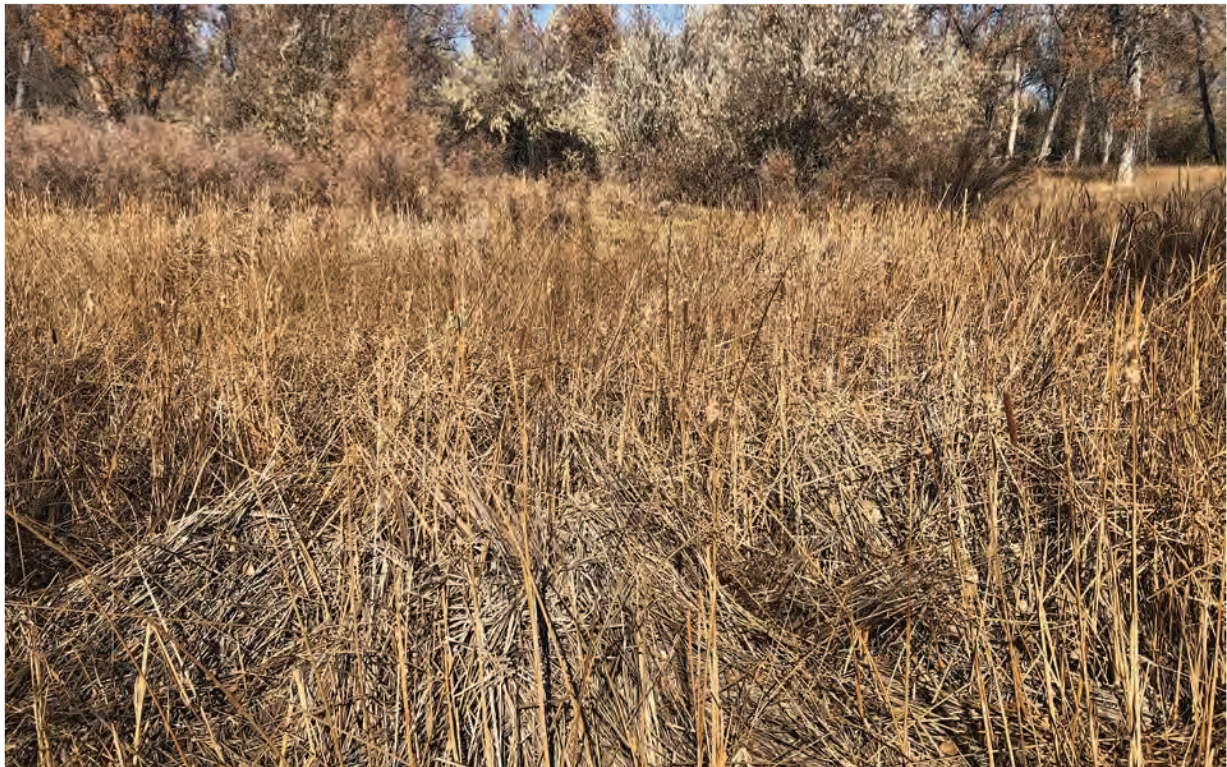
Photo 6 - Overview of the northwestern portion of Wetland F in the western portion of the project area.
View is to the northwest.

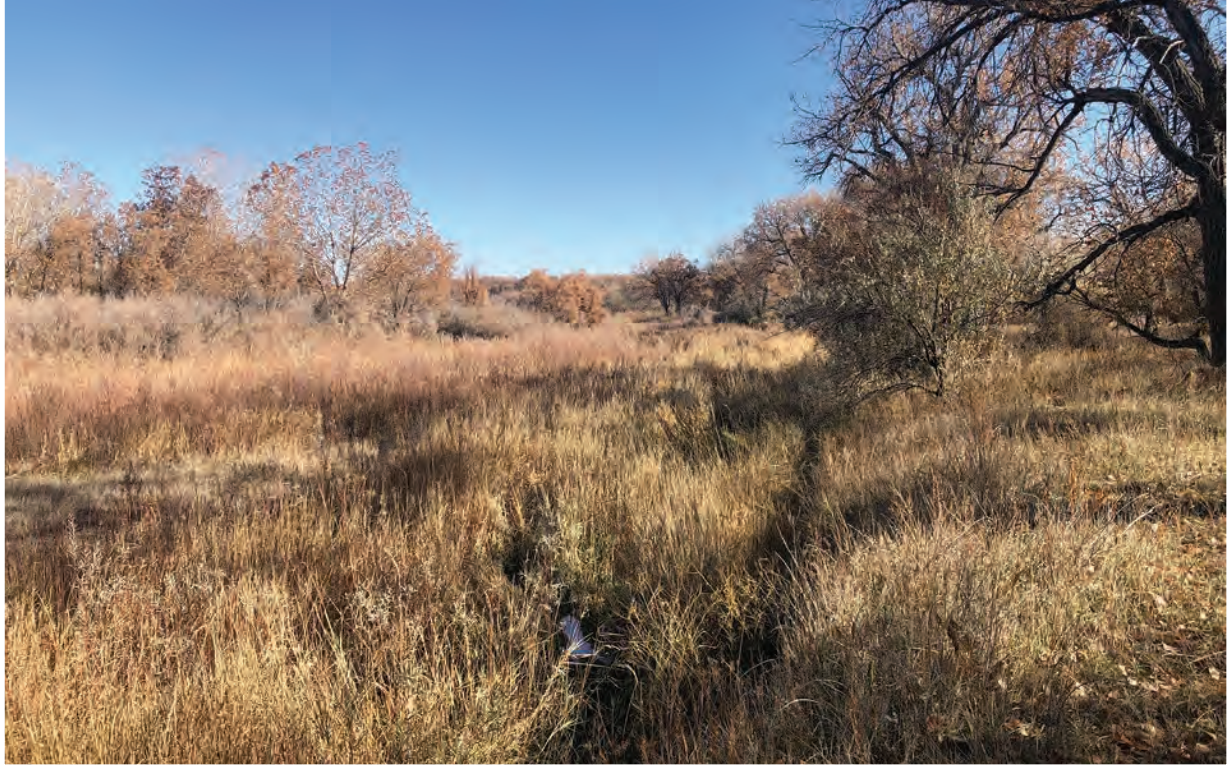
Photo 7 - Overview of the South Platte River side channel adjacent to the northern project area boundary. The channel appears to have dried up and is completely vegetated. View is to the east.

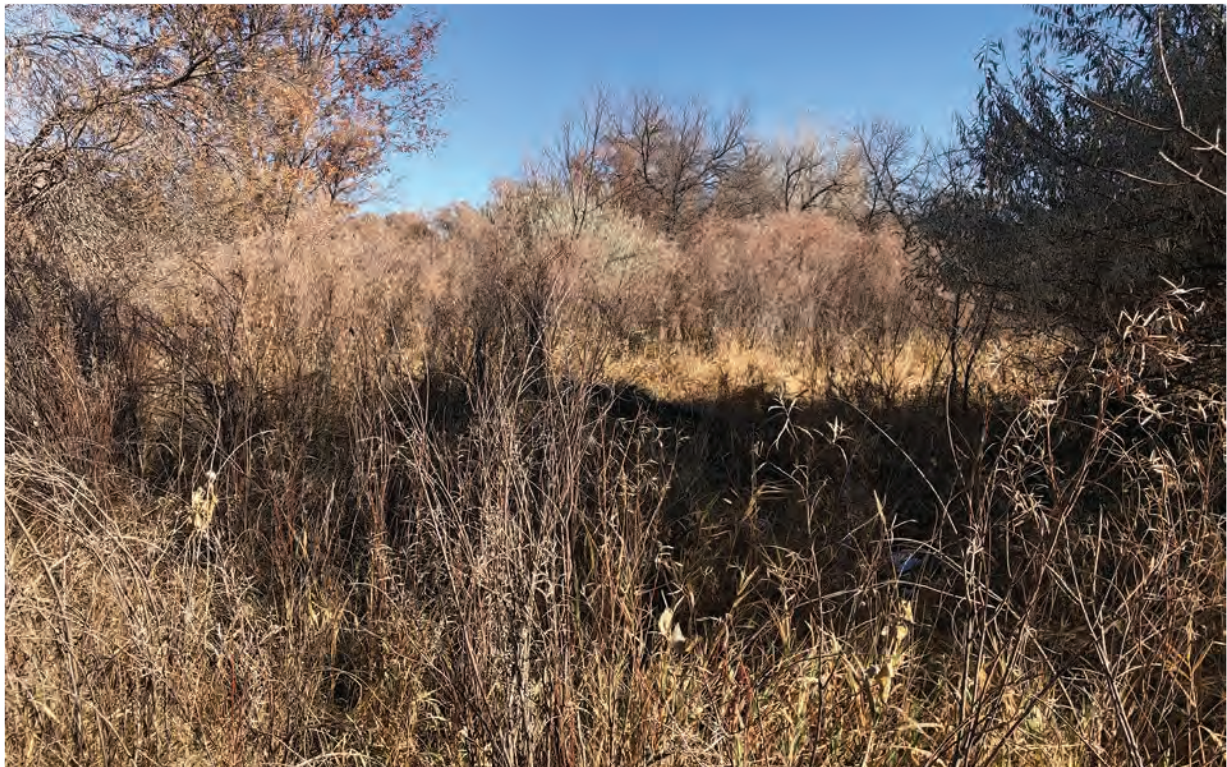
Photo 8 - Overview of the center portion of Wetland F in the center portion of the project area. View is to the northeast.

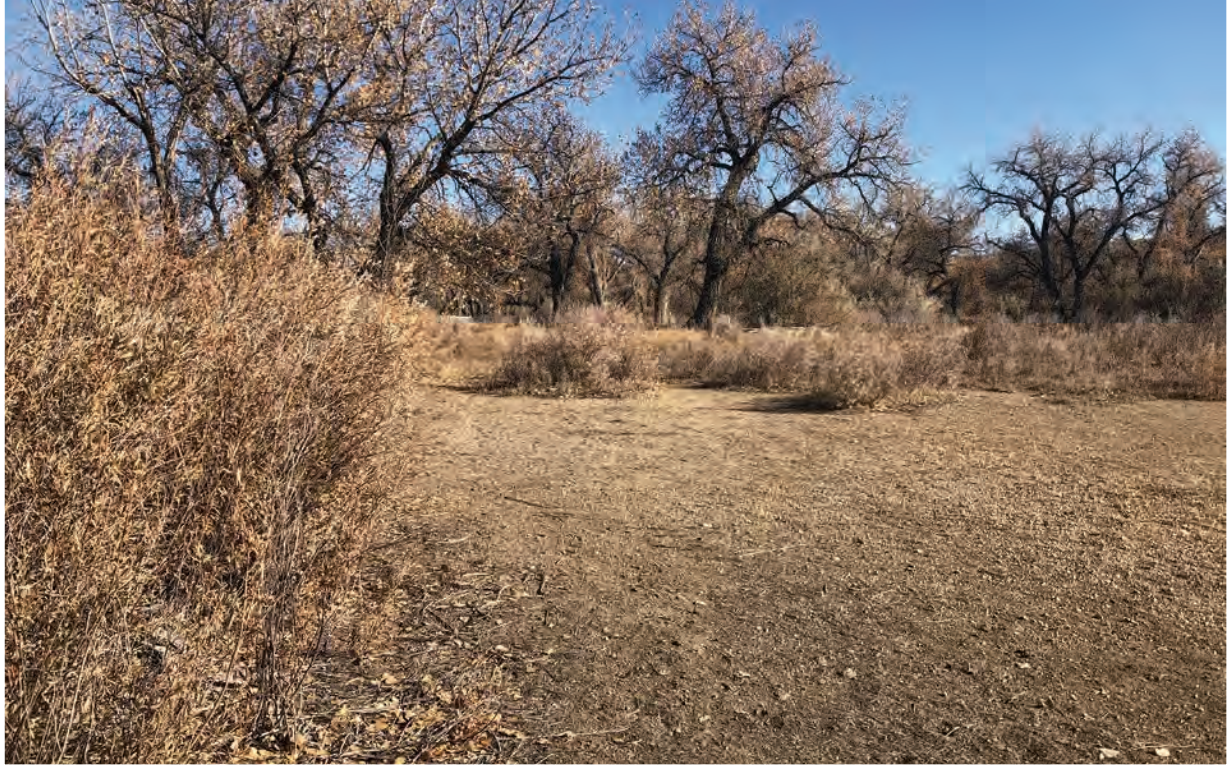
Photo 9 - Overview of upland area in the center portion of the project area. View is to the east.

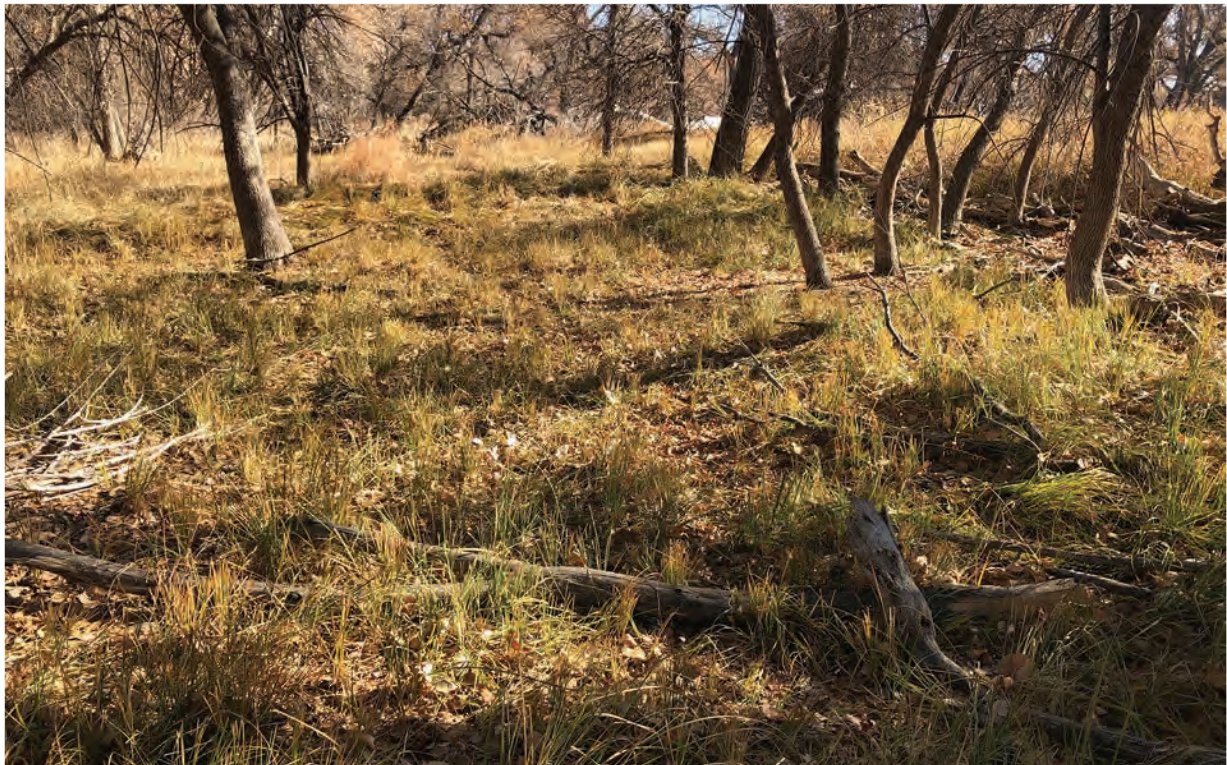
Photo 10 - Overview of Wetland G in the center portion of the project area. View is to the east.
