Re: Activities Being Conducted at the Yocam Borrow Pit, Permit No. M-2018-020

On November 14, 2024, the Division of Reclamation, Mining and Safety (Division/DRMS) performed a routine monitoring inspection of the Yocam Borrow Pit (M2018-020). During that inspection it was determined that Frontier Environmental Services was transporting material from a river restoration project to the Yocam permit area.

South Platte Mitigation Bank

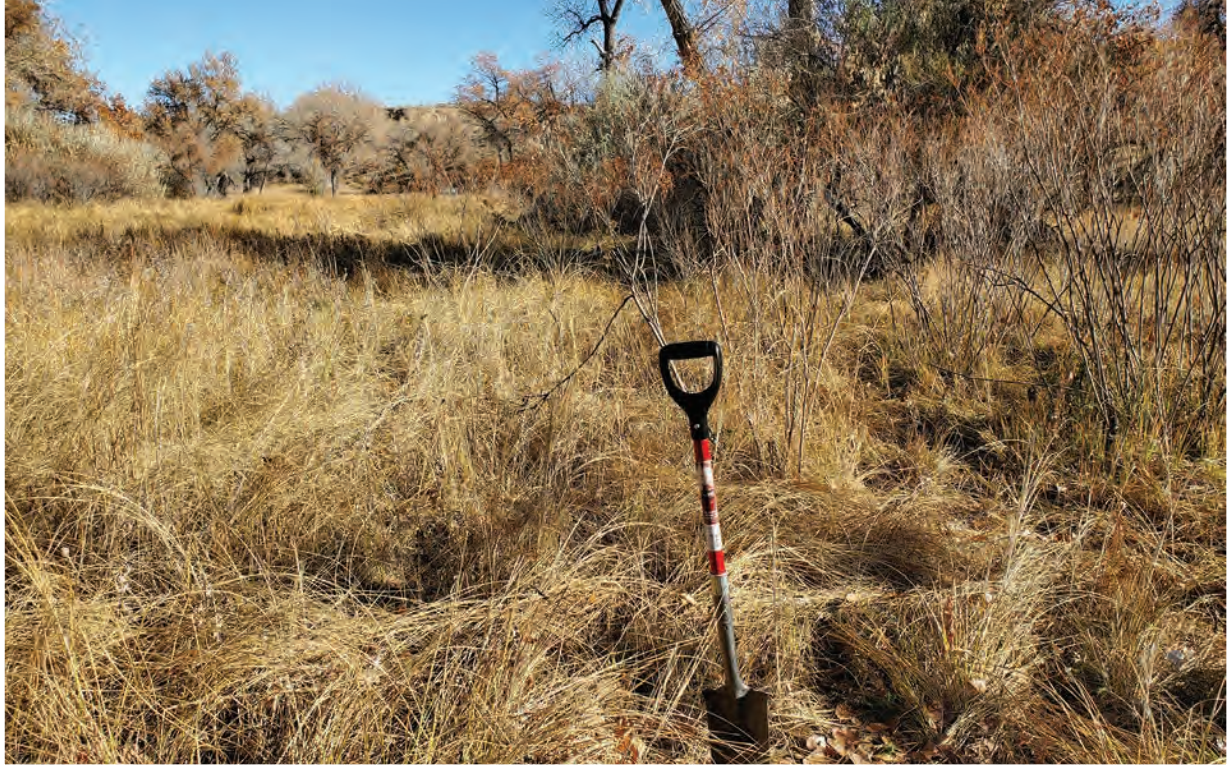
Photo 11 - Western portion of Wetland I in the south-central portion of the project area. View is to the east.

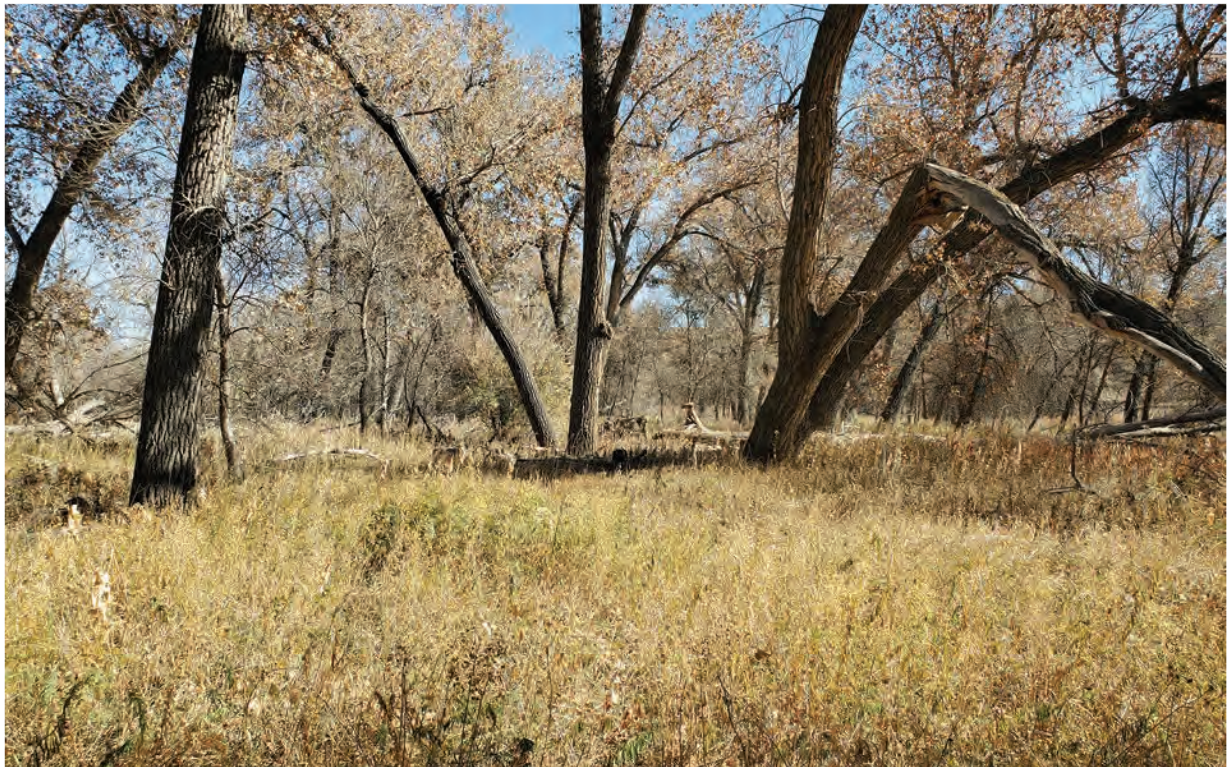
Photo 12 - Overview of upland woods in the eastern portion of the project area. View is to the east.

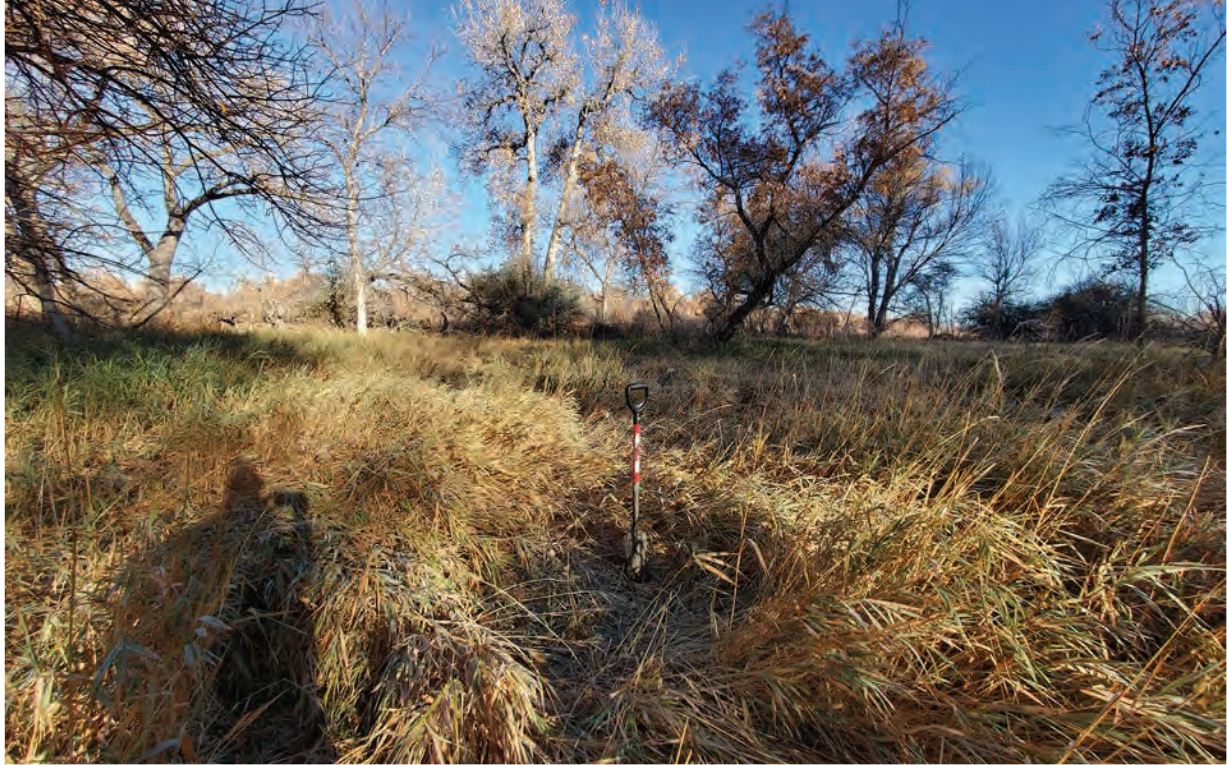
Photo 15 - Overview of the eastern portion of Wetland I in the eastern portion of the project area. View is to the northeast.

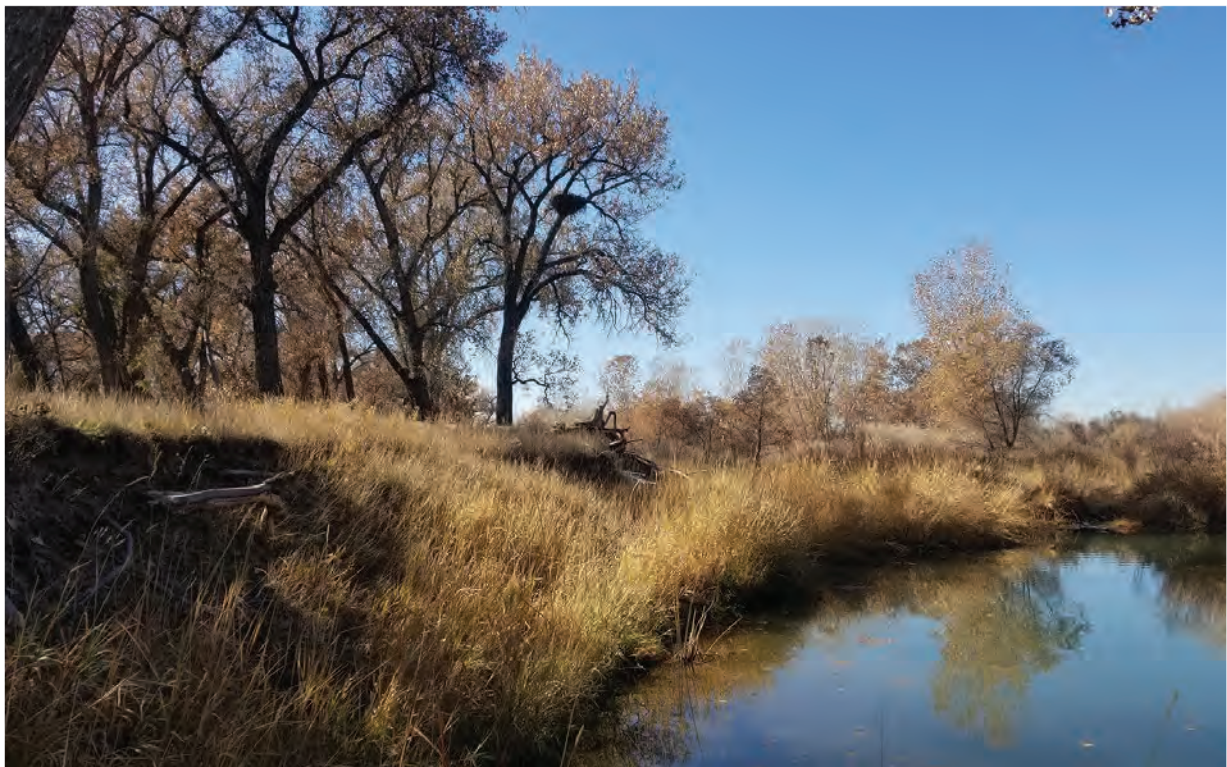
Photo 16 - Raptor stick nest. View is to the west.

In addition to species listed as threatened or endangered, ERO assessed the project area for potential habitat and the presence of species protected by the Migratory Bird Treaty Act (MBTA) and the Bald and Golden Eagle Protection Act (BGEPA). Migratory birds and eagles, as well as their eggs and active nests, are protected under the MBTA and BGEPA. Migratory bird nesting habitat typically includes trees and shrubs, but upland grasslands also are used. According to the Colorado Parks and Wildlife (CPW) Species Activity Mapping (CPW 2018, CPP 2020), the project area is located within a bald eagle nest buffer, roost site, winter concentration, summer forage, winter forage, and winter range. The project area provides suitable nesting and foraging habitat for migratory birds. A large inactive stick nest was observed in the northeast portion of the project area during the 2020 site visit (Photo 16;
