MINERALS PROGRAM INSPECTION REPORT

MINE NAME: Limon Pit	MINE/PROSPECTING ID#: M-2013-080	MINERAL: Sand and gravel	COUNTY: Lincoln
INSPECTION TYPE: Monitoring	WEATHER: Cloudy	INSP. DATE: December 6, 2024	INSP. TIME: 09:30
OPERATOR: Pine Bluffs Gravel & Excavating, Inc.	OPERATOR REPRESENTATIVE:	TYPE OF OPERATION: 112c - Construction Regular Operation

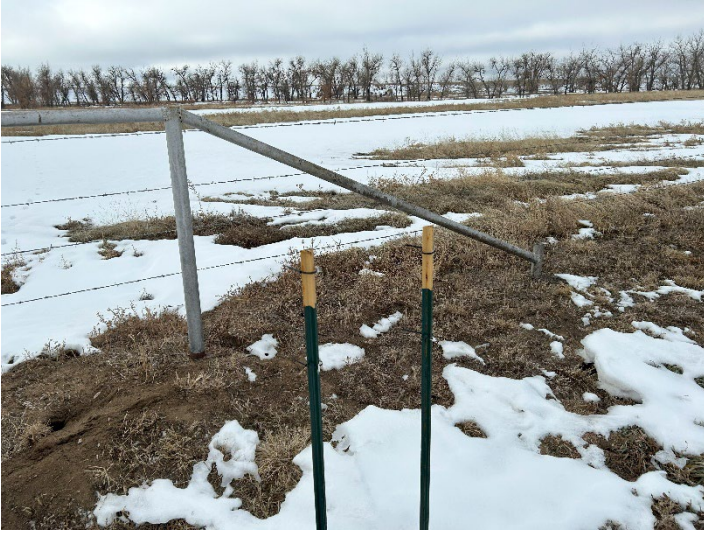
PROBLEM/POSSIBLE VIOLATION: Problem: The mine identification sign was not posted at the entrance of the mine site. This is a problem for failure to post a mine identification sign as required by Section 3.1.12(1) of the Construction Materials Rules.

Photo 1: Missing site identification sign.

CORRECTIVE ACTIONS: The operator shall, at the entrance of the mine site, post a sign which shall be clearly visible from the access road with the following: the name of the operator, a statement that a reclamation permit for the operation has been issued by the Colorado Mined Land Reclamation Board; and the permit number. The operator shall submit photo documentation that a proper sign has been posted by the corrective action date of March 8, 2025.

As mentioned, the site identification sign was not posted at the mine entrance. This is cited as a problem in this report, and the posted sign will need to follow Rule 3.1.12. Please submit proof of the postage of the new identification sign prior to the corrective action date.

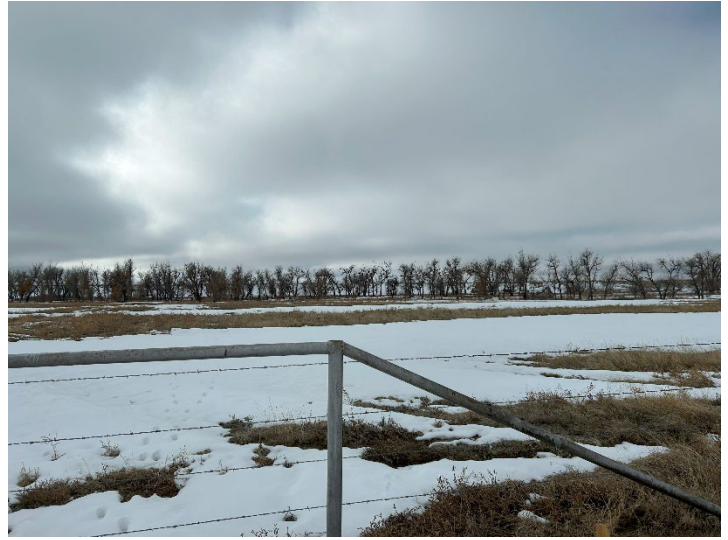
The operator has stated that no mining has taken place at this site, and as of this inspection the site appears to be untouched and in good condition.

Photo 2: Unimpacted site seen from an adjacent county road.
