MINERALS PROGRAM INSPECTION REPORT

MINE NAME: Hoffman Pit	MINE/PROSPECTING ID#: M-2005-044	MINERAL: Sand and gravel	COUNTY: Lincoln
INSPECTION TYPE: Monitoring	WEATHER: Cloudy	INSP. DATE: January 23, 2025	INSP. TIME: 12:00
OPERATOR: Lincoln County	OPERATOR REPRESENTATIVE:	TYPE OF OPERATION: 112c - Construction Regular Operation

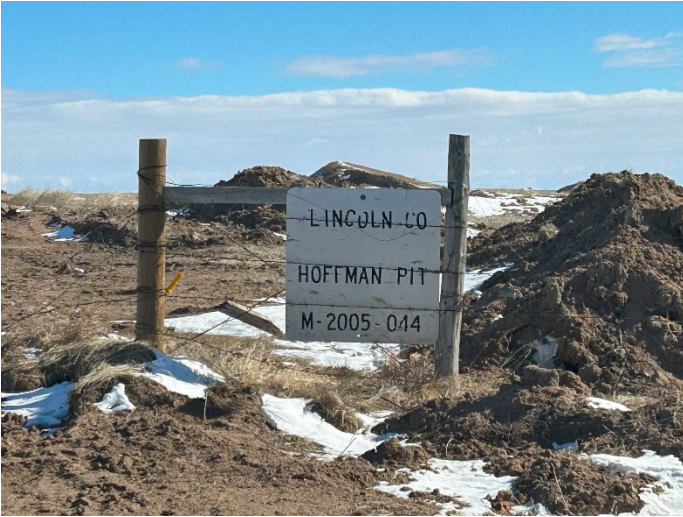
No signs of significant impacts to the prevailing hydrologic balance were visible at the time of inspection. No noxious weeds were visible during the inspection and the DRMS mine sign was clearly posted at the entrance to the site.

Photo 1: Posted mine identification sign.

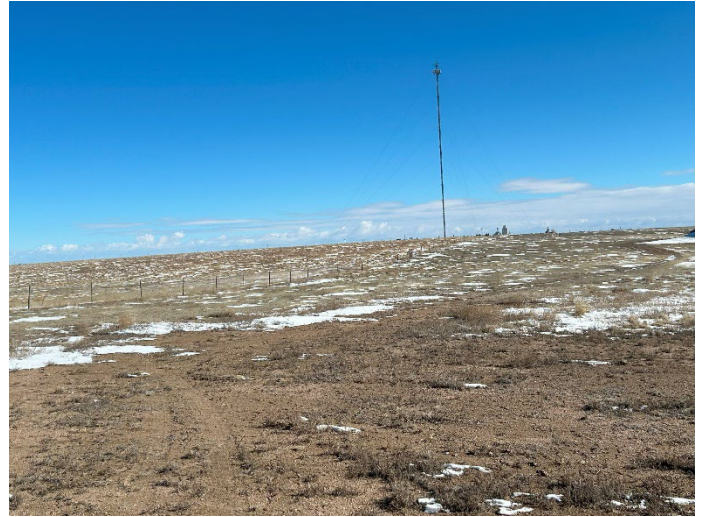
Photo 2: Northern site boundary.

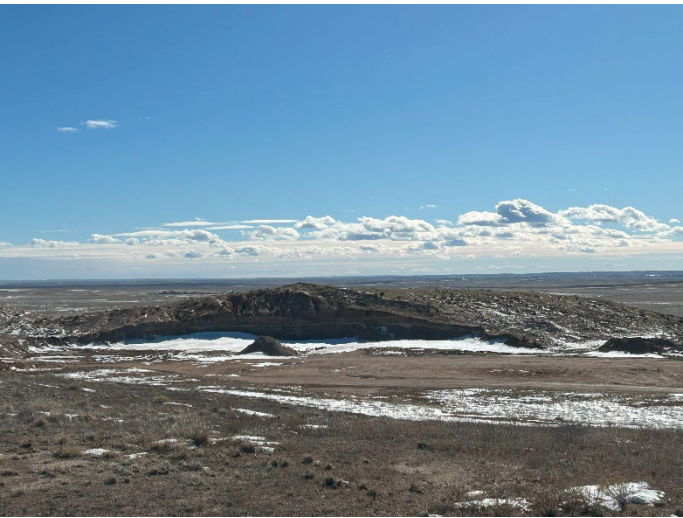
The site had evidence of recent material extraction, with an active highwall located on the south and east sides of the site. The eastern and southern boundary markers were unable to be located at the time of inspection. Please provide photographic evidence of the mentioned boundary markers by the corrective action due date. No signs of excessive erosion were present within the pit, however the northern topsoil stockpile showed signs of erosional damage due to lack of adequate stabilization. Please reseed and repair the stated topsoil stockpile by the included corrective action due date and provide photographic evidence to the Division.

Photo 3: Active highwall with camera facing south.

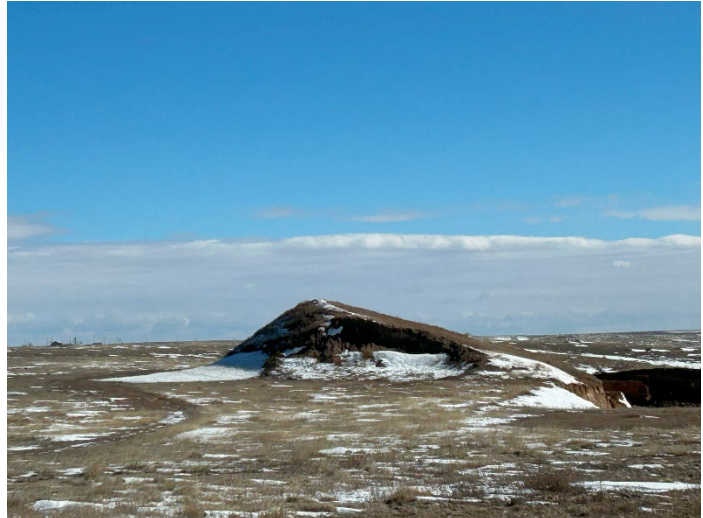
PROBLEM/POSSIBLE VIOLATION: Problem: The topsoil stockpiles do not have adequate established vegetation on them and are therefore susceptible to erosion. Rule 3.1.9(1) states if topsoil is not replaced into the backfill area within a time short enough to avoid deterioration of the topsoil, vegetative cover or other means shall be employed so that the topsoil is protected from erosion.

Photo 4: Topsoil pile with eroded section.

CORRECTIVE ACTIONS: The operator shall seed the stockpiles with the seed mix that was submitted as part of the approved Reclamation Plan. The Operator shall demonstrate compliance by providing photographic evidence of the reseeded and stable topsoil pile by the resolution due date.

CORRECTIVE ACTION DUE DATE: 4/28/25
