To: Jerald Schnabel
Castle Aggregate
File: Fourth Quarter 2024 Monitoring
Summary

Reference: Fourth Quarter 2024 Geotechnical Monitoring Summary Pikeview Quarry

Client/Project
CASTLE AGGREGATE
PIKEVIEW QUARRY SLOPE
MONITORING

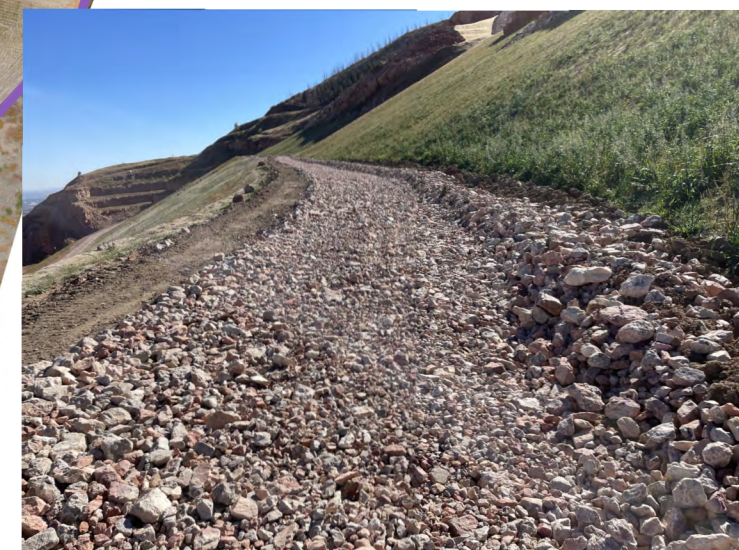
Figure No.
3

Visual inspections of the Pikeview Quarry did not reveal any evidence of large-scale instability outside of the landslide areas previously identified. No cracking, bulging, rippling, over-steepening, depressions, slumps, or dry slip-offs were observed in areas that have been graded and/or reclaimed.

1. NO CRACKS OBSERVED IN THIS AREA.
2. NO NEW CRACKS OBSERVED IN THIS AREA.
3. PHOTOS TAKEN OCTOBER 23, 2024.
4. AERIAL IMAGE FROM SEPTEMBER 30, 2024.

OBSERVATIONS FROM
OCTOBER INSPECTION
