Job Number: 99-3983

Subject: Quarterly Observation Report,  
Refuse Pile, Foidel Creek Mine, Routt  
County, Colorado.

<b>Project:</b>	Refuse Pile	<b>Project No.:</b>	99-3983	<b>Date:</b>	12/31/24
<b>Location:</b>	Foidel Creek Mine	<b>Report No.:</b>	114	<b>Time:</b>	2.5
<b>Client:</b>	Twentymile Coal Co.			<b>Mileage:</b>	45
				<b>Engr. /Tech:</b>	TT

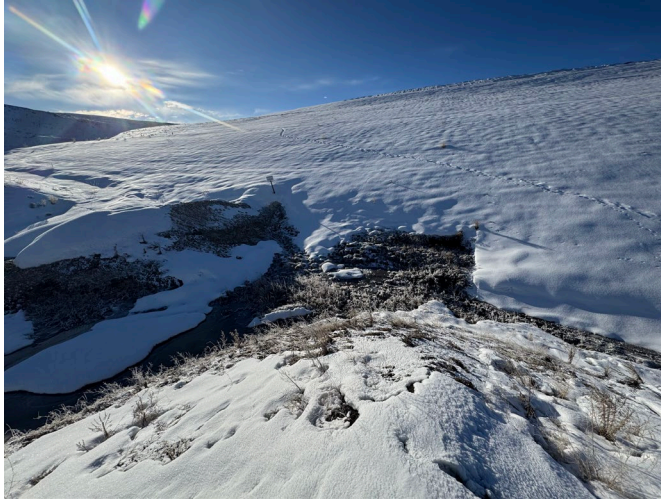
A seepage area at the toe of the northeast end of the refuse pile expansion area, approximately 30 feet northwest of the outlet of the underdrain, developed in fall 2014. At the time of our observations, the seepage was surfacing at the toe of the slope and flowing into the drainage from the undrain outlet then into the existing pond east of the Refuse Pile Expansion Area. The discharge was clear, with no evidence of sediment. No signs of washout, slumps or slope instability were observed at this time. The seepage area will be monitored during future inspections and noted in our inspection reports. Photographs of the seepage area taken at the time of our inspection on December 31, 2024 are attached.

December 31, 2024-Drain Outlet and Seepage Area

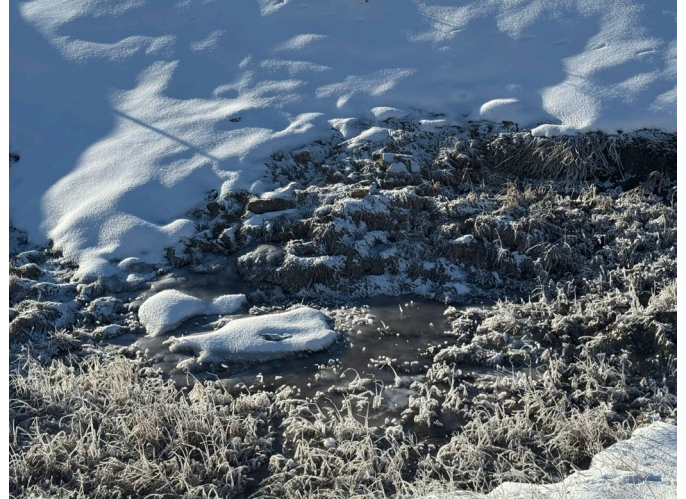
December 31, 2024-Seepage Area

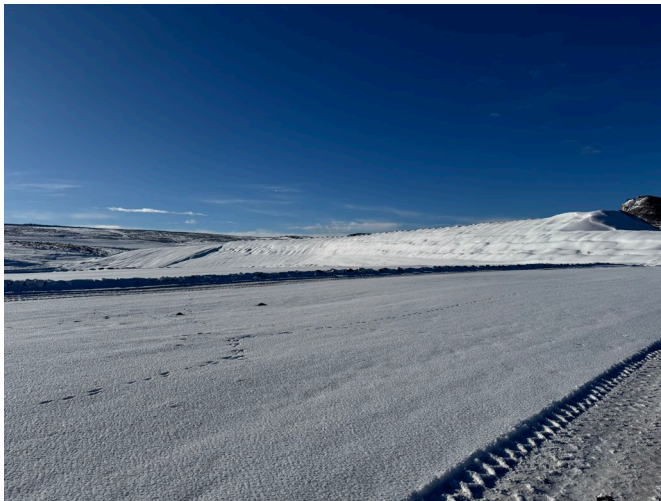
December 31, 2024- Areas 2, 3 and 4 from Expansion Area

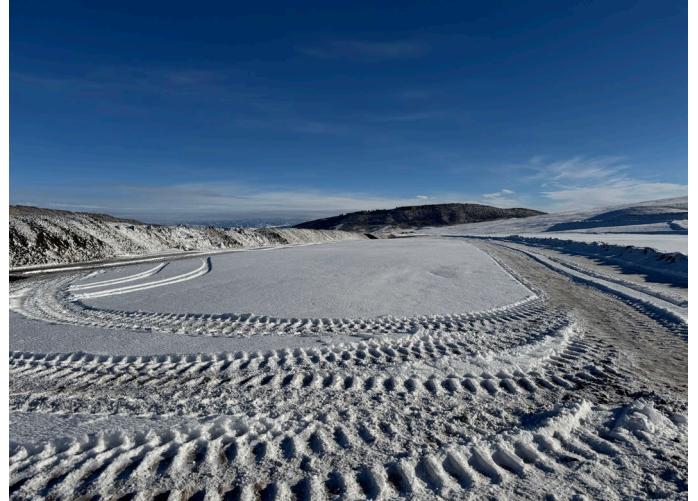
At the time of our site visit on December 31, 2024, NWCC completed a site inspection of the existing refuse pile. Based on our observations made during this visit, it appeared that the contractor was presently stockpiling, grading and compacting refuse coal in the new Expansion Area. At the time of our site visit, the refuse coal had been placed and compacted to an elevation above the third bench situated along the east side of the stockpile.

December 31, 2024- Expansion Area

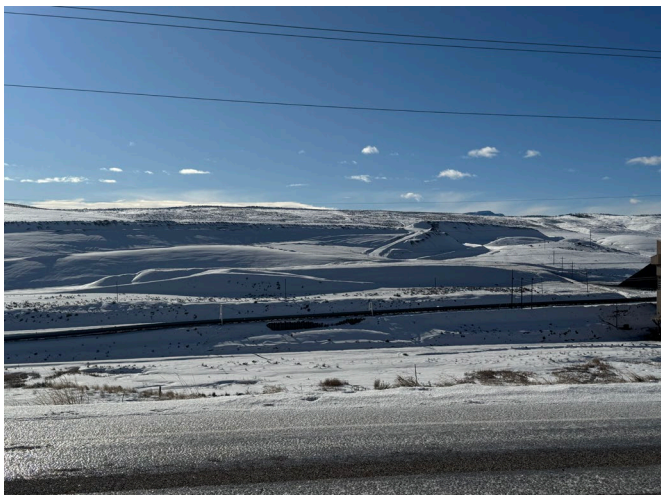
The internal roadways in the new expansion area of the pile are in good condition. The upper haul road to Areas 2, 3 and 4 of the refuse pile was not accessible due to snow cover.

December 31, 2024- Road to Area 2, 3 and 4

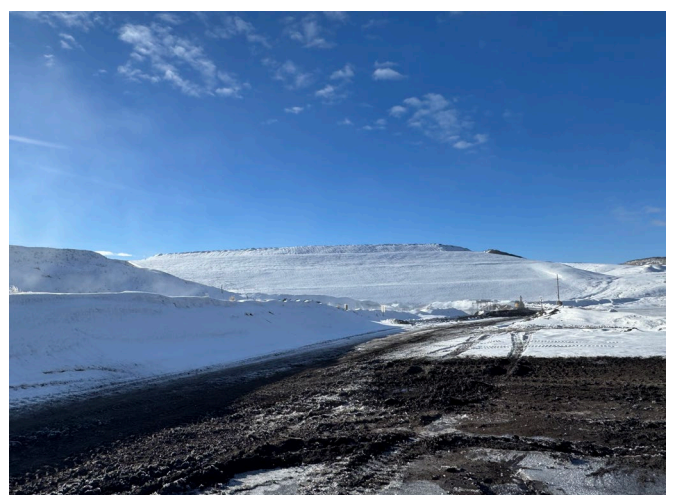
December 31, 2024- East End of Expansion Area
