Seifert Construction, Seifert Pit Reclamation Status

Minerals 3600 Mine and Reclamation Inspection
U.S. Department of the Interior
Bureau of Land Management
Royal Gorge Field Office

Date: February 26, 2025 Time: 14:45 Weather: Sunny	Operation Name: Seifert Pit Case Number: COC66333 CDRMS #: M-1985-040
<u>Attendees</u> BLM: A. Pike (images taken by BLM geologist) Operator(s): Not present Other(s): None	<u>General</u> Operation(s) are in compliance with documentation on file <input type="checkbox"/> Yes <input type="checkbox"/> No <input checked="" type="checkbox"/> N/A Operation(s) and disturbance on-site coincide with the operations and access on file <input type="checkbox"/> Yes <input type="checkbox"/> No <input checked="" type="checkbox"/> N/A Current scale certification on file <input type="checkbox"/> Yes <input type="checkbox"/> No <input checked="" type="checkbox"/> N/A Annual copies of scale tickets on file <input type="checkbox"/> Yes <input type="checkbox"/> No <input checked="" type="checkbox"/> N/A

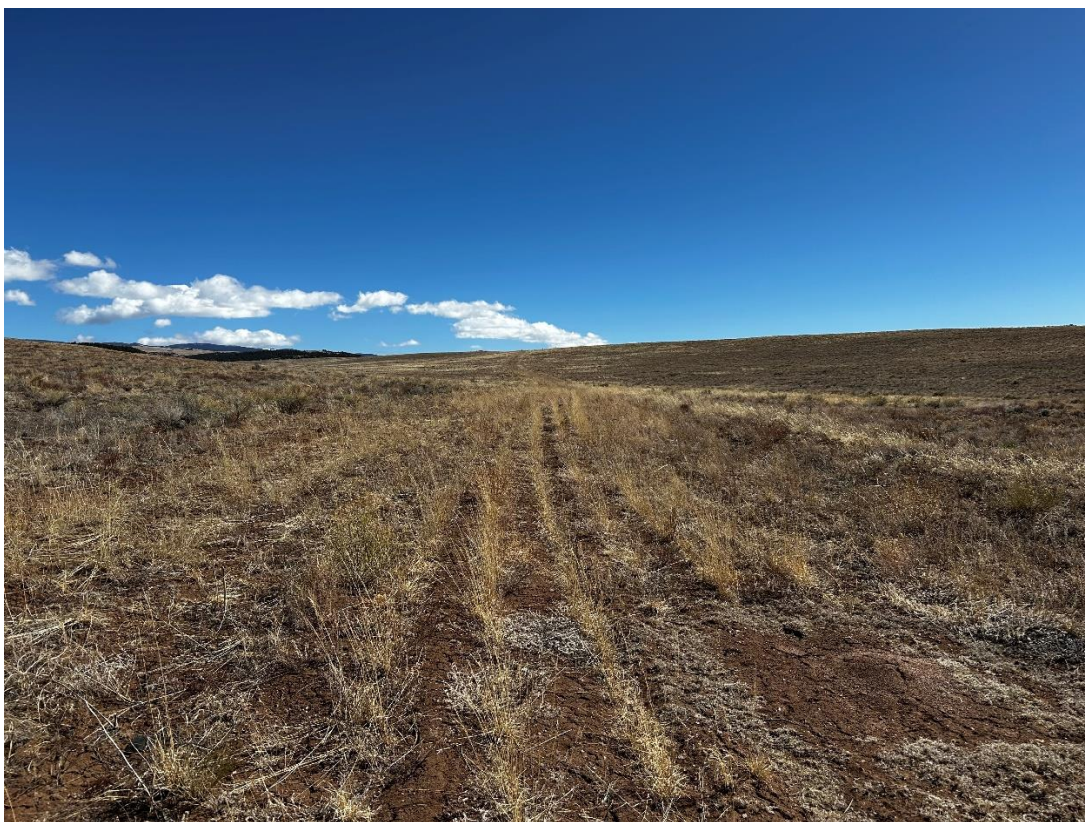
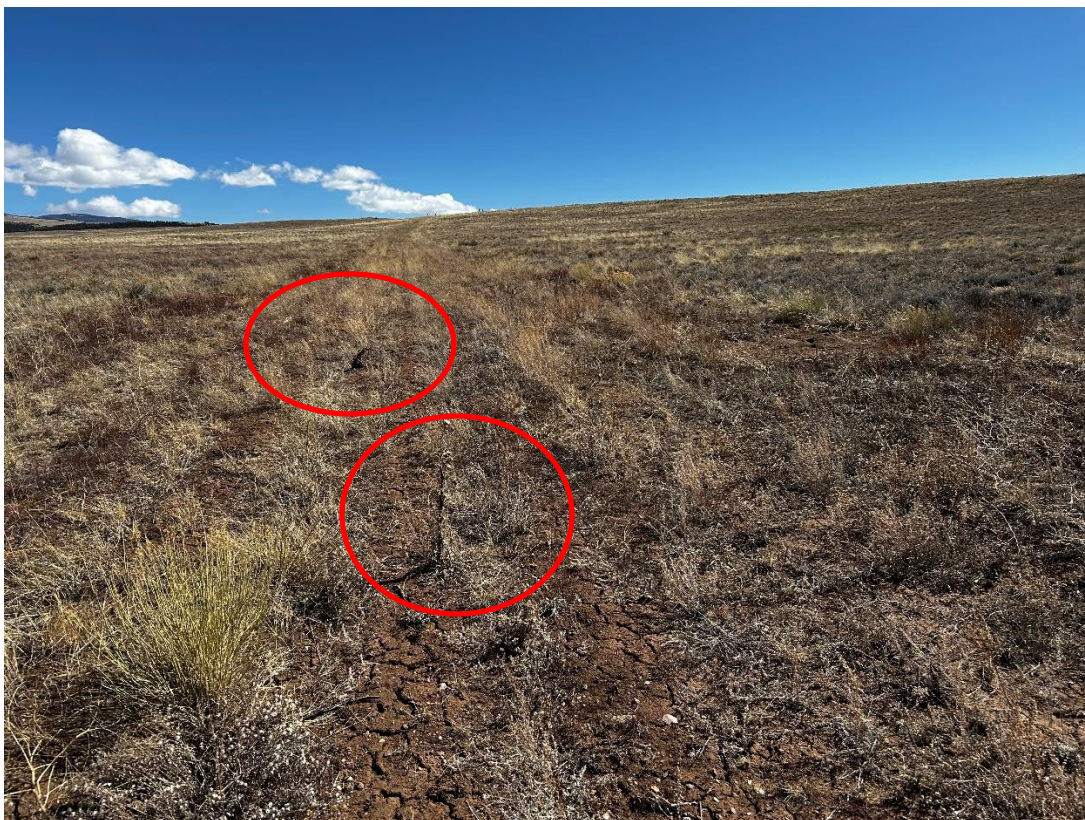
Images 1-2:

Additional Actions Necessary	
Non-Compliance Issues to be addressed by Operator	
2.d Site Conditions – Weed Management <ul style="list-style-type: none"> Class B noxious weed present along access road and pit area – musk thistle (ref. images 1-2). The State of Colorado and Custer County, CO requires an integrated management plan (e.g. cultural, mechanical, biological and chemical methods) for the prevention control of class A and B noxious weeds per the authority of the 1991 Colorado Noxious Weed Act. <ul style="list-style-type: none"> Operator needs to reference the Weed Management Plan on file. If a plan is not filed, then the operator should supply BLM with a current/updated Weed Management Plan. All musk thistle present along the road was dead due to the winter season; however, will most likely reappear during the spring, if not treated. The BLM noxious weeds specialist was consulted to determine a treatment/monitoring plan. <ul style="list-style-type: none"> The most effective way to control musk thistle is to treat them with an effective selective herbicide labeled for the site at least once per year. Cleaning up the site may take several years. The specialist recommends Milestone as it is very effective on

Comment: Noxious weeds present along reclaimed access road (red circle).

thistle species but easy on desirable species. *NOTE – If chemical methods are utilized a commercially licensed applicator will need to be contracted to eradicate/remove all noxious weeds on BLM lands. The applicator must abide by the BLM herbicide program including to make sure we have a valid pesticide use proposal for the proposed chemical and provide us with treatment records*

- BLM will provide the operator with recommendations for commercially licensed applicators.

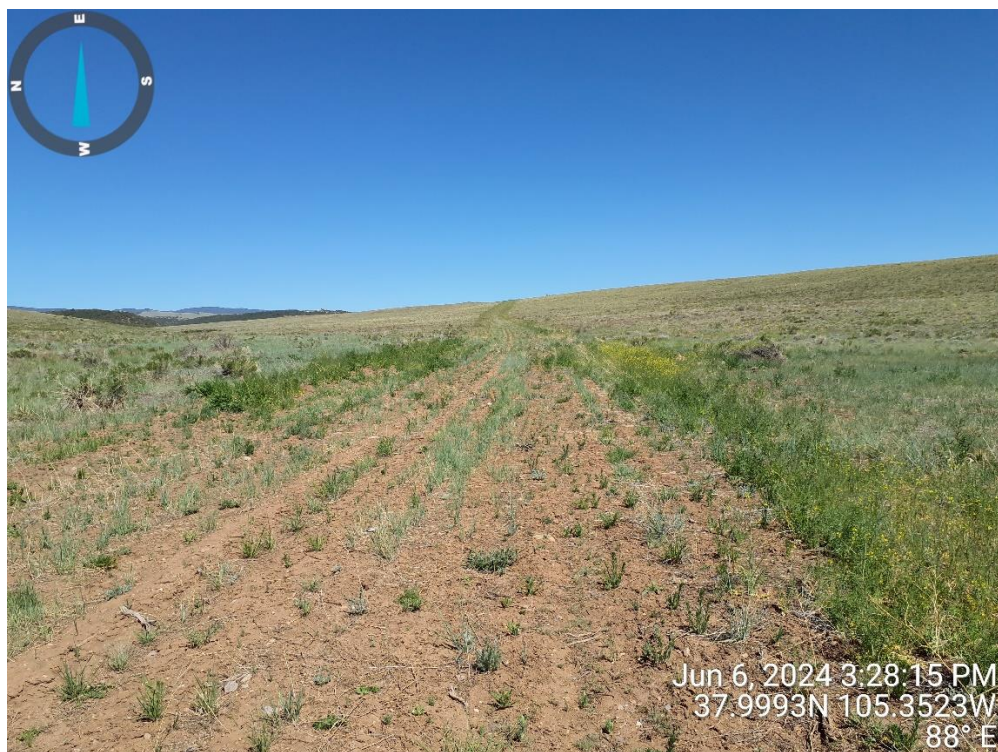
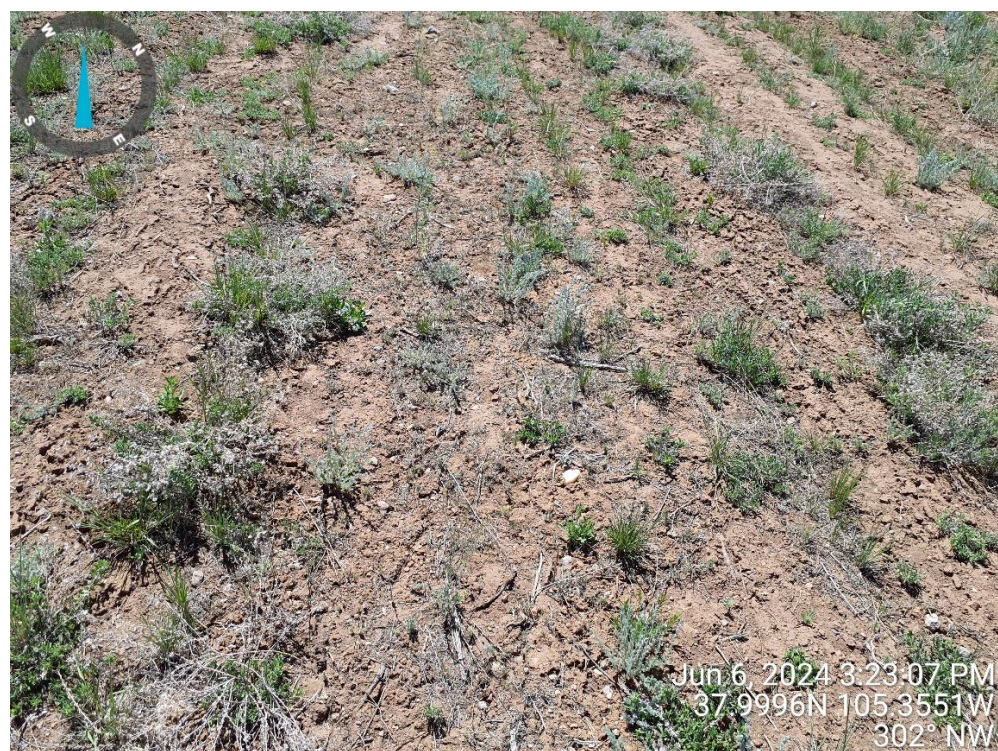
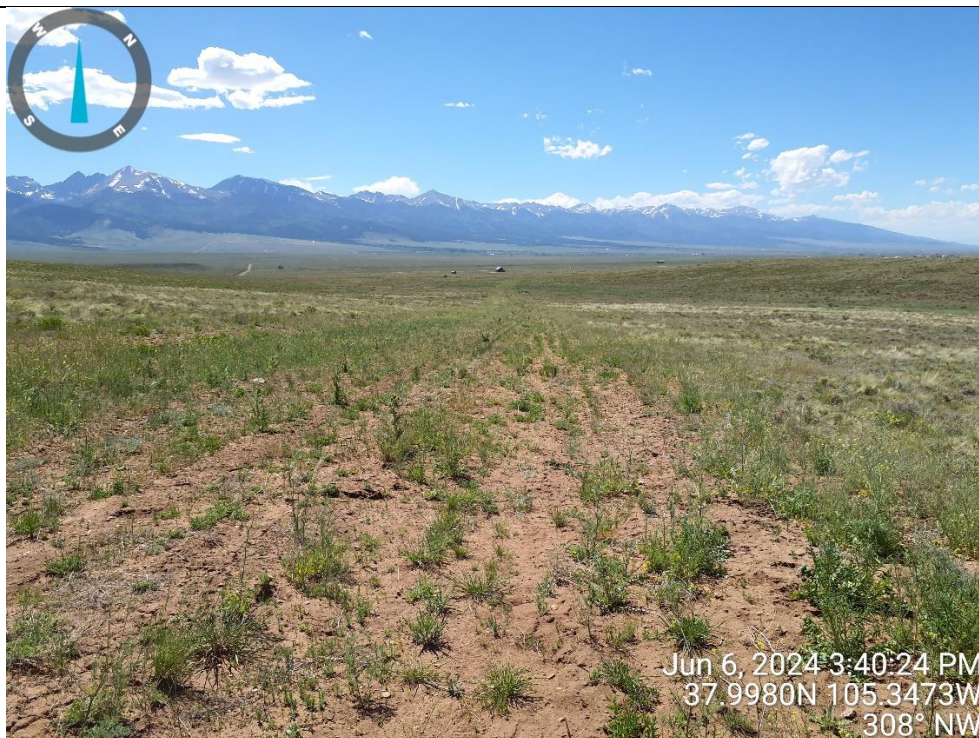
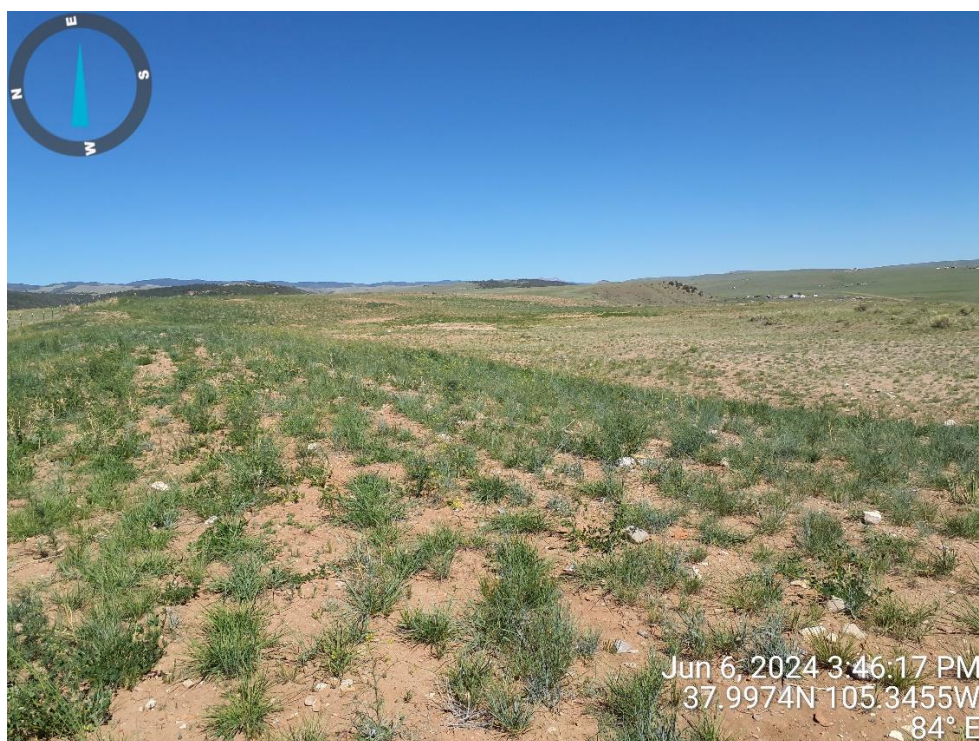
Images 1-4:

- Native vegetation has been established along all disturbed areas; however, the presence of Class B weeds indicate less desirable vegetation present (ref. images 1-4). A self-sustaining desirable vegetation population must be present with at least an 80% regrowth, compared to the surrounding undisturbed area before reclamation is deemed complete.

Comment: Revegetation along access road and pit

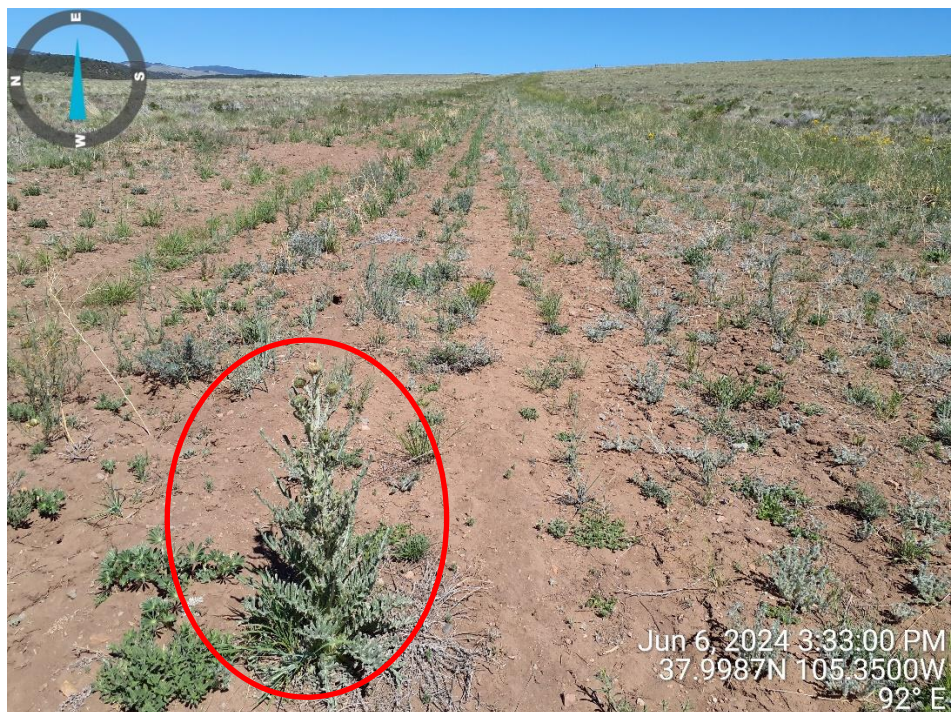
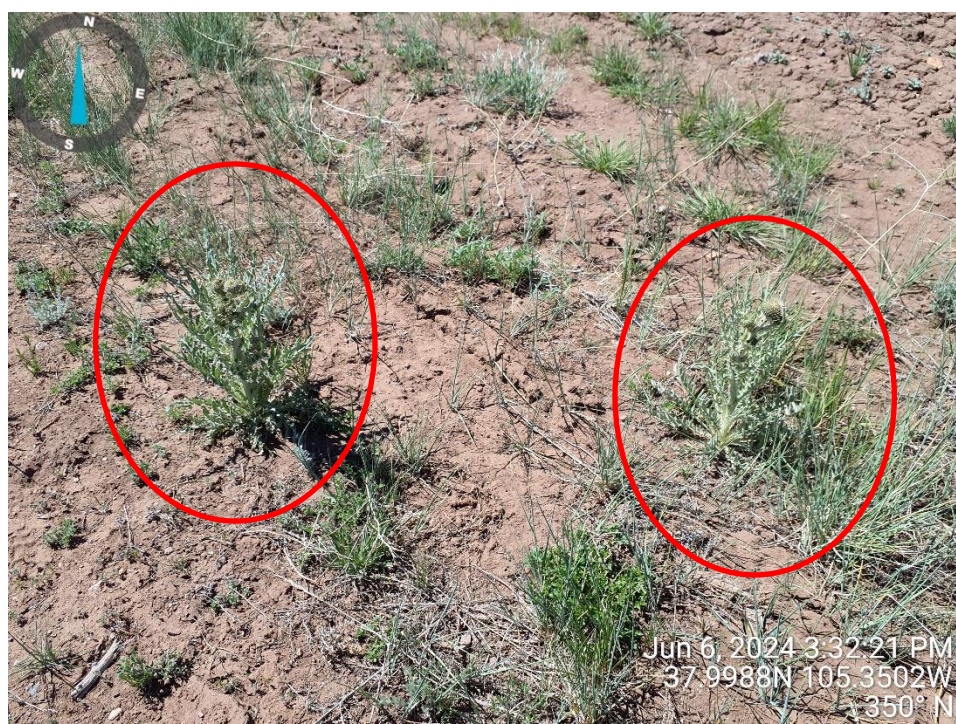
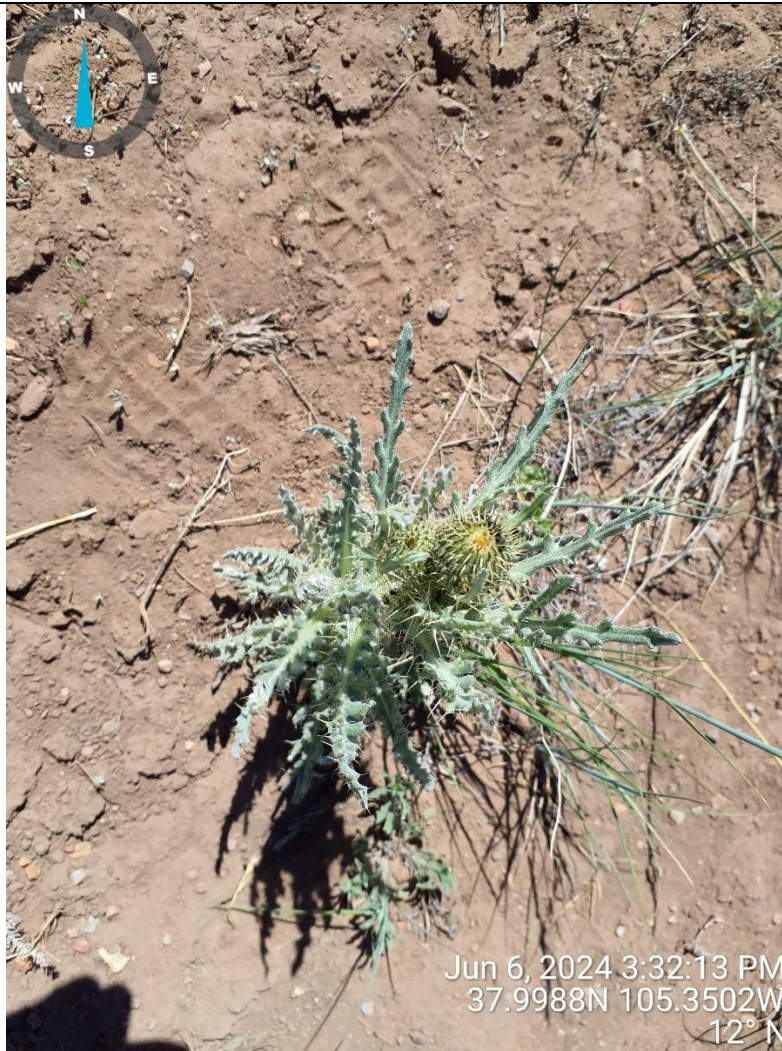
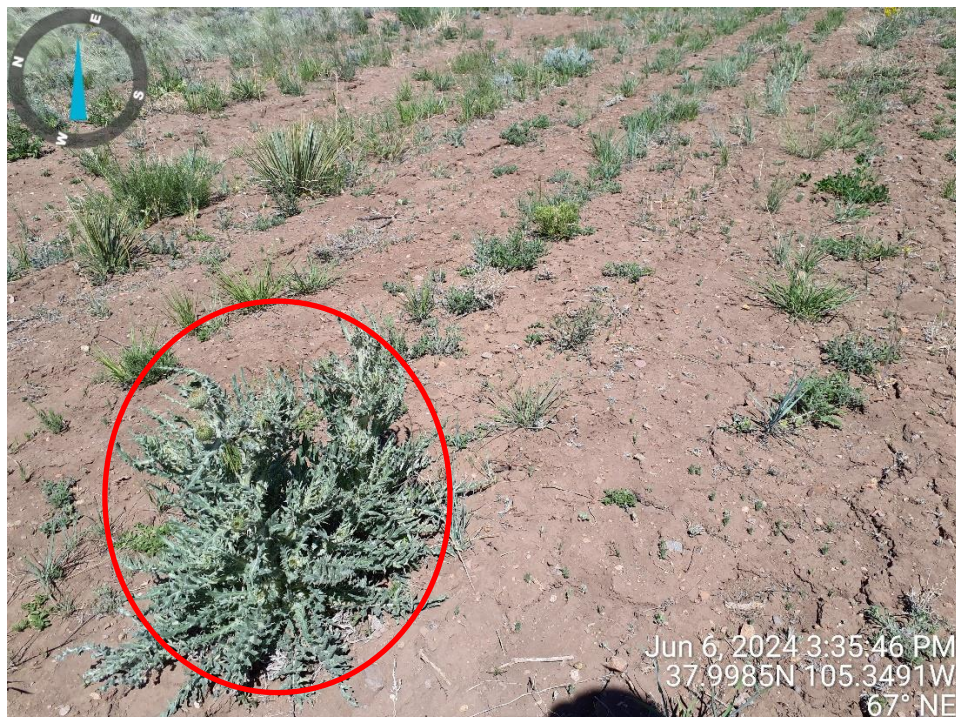
Images 5-8:

- Class B noxious weed present along access road and pit area – musk thistle (ref. images 5-8). The State of Colorado and Custer County, CO requires an integrated management plan (e.g. cultural, mechanical, biological and chemical methods) for the prevention control of class A and B noxious weeds per the authority of the 1991 Colorado Noxious Weed Act.

Comment: Noxious weeds present along reclaimed access road and pit area (red circle).

- Operator needs to reference the Weed Management Plan on file. If a plan is not filed, then the operator should supply BLM with a current/updated Weed Management Plan.

- The BLM noxious weeds specialist was consulted to determine a treatment/monitoring plan.
 - The most effective way to control musk thistle is to treat them with an effective selective herbicide labeled for the site at least once per year. Cleaning up the site may take several years. The specialist recommends Milestone as it is very effective on thistle species but easy on desirable species. ***NOTE – If chemical methods are utilized a certified commercially licensed applicator will need to be contracted to eradicate/remove all noxious weeds on BLM lands. The applicator must abide by the BLM herbicide program including to make sure we**

have a valid pesticide use proposal for the proposed chemical and provide us with treatment records*

- BLM will provide the operator with recommendations for commercially licensed applicators.

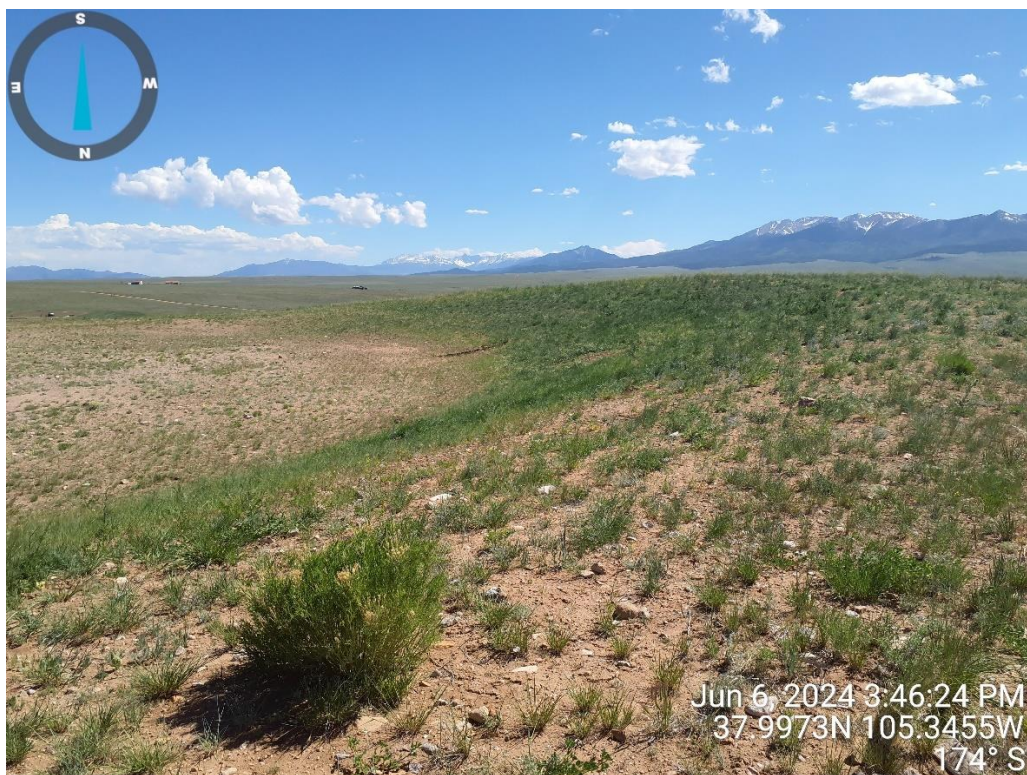
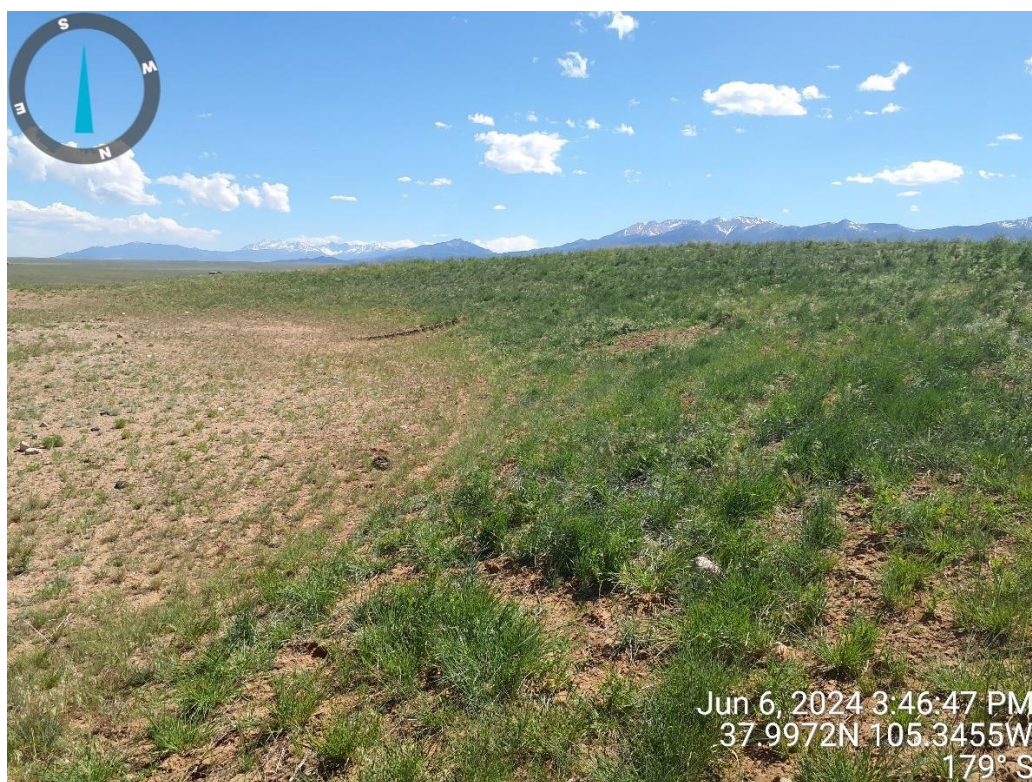
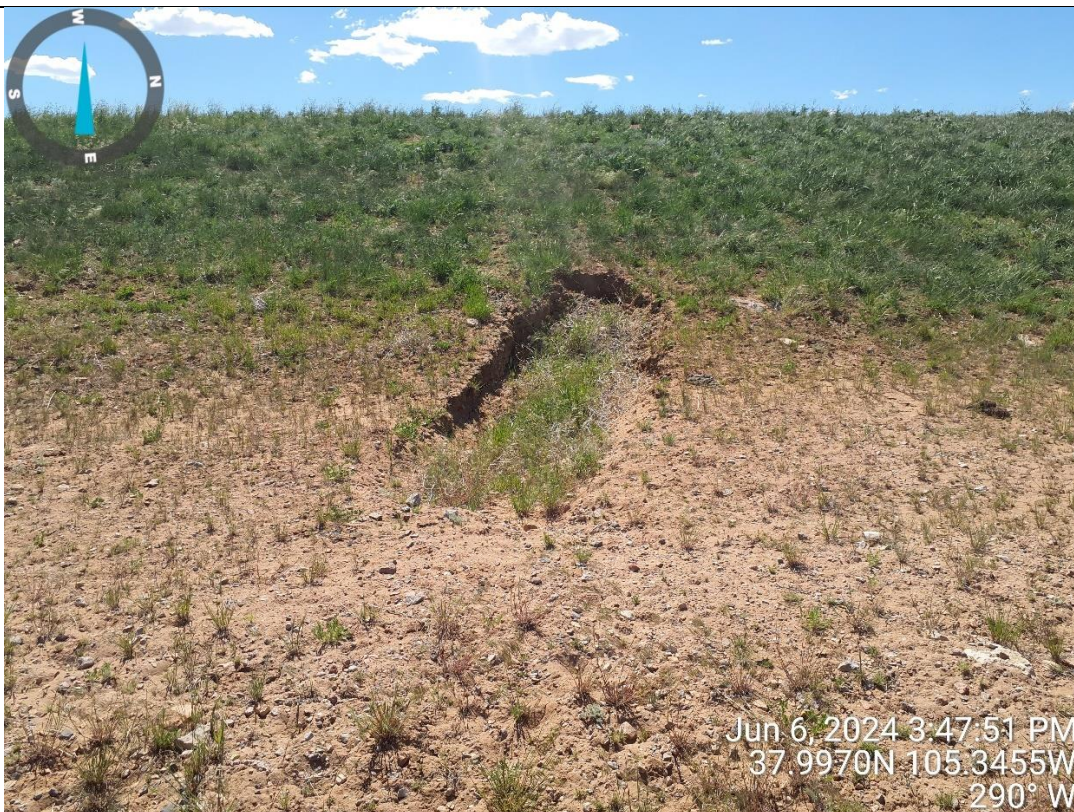
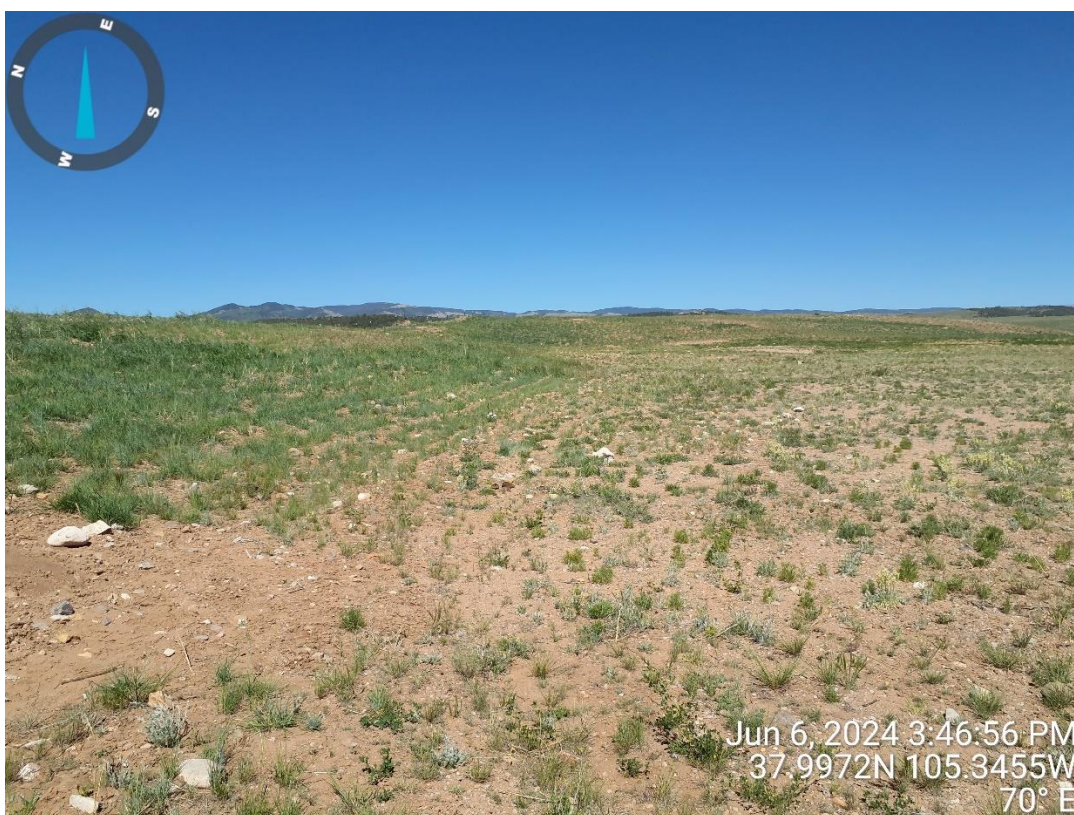
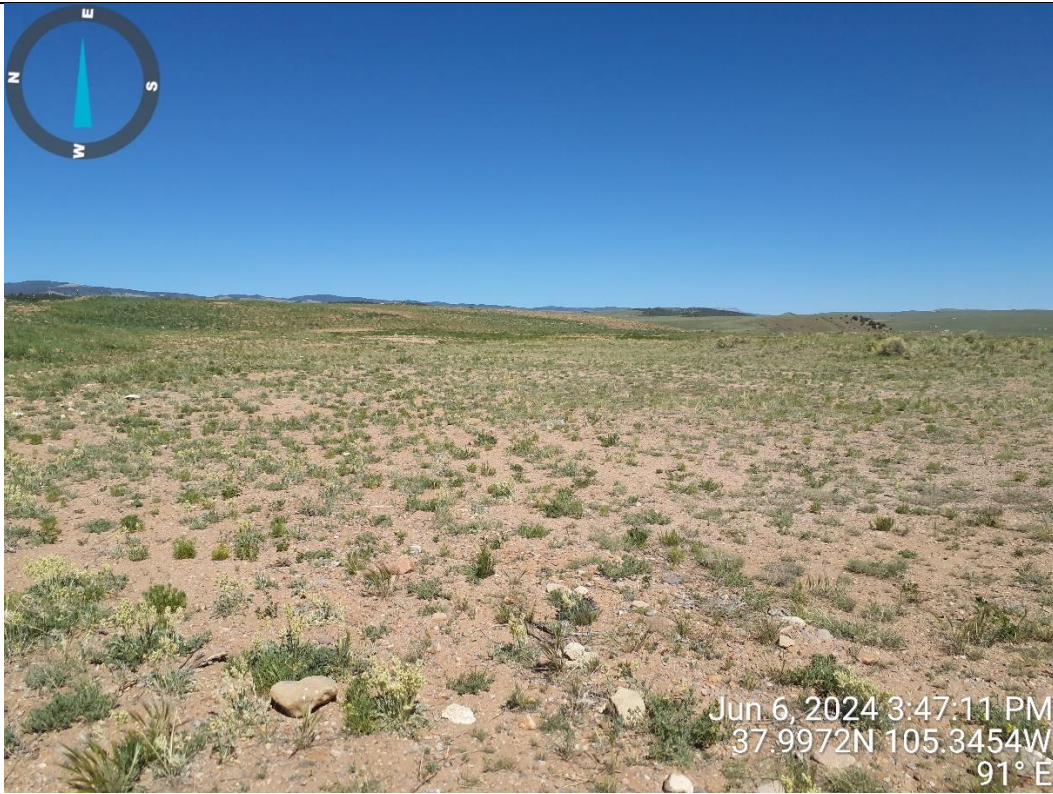
Images 9-13:

Comment: Recontoured highwall with 3:1 slope; adequate revegetation and overview of reclaimed area

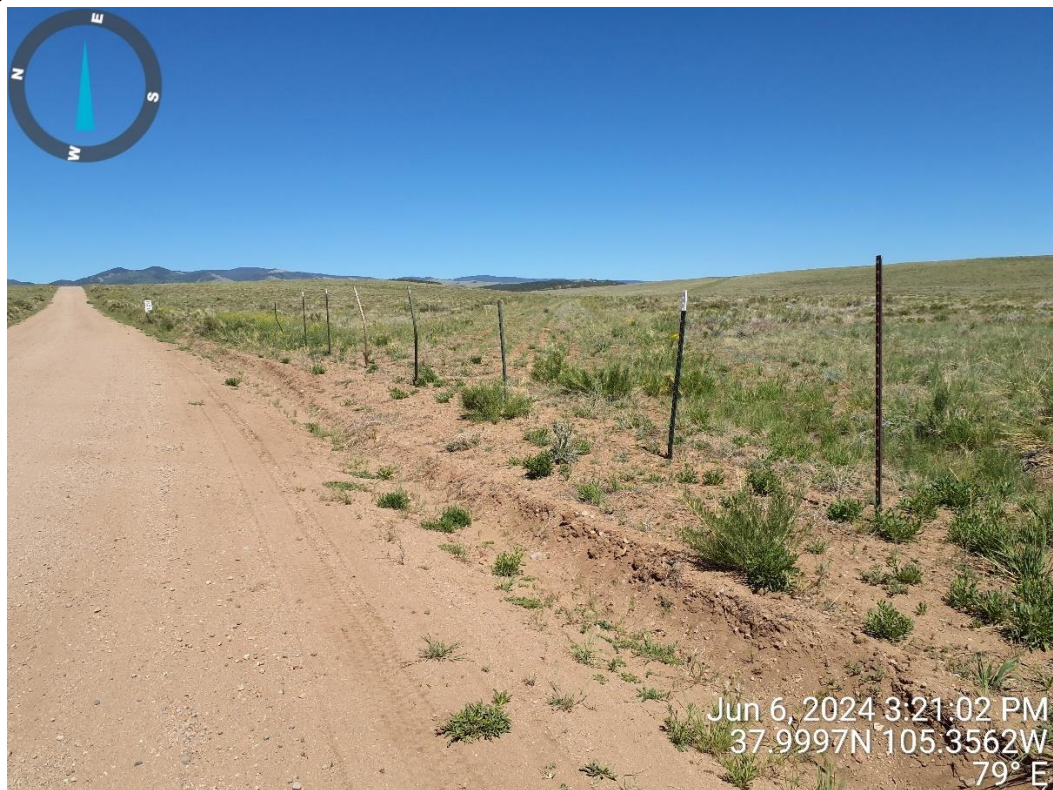
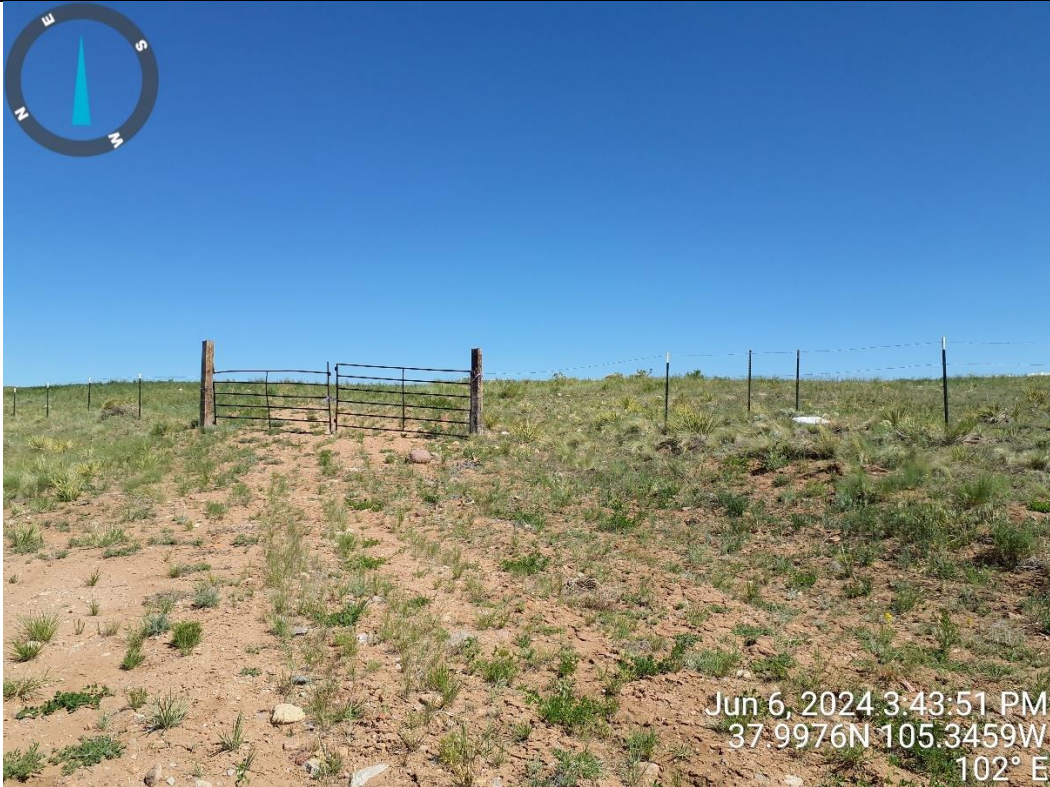
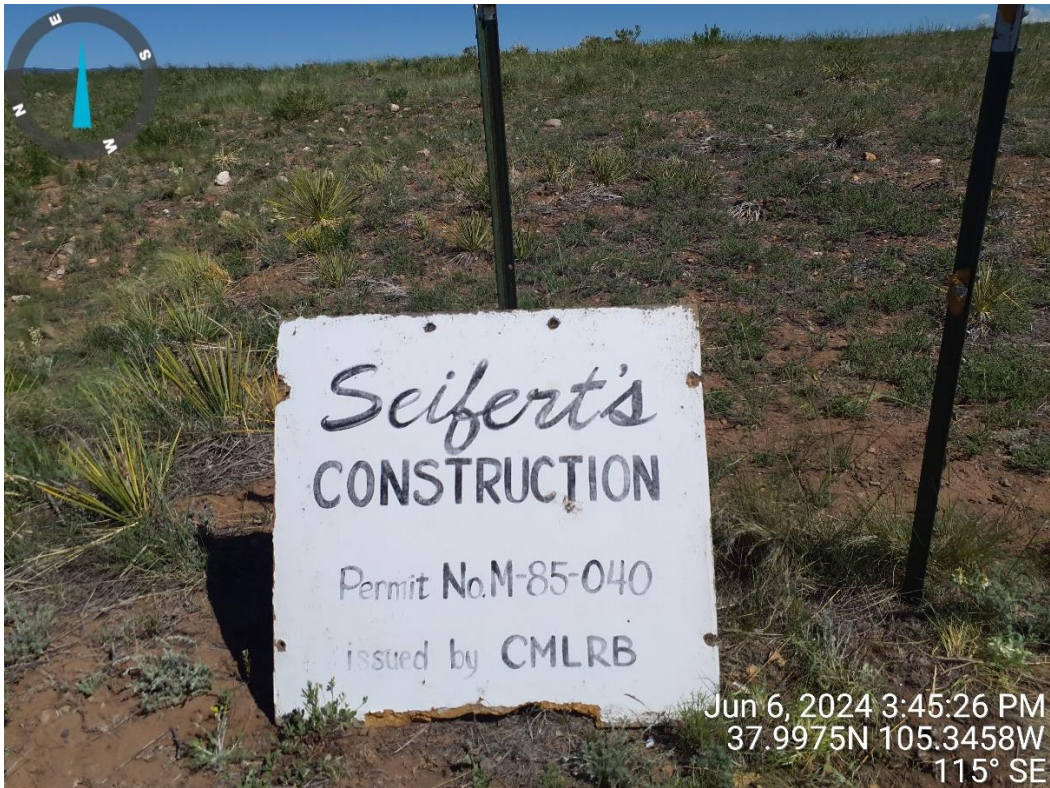
Image 14-16:

- All temporary and permanent structures need to be removed to meet all final reclamation requirements. The following structures are still present onsite (ref. images 14-16):
 - T-posts located at the entrance to the access road along off Timber Ridge Road
 - Secured gate at the entrance of the pit
 - Site signage and post

Comment: Structures still present onsite
