MINERALS PROGRAM INSPECTION REPORT
PHONE: (303) 866-3567

MINE NAME: Houchin Gravel Pit	MINE/PROSPECTING ID#: M-1980-249	MINERAL: Sand and gravel	COUNTY: El Paso
INSPECTION TYPE: Monitoring	WEATHER: Clear	INSP. DATE: February 27, 2025	INSP. TIME: 10:00
OPERATOR: Houchin Inc	OPERATOR REPRESENTATIVE: Curt Houchin	TYPE OF OPERATION: 110c - Construction Limited Impact	
REASON FOR INSPECTION: Normal I&E Program	BOND CALCULATION TYPE: None	BOND AMOUNT: \$7,177.00	
DATE OF COMPLAINT: NA	POST INSP. CONTACTS: None	JOINT INSP. AGENCY: None	
INSPECTOR(S): Hunter Ridley	INSPECTOR'S SIGNATURE:

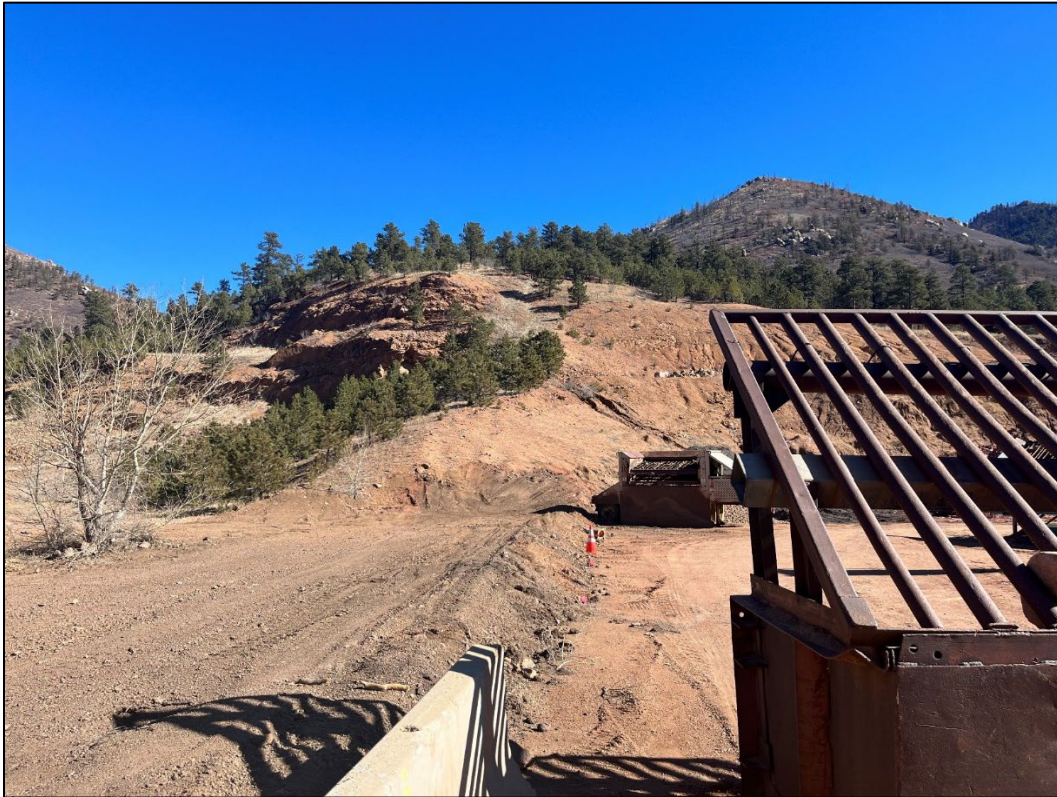
Signs and Markers: The permit sign was properly posted pursuant to Rule 3.1.12 and new boundary markers were noted at the permit boundary corners in the form of a wooden post and pink surveying whiskers (Photo 3). Note that for this permit, the property boundary line is the same as the permit boundary.

Figure 1: View north of the edge of the updated property boundary line. The permit / property boundary continues up the hillslope.

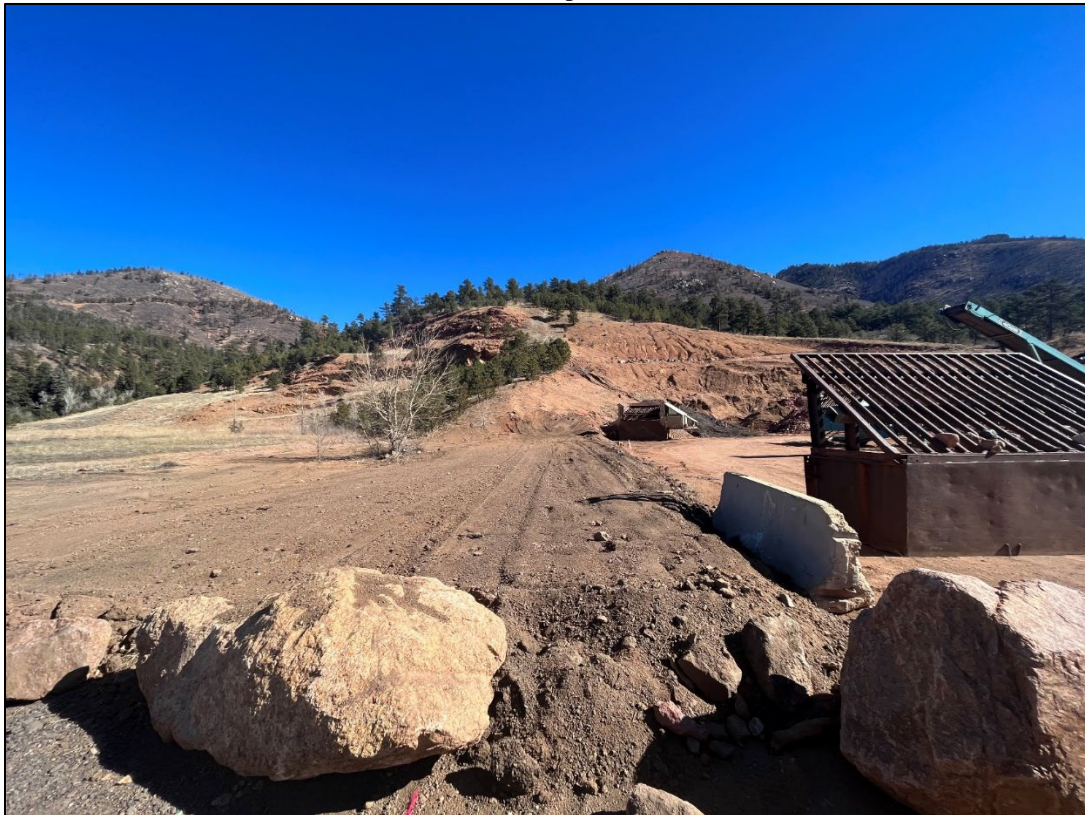
Backfilling and Grading: During the inspection, the Division observed that the area of encroachment had been graded out and noted that the earthen berm had been moved to align with the corrected property boundary line. Boulders and a concrete wall had been placed at the southeast corner of Ms. Higinbotham's property corner and clearly defined the line between her and Mr. Houchin's property (Photos 1 & 2).

Support Facilities On-site: A screen plant, loader, and two grizzly screens were observed on site. These had all been moved off the adjacent western property and are now fully contained within the approved permit boundary (Photo 2).

Figure 2: view north of the revised property boundary line. Boulders and a berm have been added to delineate the property boundary line.

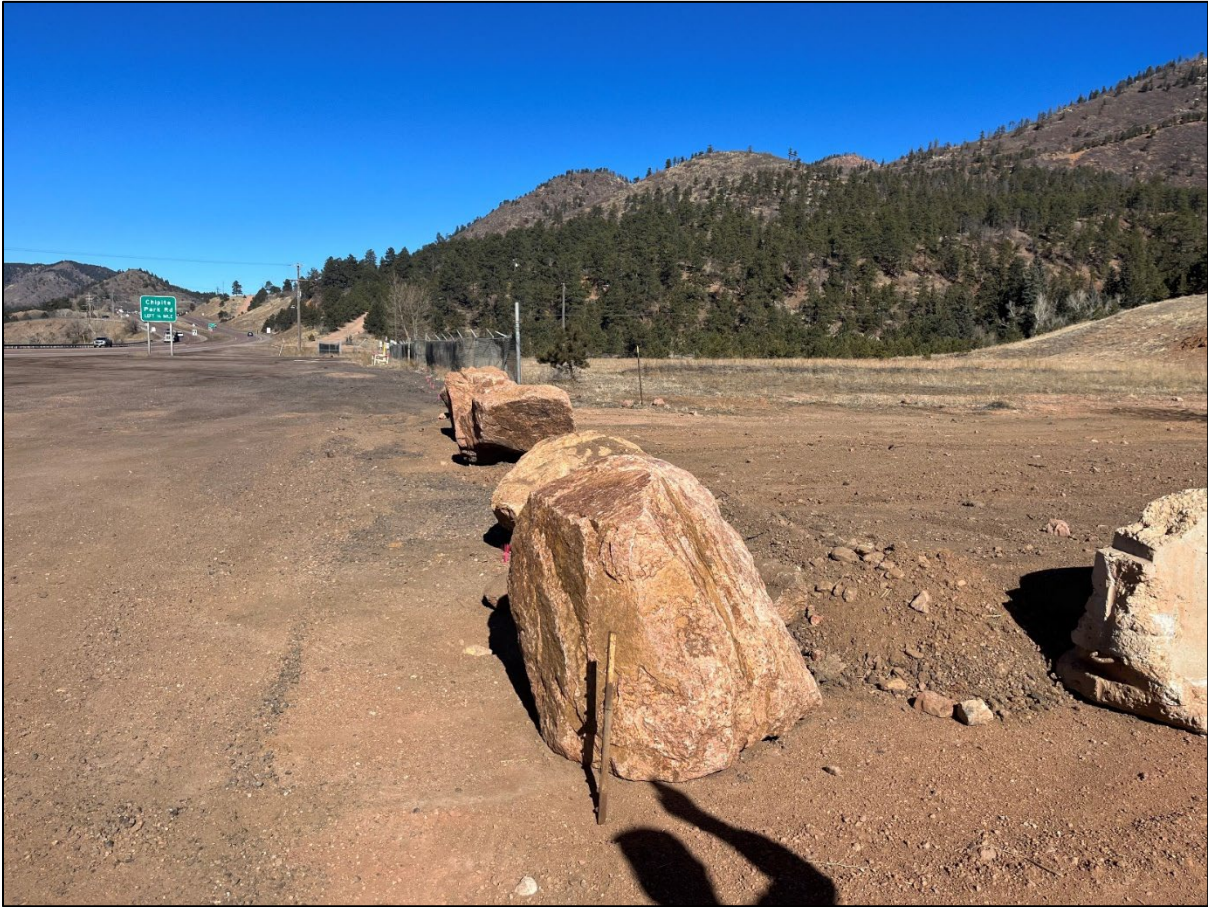
Figure 3: View west of the adjacent property. A wooden t-post and pink whiskers show the revised property line.

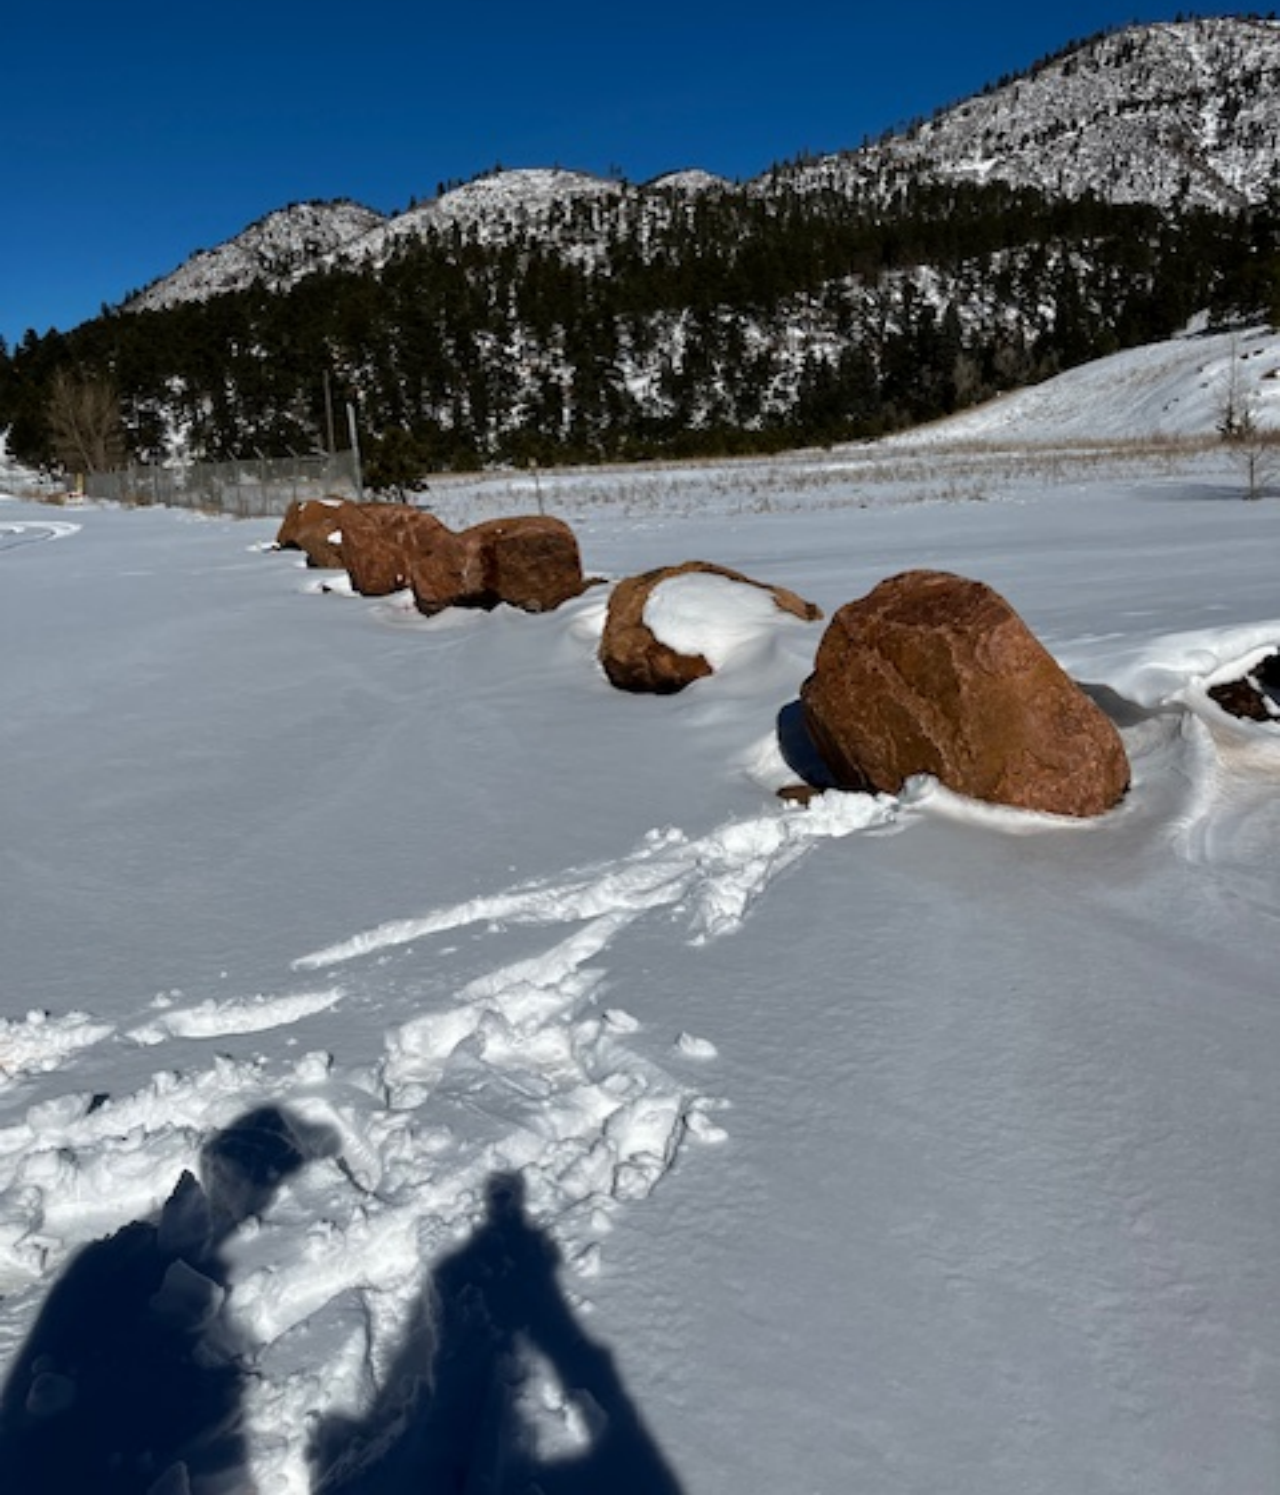
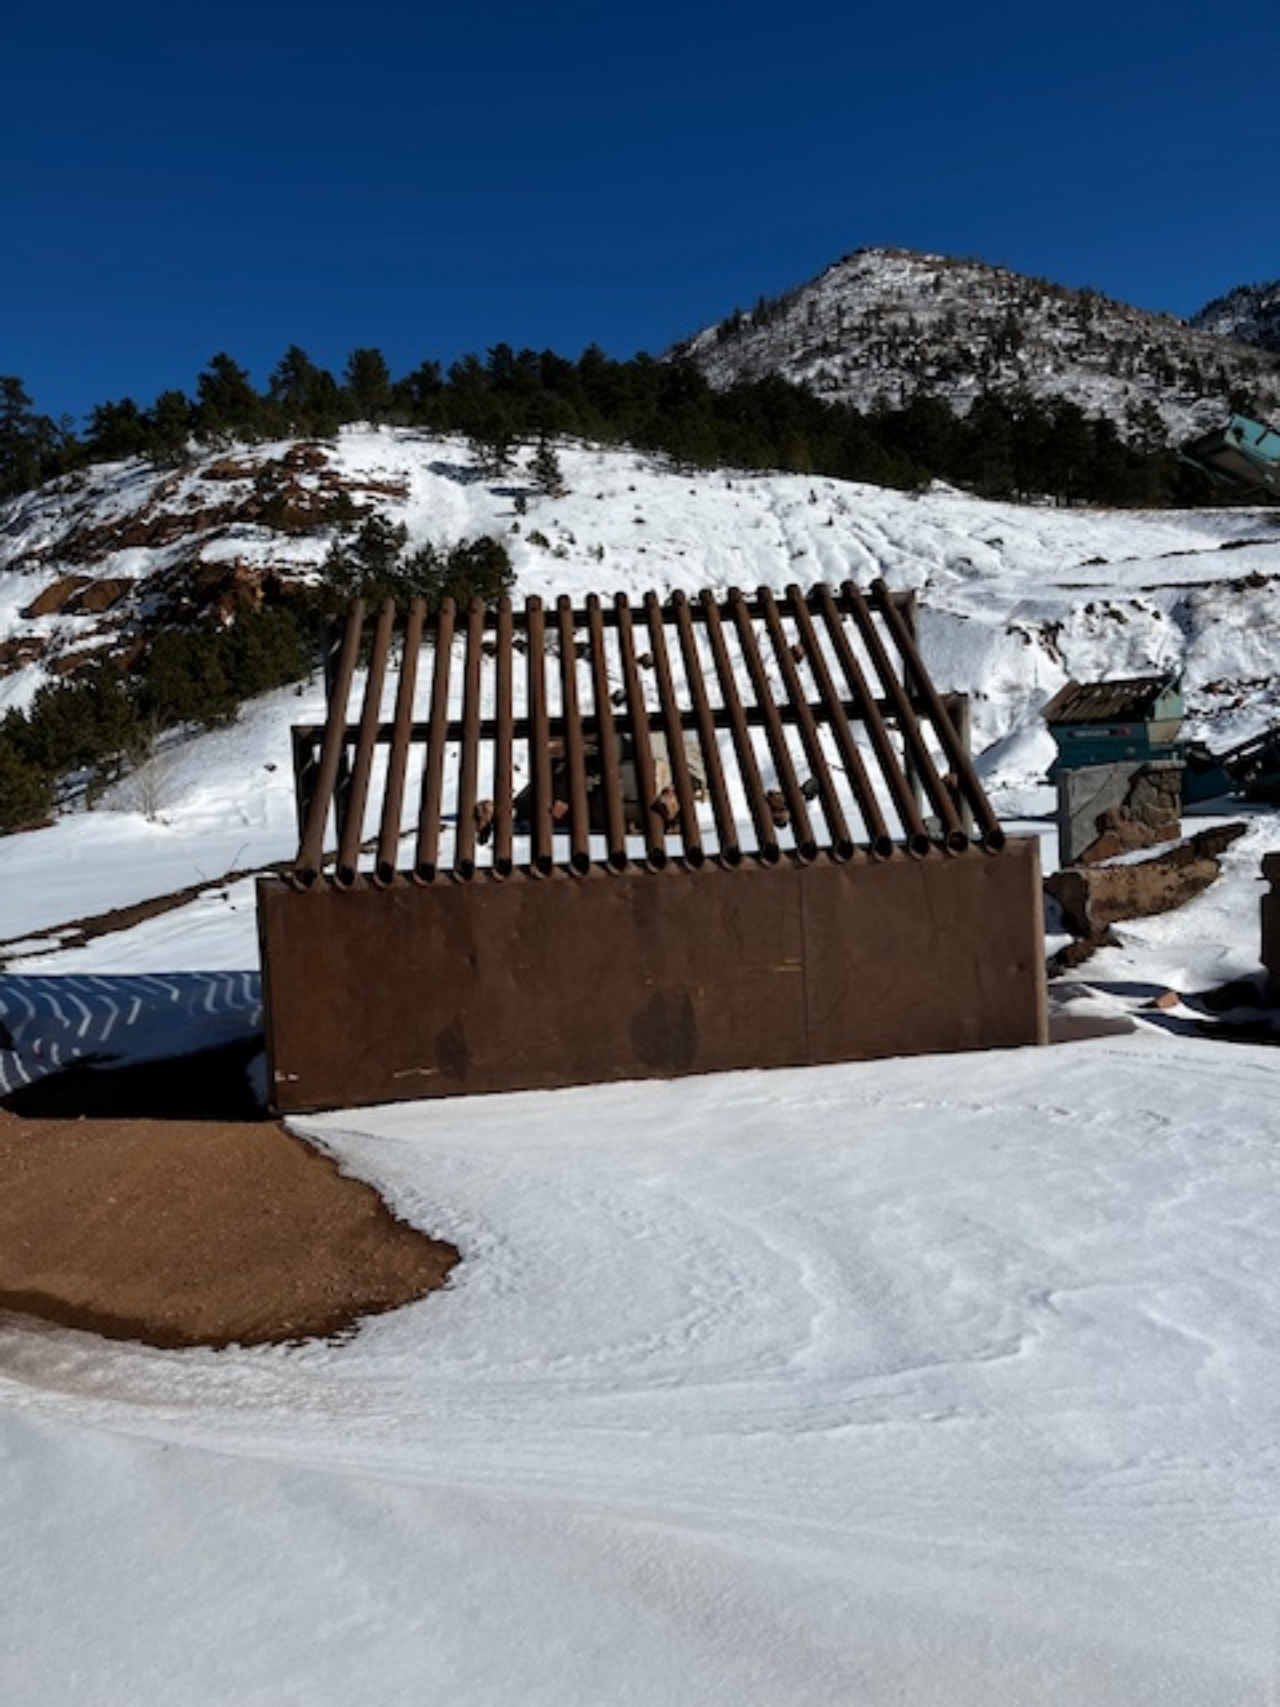
I just visited the site today and he has done extensive restoration .

As illustrated in the photos I took today. It's a bit difficult to see because of the recent snowfall. I will send you more when the project is complete and the snow has melted. Basically, I just wanted to let you know that I think Mr. Houchin is doing his best to remedy and restore the encroachment
