## March Inspections Williams Fork, Seneca IIW and Yoast

Division of Reclamation,  
Mining and Safety

<b>Permit Number:</b> C-1982-057 <b>Mine Name:</b> Seneca IIW Mine <b>Operator:</b> Seneca Property LLC  <b>Operator Address:</b> Ms. Miranda Kawcak 29515 Routt County Road 27 Oak Creek, CO 80467	<b>County:</b> Routt <b>Operation Type:</b> Surface <b>Permit Status:</b> Permanent Cessation <b>Ownership:</b> Private  <b>Operator Representative Present:</b> Ms. Miranda Kawcak
<b>Operator Representative Signature: (Field Issuance Only)</b> This report was issued electronically from the Divisions' Denver Office.

### INSPECTION INFORMATION

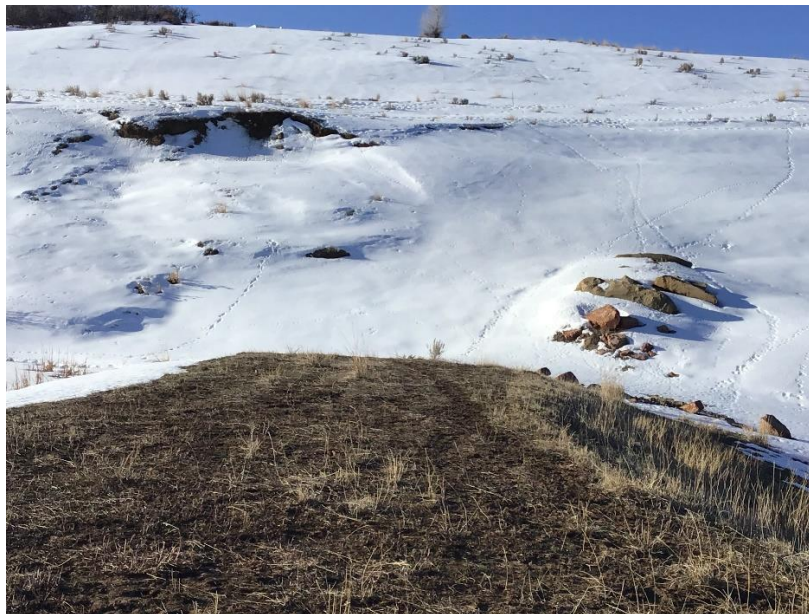
- Past slides, slumps, and cracking were observed and no new movement was detected.
- Slumped areas remain snow covered.

*Photo 1: Slumped slope above Pond 6.*

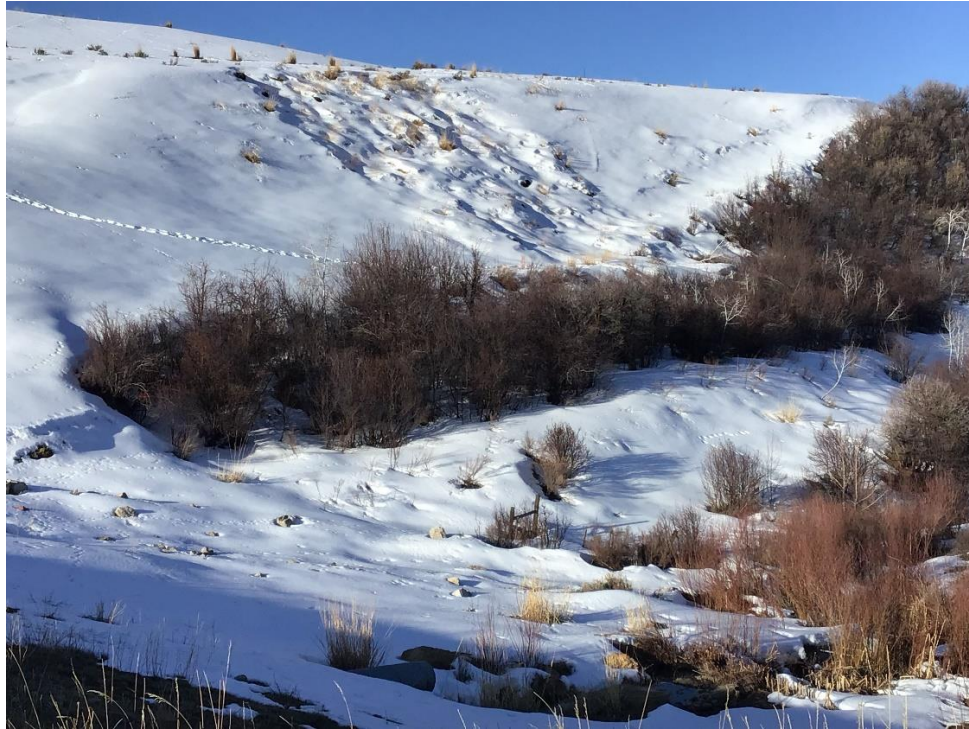
*Photo 2: Slumped slope downgradient of Pond 6.*

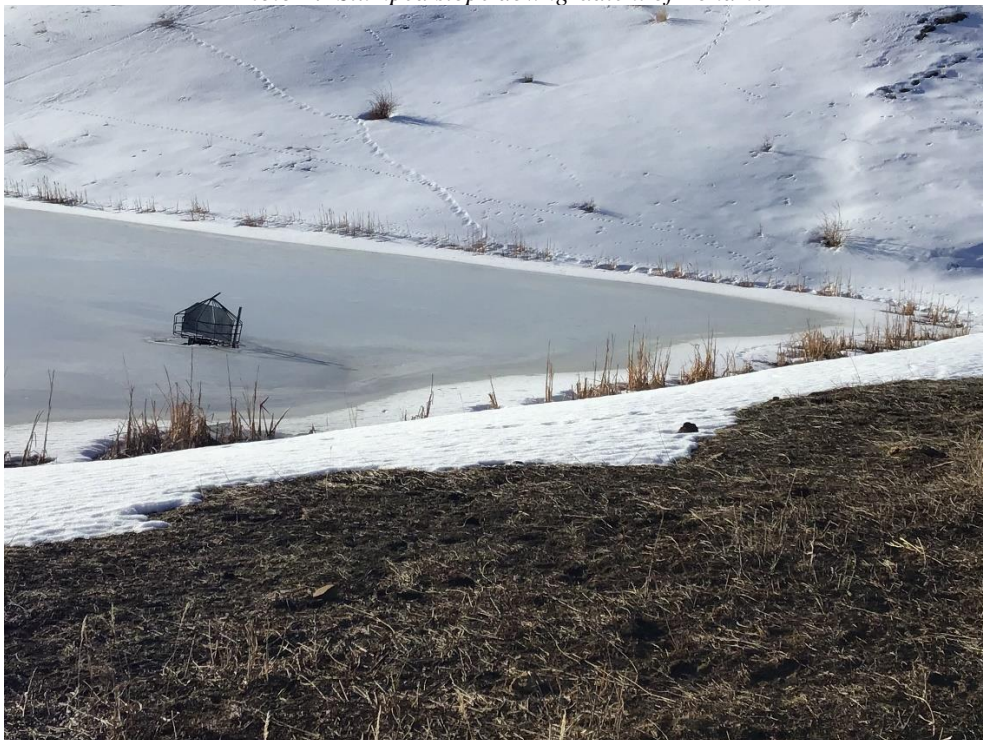
- Pond 6 banks and dam appeared stable, and snow covered with no signs of seepage.
- Pond 6 was discharging at the time of inspection.

*Photo 3: Pond 6 and decant structure. Pond 6 was discharging.*

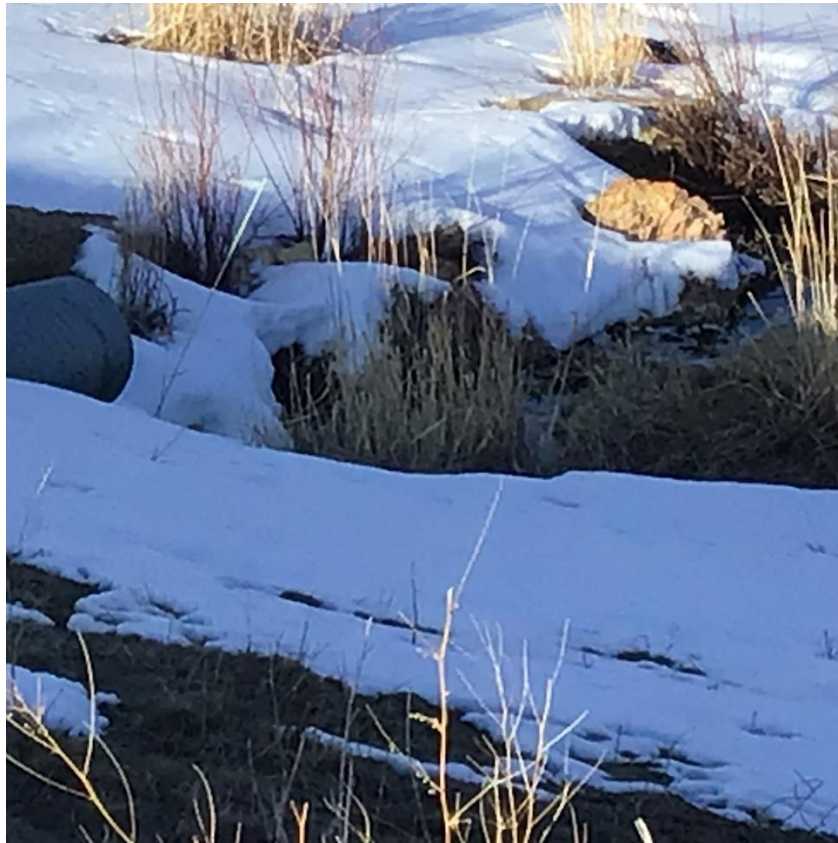
*Photo 4: Pond 6 drainage and discharge culvert.*

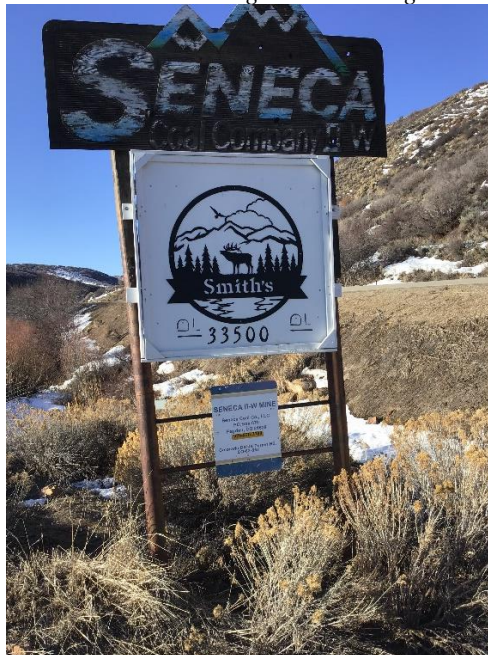
- The mine identification sign was in place at the site entrance from County Road 53. The sign was intact, displaying all required information: mine name, operator name, address, phone number, DRMS permit number and contact information.

*Photo5: Mine identification sign at entrance from County Road 53.*
