**Additional Sheet**  
**2025 Annual Report**  
**Coal Creek Resources**  
**M-1988-044**  
**Schmidt Construction Company**  
**Anniversary Date: March 28**

**SITE CONDITION:** The site was inspected on March 21 to see what the condition of the land was at the end of the 2024-2025 permit year. Following is a description of each of portions of the permit - The Plant Site and then The Pit Area.

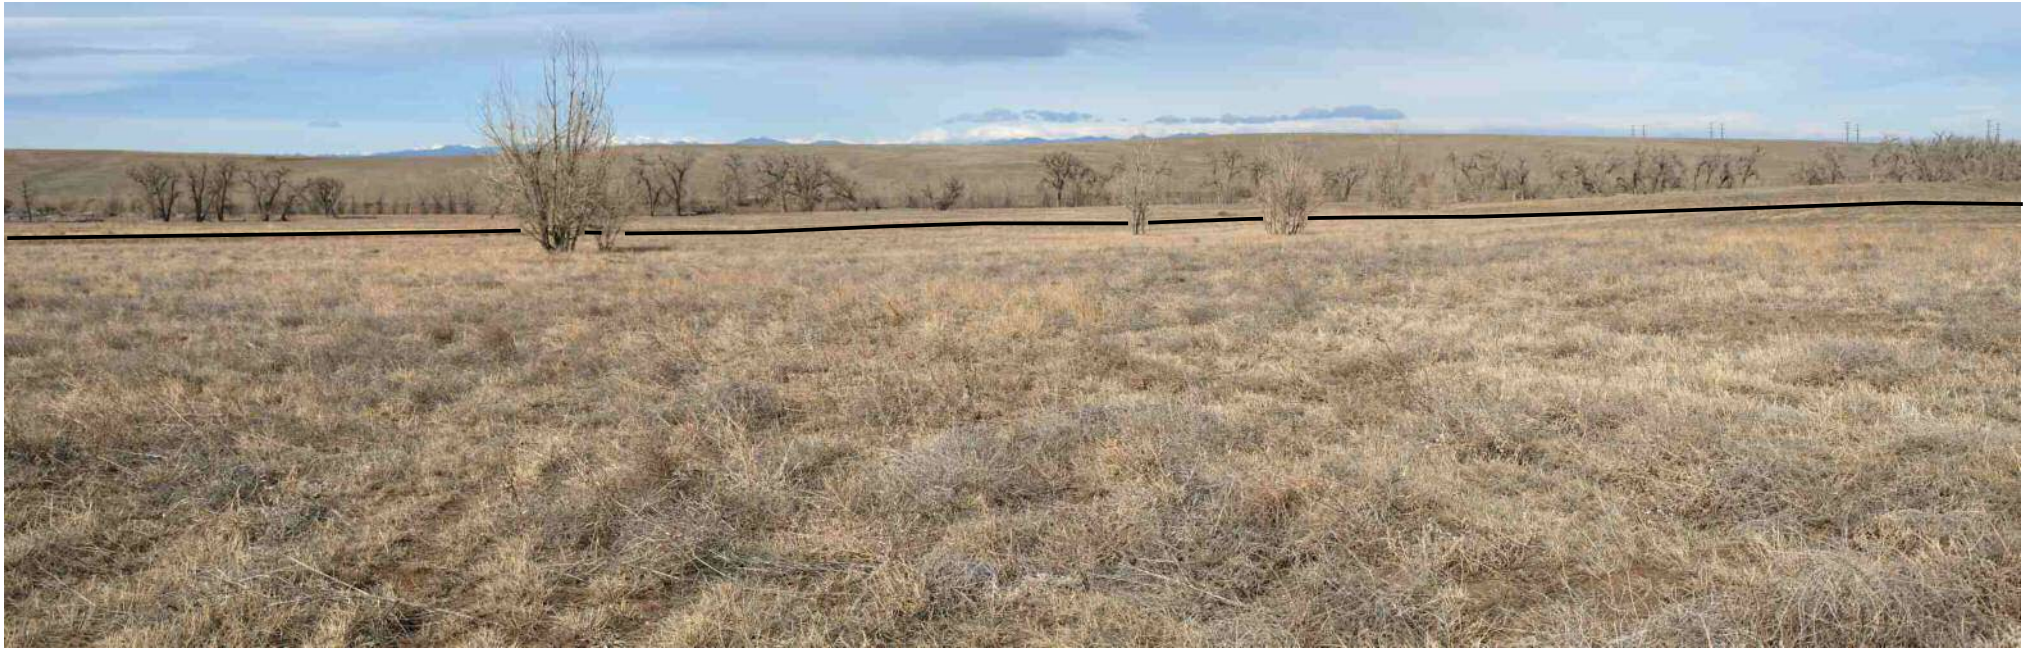
**The Plant Site** showed a continued development of the vegetation that was seen in the previous years. In fact, the site has good vegetation cover with both moderate growths of the planted species and robust growth of the native Witch Grass (*Panicum capillare* L.) and some other species. Even the most eroded and erosive areas have now been stabilized with only minor soil losses in the last year. Cuts up to 10 or more inches deep that were abundant and carried a good deal of water in 2024 are now nearly stabilized with erosion of the sides into the cut which is filling it in.

**Photo 1:** Panoramic view of Plant Site reclamation status 03-21-25. Black line is approximate western limit of reclamation.

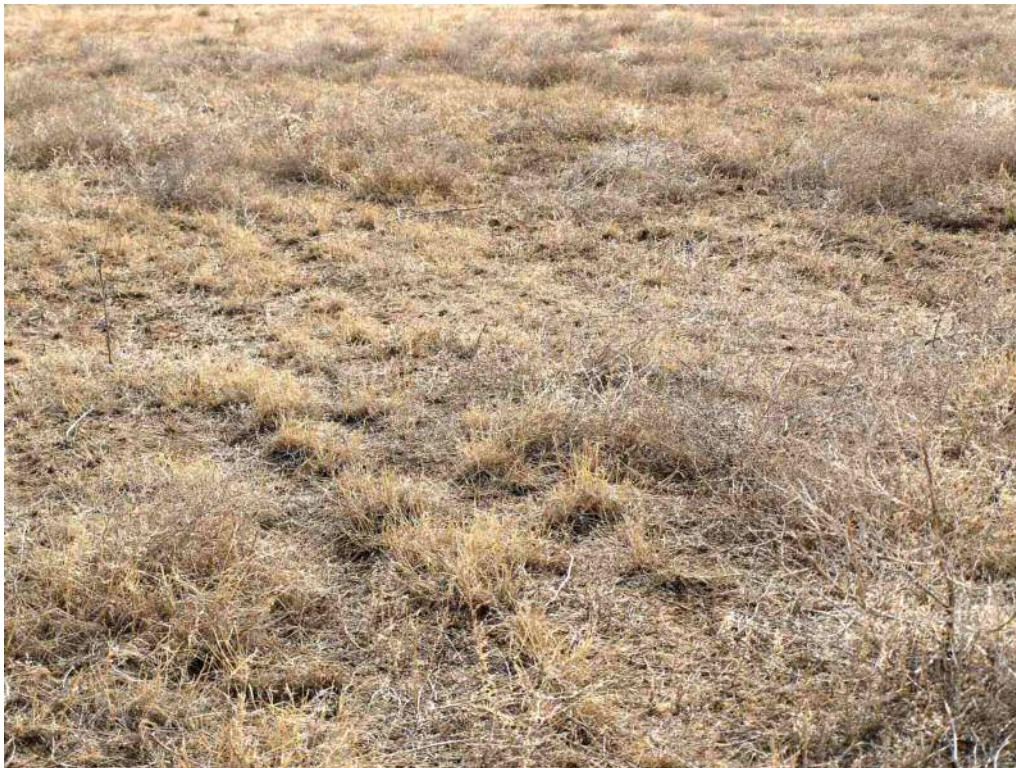
**Photo 2:** This photo is of the revegetation on the somewhat steeper slope between the top of the Plant Site and the lower portions where the sediment basins were located, the slope was seeded up and down the slope rather than following the contour as the seeding contractor was instructed to do. This initially created a heavily rilled slope with new grass plants on the high ridges and nothing growing in between the planted soil. This photo shows how the planted grasses have come in well on the actual drilled stripes and *Panicum capillare* (Witch grass which is a native invader), along with other plants, have filled in the eroded areas between the successful plantings. If the planting had been done laterally the growth would have likely reached this stage a couple of years earlier, but the final result would likely have been the same. Goes to show that even when mistakes are made the revegetation process can still correct itself - sometimes, but not always.

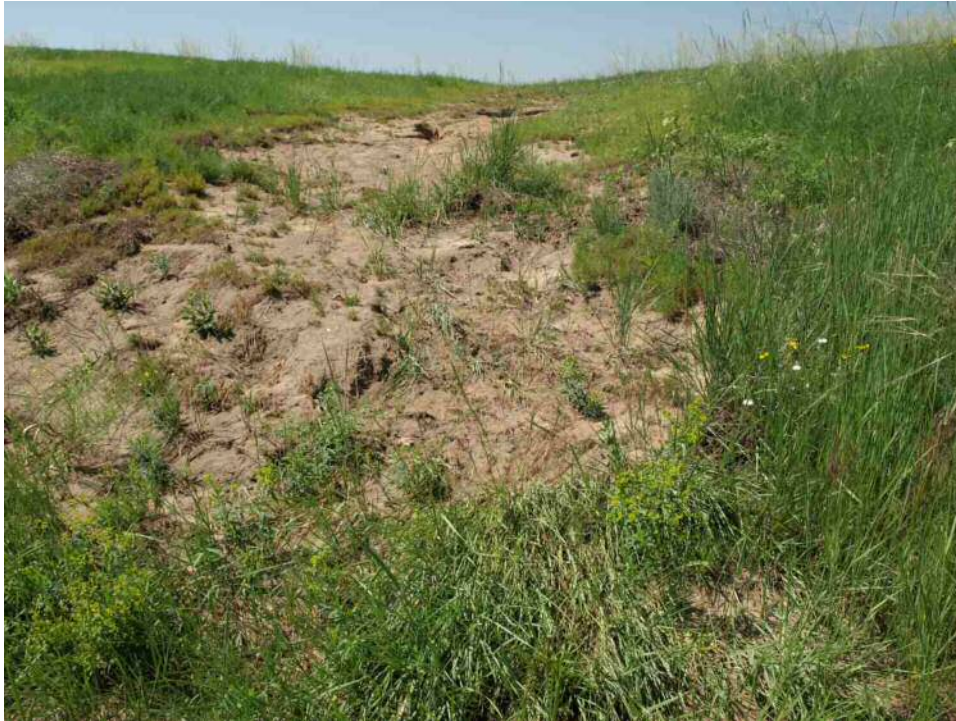
**Photo 3:** Pit outlet on June 28, 2023: At this time the outlet of the drainage from the entire pit area was not only showing some sheet erosion, but also some continued development of vegetation within the channel. Obviously, the grading was holding very well in spite of 2023 being a fairly wet year. However further up in the outlet note the dark areas. Those are erosional holes in the outlet that had developed but had not fully developed yet. The main erosion effect here was sheet erosion. The drainage upstream was in excellent condition with no rilling, gully formation, or other adverse erosional damages. That shows that the pit slopes were not discharging much sediment that was leaving the pit area in spite of most of the vegetation at this time being mostly weed species due to the failure of the planting.

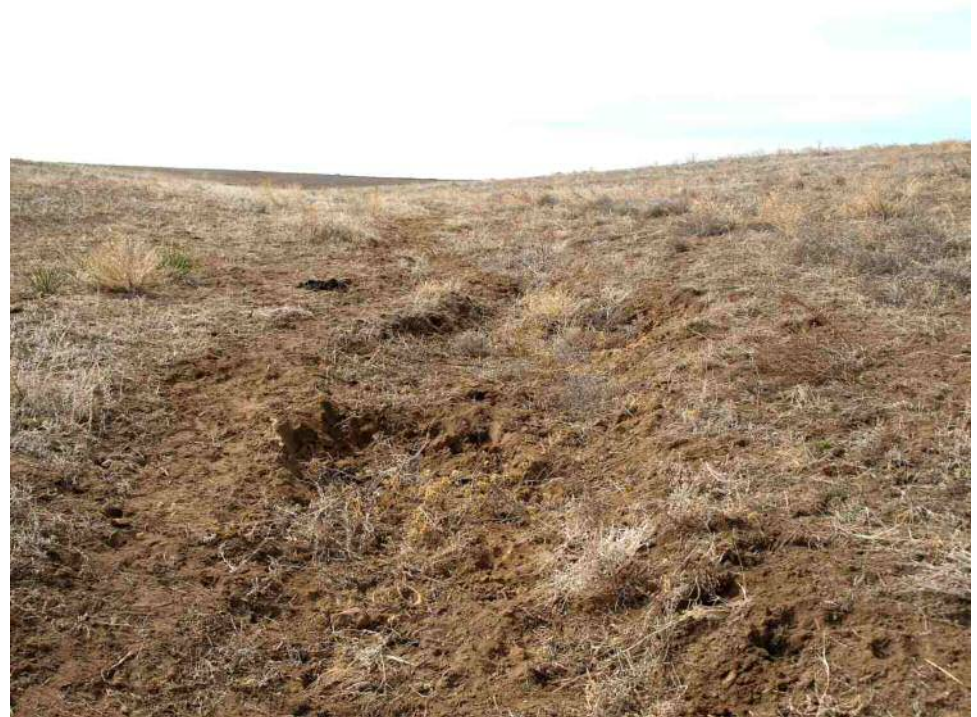
On the plus side, the flow of water out of the pit is hardly even noticeable at the outlet from the pit. As the comparison photos show, when the climate was wetter the outlet was showing some erosion. Now, the cattle seem to be using the outlet as a trail between the pit area and the adjacent grazing land across the drainage. This has effectively stabilized the outlet and the significant erosion in this area has been reduced by the cattle walking back and forth along the flow path. In fact, the outlet looks better now than it did a couple of years ago and it appears far less sediment is being discharged from the pit.

**Photo 4:** Here is the pit outlet on March 21, 2025. It actually looks very much the same as it did in 2023. The churning of the soil is due to the cattle using the outlet as a path between the pit area to the south and the native grassland on the other side of a fairly deep drainage separating the two areas. This has been in use for some time and shows high stability in spite of the increased disturbance compared to 2023.

THE OVERALL conclusion of this is that drainage from the pit area is not showing significant erosion at all in spite of the weak vegetation cover. This is also borne out by the lack of rill erosion in the pit area. However, it is recognized this apparent stability could change with a very large thunderstorm.

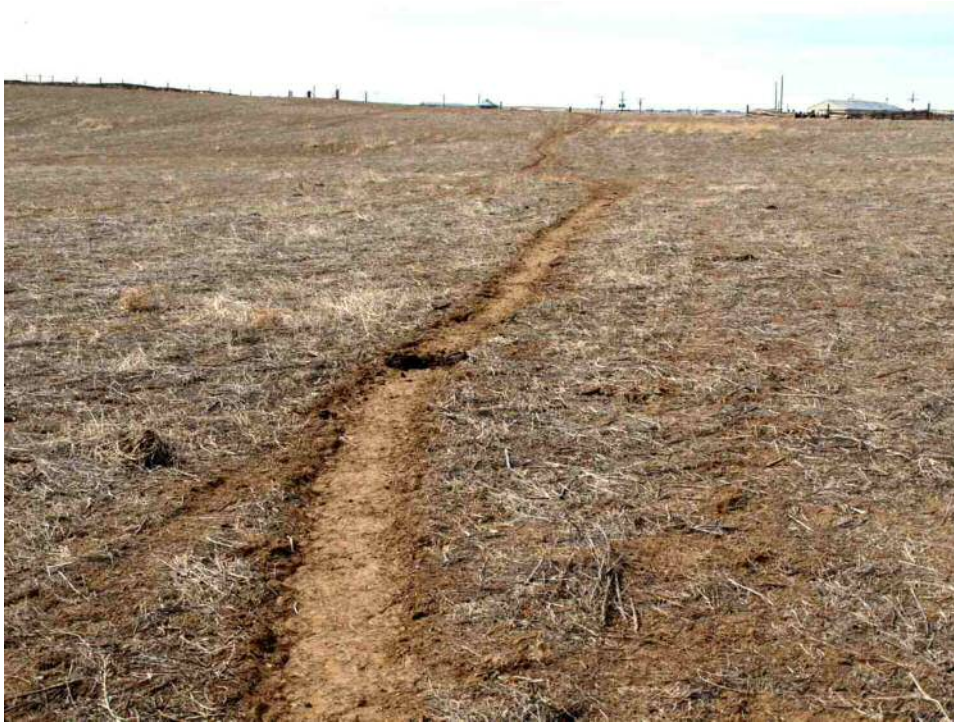
**Photo 5:** Although the grazing lessee grazes mostly cattle, they do have a few horses. Here is the horse trail the horses follow from the ranch (on the horizon) to the richer grasslands for grazing this time of the year. In summer they often stay in the pit area. Unlike cattle, horses have a tendency to follow each other in a line rather than spread out. Thus they create trails where the soil is trampled.

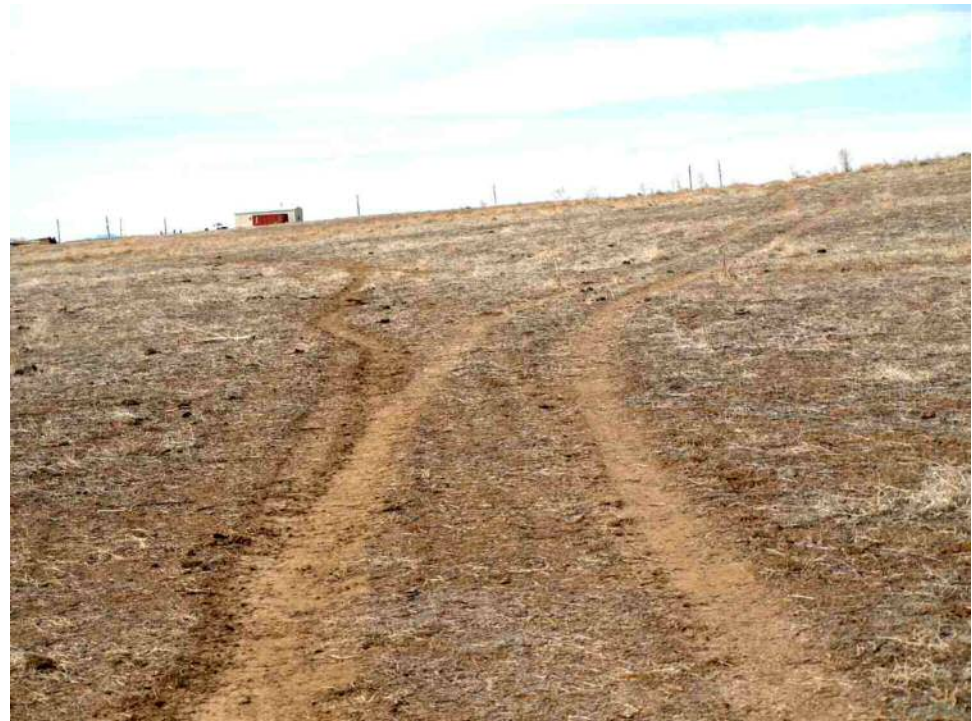
One item of concern is that it would be nice if the grazing lessee did not drive his vehicles over the pit slopes. As the photos show, a significant road is present across the west side of the pit. There is also a significant horse trail as well, but one can’t do a lot about the horses. However, vehicles should **NOT** be

**Photo 6:** Here is the location further along on the horse trail where the trail merges with the “road” that goes toward the outlet of the pit.

driven on the pit surface as it has not been released and the permit still applies to this land. Cattle and horses - OK. But **PLEASE** keep the vehicles off of the pit slopes. The climate could change and the roadway could become a severe erosion area.

**NOTE:** IT IS CERTAINLY PREFERRED THAT DRIVING ACROSS THE STILL PERMITTED AREA WOULD **NOT** BE DONE, A LIMITED AMOUNT OF THIS IS PROBABLY OK. AS LEASES ON THE LOWRY RANGE OFTEN HAVE CONSIDERABLE OVERLAP. AS EACH LESSEE IS LEASING THE ENTIRE AREA DESCRIBED IN THEIR LEASE, DOUBLE UTILIZATION OF THE LAND MAY OCCUR. IF THE PIT AREA WERE SEEDD AGAIN THIS DOUBLE USE WOULD NEED TO CEASE FOR A FEW YEARS WHILE THE VEGETATION IS DEVELOPING.
