# C1980007, West Elk Mine, March Inspection Report

# **PERMIT INFORMATION**

Permit Number: C-1980-007	County: Delta, Gunnison		
Mine Name: West Elk Mine	Operation Type: Underground		
<b>Operator:</b> Mountain Coal Company, LLC	Permit Status: Active		
Operator Address:	Ownership: Private		
Robert Munz			
5174 Highway 133	<b>Operator Representative Present:</b>		
Somerset, CO 81434			
	Natalie Stafford, Josh Thompson		
Operator Representative Signature: (Field Issuance Only)

Inspection Start Date: February 2 Inspection Start Time: 08:30 Inspection End Date: Inspection End Time:	28, 2025		Inspection Type: Coal Complete Inspection Inspection Reason: Normal I&E Program Weather: Cloudy	
Joint Inspection Agency:		Joint	Joint Inspection Contacts:	
None				
Post Inspection Agency:		Post Inspection Contacts:		
None				
Inspector(s):	Inspecto	r's Sig	nature: Signature Date:	
Leigh Simmons	Deli		April 8, 2025

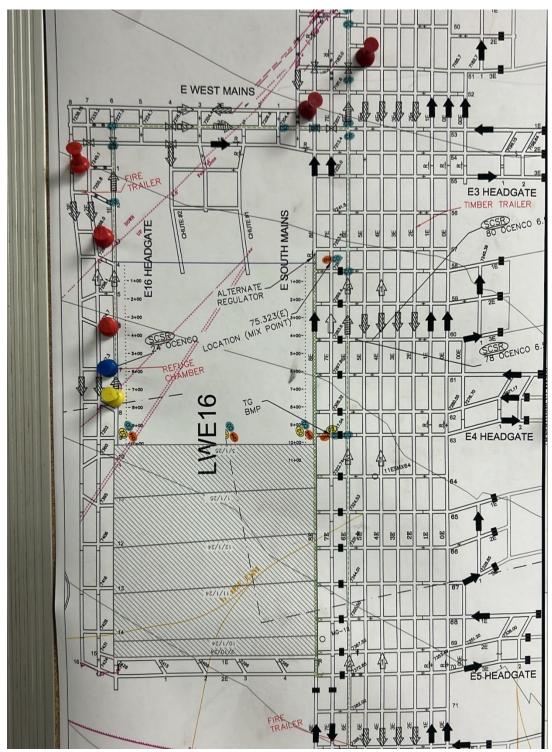
Longwall mining of the LWE16 panel was in progress, at around cross cut 9 on the head gate.

Figure 1: Mine map showing longwall progress in LWE16

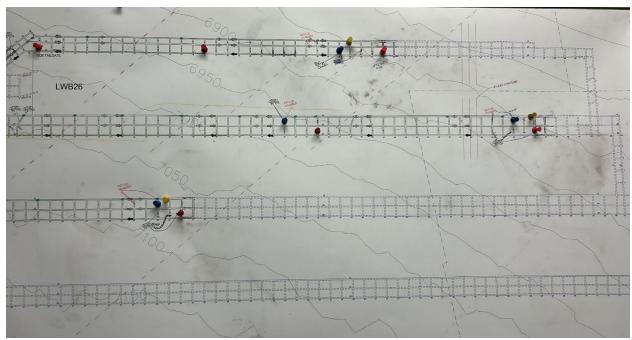
Three development crews were working: in the B26 tail gate at around cross-cut 33, in the B26 head gate at around cross-cut 56, and in the B27 head gate at around cross-cut 31.

Figure 2: Mine map showing B-seam development progress

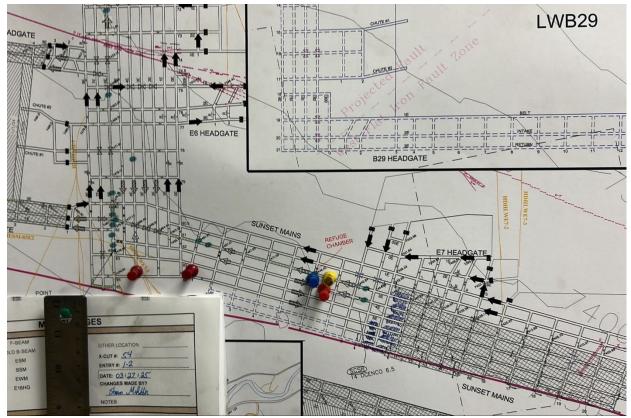
Contractors with Phoenix Mining continued to work on pillaring of the Sunset Mains, the job was nearing completion.

Figure 3: Mine map showing pillaring progress

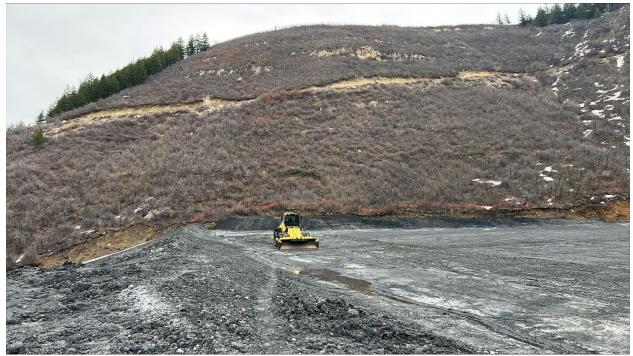
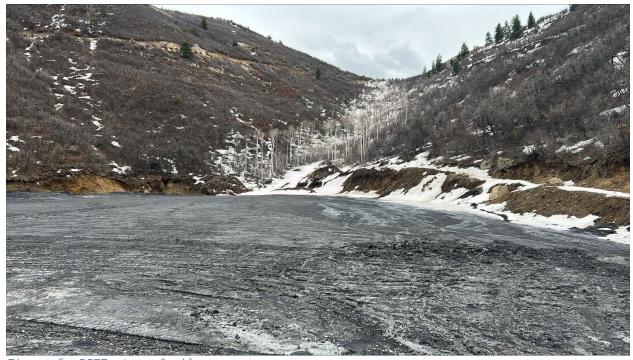
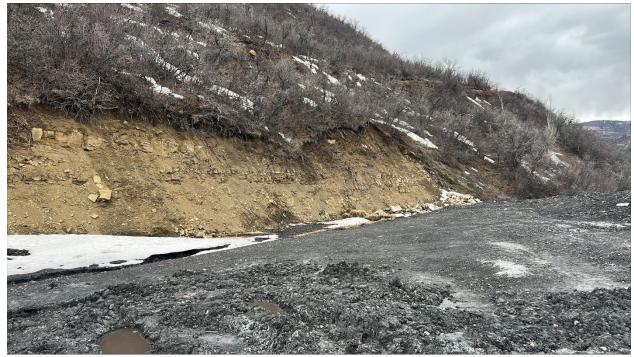
No waste had recently been transported to the RPEE, but the road was passable in a light truck. The surface of the waste pile was smooth, compact and graded to drain to the north west, but the surface material was still wet and no attempt was made to drive onto it. The recently reclaimed outslopes of the pile were in good shape after the winter, with no obvious signs of erosion. Straw wattles had remained in place.

Figure 4: RPEE, front side, top of pile

Figure 5: RPEE, top of pile

Figure 6: RPEE, northwest corner

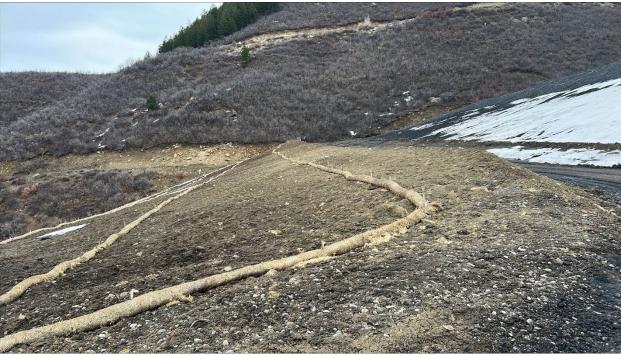
Figure 7: Recently reclaimed outslope of RPEE

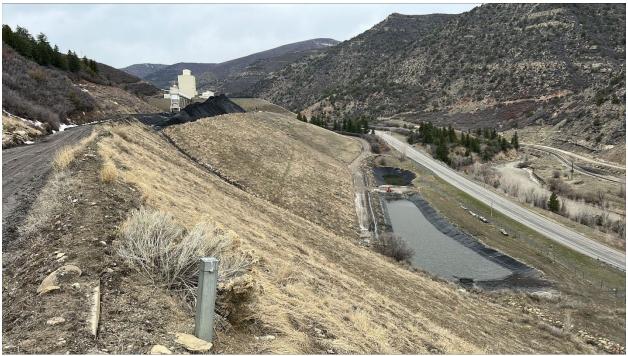
Some processing waste was being generated in order to satisfy particularly stringent shipping requirements and was being temporarily stockpiled on the RPE.

Figure 8: RPE and RPE ponds

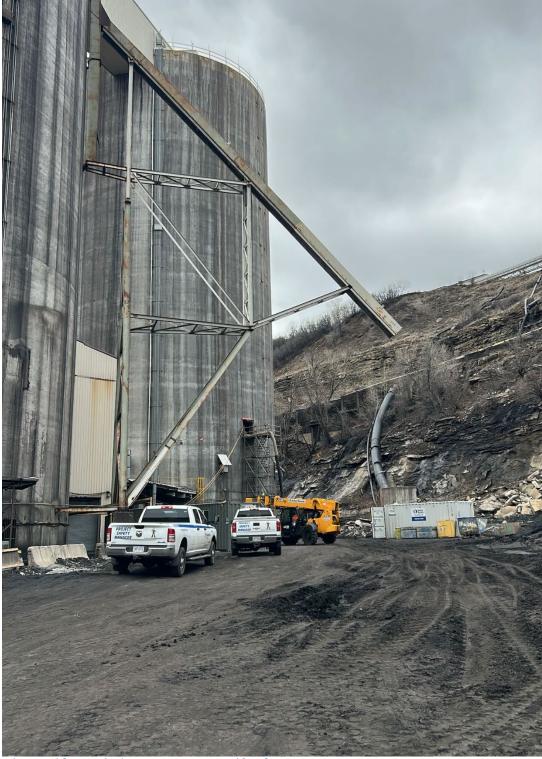
The project to line silo 2 was in progress, with 5-6 concrete trucks arriving at the site per day. The liner had been constructed up to around 48 feet.

Figure 13: Work in progress at silo 2

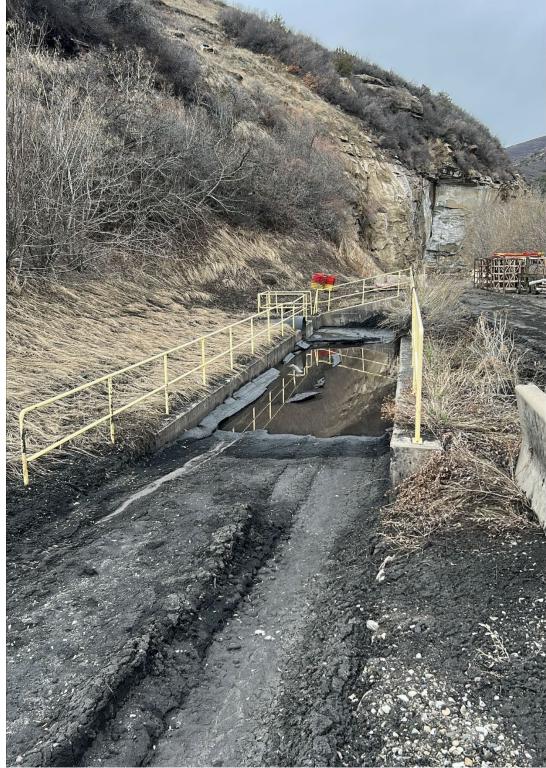
Figure 14: Sediment trap at inlet to C5E-1

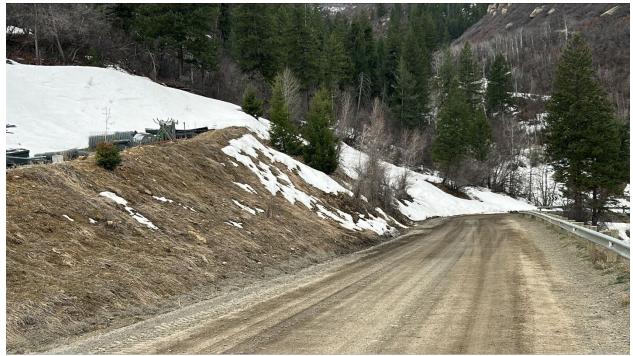
Figure 17: Small slump on edge of Material Storage Area

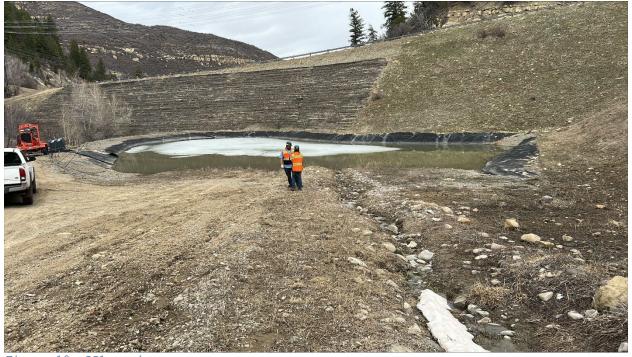
Sediment ponds SG1, RPE, MB3 and MB5E were holding water, but not discharging. No issues were observed with liners, embankments and discharge structures.

Figure 19: SG1 pond

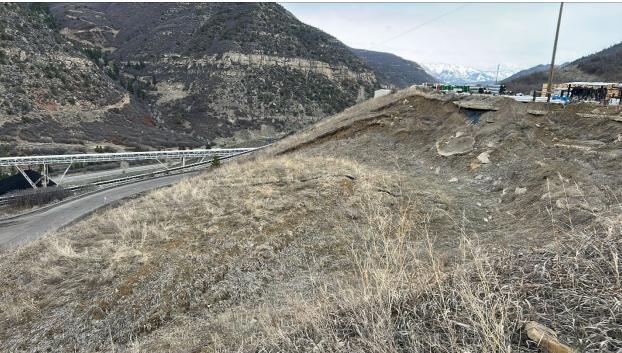
Figure 20: Slump on Material Storage Bench
