Re: Farmers Sand/Milton Reservoir M2024057- Pre-Operational Inspection Report

MINERALS PROGRAM INSPECTION REPORT
PHONE: (303) 866-3567

MINE NAME: Farmers Sand/Milton Reservoir	MINE/PROSPECTING ID#: M-2024-057	MINERAL: Sand	COUNTY: Weld
INSPECTION TYPE: Pre-operation Inspection	WEATHER: Clear	INSP. DATE: March 24, 2025	INSP. TIME: 09:00am
OPERATOR: The Farmers Reservoir and Irrigation Company	OPERATOR REPRESENTATIVE: Scott Edgar	TYPE OF OPERATION: 112c - Construction Regular Operation	
REASON FOR INSPECTION: Normal I&E Program	BOND CALCULATION TYPE: NA	BOND AMOUNT: Under review	
DATE OF COMPLAINT: NA	POST INSP. CONTACTS: None	JOINT INSP. AGENCY: None	
INSPECTOR(S): Chris Girardi Jared Ebert	INSPECTOR'S SIGNATURE:

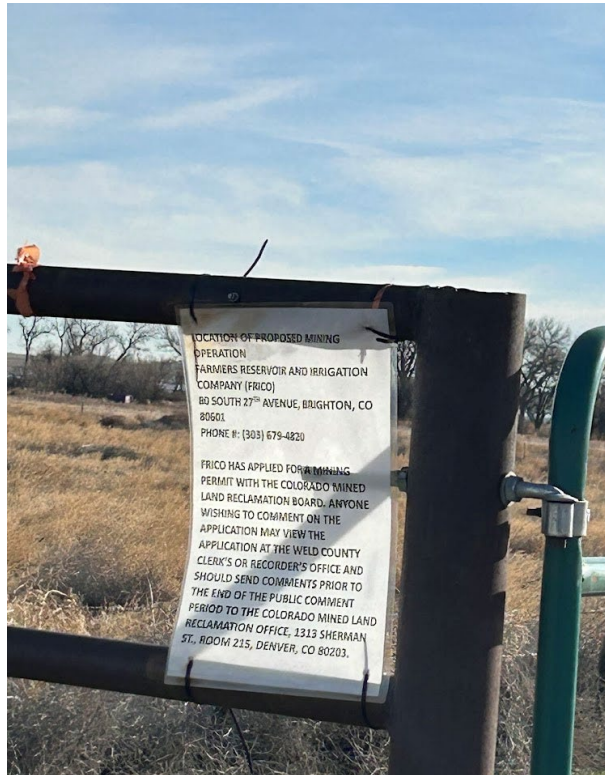
Photo 1: Mine entrance notice sign at the gate located adjacent to the northeast of County Road 32/Cavanaugh Road on the southwest side of Milton Reservoir.

The site is located approximately 9 miles southeast of LaSalle, Colorado. Notice signs (see Photos 1-5) were observed during the inspection as required by Rule 1.6.2(b). Access points to the permit area are located to the southwest, northwest, north, east, and south of the permit area. The Division met with FRICO and ERC at 9:00am at the primary mine entrance, located to the southwest of Milton Reservoir off County Road 32. The inspection started at the southwest side of the proposed affected area, which contains the West Stockpile and Stockpile 1. Both stockpiles are located along the haul road. The West Stockpile was estimated to be approximately six (6) to eight (8) feet in height, contained minor amounts of vegetation along the south end, and more recently placed sediment on the north end (see Photo 7). Stockpile 1 is significantly larger, ranging from twenty (20) to forty (40) feet in height with steep side slopes (see Photos 8-9). A grader was working on the northern end of Stockpile 1. According to FRICO, they intend to use a hydromulcher and water trucks for dust suppression. Water trucks were observed in operation at the time of the inspection. According to FRICO, salable material will be first drawn from Stockpile 1, then the North Stockpile, and the West Stockpile last. The proposed primary haul road runs parallel to Milton Reservoir on the west side (see Photo 6). The Division mentioned that additional discussions between FRICO, the Division, and Colorado Parks and Wildlife (CPW) need to be held regarding the location of the proposed future sand processing plant under consideration to be located along the southwest portion of the Milton Reservoir and the Stockpile 1 location (see Photo 9).

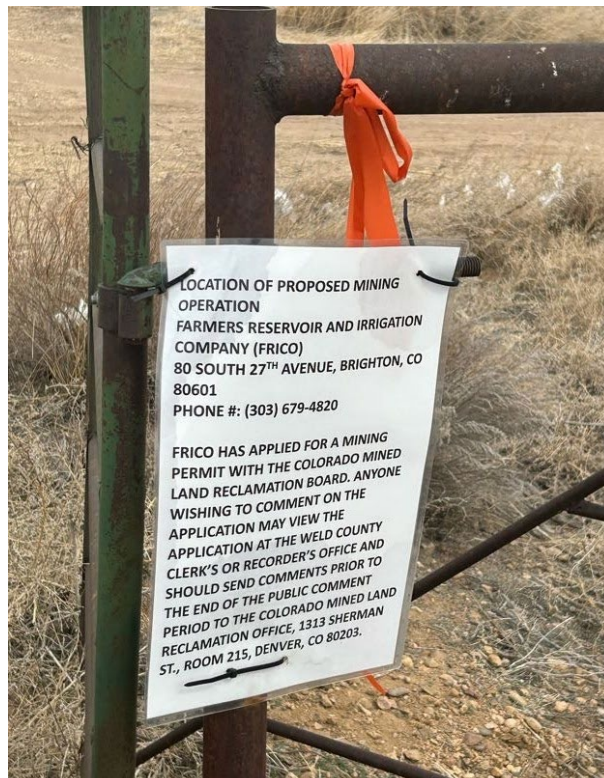
Photo 2: Mine entrance notice sign at the gate located on an access road approximately 0.37 miles to the north of County Road 30 to the south of Milton Reservoir.

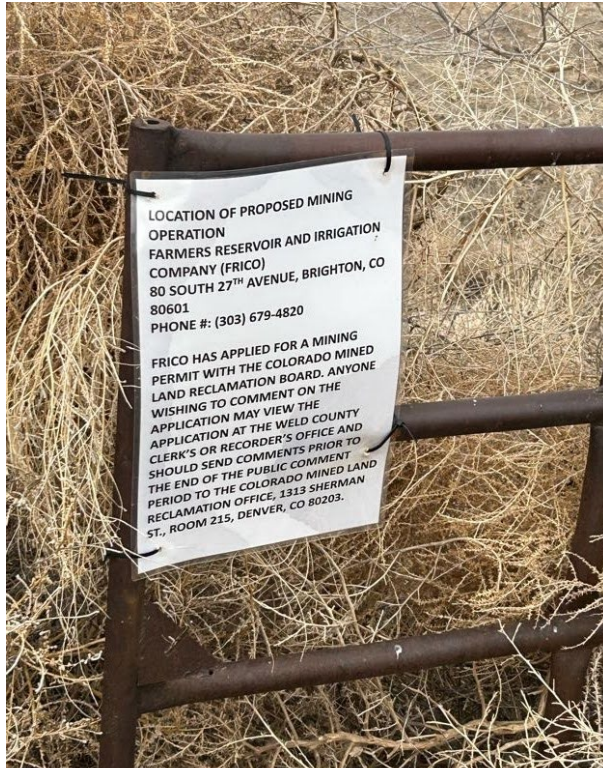
Photo 3: Mine entrance notice sign at the gate located on an access road approximately 0.13 miles to the west of County Road 47 to the east of Milton Reservoir.

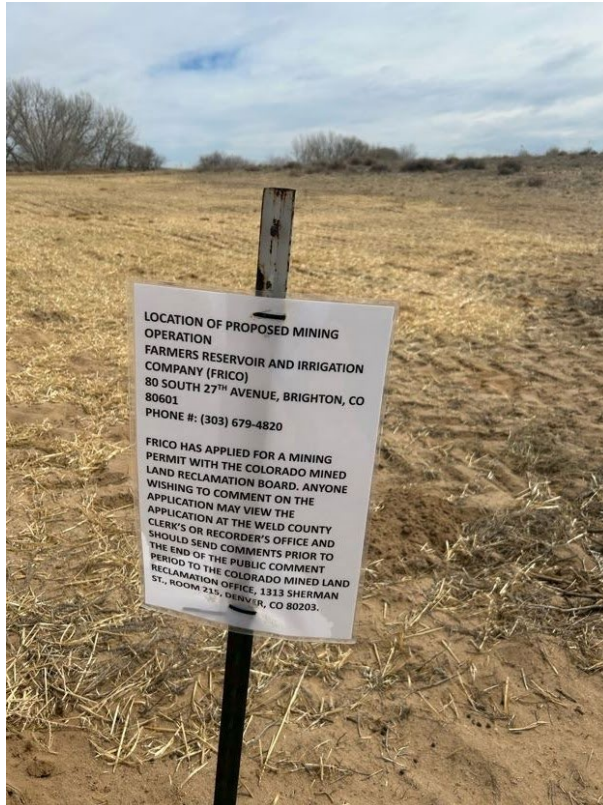
Photo 5: Mine entrance notice sign at the gate located on Beebe Draw Farms Parkway to the northeast of Milton Reservoir and adjacent to the Platte Valley Canal.

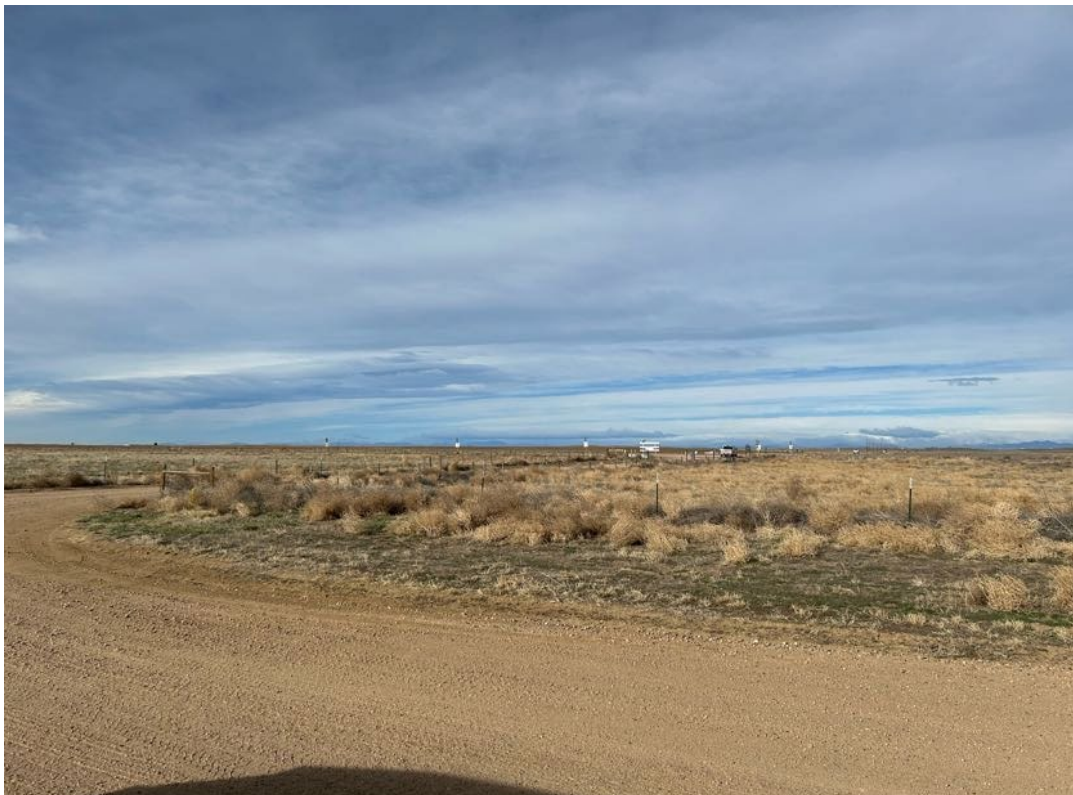
Photo 6: View of haul road that runs parallel to Milton Reservoir, facing southwest.

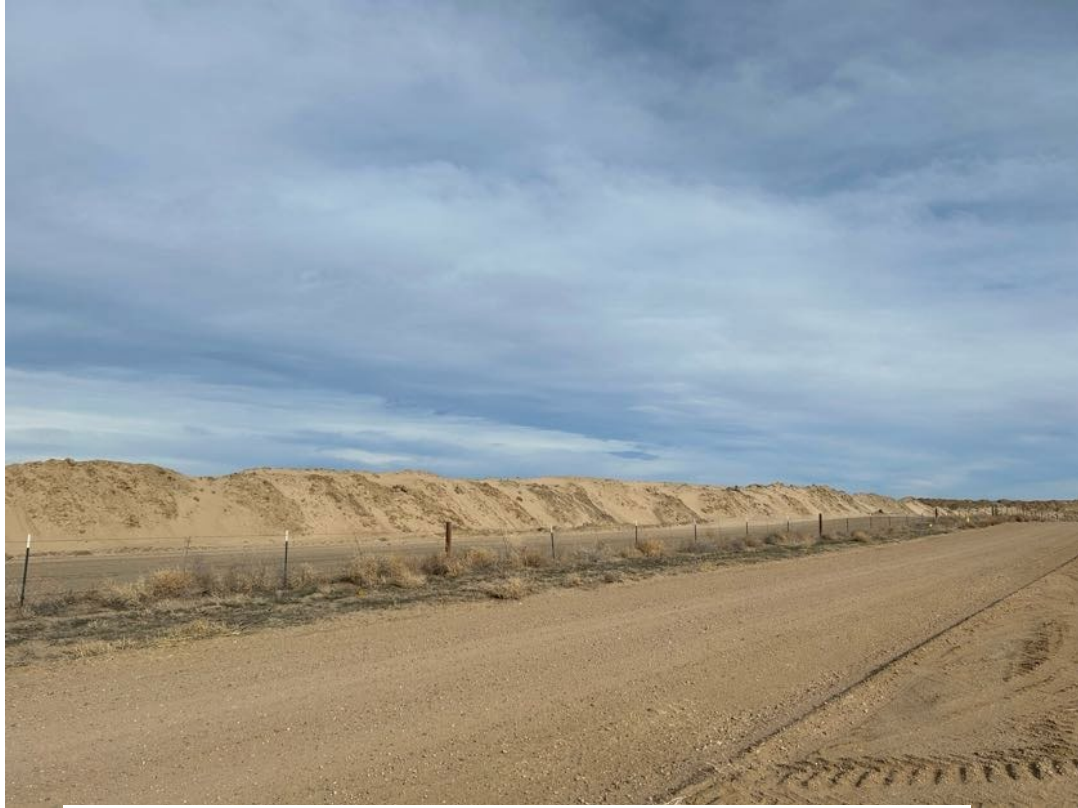
Photo 7: View of the West Stockpile, facing northwest.

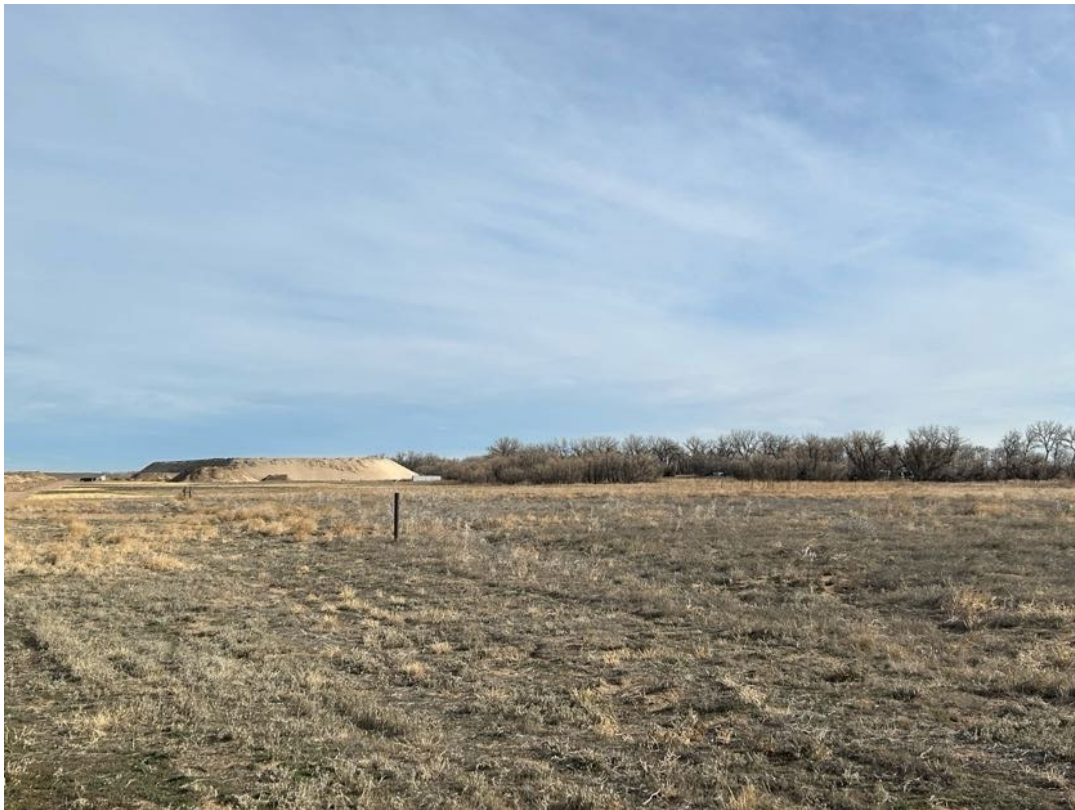
Photo 8: View of Stockpile 1 and the adjacent land to the south, facing north.

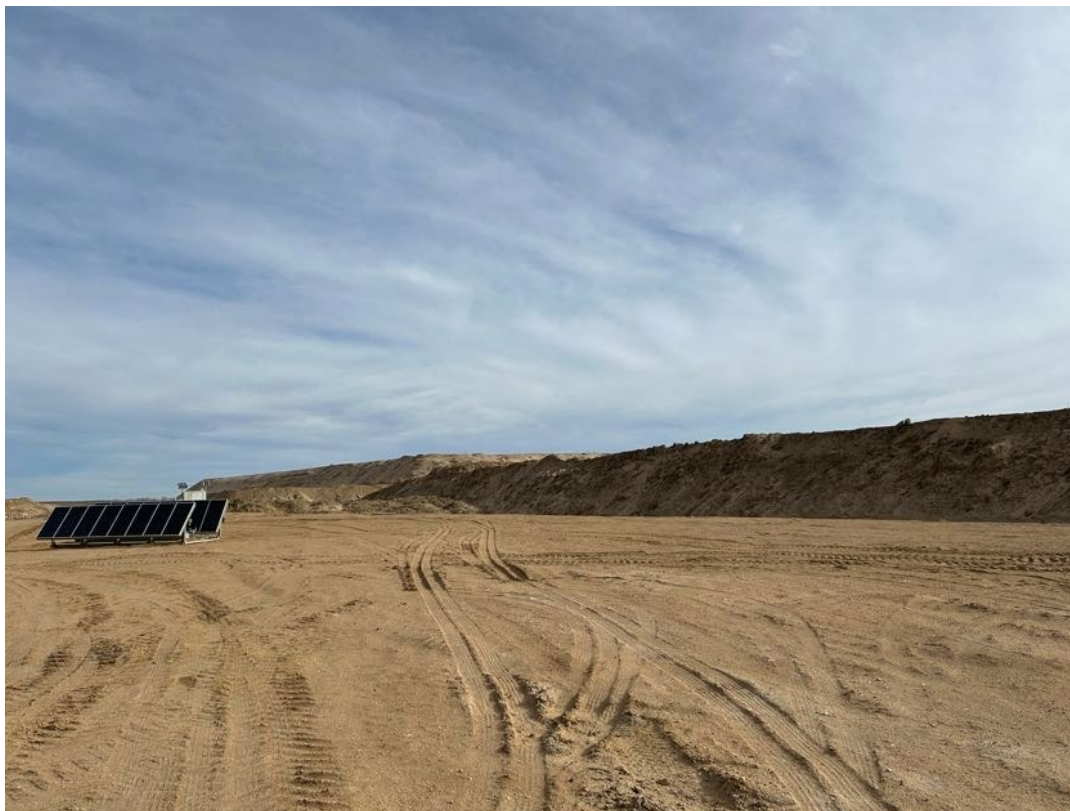
Photo 9: View of Stockpile 1, facing north.

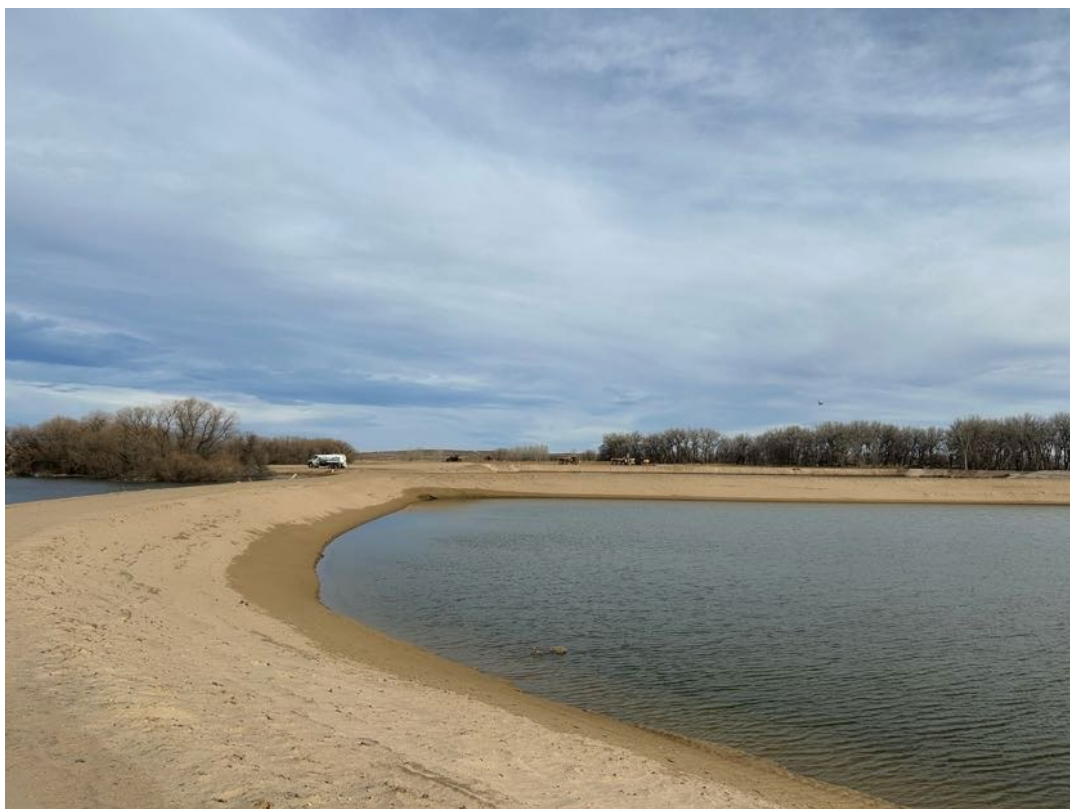
Located to the north of Stockpile 1 and the West Stockpile adjacent to Milton Reservoir are the In-Res Settling Ponds, which were the initial settling ponds before subsequent settling ponds were constructed to account for the increased amount of dredged material. These settling ponds are separated by low embankments and allow dewatering of the material from the base of the ponds through interconnected pipes. The Division was able to drive along the embankments (see Photos 10-11). All the settling ponds had gentle side slope configurations graded at a 3:1 horizontal to vertical ratio or less and were filled with water. The dredged material is still being excavated from the ponds. Four haul trucks and one excavator were active at the time of the inspection. Several species of birds were observed along the embankments, including pelicans and eagles (see Photo 12).

Photo 10: View of an In-Res Settling Pond and a water truck, facing north.

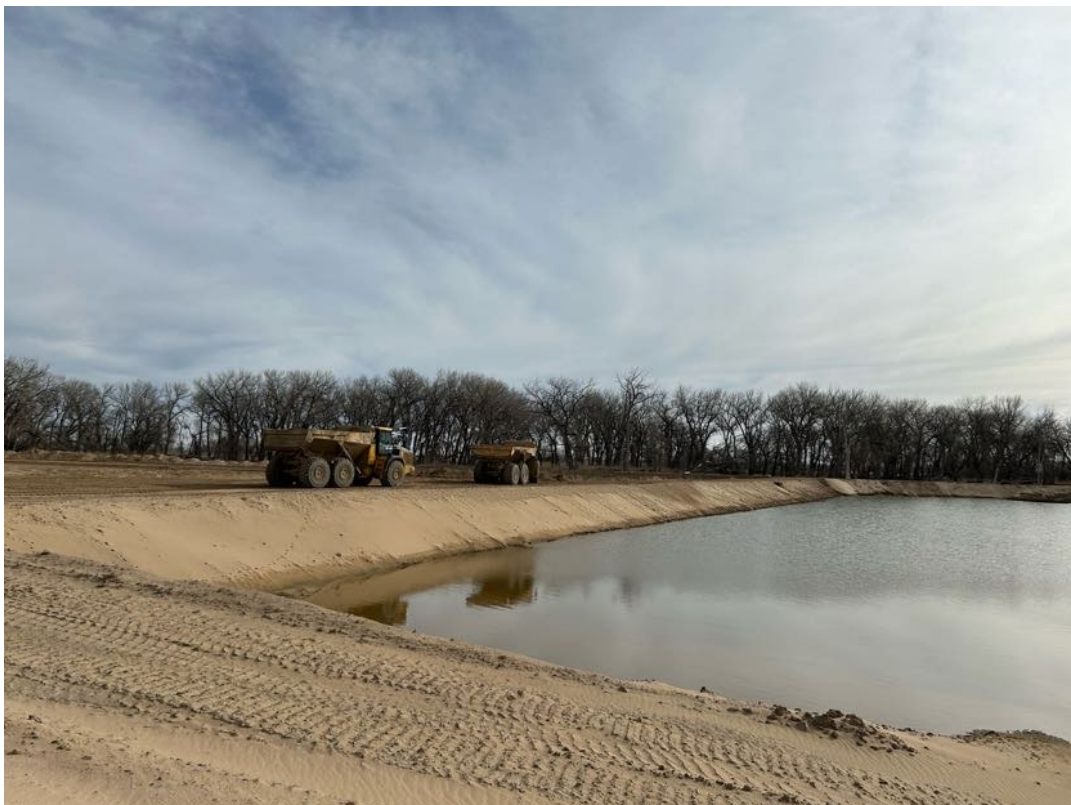
Photo 11: View of In-Res Settling Pond and haul trucks, facing east.

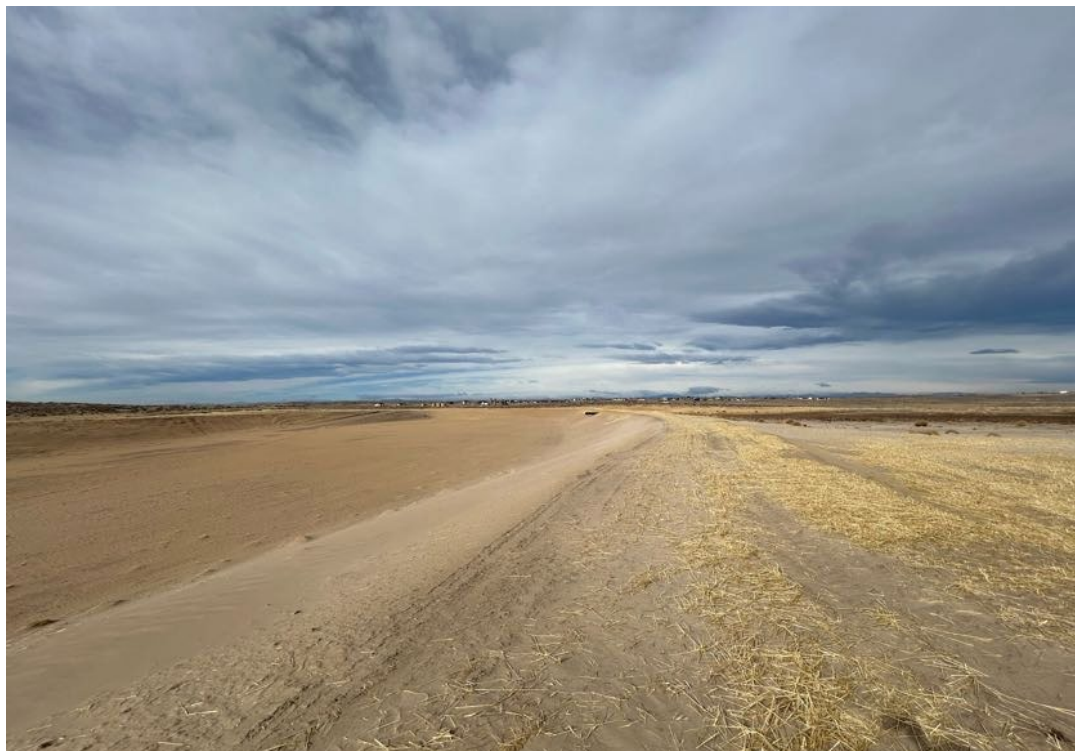
After the material is dredged from the bottom of Milton Reservoir, the material is pumped the equalizing tank, then pumped to the cyclone. The overflow from the cyclone is then delivered via a pipeline to the settling ponds where any fine-grained material will settle in the before the water is diverted back to Milton Reservoir. The settling ponds are connected via overflow spillways (see Photo 15). After the material is dewatered in the settling ponds, the sand is excavated and transported to the stockpiles. At the time of the inspection, all four settling ponds did not contain water. In addition, the side slopes of the ponds exhibited 3:1 configuration, the side slopes had been hydro-mulched. According to the Applicant, the side slopes and embankments (see Photos 13-15) had also been seeded as dust and erosion control measures.

Photo 13: View of the North Settling Pond 2, pond side slopes, seeded embankment, facing west.

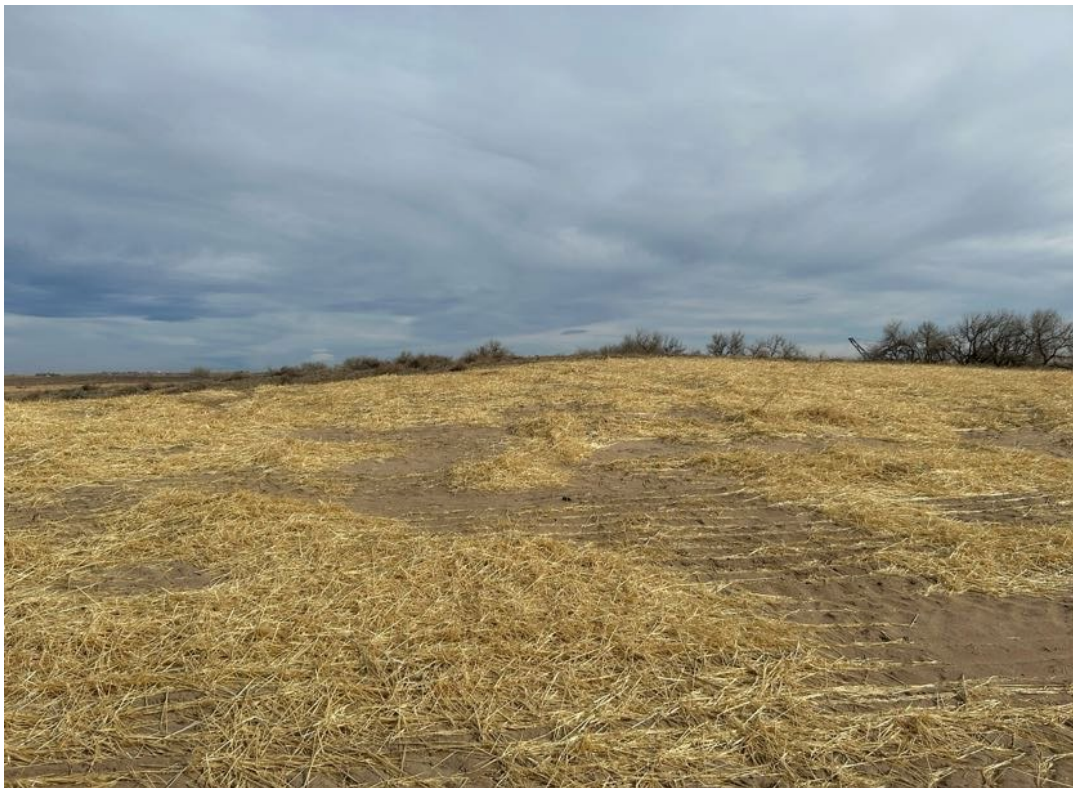
Photo 14: View of seeded embankment between North Settling Ponds 2 and 3A, facing northeast.

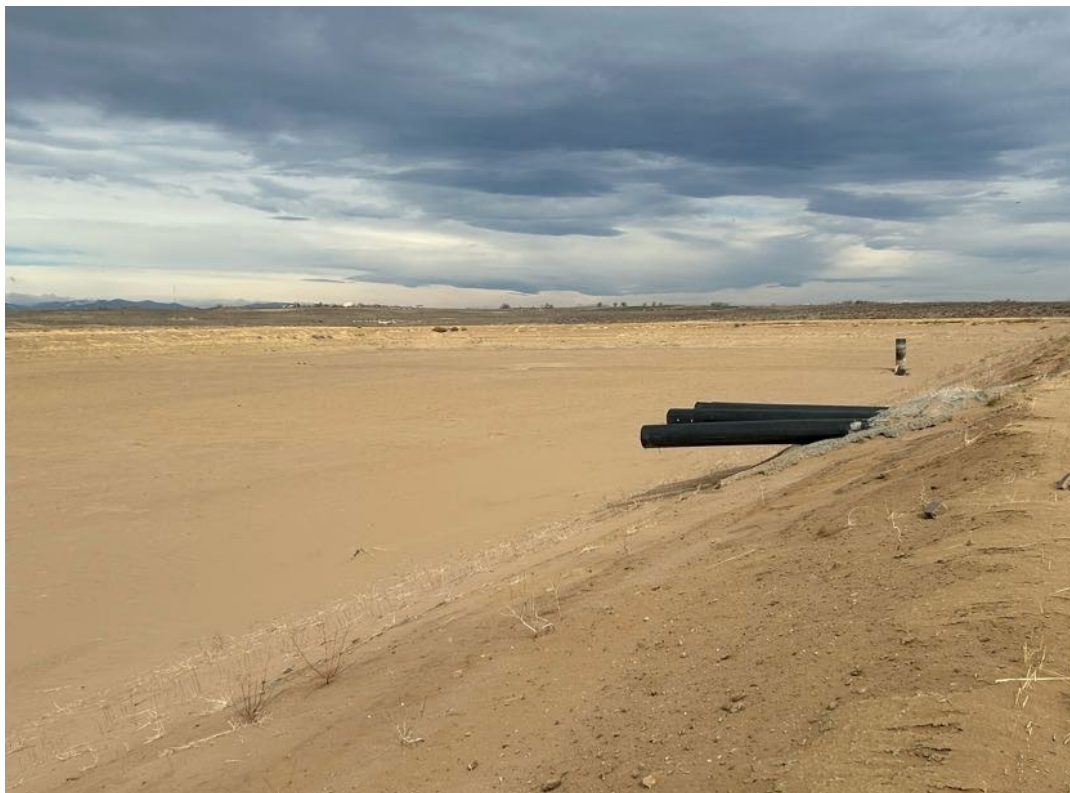
Photo 15: Overflow spillway pipes connecting North Settling Pond 4 and Milton Reservoir, facing north.

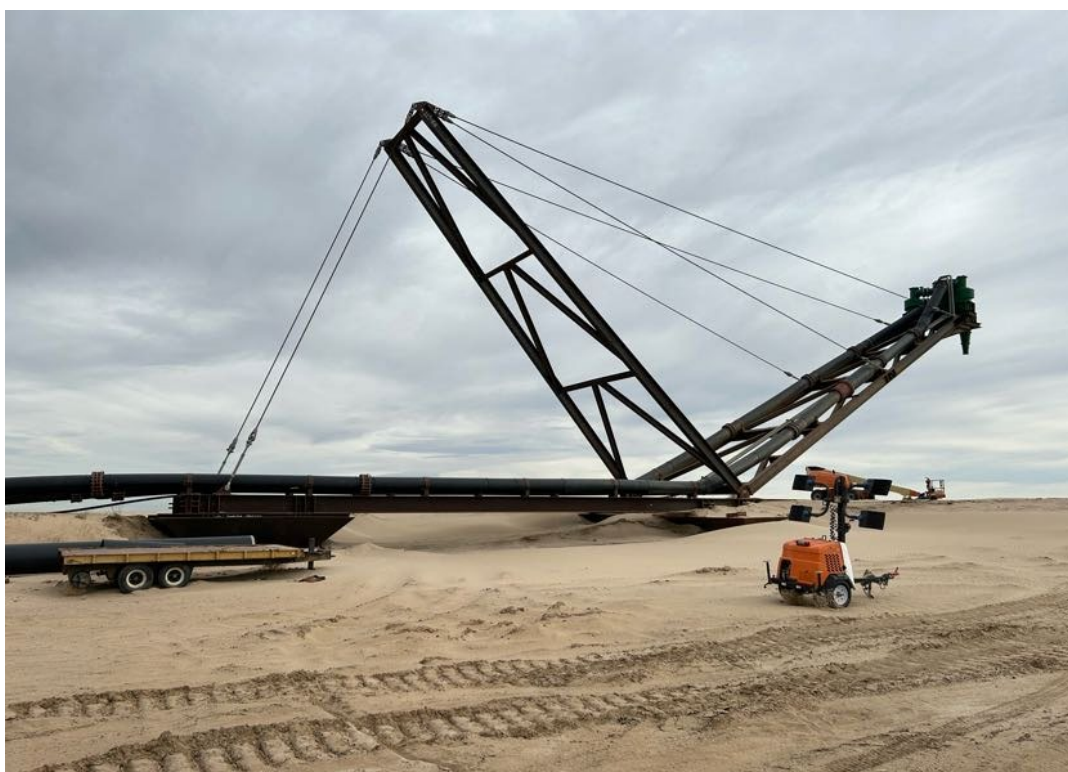
Photo 16: View of Cyclone in the North Fill Area near the N1 Stockpile, facing north.

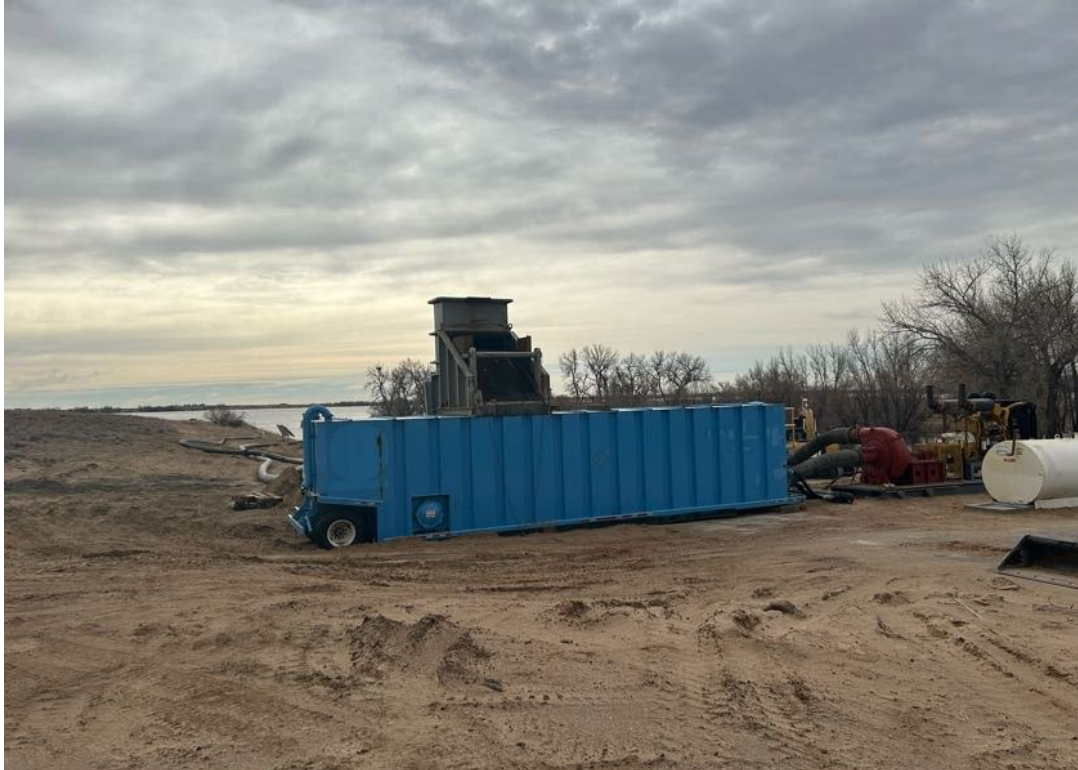
At the time of the inspection, the dredge was not operational and was located along the northern shoreline of Milton Reservoir where the Platte Valley Canal discharges to the reservoir. FRICO intends to resume dredging in March, however they are awaiting the installation of liners along several embankments before they can resume dredging operations. The Cyclone was inactive at the time of the inspection and was currently undergoing maintenance (see Photo 16). A laydown area was located along this shoreline and contained various equipment, including an excavator, a water holding tank, and fuel storage tanks (see Photo 17). No problems were observed in the laydown area.

Photo 17: View of the Laydown Area, including the Water Holding Tank and fuel storage tank facing south towards Milton Reservoir.

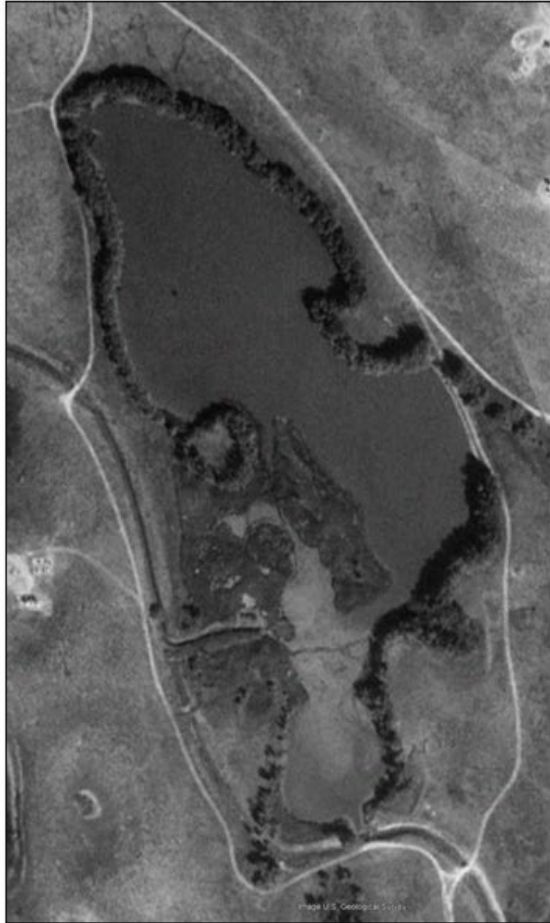
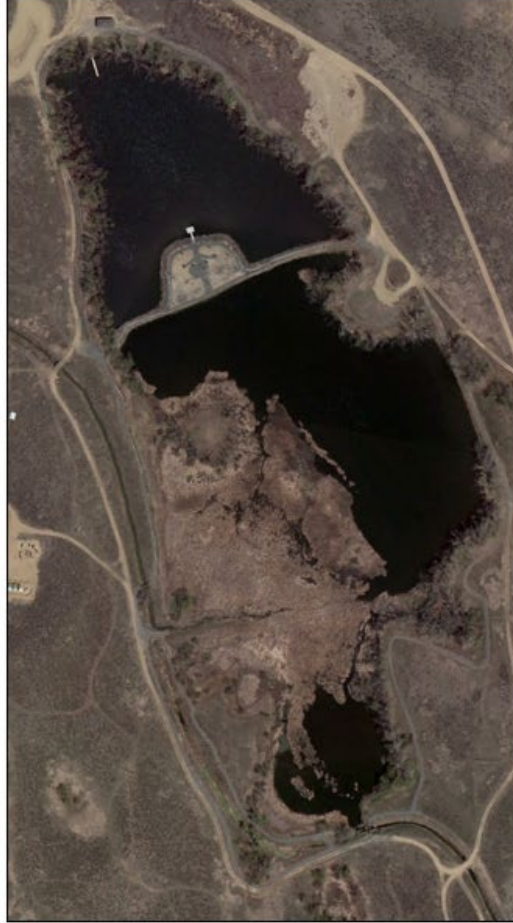
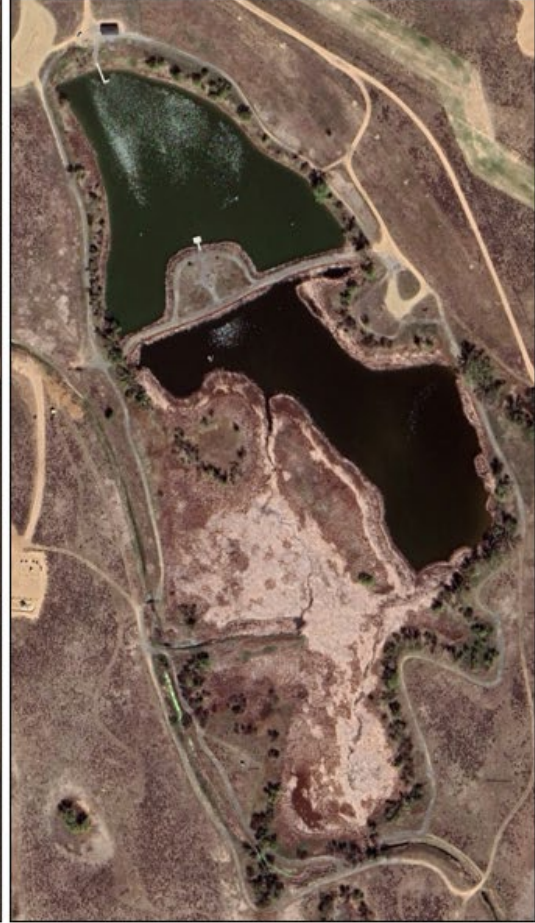
Figure 1 – Lake Christina Timelapse

A. September 29, 1999, Google Earth Image

B. May 4, 2011, Google Earth Image

C. May 2, 2024, Google Earth Image

The Division observed Lake Christina from the south end, as the north and south portions of the lake are separated by an earthen berm (see Photo 19). The sediment material being removed from Lake Christina by FRICO is being transported to an area adjacent to the east side of the Platte Valley Canal. Upon observation, the excavated material appeared to predominantly be a clayey sand. The material was mostly brown and with minor amounts of dark grey, was dry, and exhibited no hydrocarbon staining or distinguishable odor (see Photo 18). Minor amounts of mulch was intermixed with the material. According to the Operator, the excavated material will not be sold and will remain onsite where the area will be reclaimed via grading and reseeded. FRICO has a discharge permit for the dredging operations. The Division has been in communication with the Colorado Department of Public Health and Environmental (CDPHE) and they are aware of the situation and will be conducting their own inspection.
