PERMIT INFORMATION

Permit Number: C-1980-007 Mine Name: West Elk Mine Operator: Mountain Coal Company, LLC Operator Address: Robert Munz 5174 Highway 133 Somerset, CO 81434	County: Delta, Gunnison Operation Type: Underground Permit Status: Active Ownership: Private
	Operator Representative Present: Natalie Stafford, Josh Thompson
Operator Representative Signature: (Field Issuance Only)

INSPECTION INFORMATION

COMMENTS

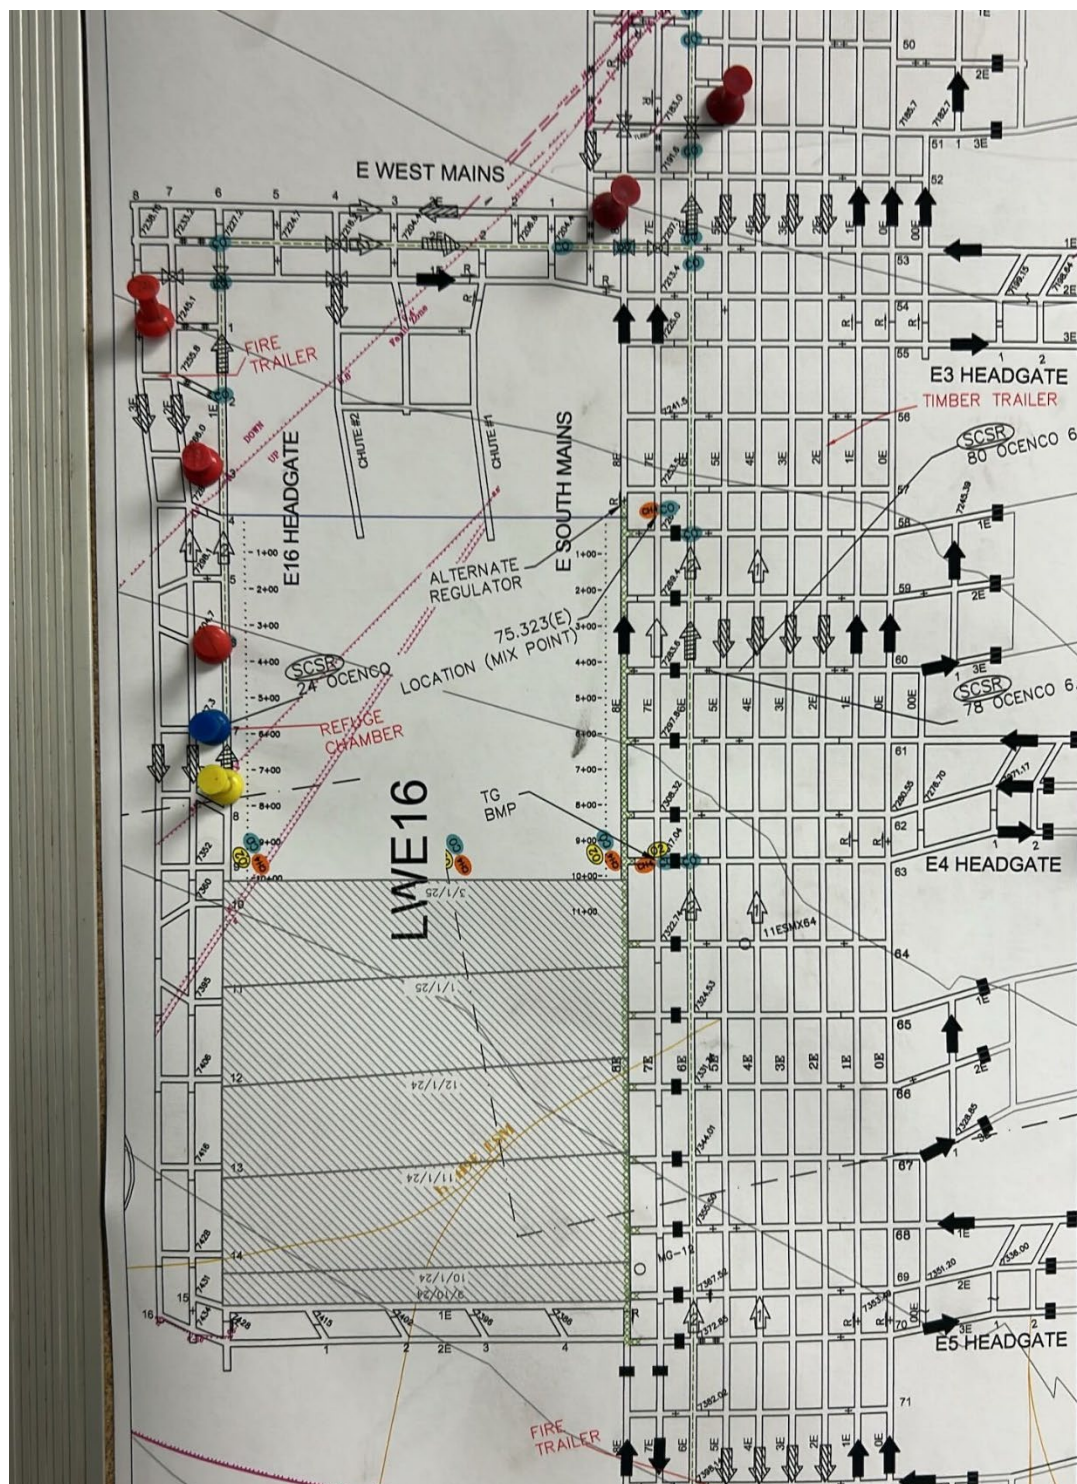
Figure 1: Mine map showing longwall progress in LWE16

Longwall mining of the LWE16 panel was in progress, at around cross cut 9 on the head gate.

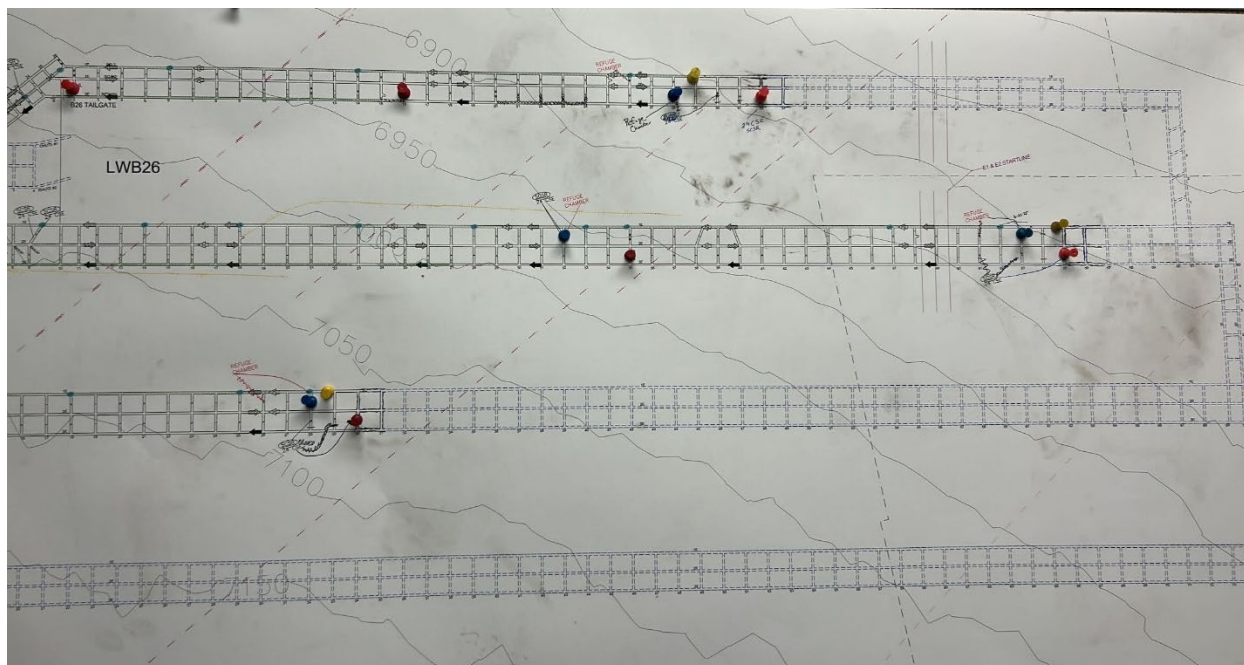
Figure 2: Mine map showing B-seam development progress

Three development crews were working: in the B26 tail gate at around cross-cut 33, in the B26 head gate at around cross-cut 56, and in the B27 head gate at around cross-cut 31.

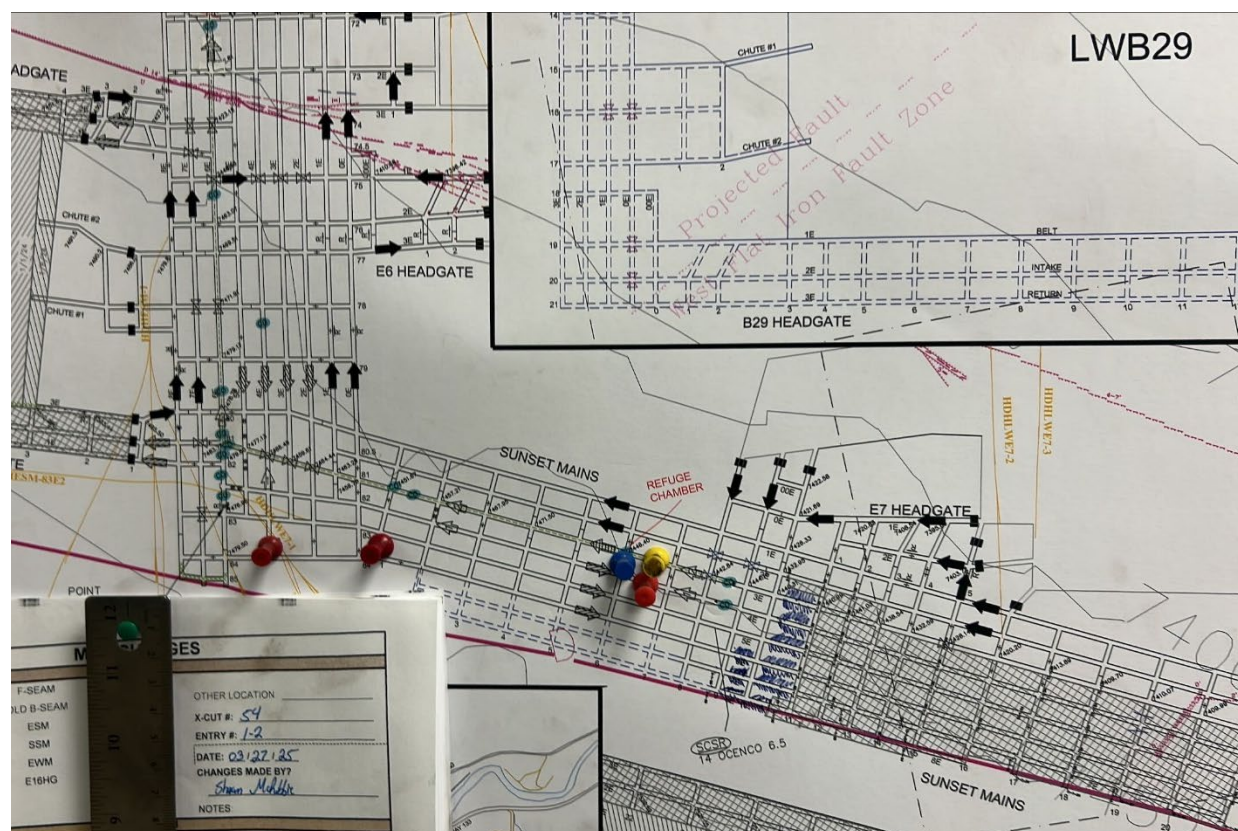
Figure 3: Mine map showing pillaring progress

Contractors with Phoenix Mining continued to work on pillaring of the Sunset Mains, the job was nearing completion.

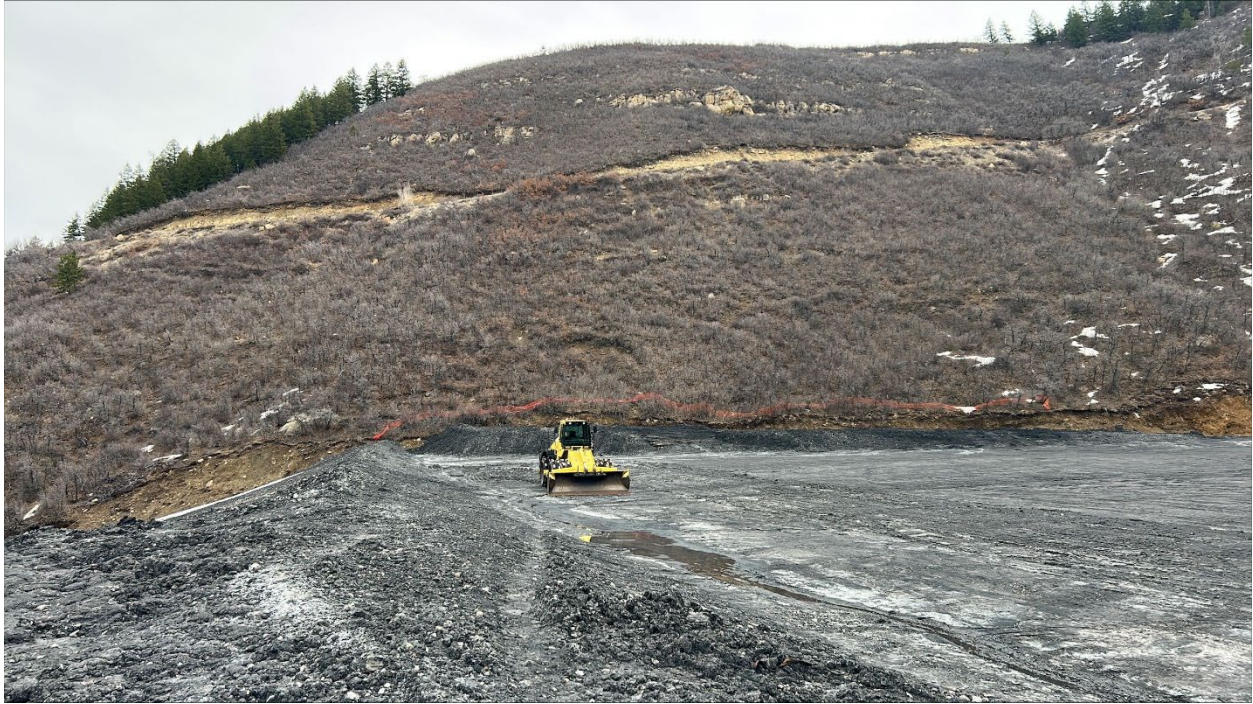
No waste had recently been transported to the RPEE, but the road was passable in a light truck. The surface of the waste pile was smooth, compact and graded to drain to the north west, but the surface material was still wet and no attempt was made to drive onto it. The recently reclaimed outslopes of the pile were in good shape after the winter, with no obvious signs of erosion. Straw wattles had remained in place.

Figure 4: RPEE, front side, top of pile

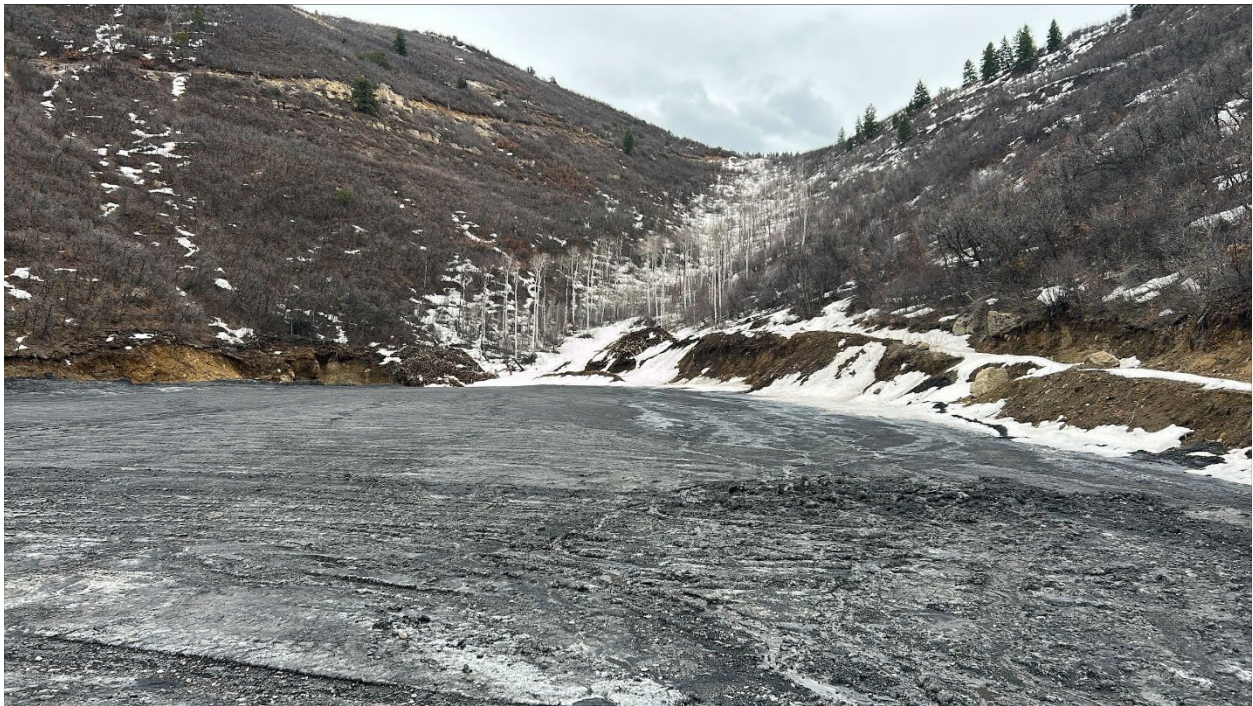
Figure 5: RPEE, top of pile

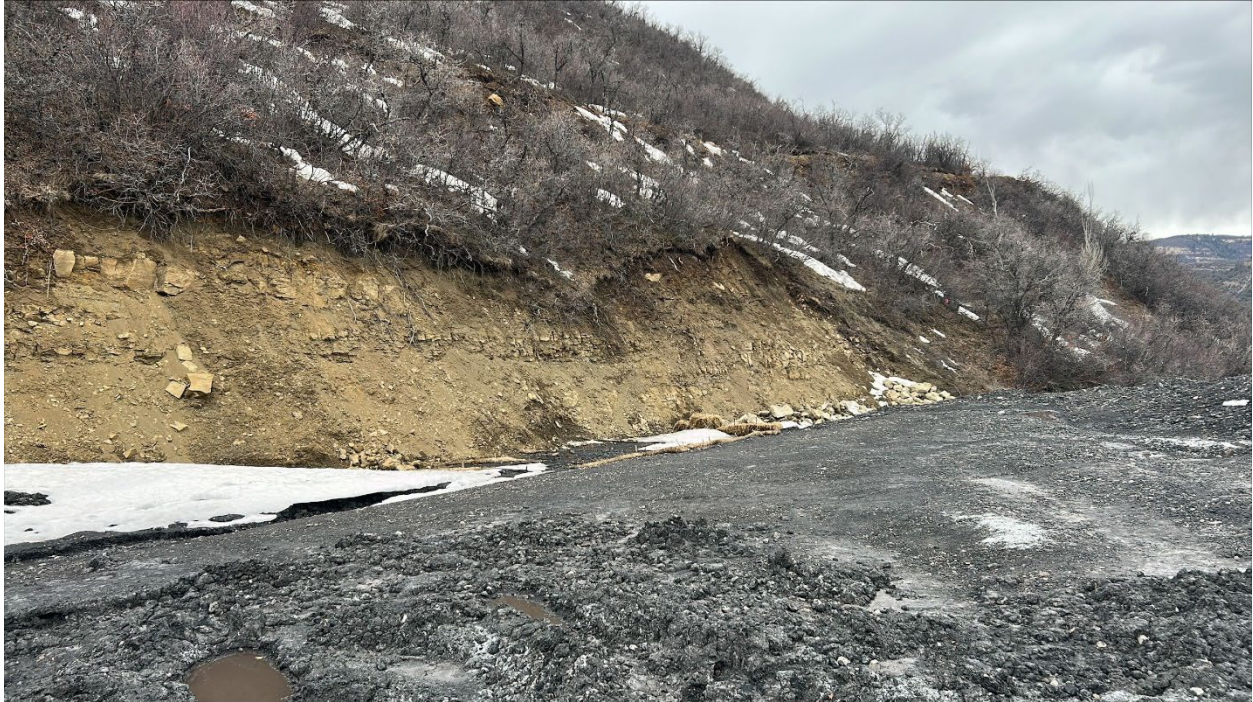
Figure 6: RPEE, northwest corner

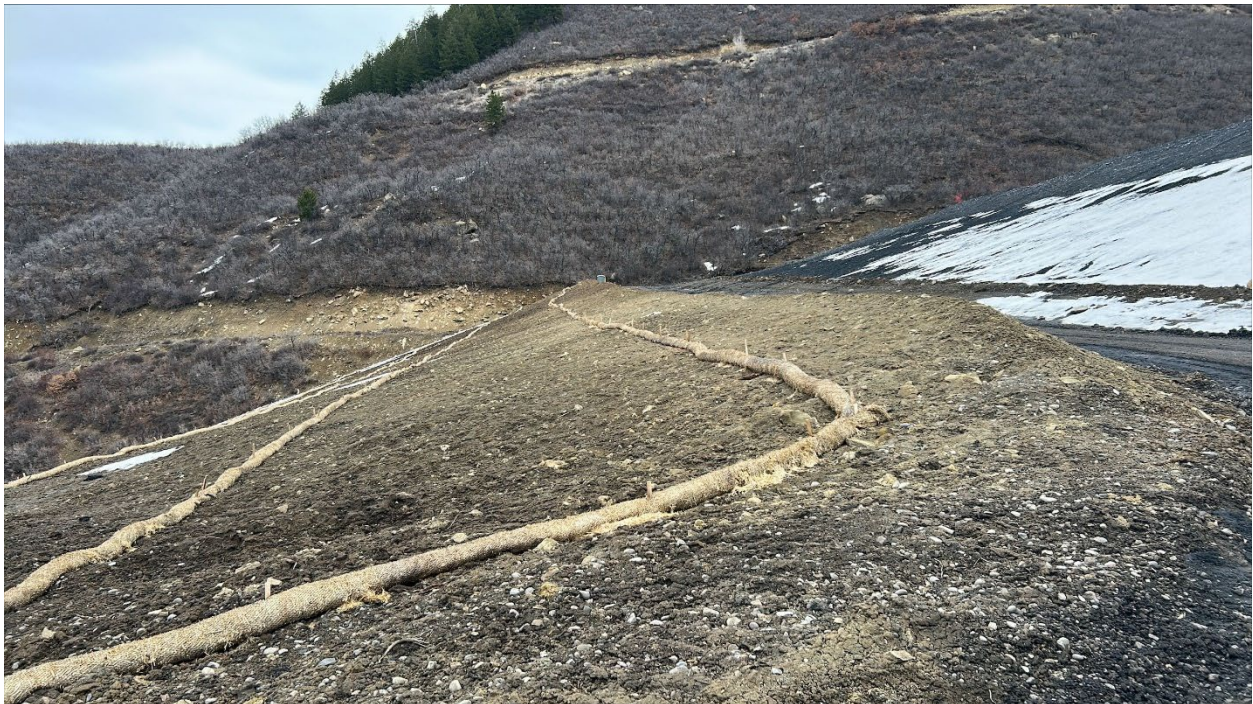
Figure 7: Recently reclaimed outslope of RPEE

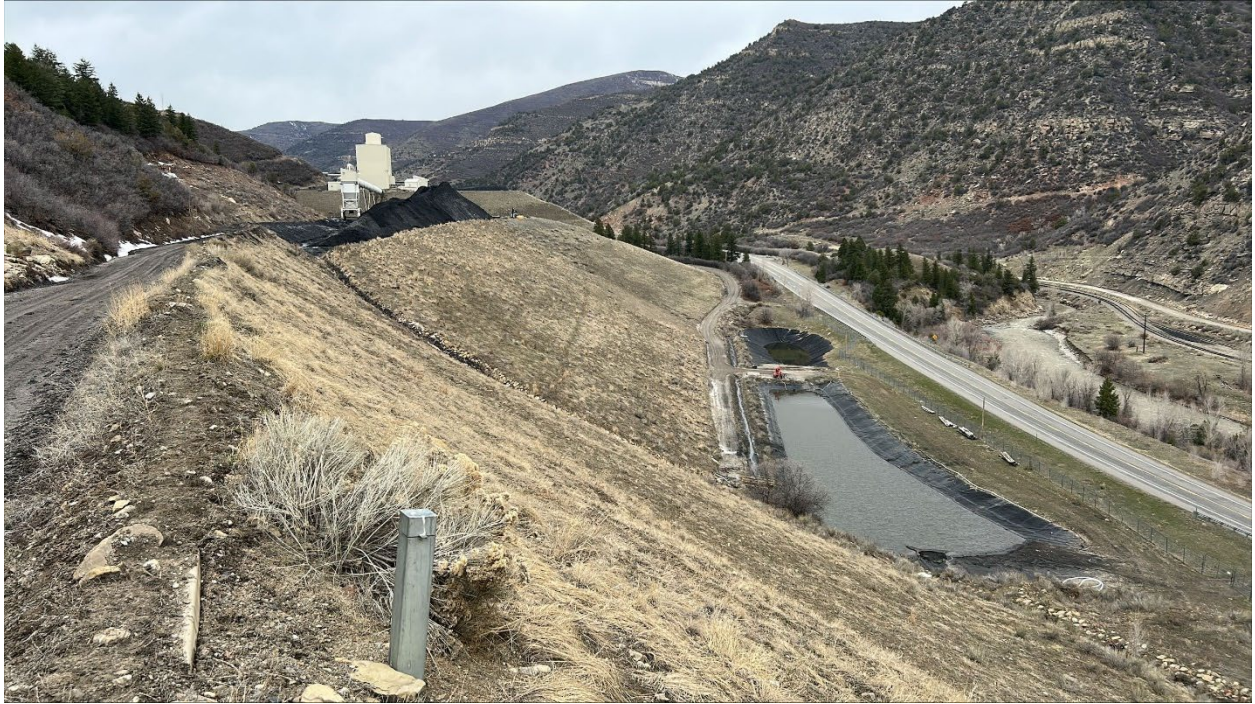
Sediment ponds SG1, RPE, MB3 and MB5E were holding water, but not discharging. No issues were observed with liners, embankments and discharge structures.

Some processing waste was being generated in order to satisfy particularly stringent shipping requirements and was being temporarily stockpiled on the RPE.

Figure 8: RPE and RPE ponds

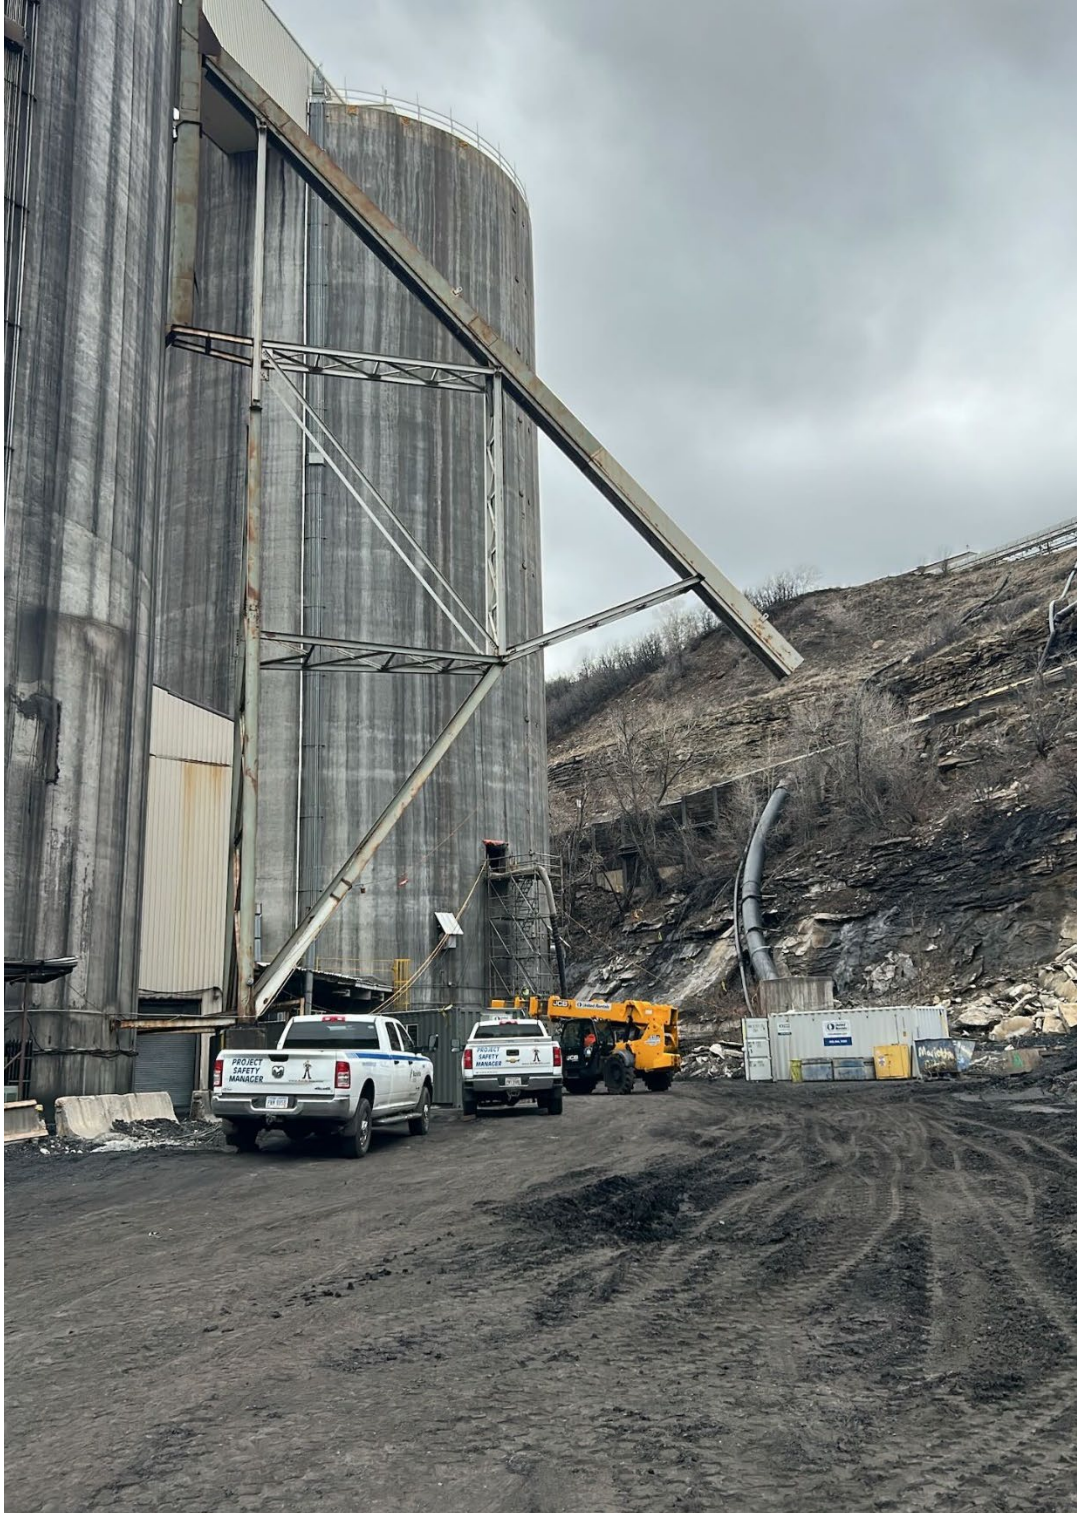
The project to line silo 2 was in progress, with 5-6 concrete trucks arriving at the site per day. The liner had been constructed up to around 48 feet.

Figure 13: Work in progress at silo 2

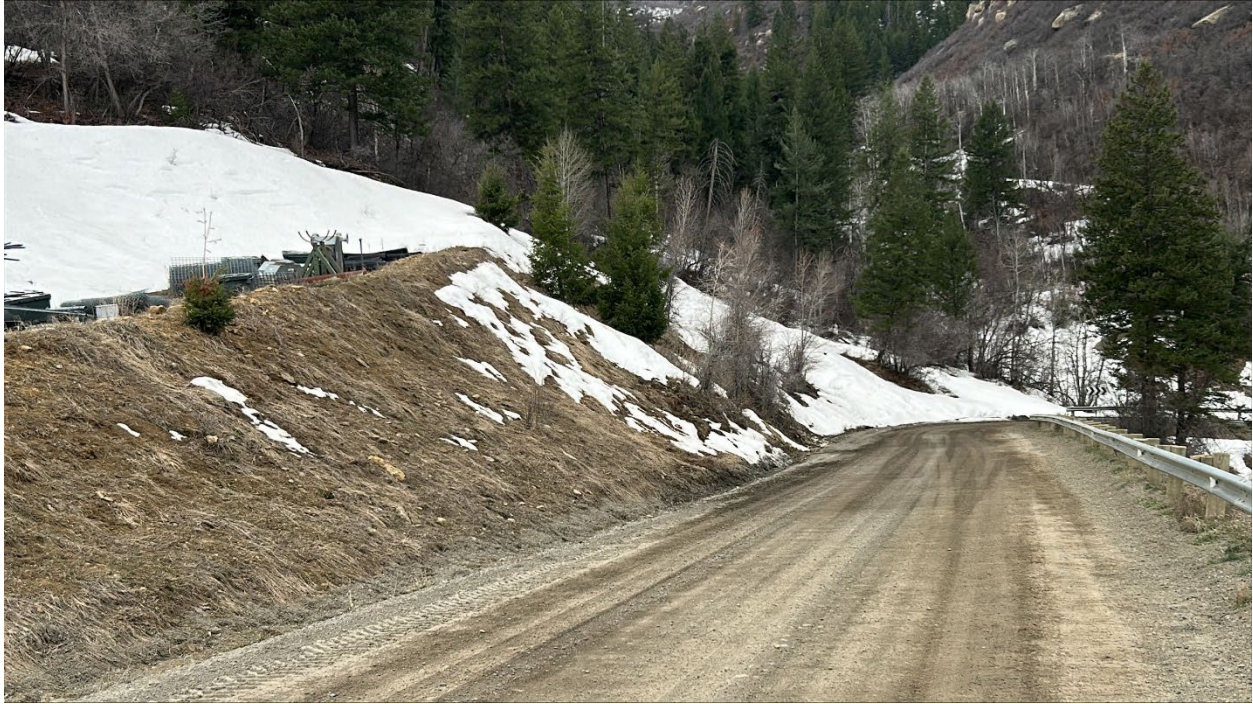
Figure 17: Small slump on edge of Material Storage Area

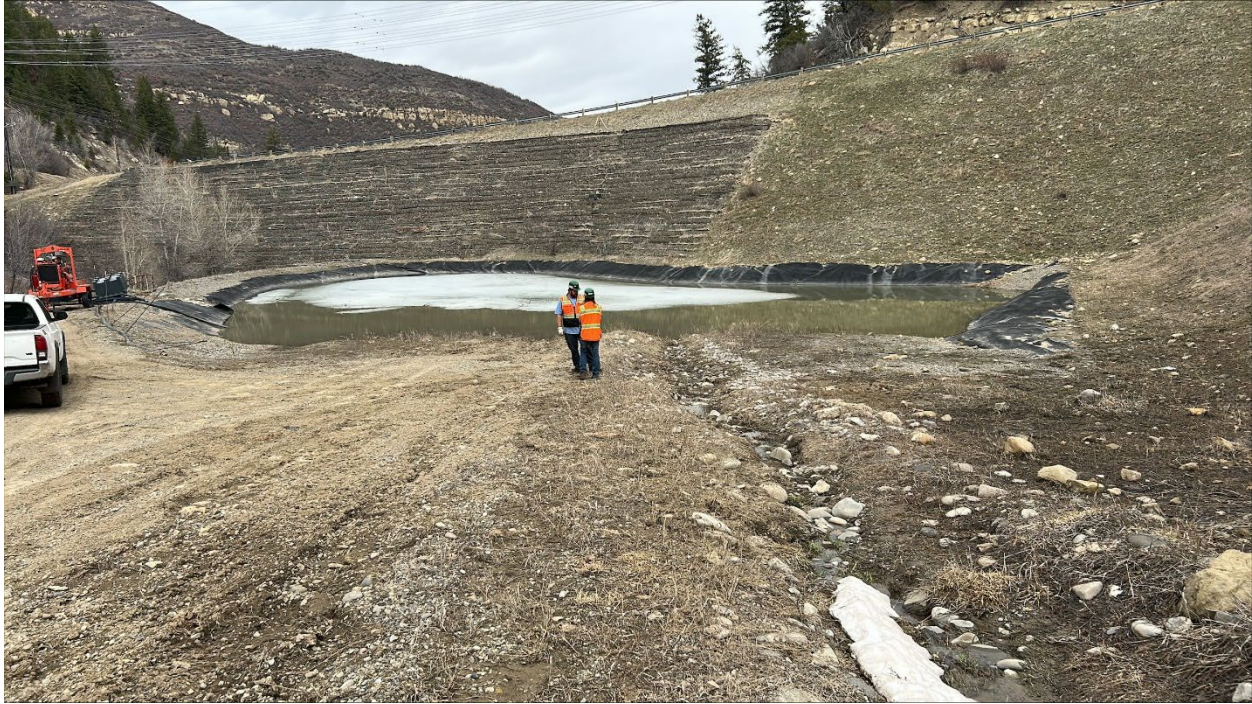
Figure 19: SGI pond

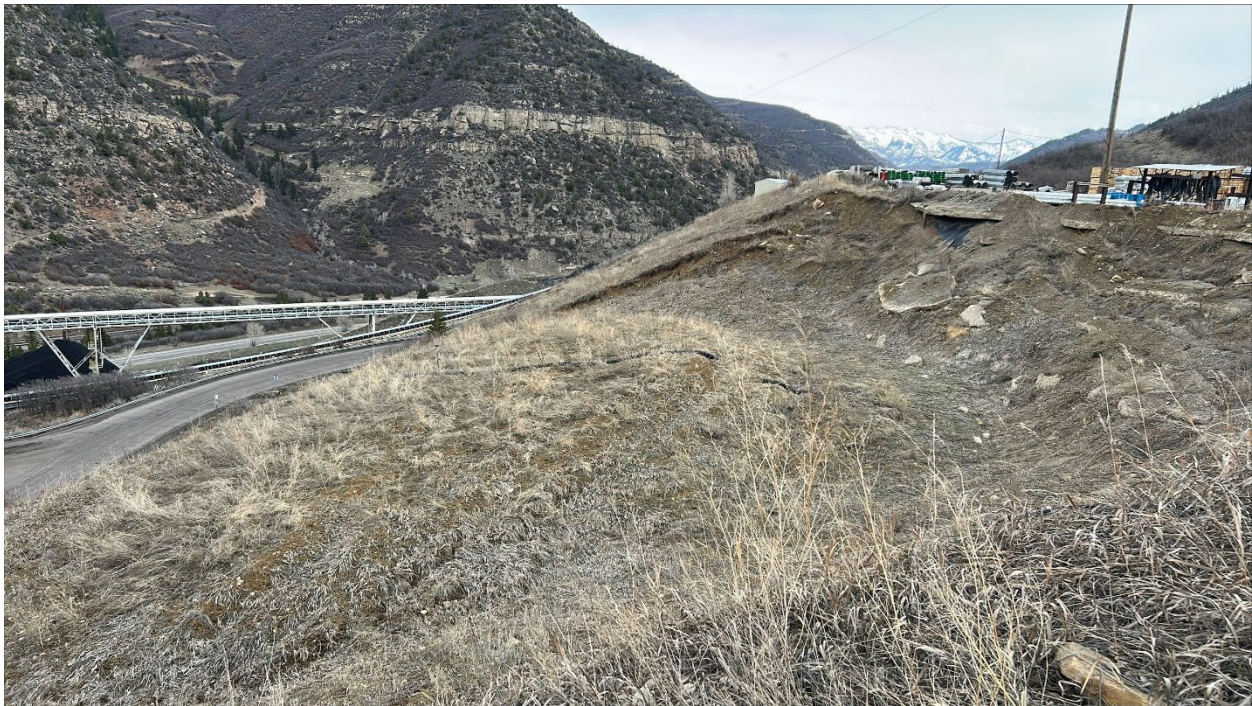
Figure 20: Slump on Material Storage Bench
