MINERALS PROGRAM INSPECTION REPORT
PHONE: (303) 866-3567

MINE NAME: Henderson Mine	MINE/PROSPECTING ID#: M-1977-342	MINERAL: Molybdenum	COUNTY: Clear Creek
INSPECTION TYPE: Monitoring	WEATHER: Cool, Partly Cloudy	INSP. DATE: March 17, 2025	INSP. TIME: 09:00
OPERATOR: Climax Molybdenum Company	OPERATOR REPRESENTATIVE: Ron Hickman and Miguel Hamarat	TYPE OF OPERATION: 112d-3 - Designated Mining Operation	
REASON FOR INSPECTION: Normal I&E Program	BOND CALCULATION TYPE: None	BOND AMOUNT: \$271,566,513.00	
DATE OF COMPLAINT: NA	POST INSP. CONTACTS: None	JOINT INSP. AGENCY: None	
INSPECTOR(S): Nikie Gagnon	INSPECTOR'S SIGNATURE:

The current Environmental Protection Plan (EPP) for the Mine and Mill was approved by the Division under Technical Revision no. 34 (TR34). The purpose of the inspection was to observe the designated chemical storage facilities listed in Section 7.2.2 of the approved EPP.

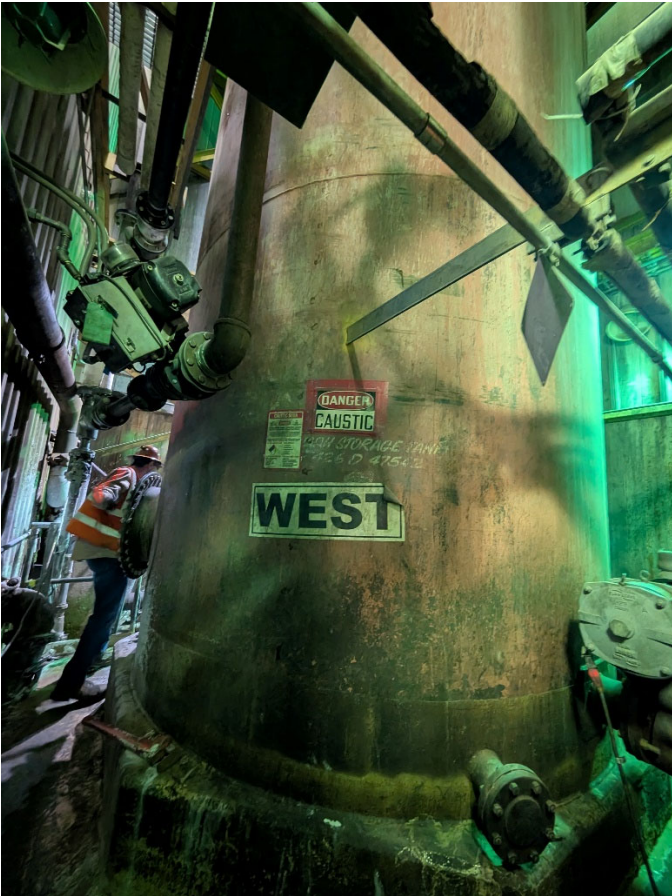
Mill EPF 2.1 - Sodium Hydroxide Storage: Two 12,300 gallon tanks are in the Nokes building on the north side of the mill building. The tanks are equipped with sonic level detectors and alarms that warn of high tank levels. The containment area was clean and clear of obstructions.

Photo 1: Mill EPF 2.1 - Sodium Hydroxide Storage West Tank in building adjacent to the north side of the Mill.

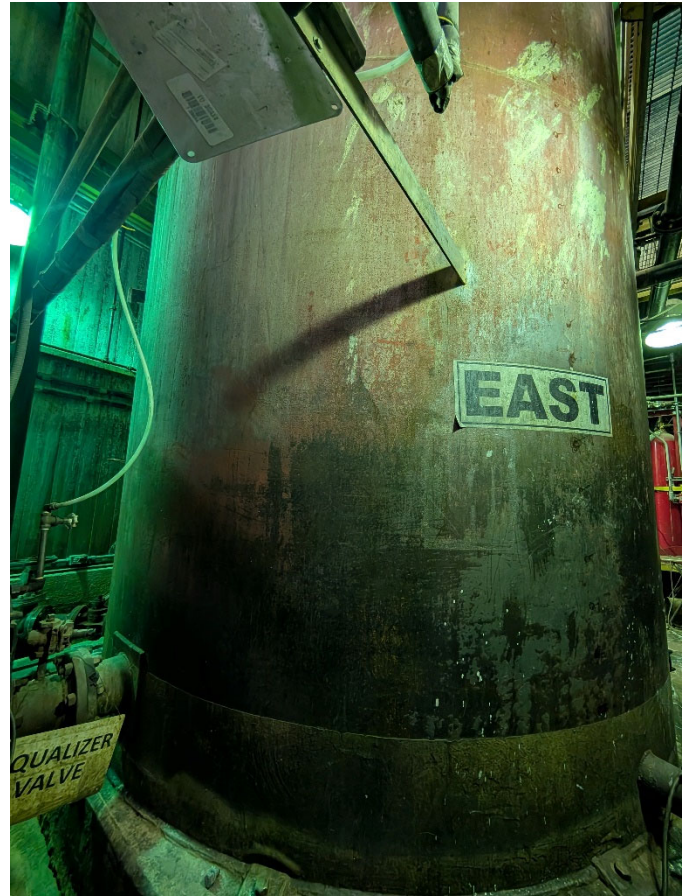
Photo 2: Mill EPF 2.1 - Sodium Hydroxide Storage East Tank in building adjacent to the north side of the Mill.

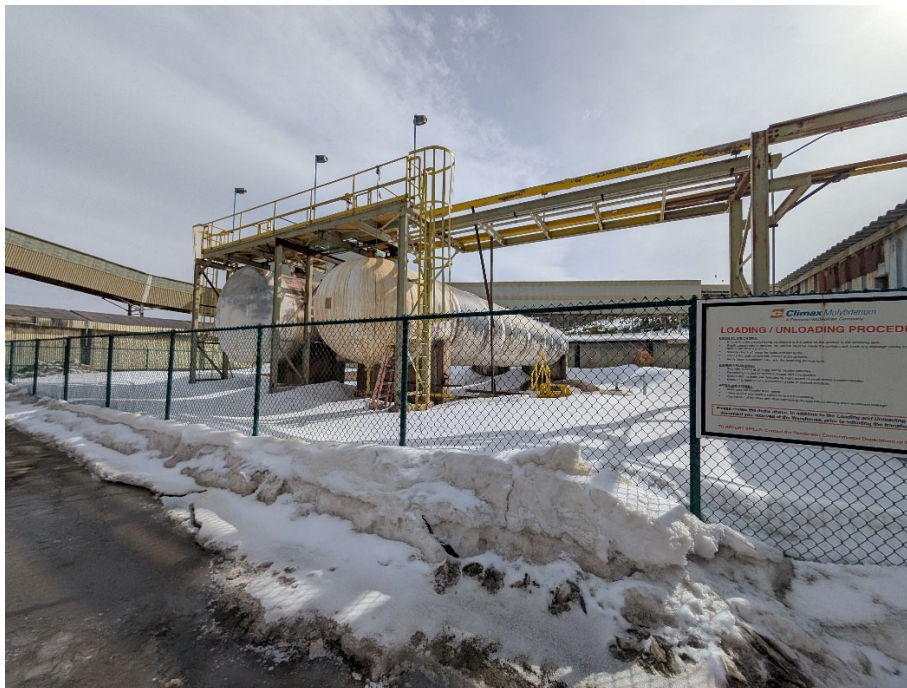
Mill EPF 2.2 - Hydrochloric Acid Storage: Two 50,000-gallon HCL tanks are located outside the mill building on the north side. The north tank is not presently being used. The tanks are sectioned off from the rest of the area by a perimeter fence.

Photo 3: Mill EPF 2.2 – Hydrochloric Acid storage yard on north side of Mill.

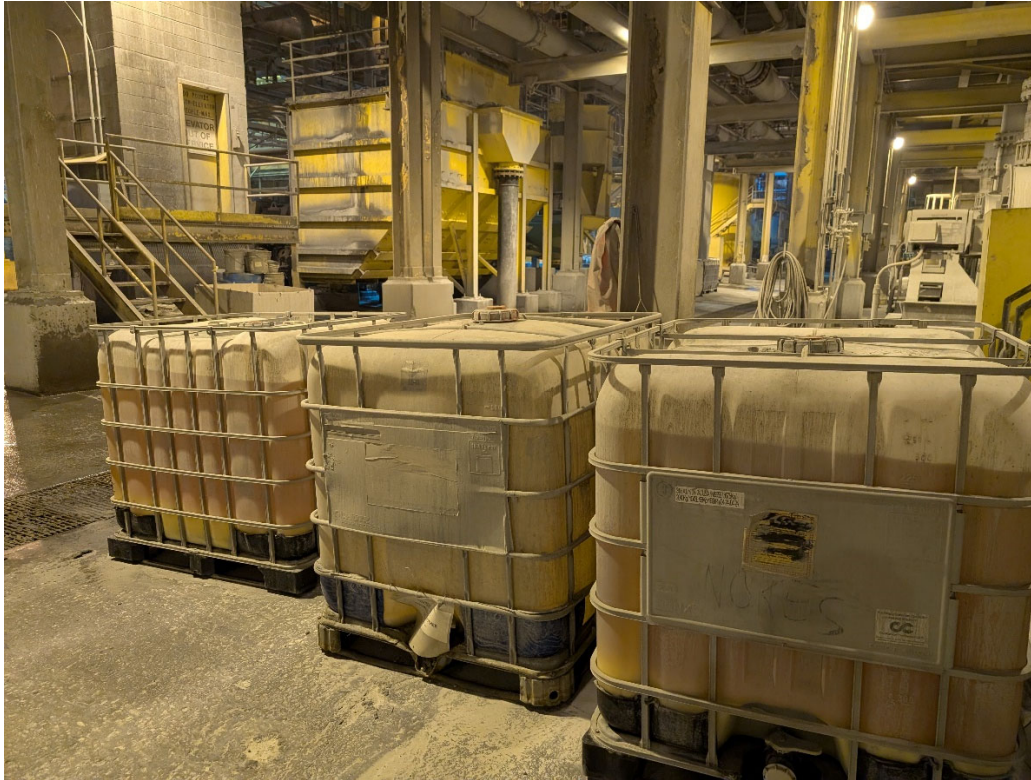
Mill EPF 2.3a - Frother Chemical Storage (Dowfroth 250-C): Frother is stored in 275-gallon totes. Six totes were observed stored on the main floor of the mill building for a total of 1,650 gallons. The maximum approved storage quantity is 2,750 gallons. The containers appeared to be in good condition and no spills were noted.

Photo 4: Mill EPF 2.3a - Frother Chemical Storage (Dowfroth 250-C) totes

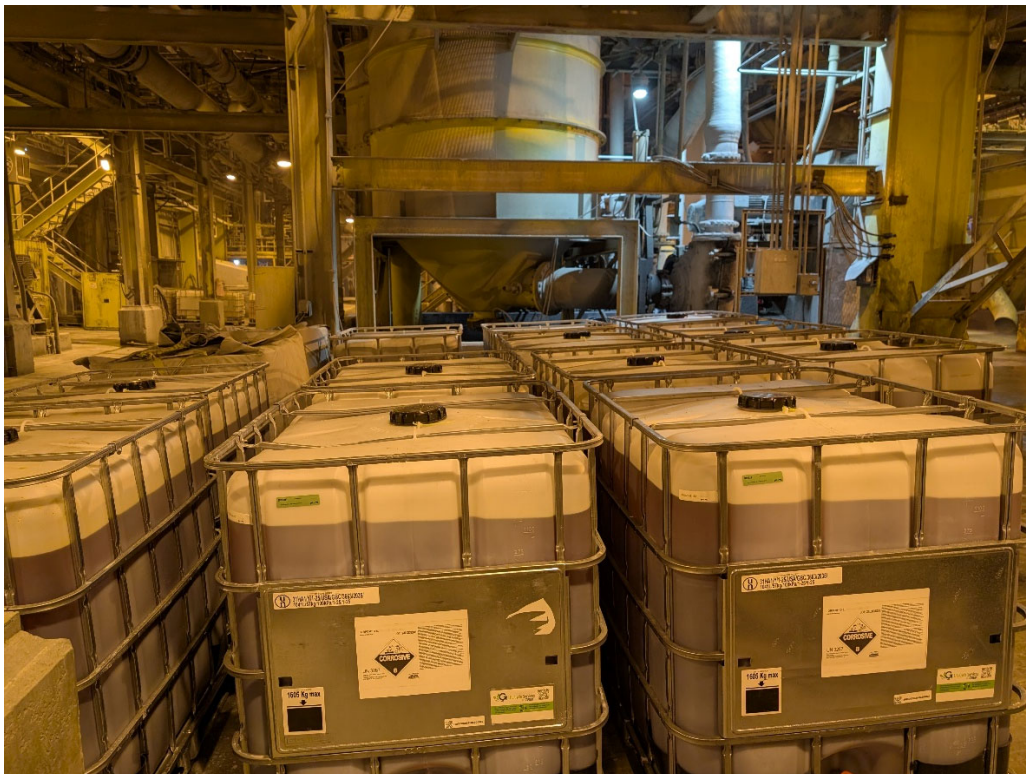
Mill EPF 2.3b - Depressant Chemical Storage (Orform D8 Depressant): Fourteen - 275-gallon totes were stored on the main floor of the mill building for a total of 3,850 gallons. The max approved quantity is 5,400 gallons. The containers appeared to be in good condition and no spills were noted.

Photo 5: Mill EPF 2.3b – Depressant Chemical Storage totes

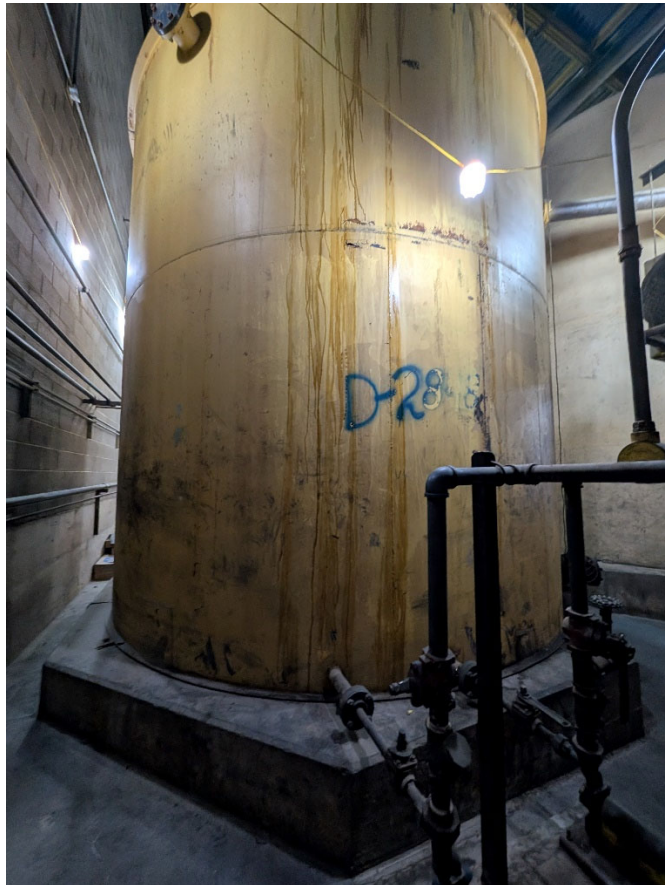
Mill EPF 2.4 - Pine Oil Storage: The 16,121-gallon tank is located in a separate tank room on the north side of the mill building. The tank appeared in good condition and the secondary containment area was clear of obstructions.

Photo 6: Mill EPF 2.4 - Pine Oil Storage

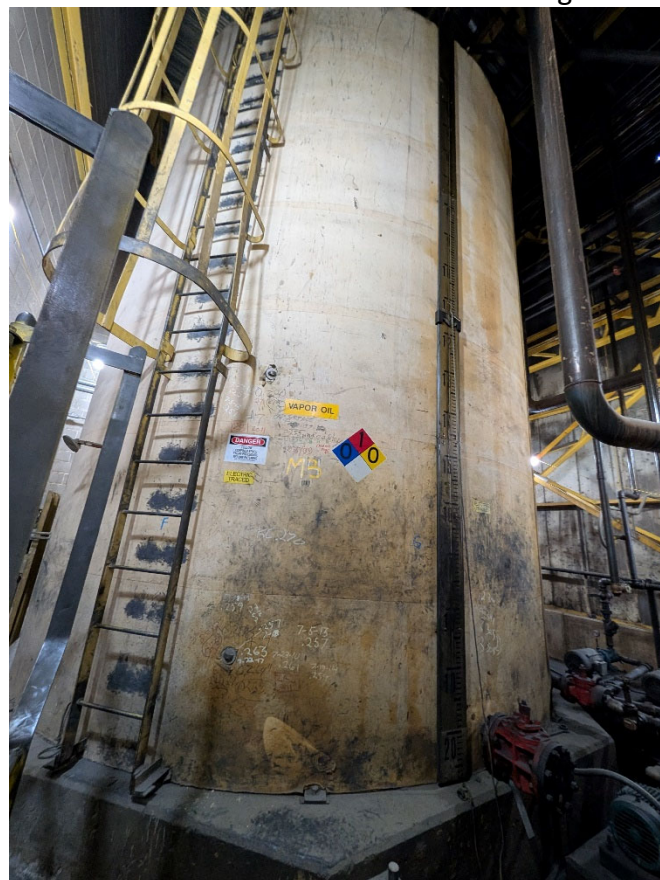
Mill EPF 2.5 - Collector Oil Storage (vapor oil and diesel #2): The collector oil and diesel tanks are each in a 32,000-gallon tank in a separate tank room on the north side of the mill building. Both tanks appeared to be in good condition and the secondary containment was clear of obstructions.

Photo 7: Mill EPF 2.5 - Collector Oil Storage

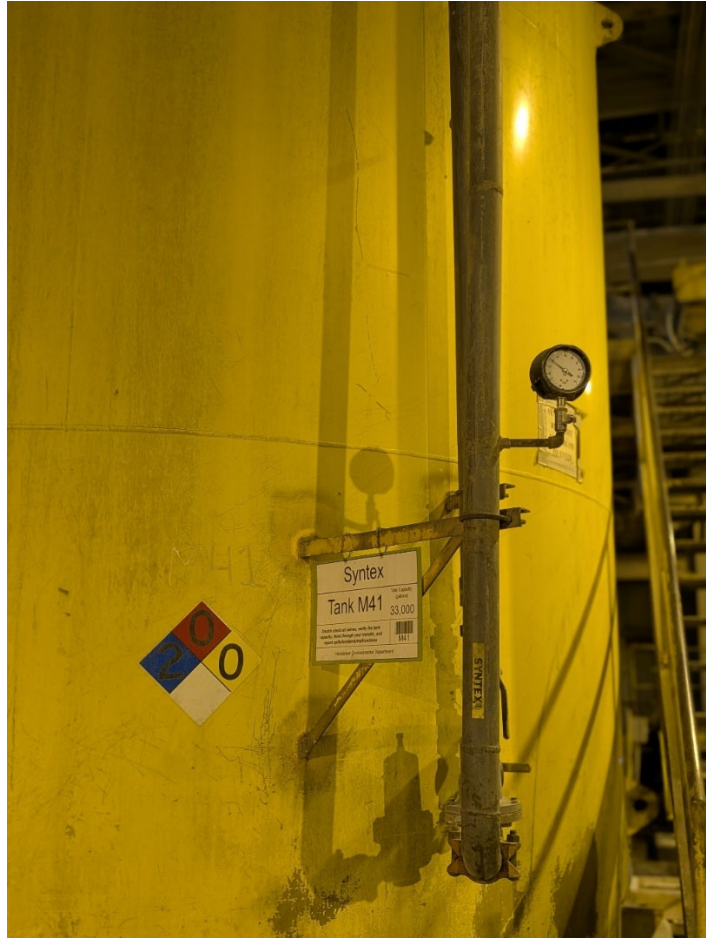
Mill EPF 2.6 - Syntex Storage: The 33,000-gallon storage tank is located approximately in the center of the mill building. The tank appears to be in good condition and no leaks or spills were noted.

Photo 8: Mill EPF 2.6 - 33,000 gallon Syntex Storage

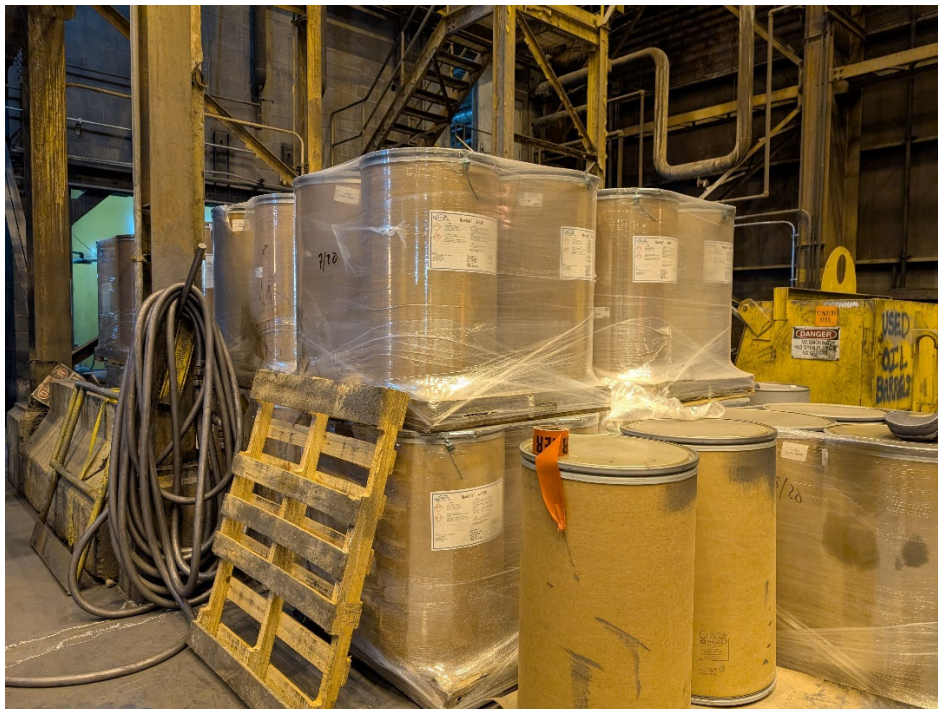
Mill EPF 2.7 - Sodium Lauryl Sulfate Storage: 70 - 220 lbs. storage containers were onsite for a total quantity of 17,380 lbs. The max approve quantity is 26,400. The storage location was clean and no spills were noted.

Photo 9: Mill EPF 2.7 - Sodium Lauryl Sulfate storage area

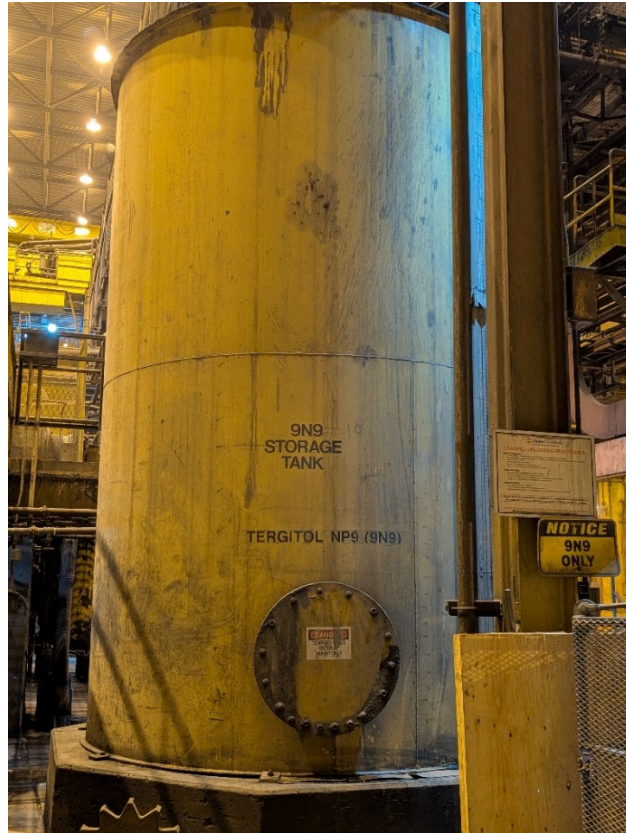
Mill EPF 2.8 - Tergitol NP-9/9N9 Surfactant Storage: The main 9,400-gallon, double walled storage tank is in the mill building on the ground floor. A second 500-gallon plastic storage tank is located on the upper floor, on the east side. Both tanks were in operating condition and no leaks were noted.

Photo 10: Mill EPF 2.8 - Tergitol NP-9/9N9 Surfactant Storage

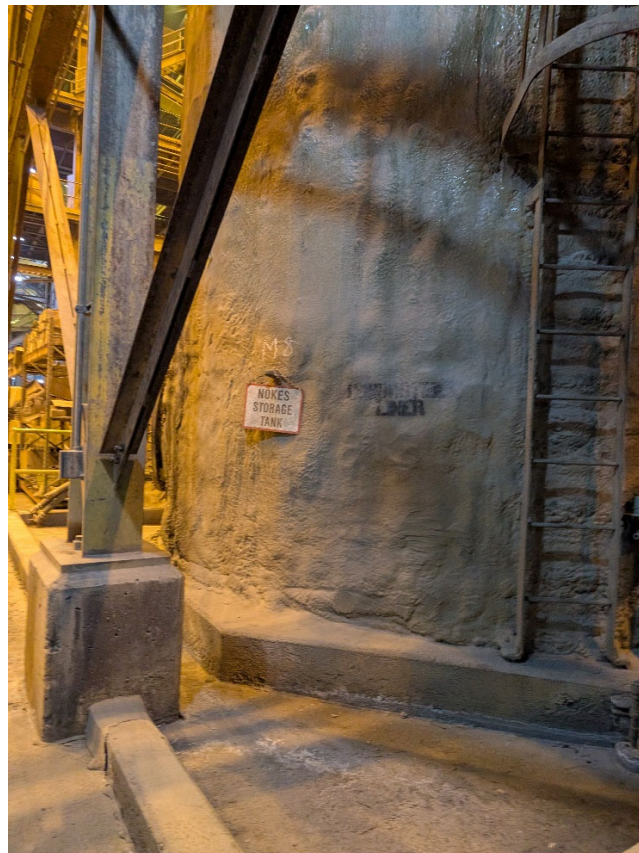
Mill EPF 2.10 - Nokes Storage: The 21,800 gallons storage tank is in the main mill building on the north side, ground level. No spills were noted in the storage location.

Photo 11: Mill EPF 2.10 - Nokes Storage Tank

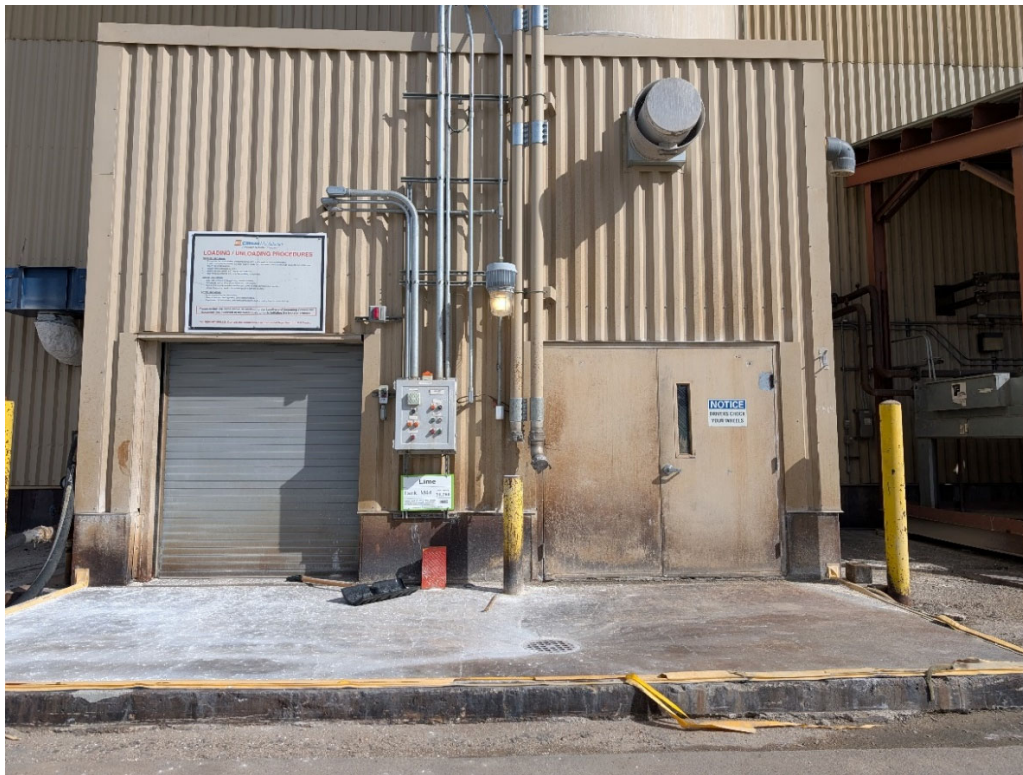
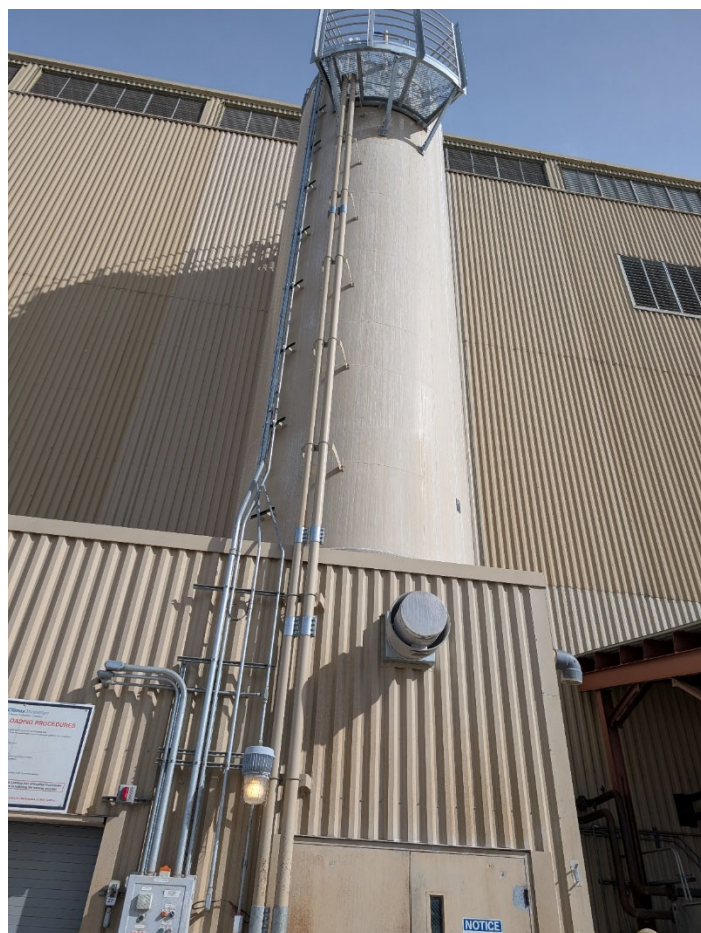
Mill EPF 2.9 - Quicklime Storage: The 31,760-gallon tank is outside the main mill building on the south side. No evidence of spills was observed. The operator stated they plan to replace the spill containment edging around the concrete slab. This is routine maintenance after winter.

Photos 11 & 12: Mill EPF 2.9 – Quicklime Storage.

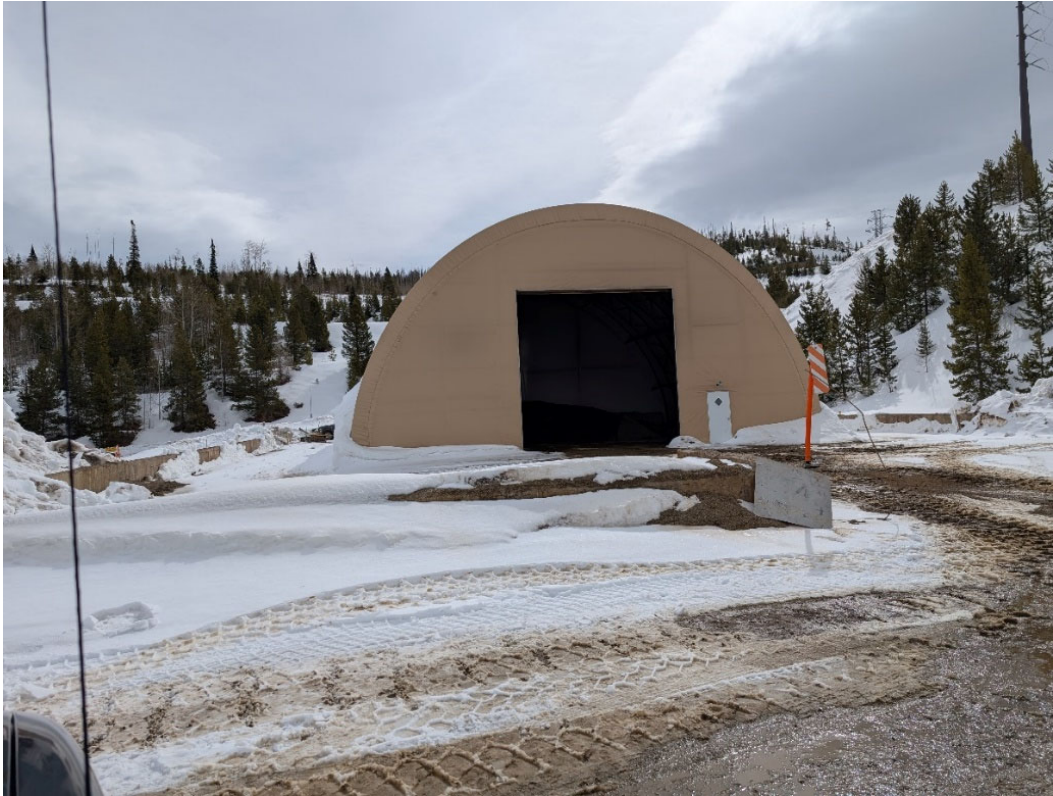
Photos 13: Looking at sand shed to be relocated for the WTP.

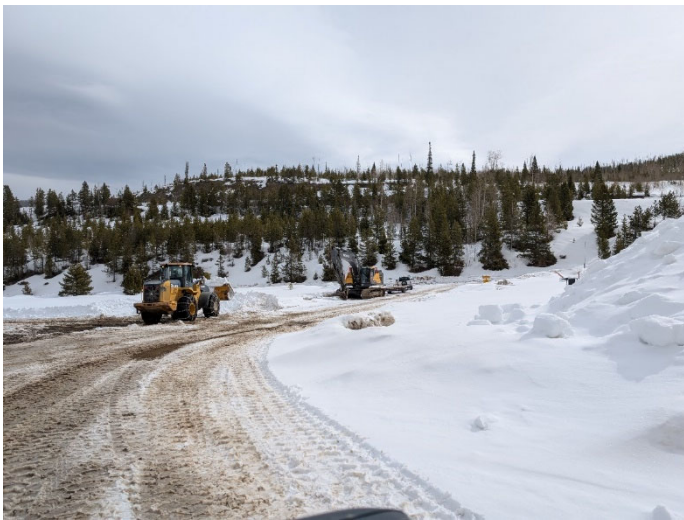
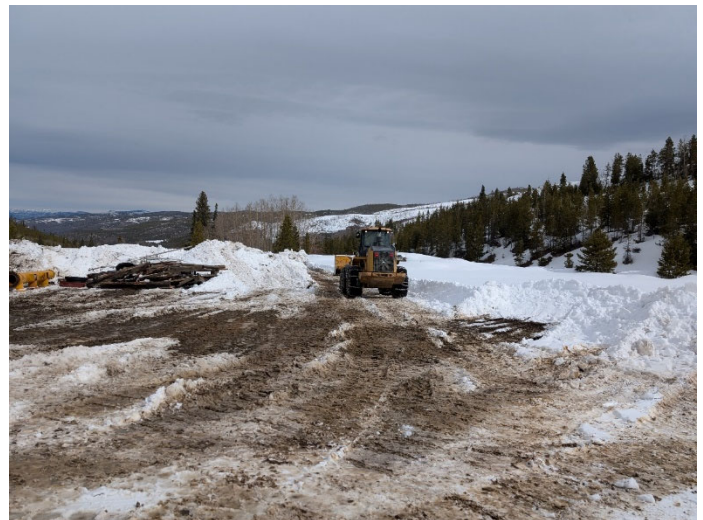
Per Rule 7.4.2, the Division is required to conduct general inspections of phased facility construction. During this inspection, the Division observed mobilization and clearing activities for the WTP which began on March 17, 2025. Following the inspection, the Mr. Hickman submitted the approved construction drawings for the WTP for the permit file.

Photos 14-15: Looking at the future site of the Water Treatment Plant, below the north side of the Mill. Equipment mobilized for the initial clearing and demolition work.
