COLORADO
Division of Reclamation,
Mining and Safety
Department of Natural Resources

**Re: Adequacy Review No. 3, 112c Construction Materials Amendment Application (AM-1)
Kirtright Pit, Permit No. M-1986-123**

Attachment 1

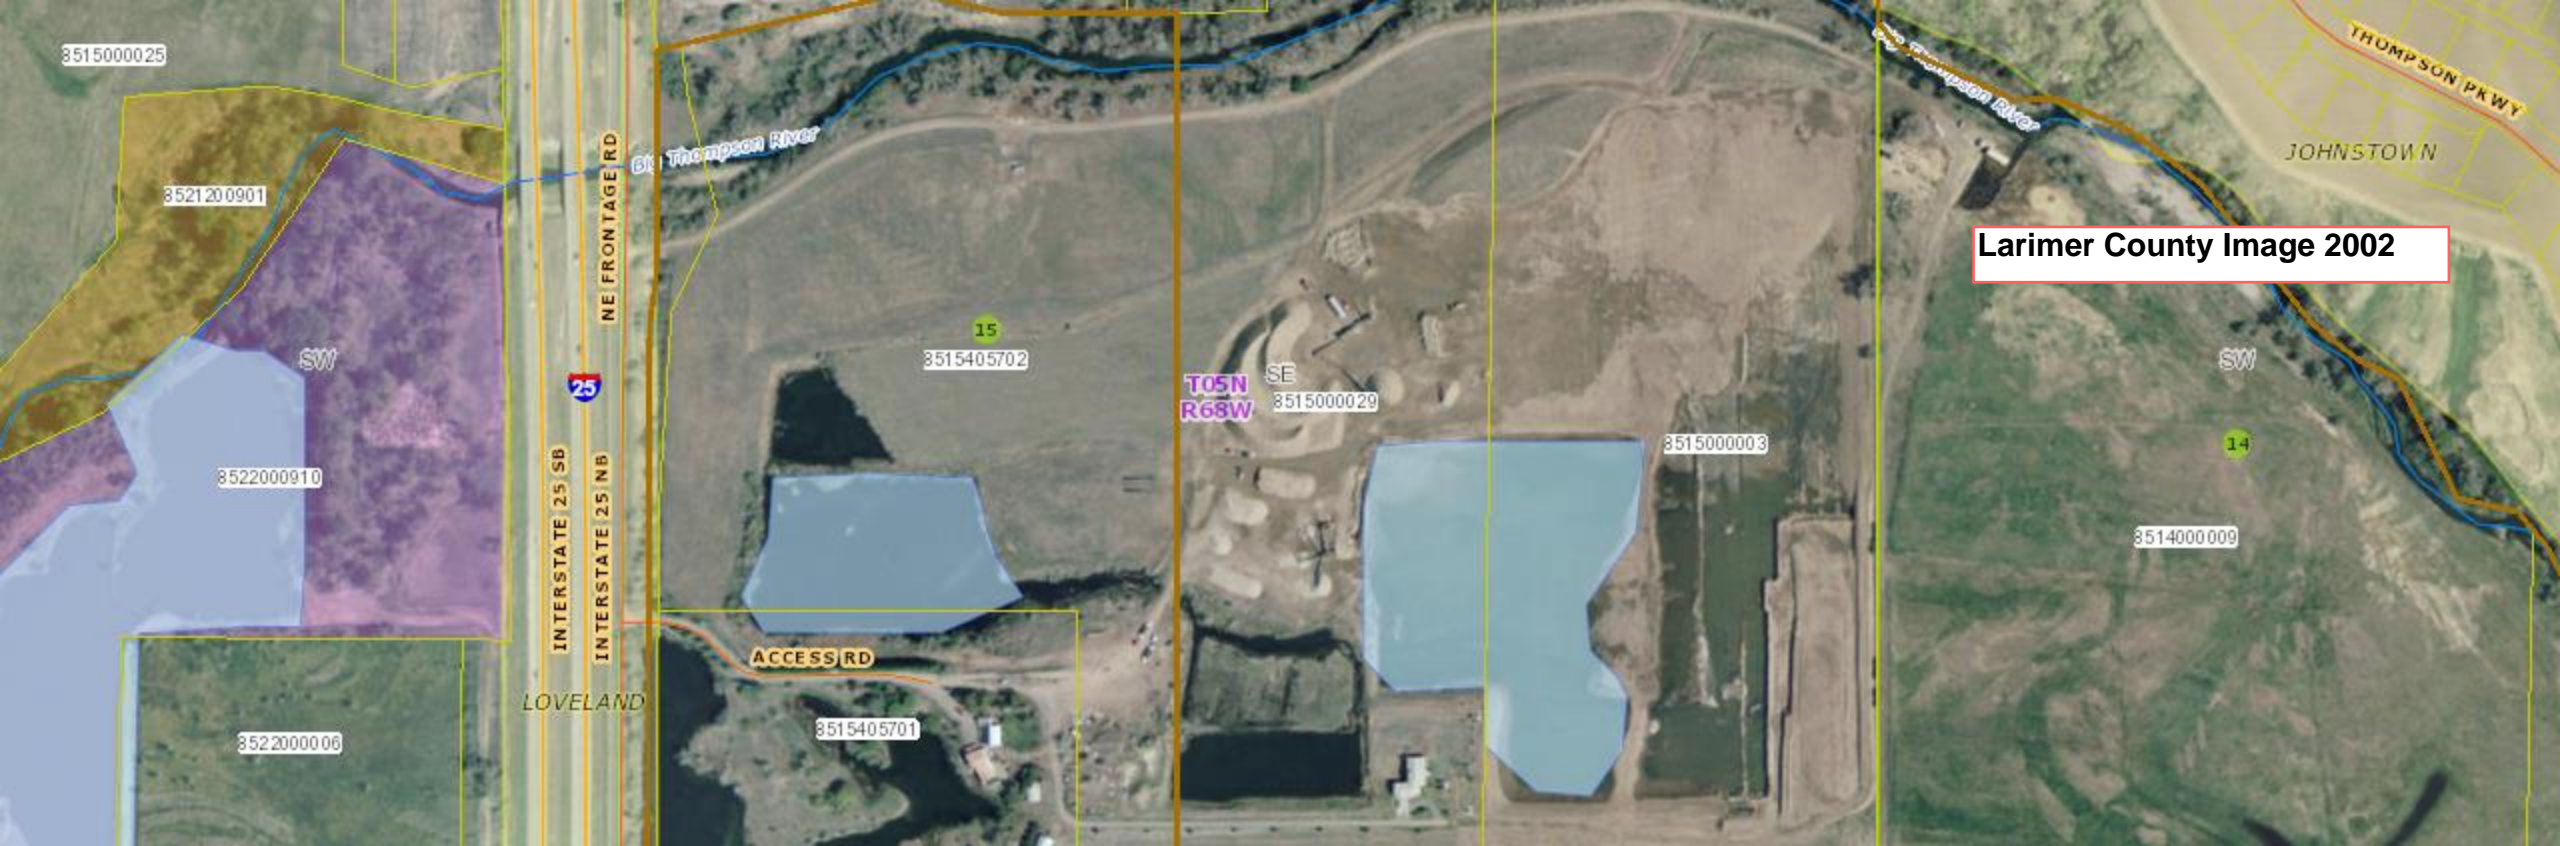
Aerial Image 1999

1. During the inspection the Division noted there are three isolated piles of gravel material in the area north of the currently approved and proposed permit boundary. Two of the piles (Pile 1 and 2) are on the easternmost property owned by Randy Kirtright and the other (Pile 3) is on the O'Brien property. Two of the piles (Pile 1 and 3) are north of the proposed/current permit boundary. The other (Pile 2) appears to be on the proposed/current permit boundary. A review of historic aerial imagery, using Google Earth and the Larimer County Assessor's website, shows that these piles were generated

during mining operations at the Kirtright Pit that occurred outside the approved permit boundary. Please see attachment 1. The Applicant must, at a minimum, expand the currently proposed permit boundary to the limits that were originally proposed (see response to incompleteness #2 dated June 7, 2024) to incorporate all areas that have been affected by the Operator during mining of the Kirtright Pit and to allow access to the three piles that need to be reclaimed and to address grading concerns discussed below.

6. Please describe how the area outside the currently approved permit boundary was affected by mining (as discussed in Item #1 above) and how it was reclaimed. Please provide a plan for reclaiming the area currently affected by the exiting stockpiles. Also, it appears to the Division that this area in question had an unmined surface elevation of around 4840' and now has an elevation of 4835'. This now low-lying area should be graded so the area positively drains back toward the river, please revise the reclamation plan and map to address this.

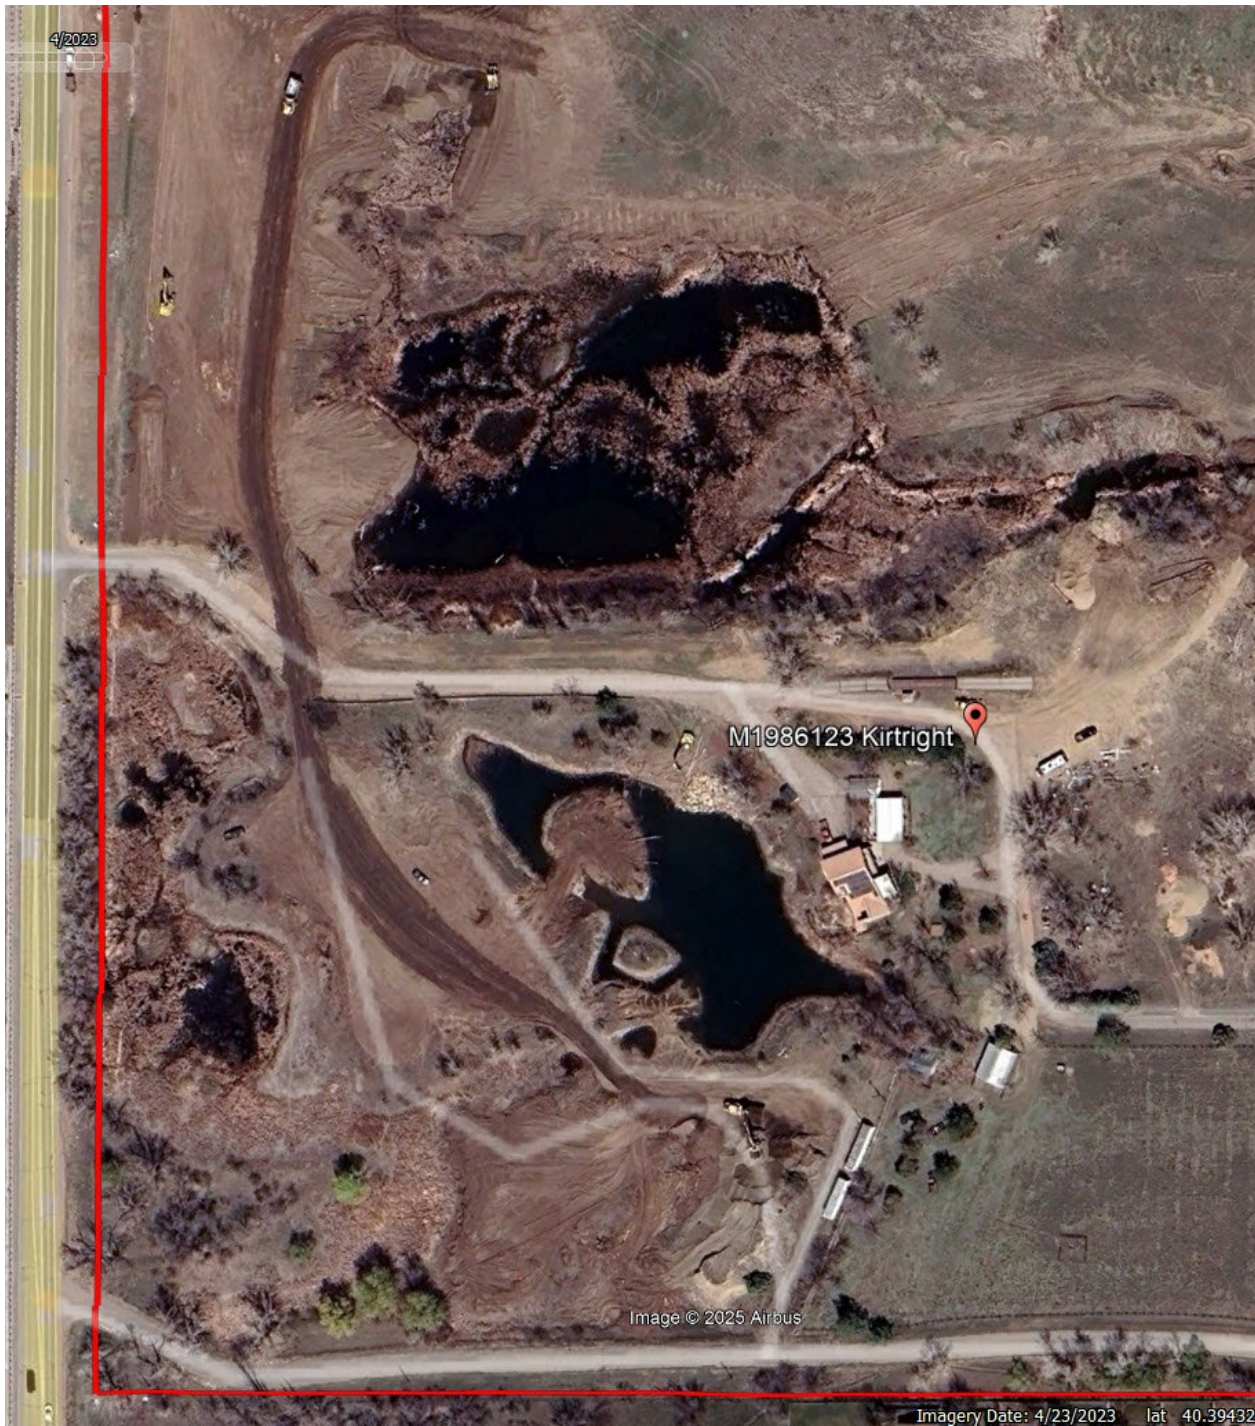
Aerial Image September 2021

8. In the responses to the Division's preliminary adequacy review the majority of the pre-1981 area is shaded to indicate the Applicant/Operator has never mined or affected this area. The Division

noted during its inspection that a large pile of gravel was now located in this area that was not there during the 2023 inspection, please comment on the origins of this pile. A review of aerial imagery from May 2023 indicates that haul trucks are being loaded with material from the shaded pre-1981 area and that material used to backfill the Pond 1 area, attachment 2. Additionally, it appears other areas of the pre-1981 area were graded and contoured during this same time. These areas also need to be included into the affected area and details for their reclamation into the Reclamation Plan.

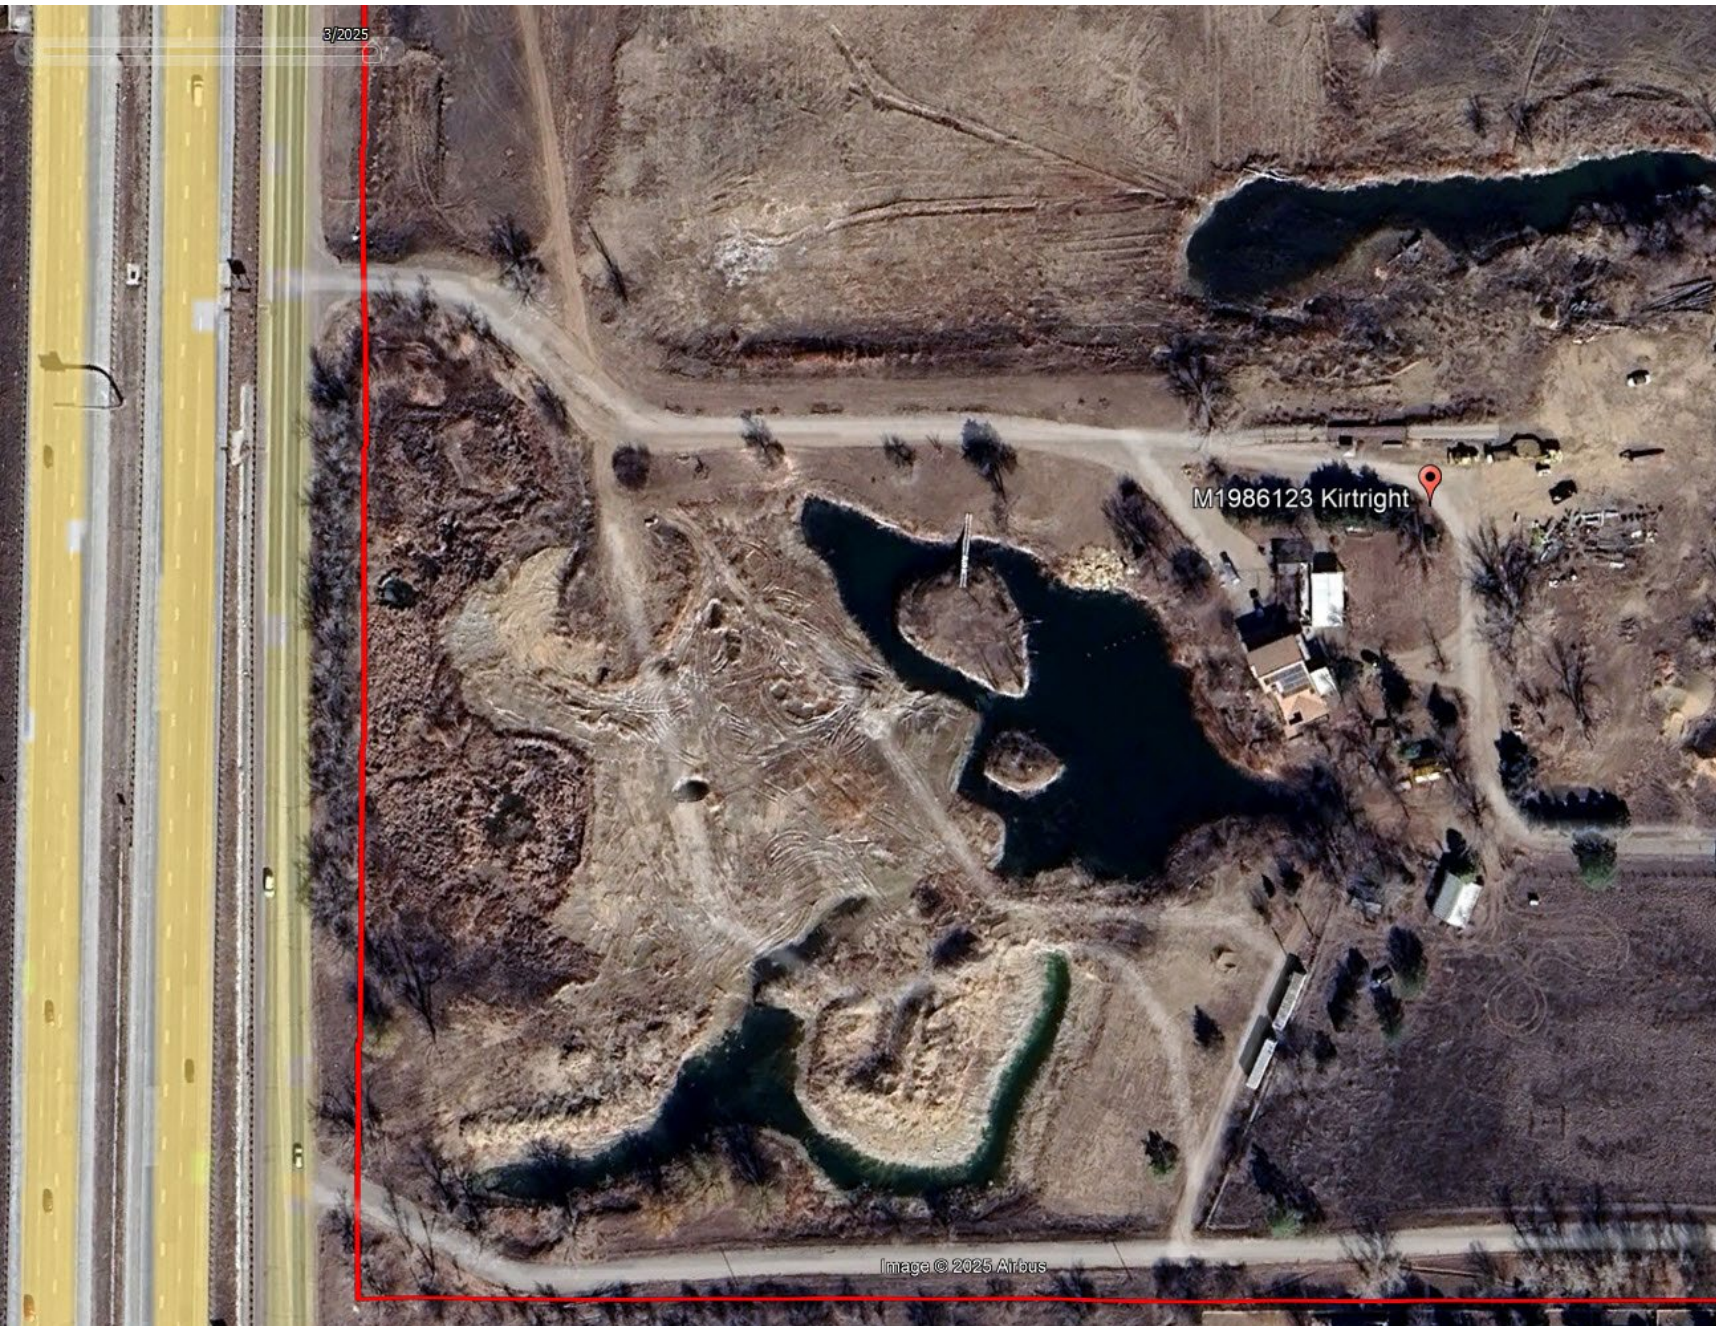
Aerial Image May 2023

Disturbance of Pre-1981 area has moved to the southwestern area. Travel paths lead to backfilling activities in the Pond 1 area.
