**MINERALS PROGRAM INSPECTION REPORT**  
**PHONE: (303) 866-3567**

<b>MINE NAME:</b> Smith Ranch Pit No 2	<b>MINE/PROSPECTING ID#:</b> M-1988-022	<b>MINERAL:</b> Gravel	<b>COUNTY:</b> Lincoln
<b>INSPECTION TYPE:</b> Surety Release Inspection	<b>WEATHER:</b> Clear	<b>INSP. DATE:</b> April 22, 2025	<b>INSP. TIME:</b> 11:00
<b>OPERATOR:</b> Lincoln County	<b>OPERATOR REPRESENTATIVE:</b>	<b>TYPE OF OPERATION:</b> 110c - Construction Limited Impact	
<b>REASON FOR INSPECTION:</b> Surety Release Requested	<b>BOND CALCULATION TYPE:</b> None	<b>BOND AMOUNT:</b> \$0.00	
<b>DATE OF COMPLAINT:</b> NA	<b>POST INSP. CONTACTS:</b> None	<b>JOINT INSP. AGENCY:</b> None	
<b>INSPECTOR(S):</b> Ben Hammar Zach Trujillo	<b>INSPECTOR'S SIGNATURE:</b>

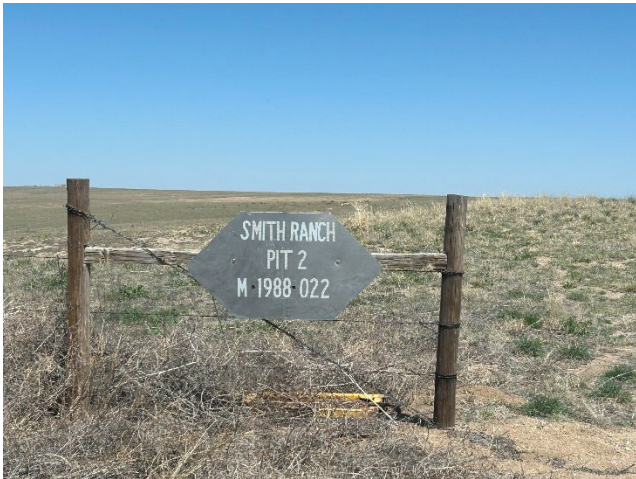
Photo 1: Posted ID sign at entrance.

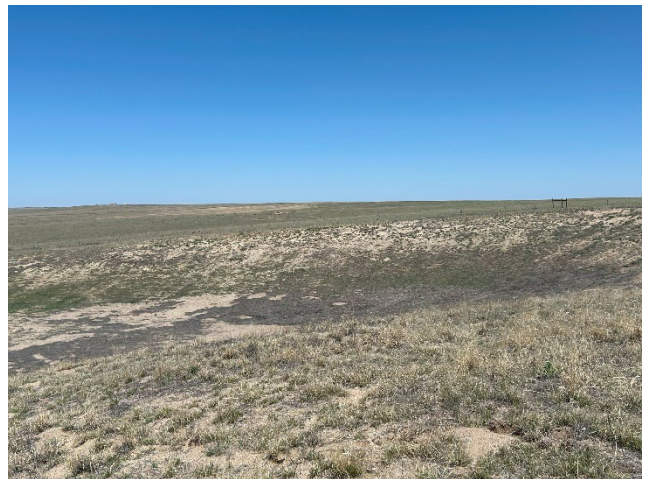
Photo 2: Least vegetated area. Note the established slopes and seeded areas.

Overall, the grading of the site appears to be adequate and adheres to the 3:1 slope requirement of the rangeland post-mining land use. Vegetation appears to be well established, with only minor bare areas located in the pit floor where water tends to pool during significant storm events. As observed during this inspection, the site appears to be trending towards complete cover and being generally in-line with the agricultural character of the surrounding land. Based on this, the Division will approve the release request and will be providing a formal approval letter to accompany this report.

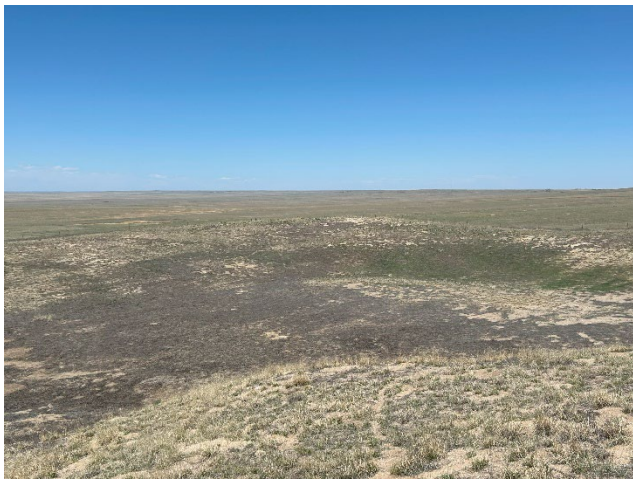
Photo 3: Pit floor with representative ground cover.  
Vegetation was dry at the time of inspection of covers the floor well.

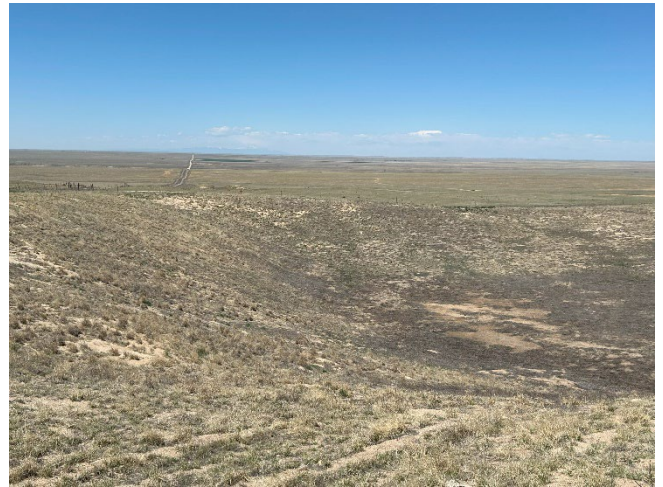
Photo 4: Western slope of the site. Vegetation is well established and similar to the surrounding cover.
