RE: Collett Property, Permit No. M-2024-012 and M-2022-051 Unresolved Problems Report

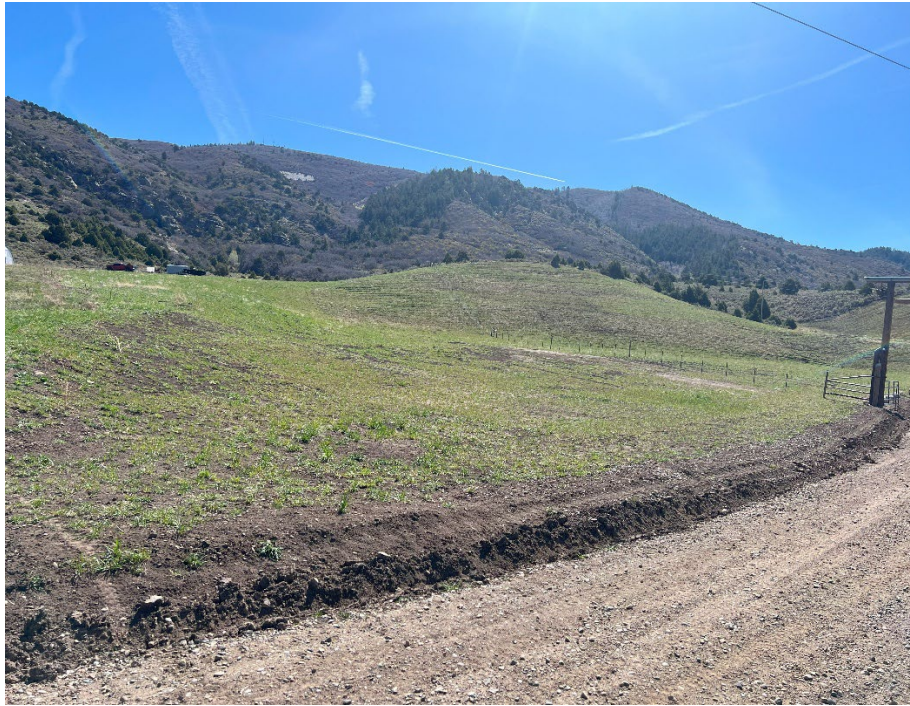
Photo 1 - Collett site facing southeast.

Problem: Erosion gullies, sedimentation, soil cracking, and ruts were observed on-site.

WW Clyde Response/Corrective Actions: WW Clyde hired Bolton Construction (Bolton) to address erosion problems. Bolton raked areas of rilling, cracking, and ruts and removed sediment from flow channels and culverts. Bolton also added riprap armor to culvert inlet/outlets. Initial site work was completed on March 28, 2025. Additional riprap armoring was placed at culvert locations on April 11, 2025.

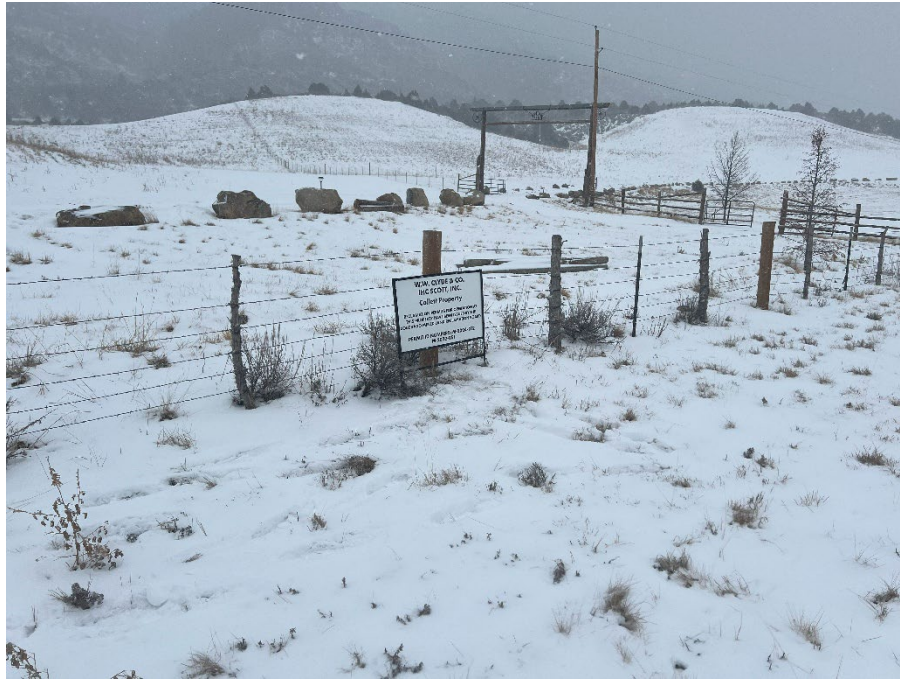
Photo 10 - Collett property sign.

Problem: The Operator shall, at the entrance of the mine site post a sign, which shall be clearly visible from the access road, with a minimum size equaling one hundred and eighty-seven (187) square inches....

WW Clyde Response/Corrective Actions: WW Clyde posted the required signage and sent a picture of sign to DRMS on December 31, 2024. The DRMS issued a letter on December 31, 2024, documenting that the inspection problem was abated.
